# AusNet

## Infrastructure at Terminal Stations

Asset Management Strategy

| <b>Document number:</b> | AMS 10-55 |

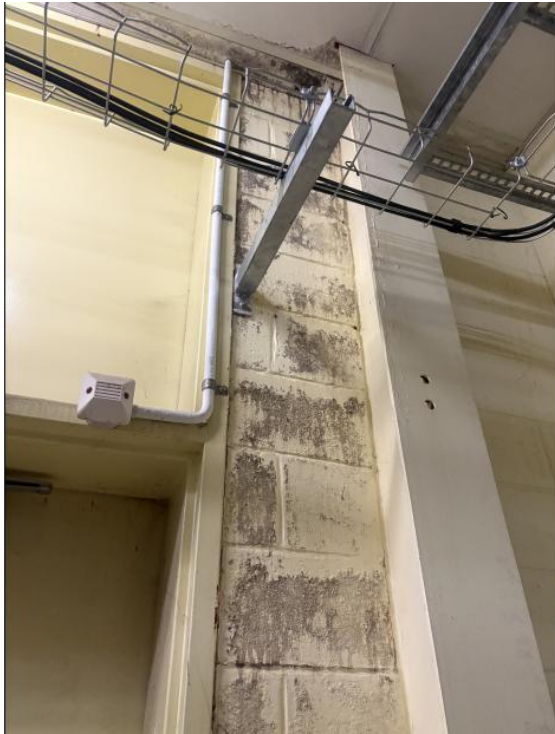
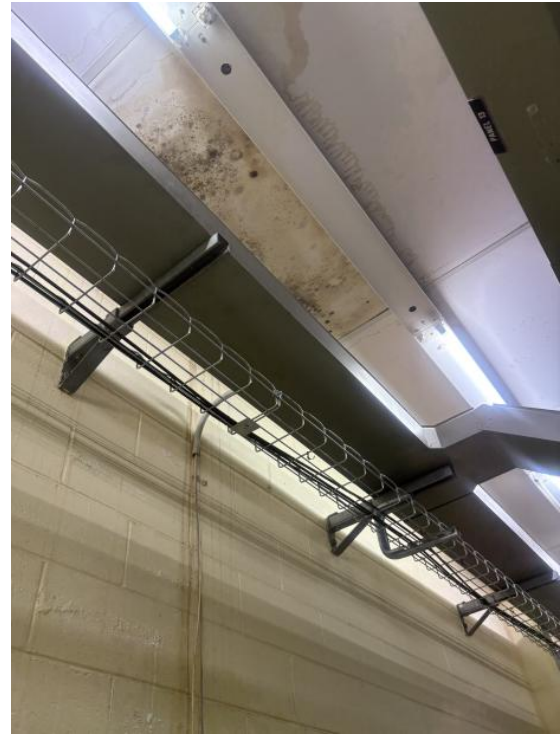
**Figure 22: Poor condition of Walls and Ceilings at LY**

Stations: LY, RCTS, TSTS, JLTS, \*MLTS, \*LYPS, \*MWTS, \*HWTS.

Scope: Refurbishment of structural elements like walls, ceilings, windows, doors, roofs, floor tiles, toilets, and ancillary rooms (mess, storage, battery).

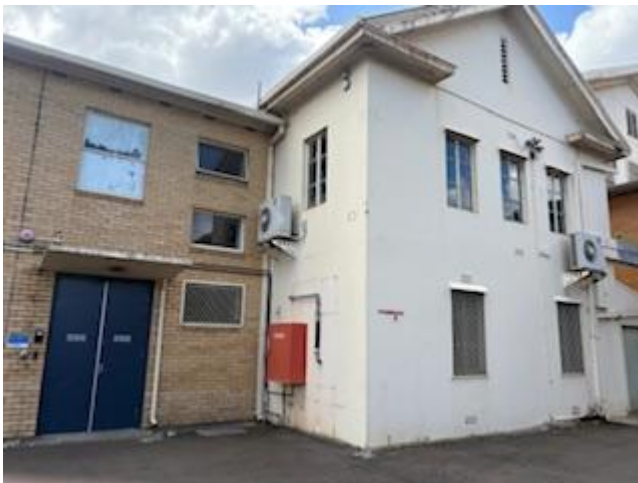
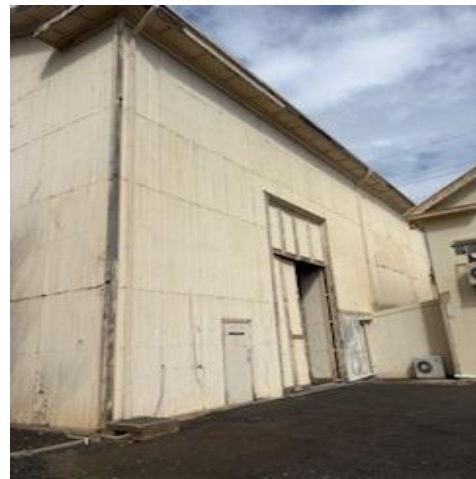
**Figure 23: Poor condition of Buildings at TTS**

Stations: \*TTS, \*BATS

Scope: Demolition of old control buildings and extension of new control buildings

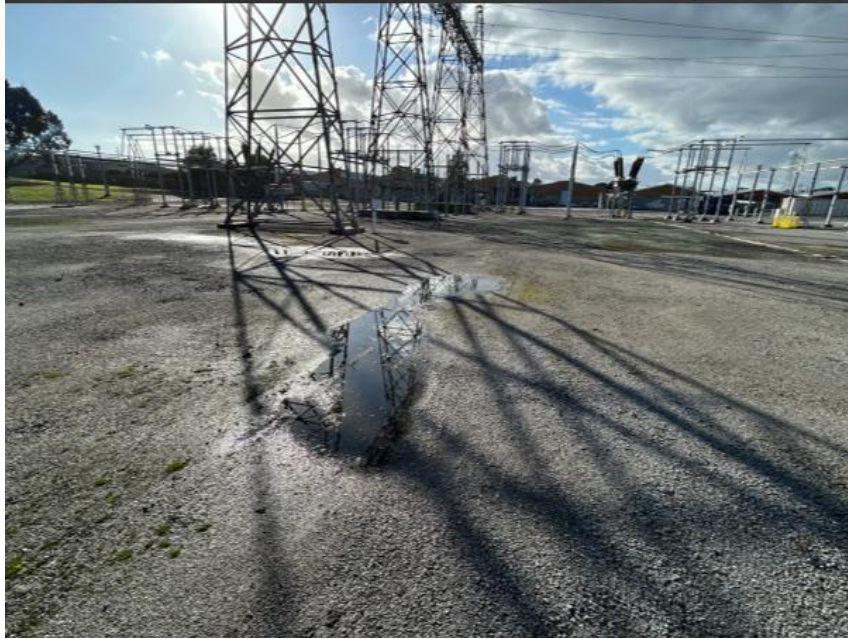
**Figure 24: Poor condition of Switchyard at HTS**

Stations: HTS, \*TTS, \*BATS, \*MWTS, \*TBTS

Scope: Surface rework, cable tray lid replacement, tray and drainage repairs.

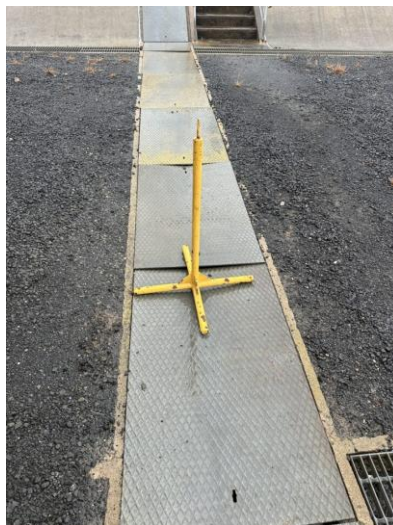
**Figure 25: Poor condition of cable trench covers at BETS**

Stations: KTS, SMTS, HWPS, HWTS, YPS, BETS, SHTS, RWTS, RCTS

Scope: Replacement of cable trench covers.

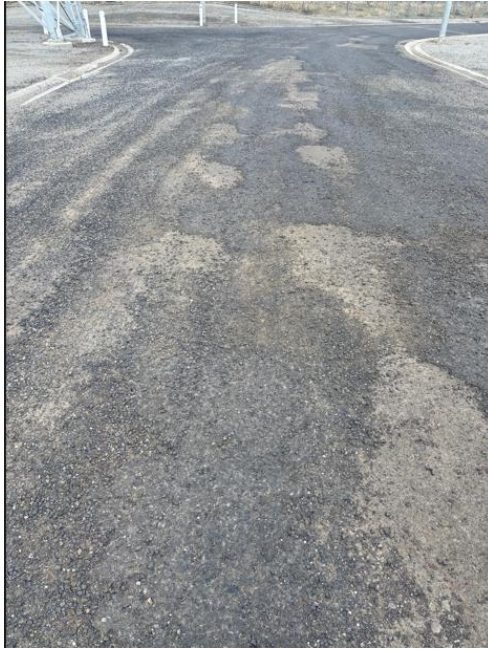
**Figure 26: Poor condition of Roads at SMTS**

Stations: SMTS

Scope: Road resurfacing and repair, including drainage and gutters.
