K-BIK Power Pty Ltd

REVIEW OF ASSETS FOR REPLACEMENT OF SUBSTATIONS WITHIN JEMENA'S NETWORK

Report Reference Number: **VIC-JEM-008-R1/V1.0**

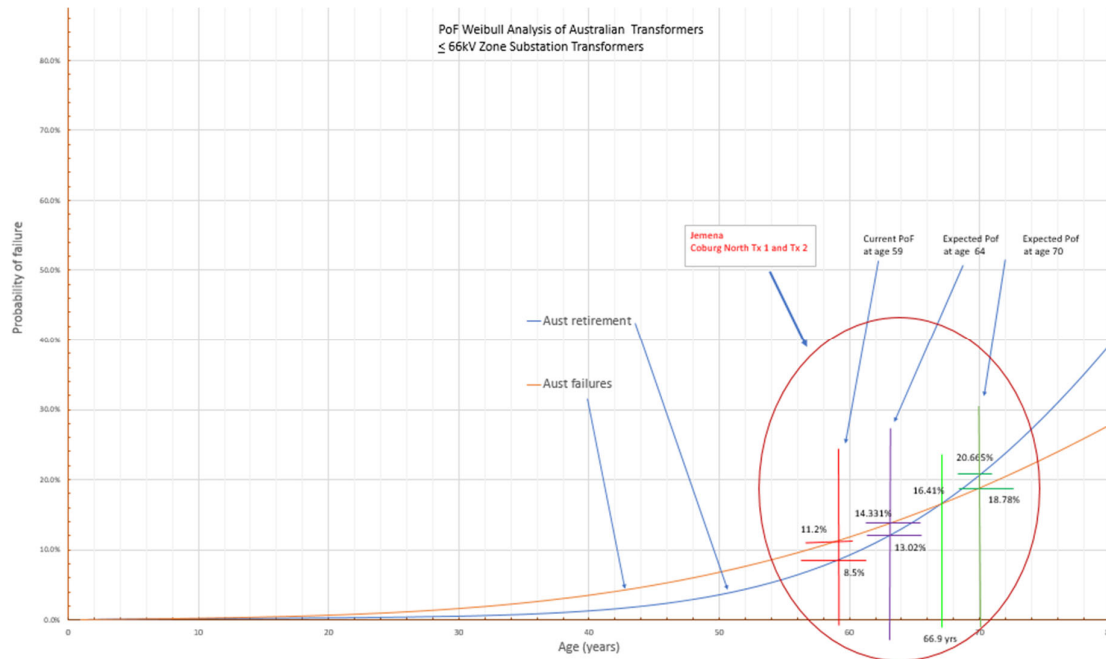
Figure 5 | Plot of PoF Weibull analysis for CN transformers

The Weibull analysis above in Figure 5 and Table 1 shows that the risk of an in-service failure increases from 5% in the first year after 2025 to 28% in 5 years and then to 61% in 10 years. This is based on continuing the routine maintenance and doing nothing else.

Note: The Weibull analysis also shows that the point at which the retirement and failure curves cross is at 66.9 years and a PoF of 16.41%. This point is generally accepted as the point at which the transformers should be retired and is almost 70 years of age. The normal design life or operational life is generally accepted as 40 years but there is more than enough industry experience and proof that transformers do last beyond that to approximately 60 years. There is also enough industry experience and proof that beyond 60 years and with internal paper insulation at <250DP the transformer has reached end of life and will likely fail before 70 years of service.

It is recommended that these transformers (Nos. 1 and 2) be replaced within the next 5 years before they fail and cause significant network disruption.

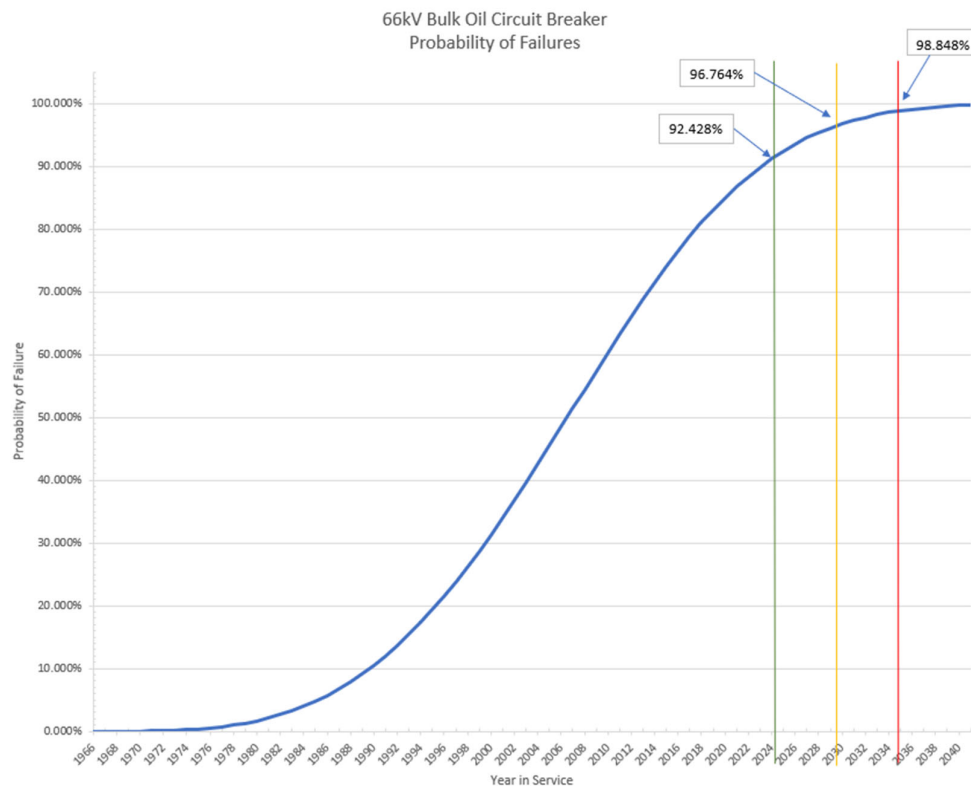
Figure 7 | CN ZSS 66kV CB Probability of Failure Curve

At present (2025) and based on the age of the circuit breakers there is a 92.4% probability that a bulk oil breaker will fail in the next year. This increases in the next 5 years to 96.76% probability when the breakers reach a 64-year service life. Noting that the breakers were made in or before 1966 and went into service in 1966 when CN was built. The assessment has been made on the service life not the nameplate age which in some instances is before 1966. Nonetheless these breakers are considered to be at a high risk of a failure over the next 12 months and beyond until they are replaced. If allowed to remain in service for the next 10 years until 2035 then the probability of a failure is almost 99% and, in that time, it is likely that at least 1 or more will fail.

The assessment done show that the risk of a failure is high mainly because the size of the fleet is small and the age of the circuit breakers.

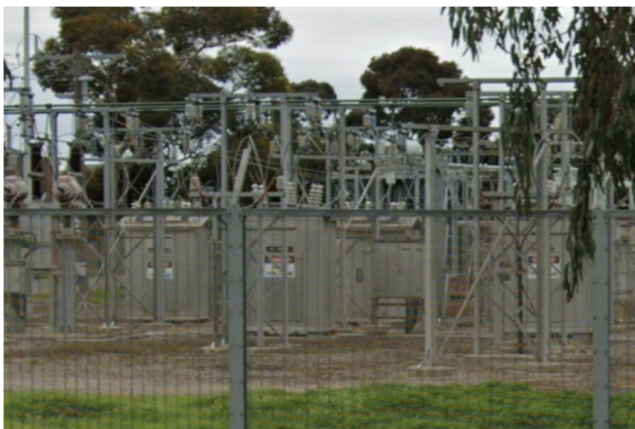
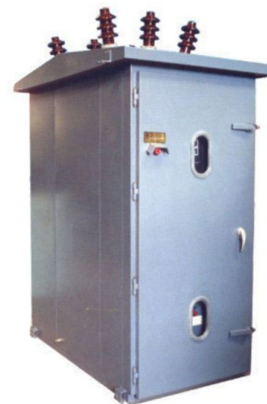
Figure 8 | CN ZSS 22kV CBs in switchyard and similar type.

The 22kV circuit breakers are indoor type breakers housed in individual outdoor enclosures. Figure 8 shows the side view of CN ZSS 22 kV yard and an example of this type of circuit breaker arrangement.

These outdoor types of circuit breaker arrangements were not manufactured as arc fault contained or vented. Therefore, switching of these breakers must be done remotely to ensure operators are

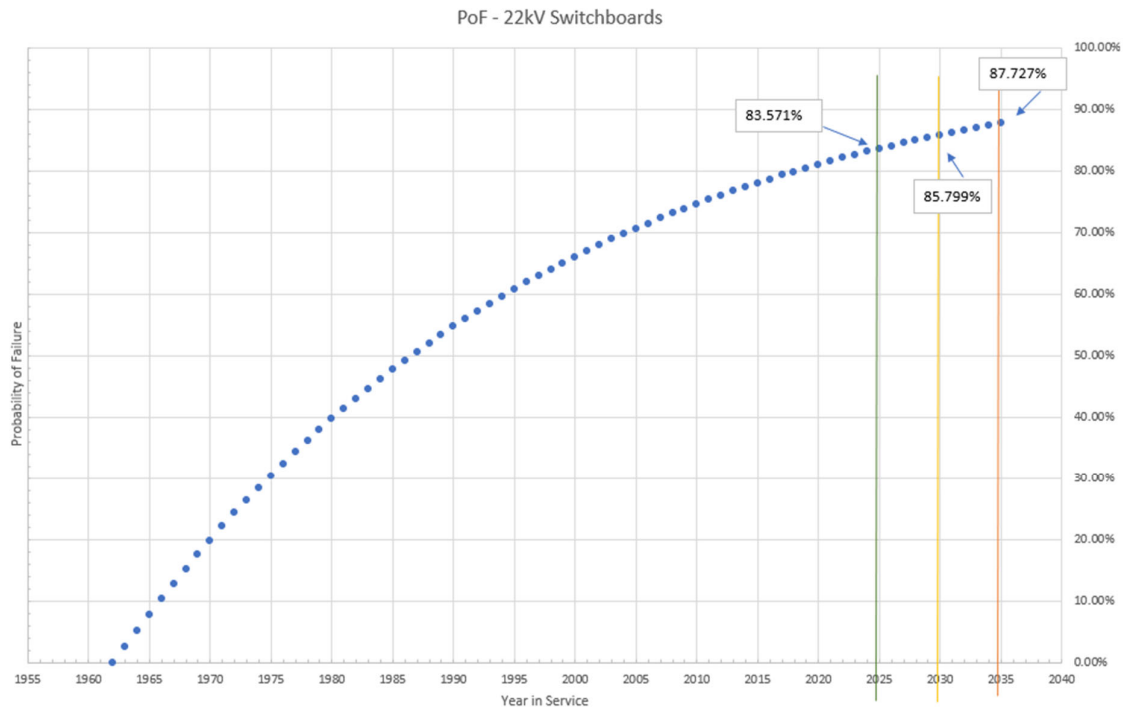
Figure 10 | CN ZSS 22kV CB Switchboard Probability of Failure Curve

Figure 10 above is the Weibull probability for the 22kV circuit breaker switchboards.

In the present state there is a 83.57% probability that Jemena will have one of these old 22kV CB panels fail in the next 12 months. If the breakers are not retired by age 73 then that probability of failure will increase to 87.73% probability of a failure in that year.

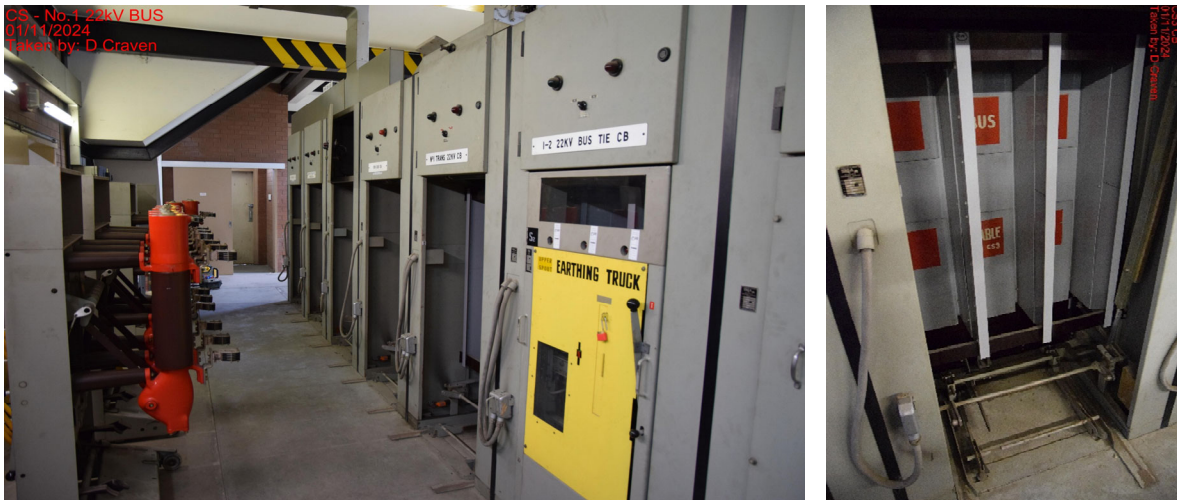
Figure 12 | CS ZSS 22kV Switchboard.

The risk is when the breaker is racked out or racked in there is at least one side of the busbar (inside the spouts) that is alive. If there is a fault at the time of racking, then the switching operator is at risk of experiencing an arcing fault. These breakers are a minimum oil type and so any arcing fault is likely to ignite the oil and cause a fire.

The switchgear has been maintained but the maintenance records are now showing that many breakers are starting to leak and need oil replacements.

Modern arc fault contained and vented switchboards only allow the operator to rack the breakers when the bolted arc fault tested door is fully closed. This way if an arc fault occurs it does not expose the operator to the same level of risk.

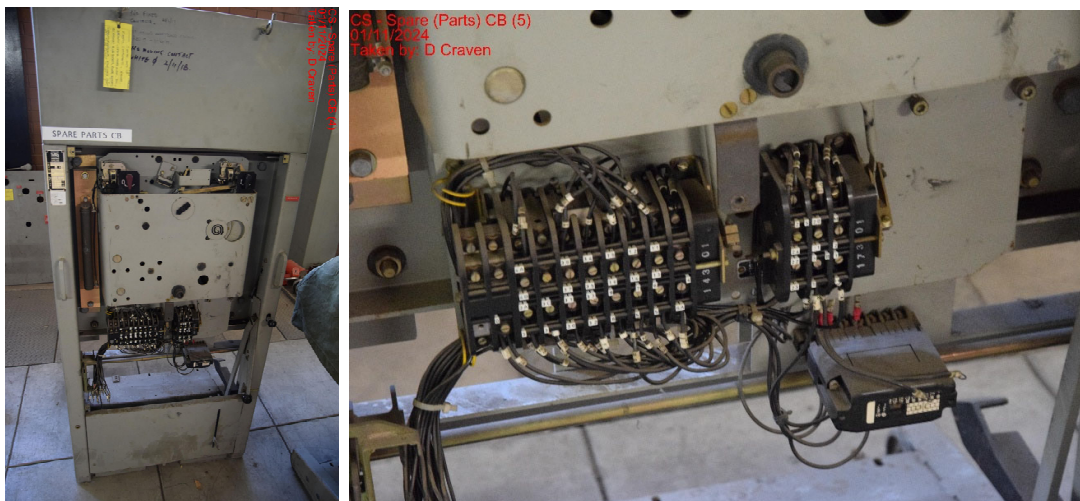
Figure 13 | CS ZSS 22kV Circuit Breaker Control Wiring

The control wiring within the circuit breakers is older exposed type wiring (refer Figure 13). The control breakers and switches are older bakelite type which are no longer manufactured. These are

electro-mechanical devices and when a control circuit issue arises it is difficult to trace. The components must be obtained from other old unserviceable breakers to ensure they operate as intended. Retrofitting new devices is not an option as the way these devices trigger a trip or close of the breaker is very specific to the manufacture of the breaker.

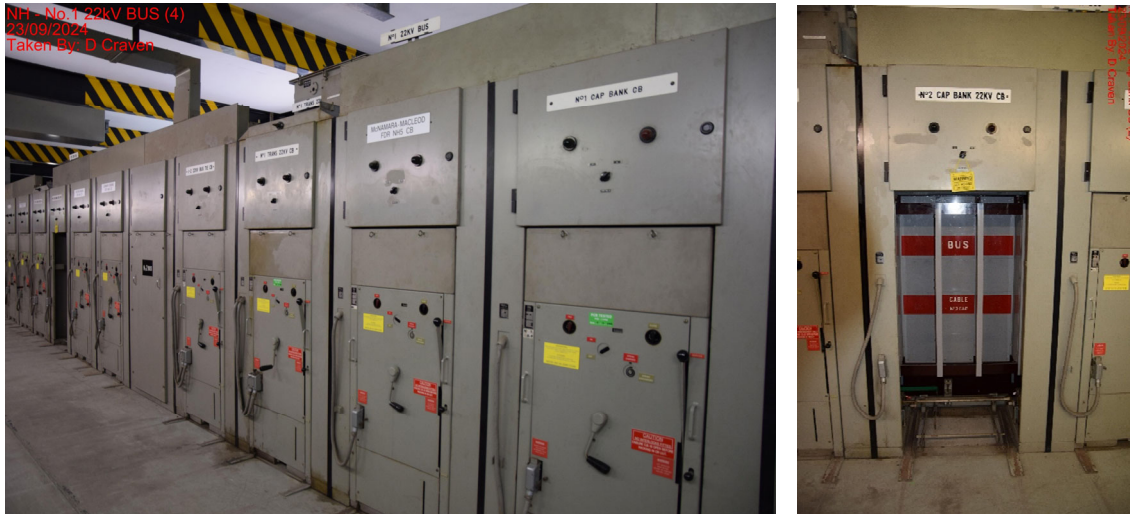
Figure 14 | NH ZSS 22kV Sprecher & Schuh Switchboard

The switchgear has been maintained but the maintenance records are now showing that many breakers are starting to leak and need oil replacements.

The PoF has been calculated for the 22kV switchboard as per Section 2 above, but this switchboard is 51 years old and therefore the PoF on the curve is at 78.8%. In 5 years this will have increased to 88.35% which is an overall increase of 10.8% above the current risk level. The boards are fast approaching end of life and have entered the wear-out phase of the bathtub curve.

Modern arc fault contained and vented switchboards only allow the operator to rack the breakers when the bolted arc fault tested door is fully closed. This way if an arc fault occurs it does not expose the operator to the same level of risk.
