# Powerlink 2027-32 Revenue Proposal

CP.02170 Chinchilla Substation Replacement

# T013 CHINCHILLA

## PRIMARY PLANT CONDITION ASSESSMENT REPORT

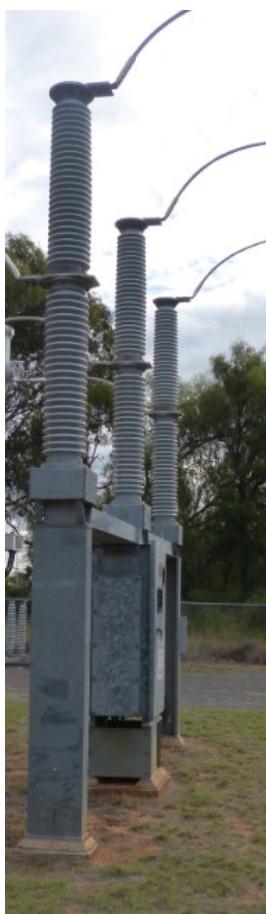
Figure 14 - CB

The circuit breaker (CB) in this bay was manufactured by Mitsubishi. It has a pneumatic-spring type operating mechanism with SF6 gas for insulating medium. This type of CB is no longer manufactured by Mitsubishi and hence no support with parts is available. Although the presence of asbestos in the CB control cubicle was confirmed in 2018, the asbestos containing materials were removed in 2019. A number of air valves within the air system of this CB failed in the last 15 years and although many have been replaced, the replacements are all second hand and therefore not in good condition. This has been evident with a faulty air drain valve requiring further replacement in 2022. This CB suffers from corrosion, issues related to non-functional counters and indicators and issues with air leaks and relays. There are issues with lack of relevant skills to maintain this type of CB. With the spare parts shortage and breaker's mechanism becoming slower, it is estimated it can be maintained in an electrically and mechanically safe condition for a maximum of 3 years with 2-3 outages per year required to keep up with expected corrective repairs.

Based on the above observations, it is recommended to replace the circuit breaker in the next 3 years, as its failure will result in network loads being put at increased risk of losing electricity supply for a long period (due to CB not being supported and no spare parts being available and CB replacement most likely requires replacement of structure and foundations). In addition, the failure would potentially result in a significant SF6 gas leak, causing harm to environment. No explosive failures of this type of circuit breaker were recorded in Powerlink.

In summary, it is recommended that the CVT, SAs and CB be replaced within the next 3 years, including their structures and foundations.

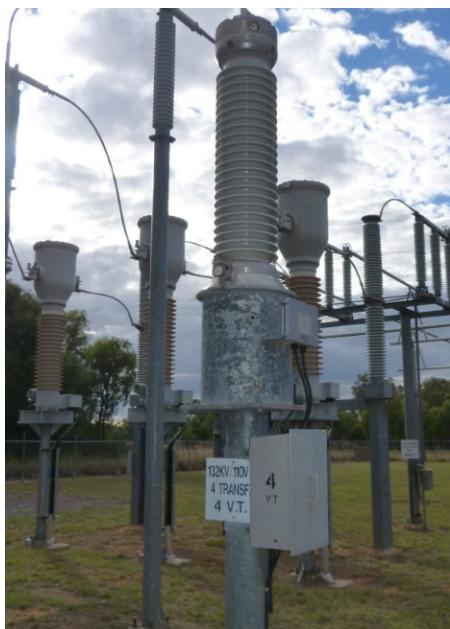
Figure 16 - A Ph. CVT and the new CT's behind.

The capacitive voltage transformer (CVT) on phase A in bay D01 was manufactured in 1983 and has been in service for 42 years. According to maintenance records, it has a smashed gauge and oil level appears to be low. As its failure due to the porcelain casing can result in

major safety consequences and it is clear that gaskets are significantly aged allowing moisture ingress, it is recommended to replace it within the next 3 years.

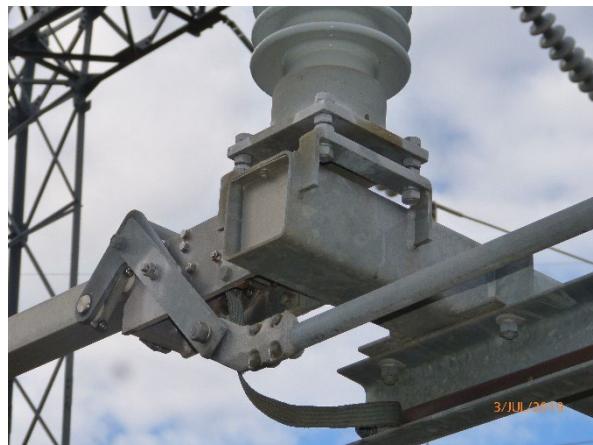
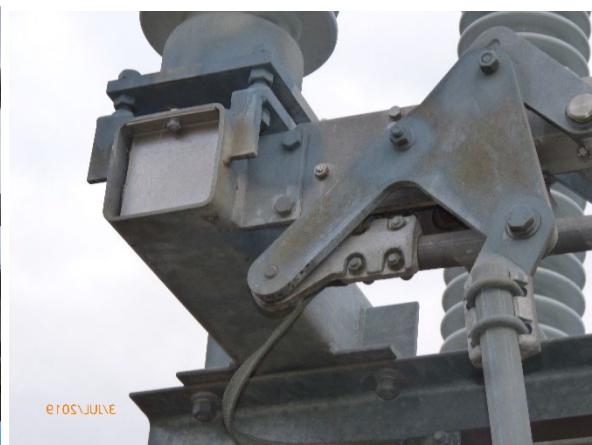
The assets in this bay were handed over to Powerlink in the year 2012 and therefore the data on maintenance history is available only from this year onwards. The bus section isolator visually seems to be in good condition. Maintenance work has been done to mitigate corrosion which has been painted and protected refer Figure (9). This model of disconnecter is such that maintenance is difficult and contact corrosion leads to very high resistance measurements. Overheating at the contact points may result in arcing, failure of the disconnecter and loss of ability to supply both transformers via one feeder. The issue of stiffness of operation and binding of the moving assembly may result in misalignment of the contacts, difficulty in operation and exacerbate the contact resistance problems leading to accelerated overheating. The main difficulty associated with the maintenance is a round bar contact and spring-loaded fingers inside the housing of the rotating arm which are difficult to access. It is recommended that this disconnecter is replaced within 3-5 years.

Figure 18 - Corrosion repair on bus section disconnector.

Figure 17 - Corrosion repair on bus section disconnector.

Based on the above observations, it is recommended to replace the disconnector in the next 3-5 years. It is recommended that the existing structures and foundations are replaced during the same project.

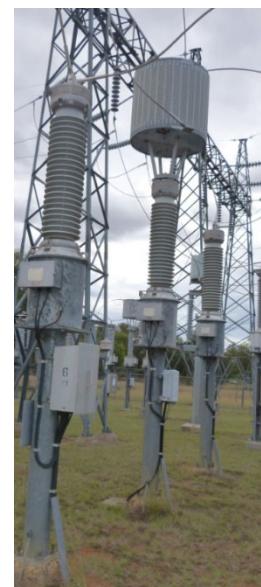
Figure 19 - CVT

The CVTs indicate low oil level and it is not clear if there is an issue with gauges. It is clear that gaskets are deteriorated and allow moisture ingress. Considering these have porcelain casing and to avoid potential major safety consequences, it is recommended to decommission these CVTs.

Based on the above observations, it is recommended to decommission and scrap the entire bay during the Chinchilla primary plant replacement project. All of the equipment is near functional end of life and operational engineering should be consulted to advise of any spare parts that should be retained. The structures and foundations should also be scrapped as part of this project.

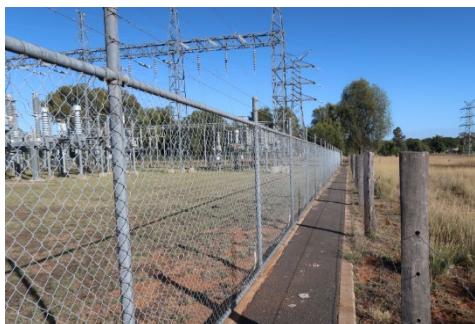
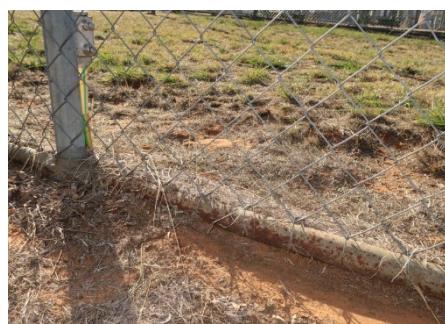
The substation security fence consists of two parts. The original fence is a chain wire fence with top and bottom rail and two barbed wires above the top rail as shown in Figure 21. The fence is 2.2m high. The fence is in good condition in particular where there is a clear space between the bottom rail and the ground as shown in Figure 21. However sections of the fence along the eastern and southern boundary have soil and vegetation in contact with the bottom rail causing corrosion. As per Powerlink SSC-424 fencing standards, this is not compliant. This portion of the fence should be replaced and brought up to latest Powerlink standard.

Figure 31 - Old section of fence

Figure 30 - Old section of fence

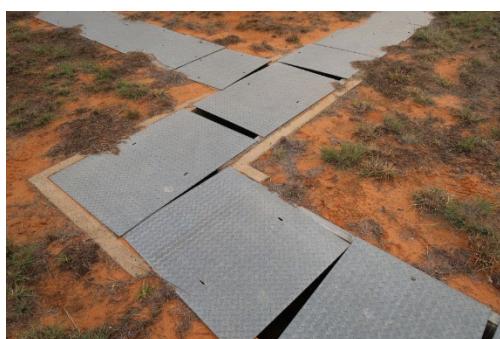
Figure 33 - Cable trenches

The cable tranches and covers are in good condition however the covers are badly placed with many gaps increasing probability of a trip and fall.

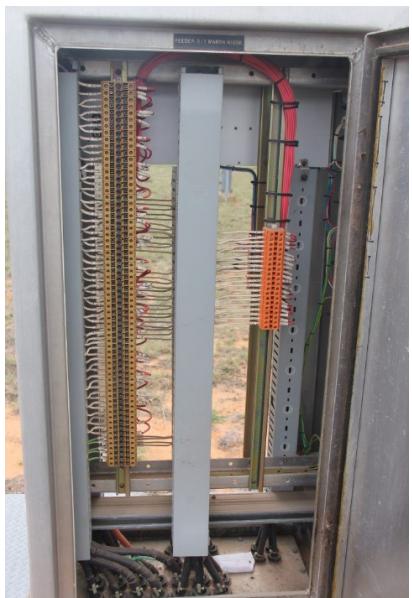
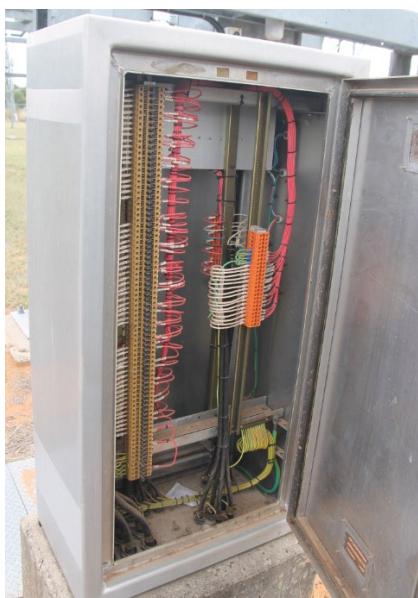
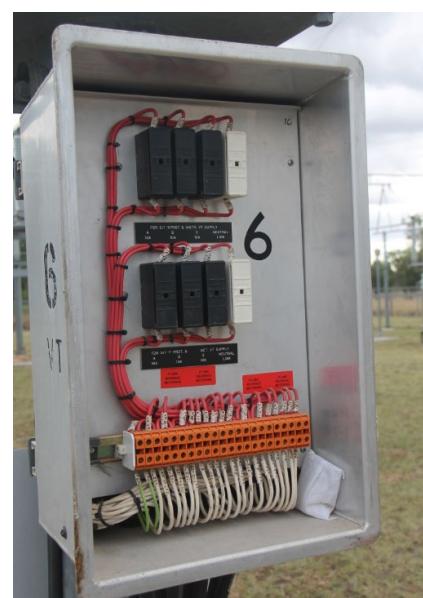
Feeder 3/1 marshalling kiosk (Feeder 7168)

expensive. These fuses should be replaced with MCBs to improve the performance of circuitries according to current design standard.

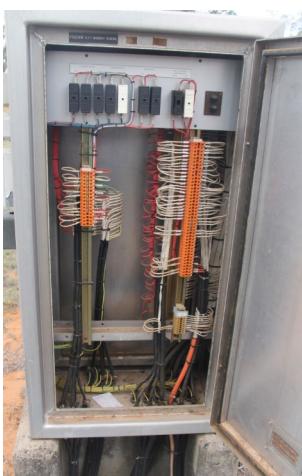
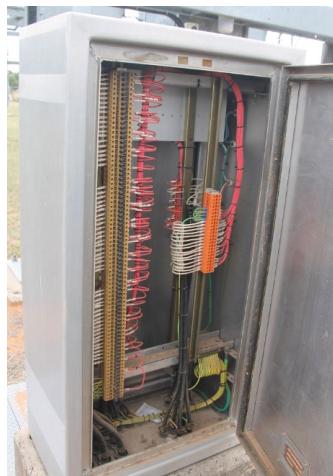
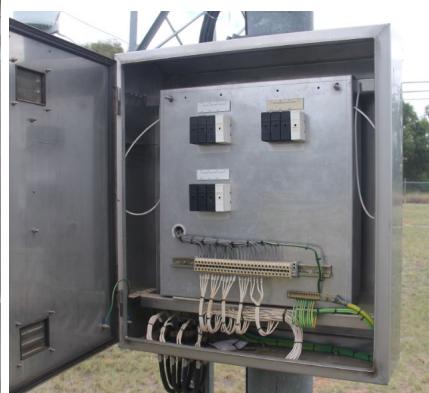
Feeder 4/1 marshalling kiosk (Feeder 7350)

Marshalling kiosks and VT box for feeder 7350 were built in 1992. Orange coloured Utilux terminals in the bay marshalling cubicles are showing signs of embrittlement. They should be replaced with major secondary system replacement. The physical disconnect terminals for CT circuits for bay marshalling kiosks need to be replaced to mitigate CT open circuit risks with major secondary system replacement according to SU0031 New Physical Disconnect Terminals for CT Circuits. Associated control cables will reach the end of asset life and need to be replaced between 2027 and 2032. Fuses used on associated marshalling kiosks do not provide safety and monitoring features and make the event investigation more difficult. Maintenance on these fuses is expensive. These fuses should be replaced with MCBs to improve the performance of circuitries according to current design standard.

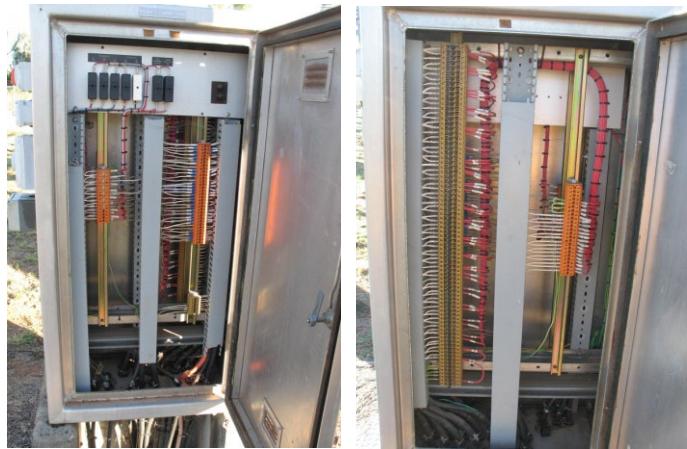
Feeder 3/2 marshalling kiosk (Feeder 7349)

circuits for bay marshalling kiosks need to be replaced to mitigate CT open circuit risks with major secondary system replacement according to SU0031 New Physical Disconnect Terminals for CT Circuits. Associated control cables will reach the end of asset life and need to be replaced between 2021 and 2026. Fuses used on associated marshalling kiosks do not provide safety and monitoring features and make the event investigation more difficult. Maintenance on these fuses is expensive. These fuses should be replaced with MCBs to improve the performance of circuitries according to current design standard.

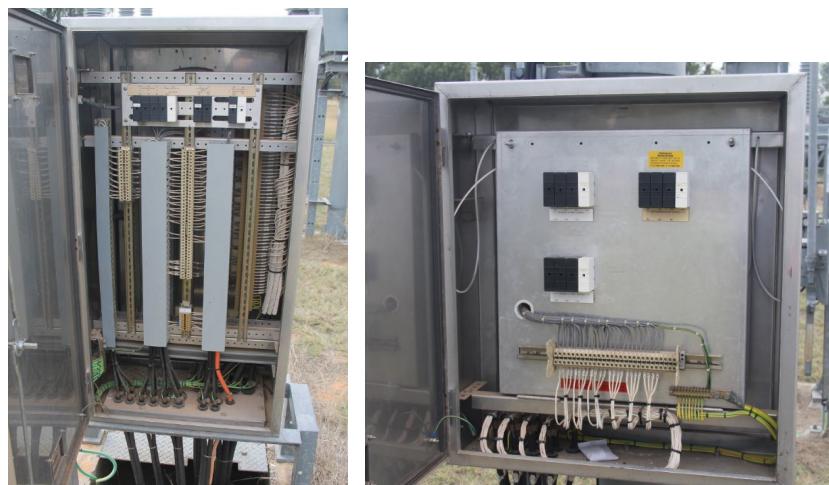
Feeder 5/2 marshalling kiosk (Feeder 7183)

Marshalling kiosks and VT box for feeder 7183 were built in 1992. Orange coloured Utilux terminals in the bay marshalling cubicles are showing signs of embrittlement. They should be replaced with major secondary system replacement. The physical disconnect terminals for CT circuits for bay marshalling kiosks need to be replaced to mitigate CT open circuit risks with major secondary system replacement according to SU0031 New Physical Disconnect Terminals for CT Circuits. Associated control cables will reach the end of asset life and need to be replaced between 2027 and 2032. Fuses used on associated marshalling kiosks do not provide safety and monitoring features and make the event investigation more difficult. Maintenance on these fuses is expensive. These fuses should be replaced with MCBs to improve the performance of circuitries according to current design standard.

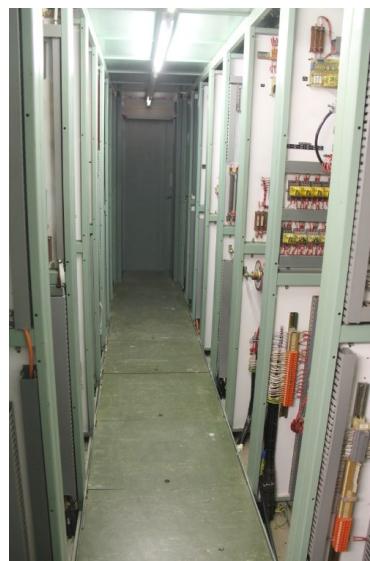
Tunnel panel arrangement

Secondary systems at Chinchilla are housed in a type of tunnel panel which are not the current practice and represent additional safety risks for field personnel. This arrangement has separate protection and auxiliary panels. This type of construction is vulnerable to cause human error on mis-tripping of primary plant when maintenance is conducted and it is also expensive to work on because of the inter panel wiring. These panels need to be replaced to mitigate associated safety risks with major secondary system replacement.

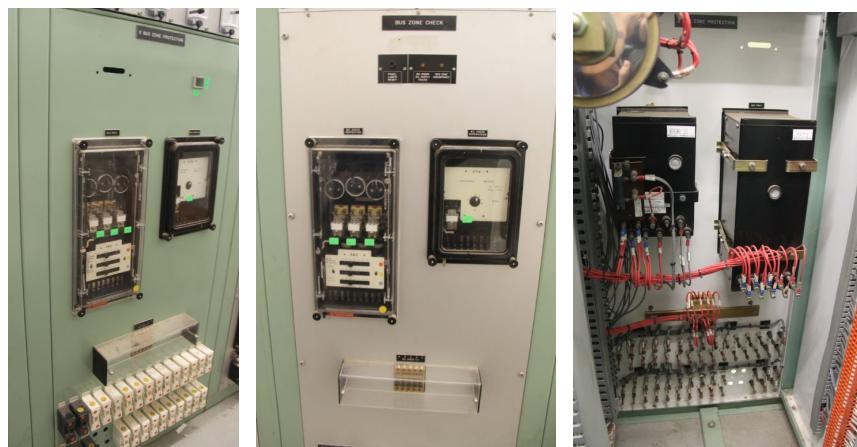
132kV Bus zone protection and control panels

Duplicate high impedance differential relays [REDACTED] are used to protect 132kV bus zones 1 and 2 with a master and check arrangement. This does not provide full redundancy as required by the current National Electricity Rules. These relays were installed in 1985 and have reached the end of technical asset life. These relays need to be replaced as soon as possible.

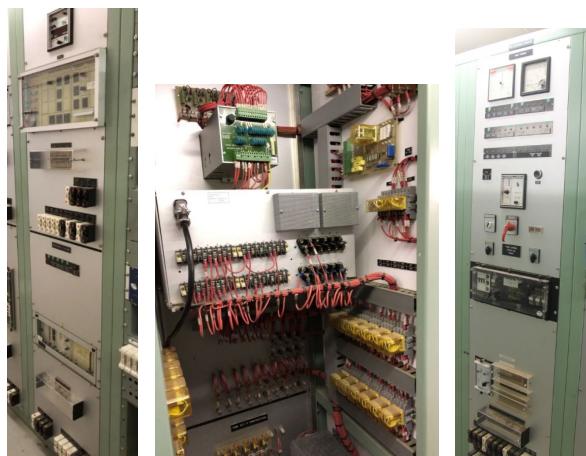
Feeder 3/1 7168 protection and Control & Auxiliary panel

Secondary systems for Feeder 7168 were installed in 1985 and associated equipment have become obsolete and there are no spares available. These secondary systems need to be replaced as soon as possible.

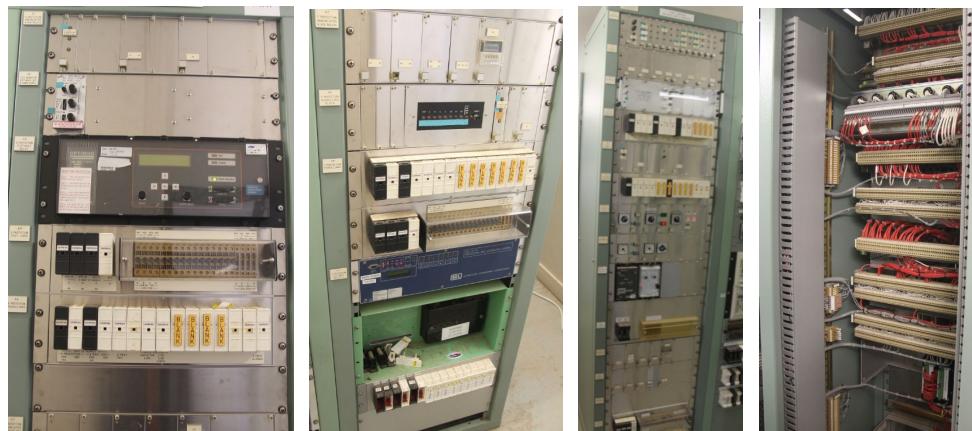
Feeder 3/1 7183 protection and Control & Auxiliary panel

Majority of secondary systems for Feeders 7183 were installed in 1992 and have reached the end of technical asset life. These secondary systems need to be replaced as soon as possible.

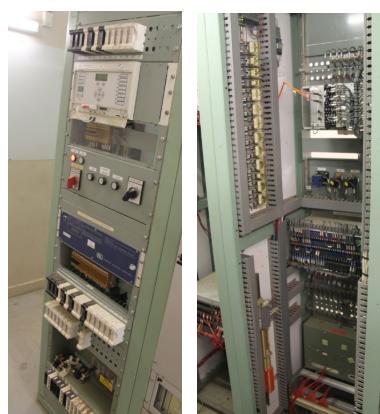
Feeder 7349 protection and control panel

Secondary systems for Feeder 7349 and 7350 are housed by a type of tunnel panel arrangement. This type of construction is vulnerable to cause human error on mis-tripping of primary plant when maintenance is conducted and it is also expensive to work on because of the inter panel wiring. They should be replaced between 2022 and 2025.

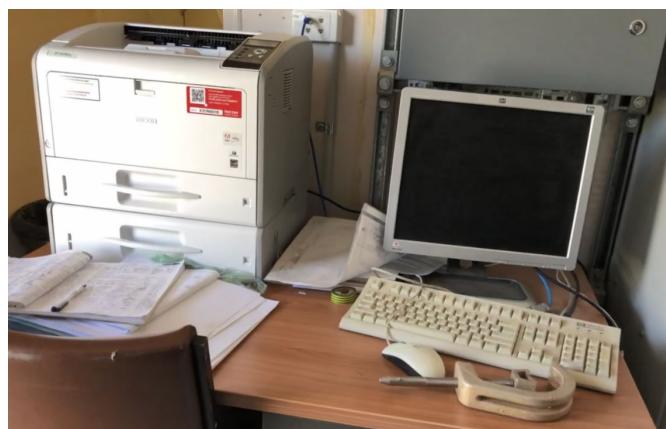
Energy Queensland HMI Wonderware PC was not in service when the site visit was carried out. This raised concerns on maintain Powerlink assets. Powerlink needs to implement own HMI for a long term.

HMI equipment (Wonderware PC disconnected)
