Powerlink 2027-32 Revenue Proposal

CP.02478 South Pine Transformer 5 Replacement

Transformer Condition Assessment

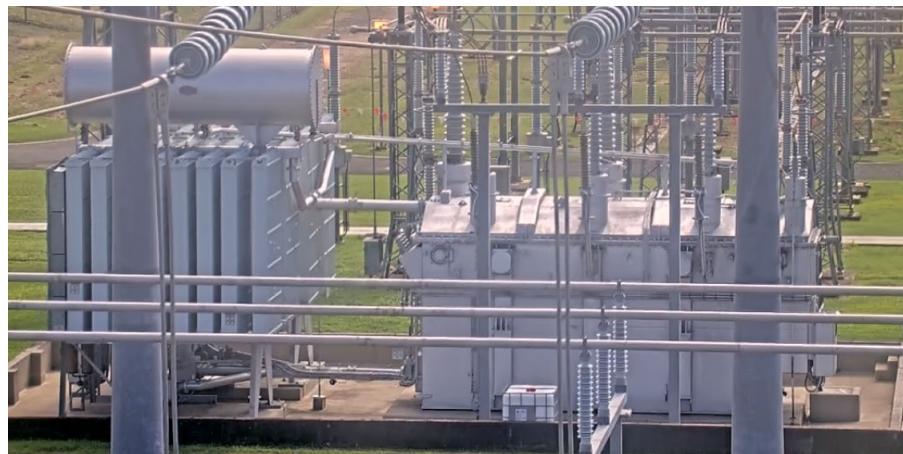
This transformer was refurbished and repainted in 2011 under project OR.01272 and whilst the paint has oxidised, its condition at present is still very serviceable with no signs of any significant corrosion. Previous localised areas of corrosion appear to have been rectified more recently. The base of the transformer could not be inspected on this occasion.

Figure 3: Transformer 110kV side showing overall condition. Photograph taken using the substation remote monitoring camera system.

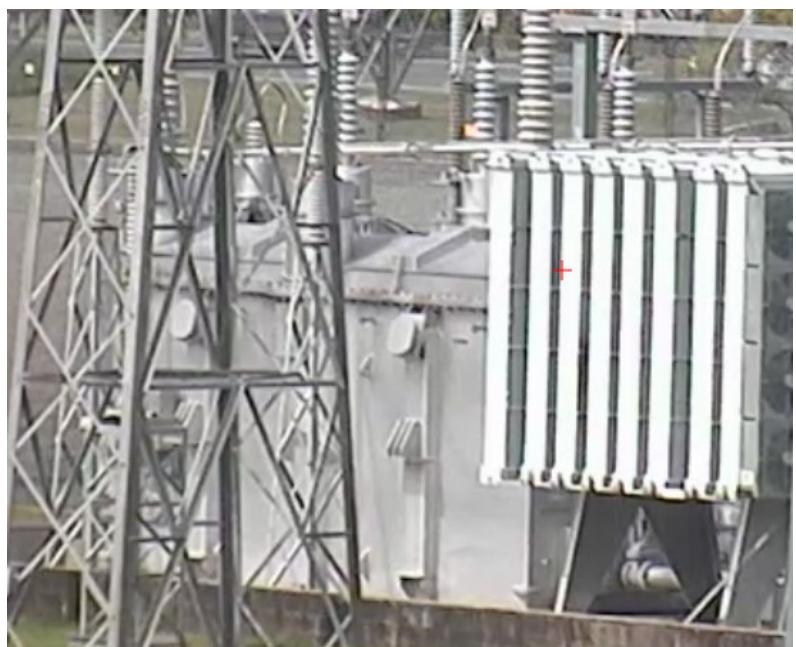
Figure 4: Transformer 275kV side showing overall condition. Photograph taken using the substation remote monitoring camera system.

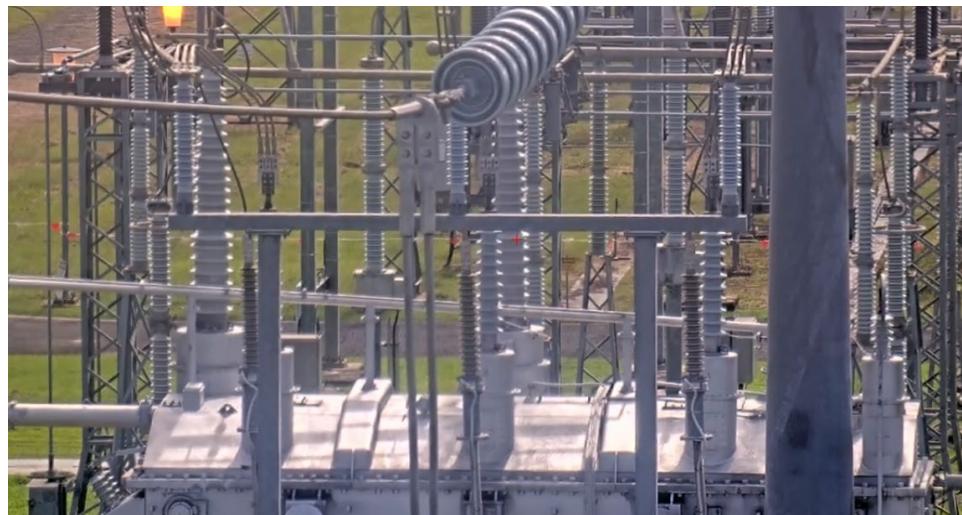
Even with the retrofitted welded tank to lid modification in 2011, the LV side of the main tank in 2020 was showing oil leaks between the lid and main tank flange via the heat effected Dome Nut 'O'-ring oil seals. These oil leaks roughly aligned with the centre line of each of the three phase internal windings where the windings are closest to the side of the main tank wall.

Extra heating in those regions is occurring due to stray flux and resulting currents passing through the Dome Nut bolts from lid to main tank. The localised heating accelerates the degradation of the neoprene 'O'-ring seals on the Dome Nuts as well as causing the clamping bolts to elongate more in those regions which lowers the bolt's clamping pressure. When this transformer was designed, flux shunts were not normally used on the tank walls but aluminium flux rejecters were favoured on the active part instead but this resulted in a loss of control over the final flux paths. Both effects over time will continue to allow oil to bypass degraded 'O'-ring seals on the Dome Nuts.

Figure 5: Transformer 110kV side showing overall condition on the lid.
Photograph taken using the substation remote monitoring camera system.

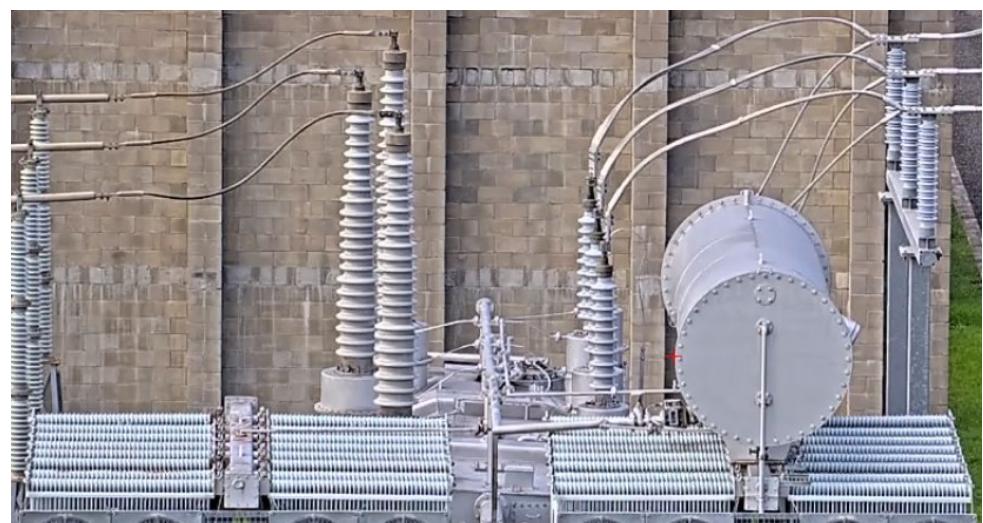
There seem to be no signs of oil leaks around the top of the HV and LV bushings or main conservator.

Figure 6: Transformer bushings and main oil conservator condition.
Photograph taken using the substation remote monitoring camera system.

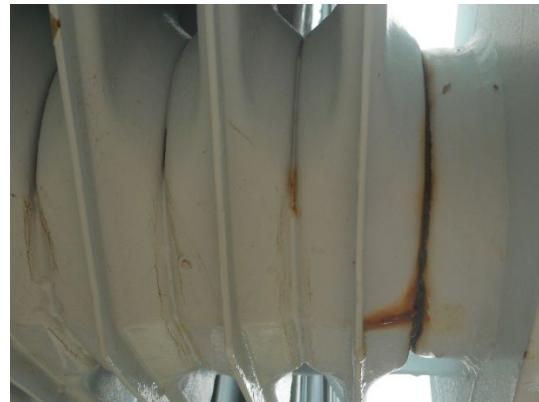
The type of corrosion between the radiator panel individual fins shown in the figure below was an issue for this transformer in 2020 and needs to be detected early if it returns. It is difficult to see via a remote substation camera system if the corrosion was properly removed and treated or is being covered by existing surface coatings.

Figure 7: Transformer cooler bank radiator panel corrosion from 2020. Need to confirm if that corrosion has reappeared.

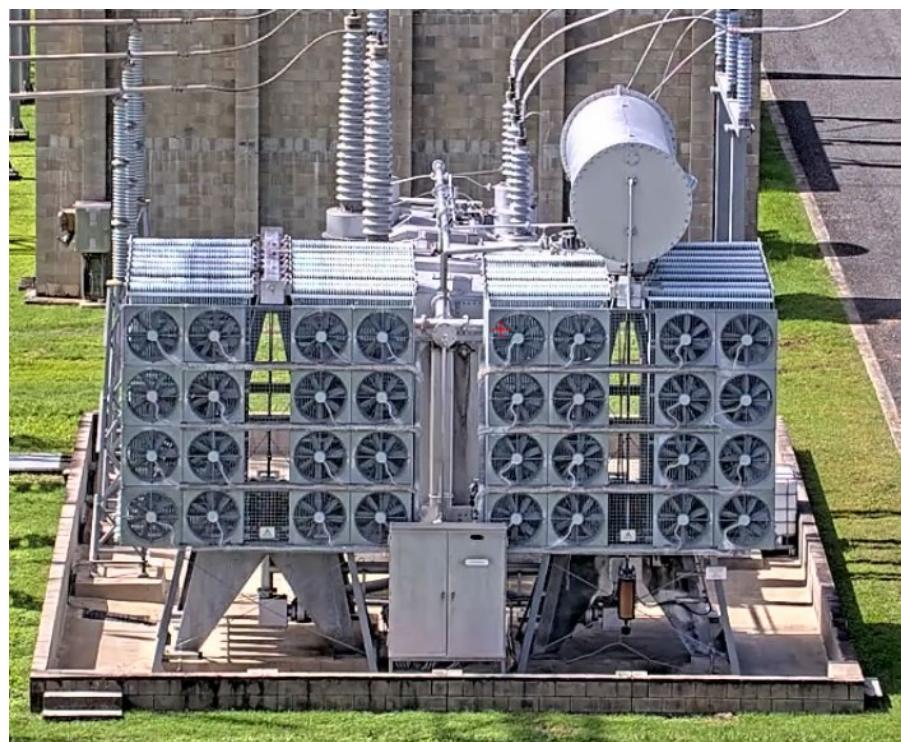
Figure 8: Overall view of the transformer from the cooler bank end showing clean concrete surfaces. Photograph taken using the substation remote monitoring camera system.

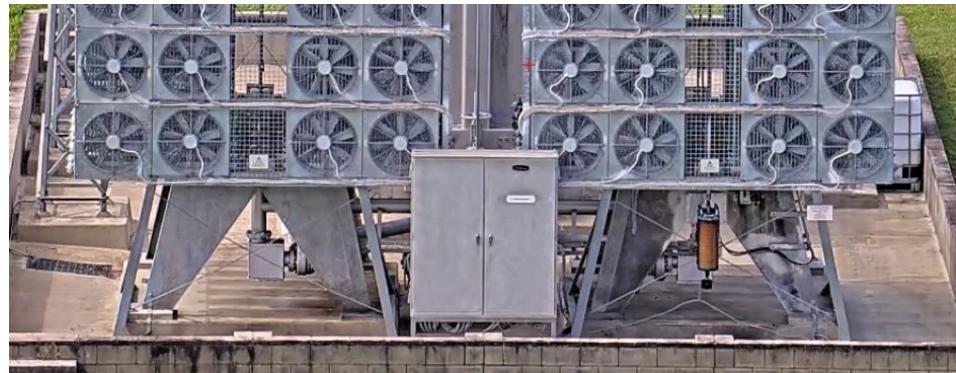
Figure 9: Close-up view under the cooler bank does not show any significant signs of oil leaks on the concrete surfaces. Photograph taken using the substation remote monitoring camera system.

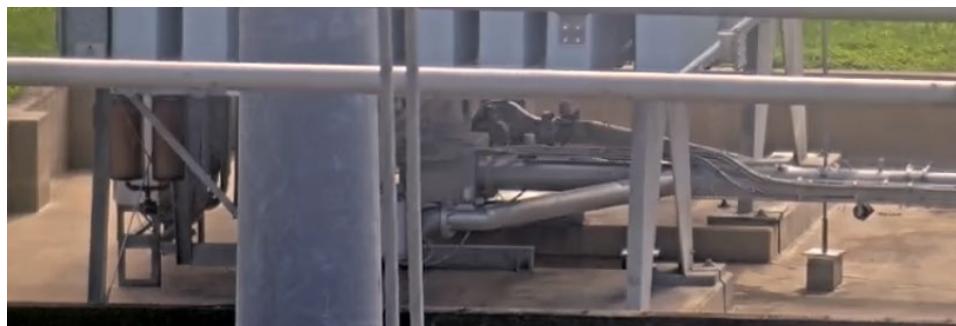
Figure 10: Side view under cooler bank does not show any significant signs of oil leaks on the concrete surfaces. Photograph taken using the substation remote monitoring camera system.

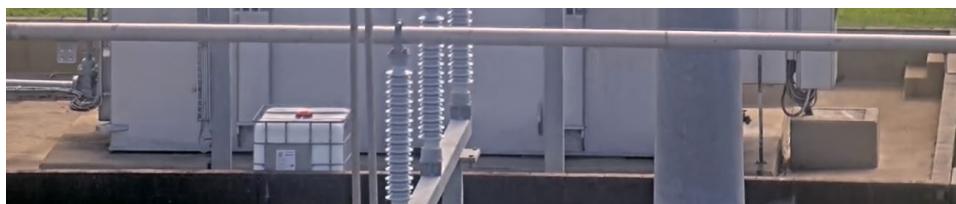
Figure 11: The concrete plinth and surrounding apron of the transformer main tank also appears to be clean / dry from oil residue. Photograph taken using the substation remote monitoring camera system.

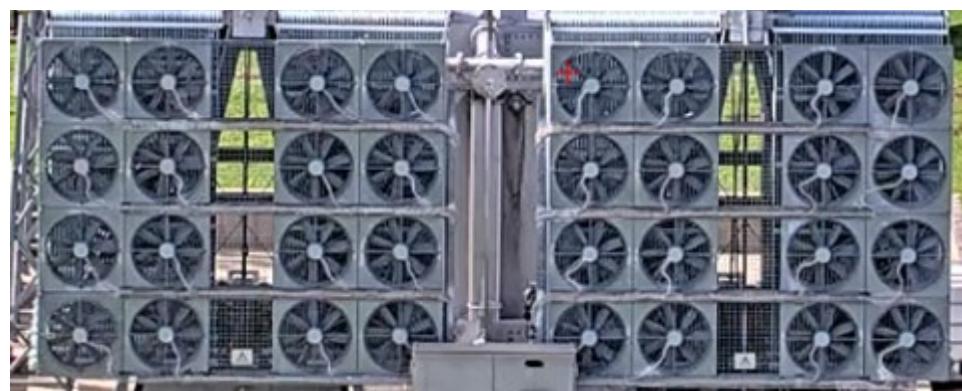
The cooler bank radiator panels still appear to be in a reasonable overall condition. The cooling fans and their housings still appear to be in reasonable condition when viewed via the substation remote camera system.

Figure 12: Transformer Cooler Bank cooling fans. Photograph taken using the substation remote monitoring camera system.

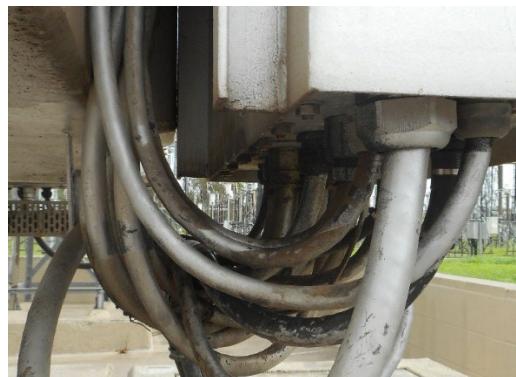
The external black PVC/PVC multi-core cables have been painted when the transformer was refurbished and this has provided some UV protection. This paint was not designed to adhere to the outer cable PVC surface and as such, some paint has been progressively delaminating. After 44 years, the cables are sure to have taken a set and any significant cable flexing could likely create significant insulation damage.

Figure 14: The original external multicore cabling was Black PVC/PVC and whilst being aged, the only cracking visible is in the paint coating. These cables would have taken a set and should not be subjected to any significant flexing.

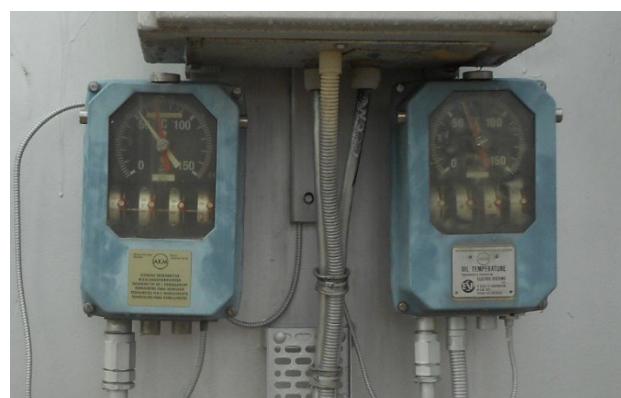
There is no indication in the maintenance history / notifications that the WTI and OTI temperature monitoring instruments have been replaced as recommended in 2020 due to the poor visibility when looking through the viewing glass of the instruments.

Figure 15: Photograph taken in 2020 showing one AKM winding temperature measurement instrument (WTI) and one top oil temperature measuring instrument (OTI) installed.

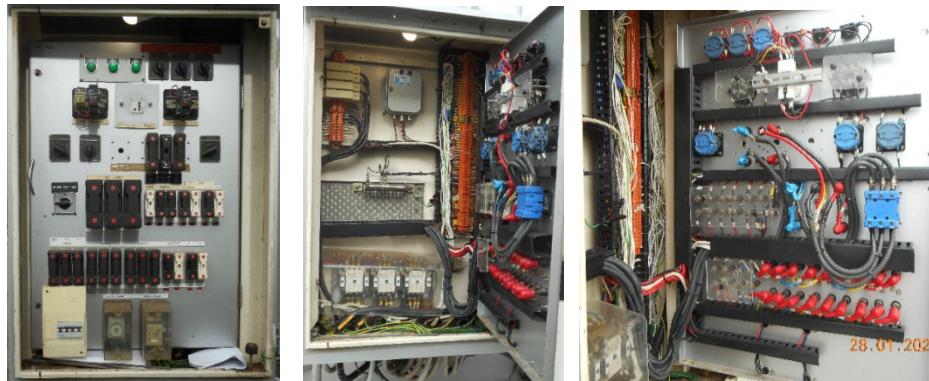
The OSD-PSS-REP-028 - *H002 South Pine 5 Transformer Condition Assessment Report* in 2019 did mention insulation resistance issue(s) in the Main Control Cubicle and suggested the cubicle should be replaced with a new one. The historical maintenance history records do not show this recommendation having been addressed.

Figure 16: Year 2020 photographs (if still relevant) of the Main Control Cubicle internal views. Various componentry has been replaced over the years due to failure.

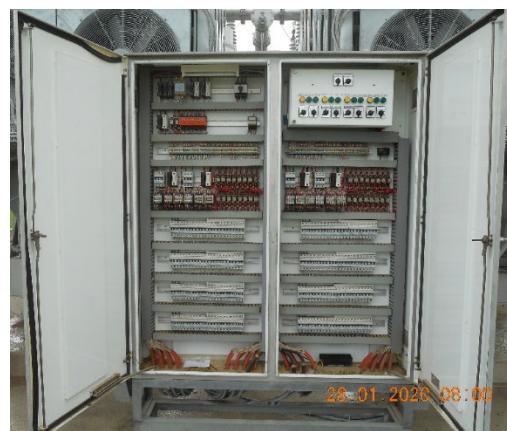
Due to the transformer being uprated from 200MVA to 250MVA later in its life (prior to 2000) by the addition of 32 forced draught cooling fans on the cooler bank, the Fan Control Cubicle is not as old as the original transformer and appears to be in reasonable condition.

Figure 17: Year 2020 photograph of the Fan Control Cubicle.

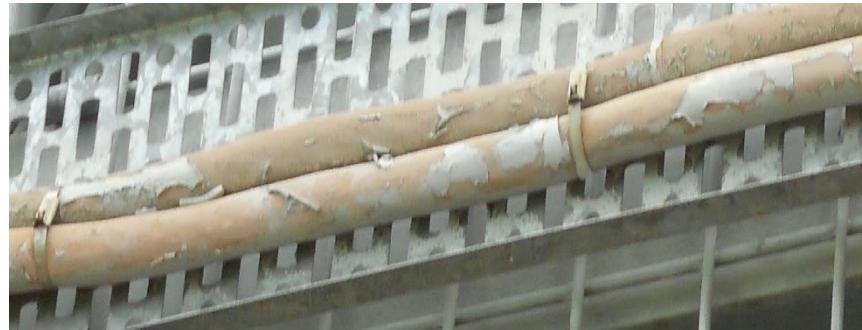
When this transformer was uprated, the fans were wired using multicore cables with orange outer PVC insulation. In 2009, it was noticed that the outer PVC of these cables was deteriorating / cracking due to the orange coloured PVC having worse natural UV stabilisation characteristics compared to black PVC.

The cables were eventually painted to help shield them from direct sunlight. Now there are extensive areas on these cables where the paint coating has flaked off exposing the faded and aged outer orange PVC. These cables would be very inflexible with PVC embrittlement and should be periodically visually checked during substation RSMs and the cables with the most outer physical damage / cracking should than be electrically tested for DC Insulation Resistance between cores and to earth.

Figure 18: Year 2020 photograph of the orange PVC multicore cables showing paint flaking off the already faded outer PVC insulation.

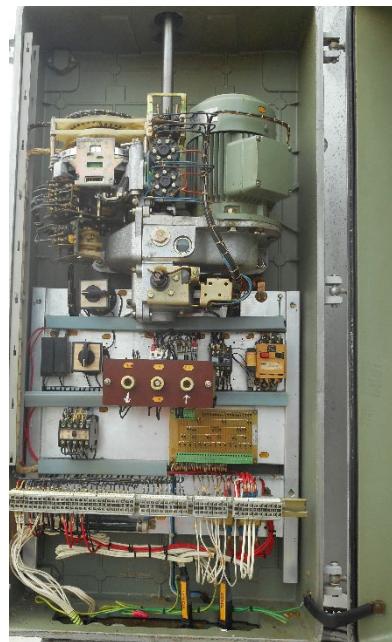
The transformer has a Reinhausen (MR) on-load tap changer (OLTC). The tap changer had 233,907 operations when inspected in 2020. Reinhausen stated the OLTC was in good condition when last serviced in 2019.

Figure 20: Year 2020 photograph of the Reinhausen OLTC Control Cubicle internal view.

The tap change motor gearbox oil level was correct and there were no signs of oil leaks collecting on the cubicle cable gland plate.

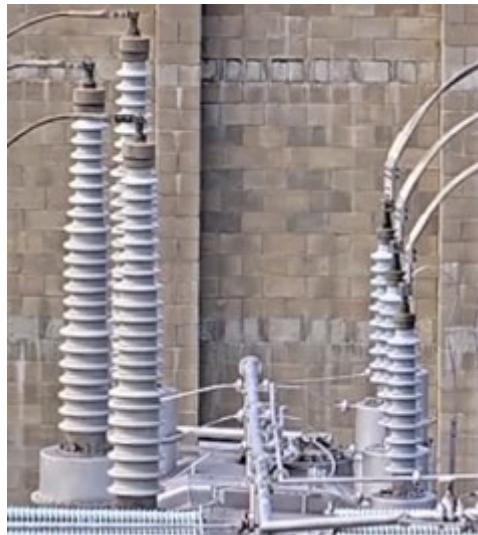
The HV and LV bushings still appear to be the original ones supplied with the Tyree transformer from new. The internal insulation of the 44 year old HV and LV bushings are a synthetic resin bonded paper (SRBP) design that has proven by visual inspections of many SRBP bushings over the years to be subject to progressive delamination of the concentric capacitive layers due to poor resin bonding of the paper layers during manufacture and the continual 100Hz vibration during operation working these incomplete adhesion bonds in shear. The potential consequences of a bushing failure can be catastrophic involving field personnel injury or death as well as an extended transformer outage or complete loss of the transformer. These HV and LV bushings need to be replaced with a newer, safer design if this transformer is to remain in service, however, as discussed in the Summary, clause 1, this transformer has effectively reached statistical end of life and needs to be replaced within the next 4 to 5 years or sooner. It may therefore be more appropriate to take other safety measures to protect field staff rather than replace the bushings.

Figure 21: View of transformer HV and LV SRBP bushings. Photograph taken using the substation remote monitoring camera system.

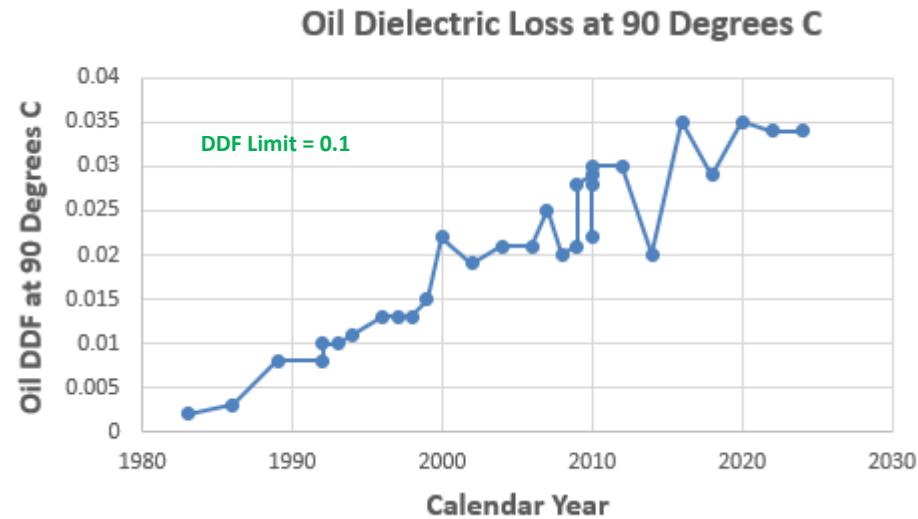
The oil dielectric loss (DDF) and acidity level have not changed that significantly over the life of the transformer and are still considered acceptable for the transformer's age. The oil resistivity (G Ohm.m) has progressively reduced as expected over the transformer's life, in correlation with the changing DDF of the oil.

Figure 23: Transformer oil Dielectric Loss (DDF) characteristics over its service life. The DDF results are still well below the limit.

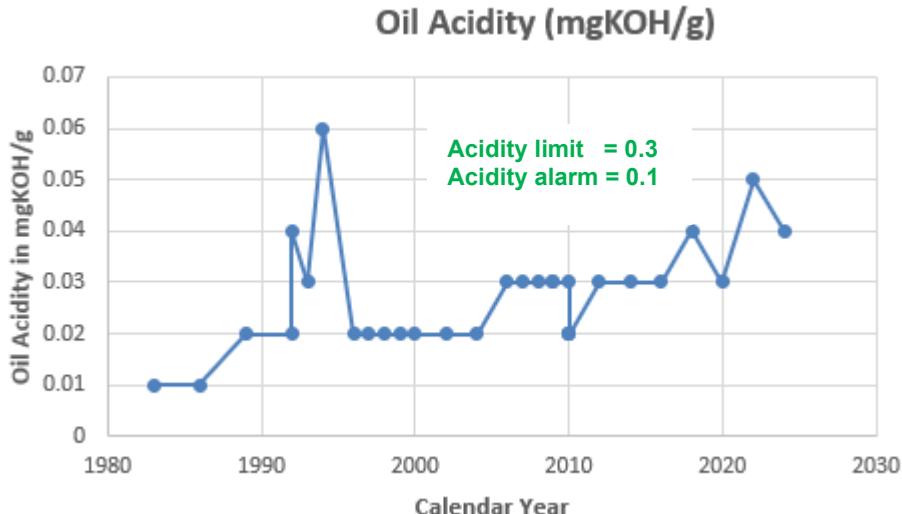
Figure 24: Transformer oil Acidity characteristics over its service life. The acidity level is still well below the limit.

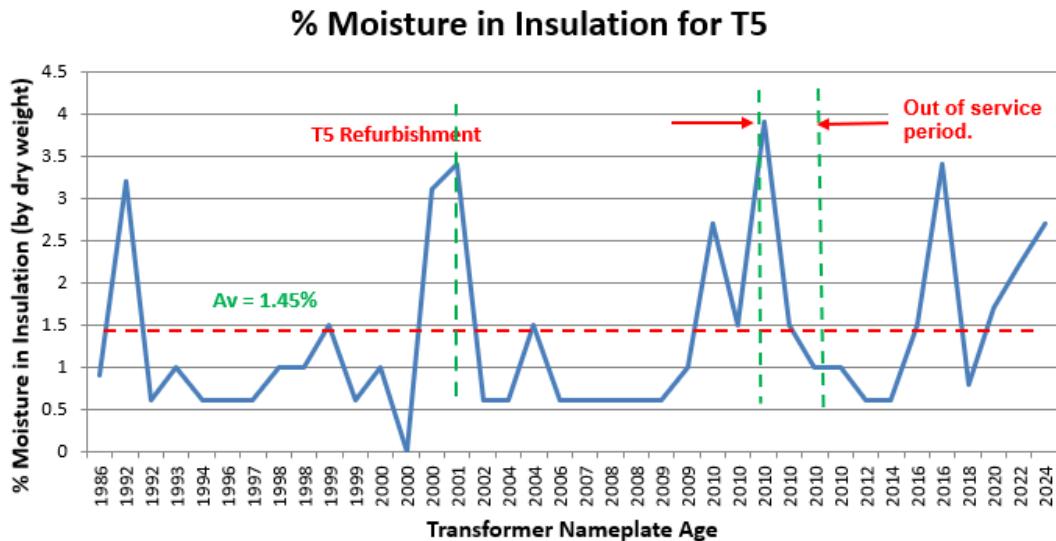
The percentage of moisture in the cellulose insulation was measured by Powerlink's field staff in June 2019 using a "Dirana" test instrument for a *Dielectric Response Analysis* test. A figure of 1.5% by dry weight moisture in the cellulose insulation was determined by that test. A separate calculation using Powerlink's own software and Oil Laboratory test data provided a calculated result of 1.4% by dry weight as shown in the graph below.

This is good correlation between the two methods of calculation for the cellulose moisture content and gives more confidence in the moisture level being well below 2%. The 1.5% or even up to 2% is a very acceptable figure for the internal high voltage cellulose insulation system of an unsealed transformer after 44 years of service, especially considering it has had a number of oil leaks over time.

Figure 25: Transformer calculated % moisture in cellulose by dry weight based on Oil Laboratory test data. The moisture level is very acceptable for a transformer after 44 years of service.

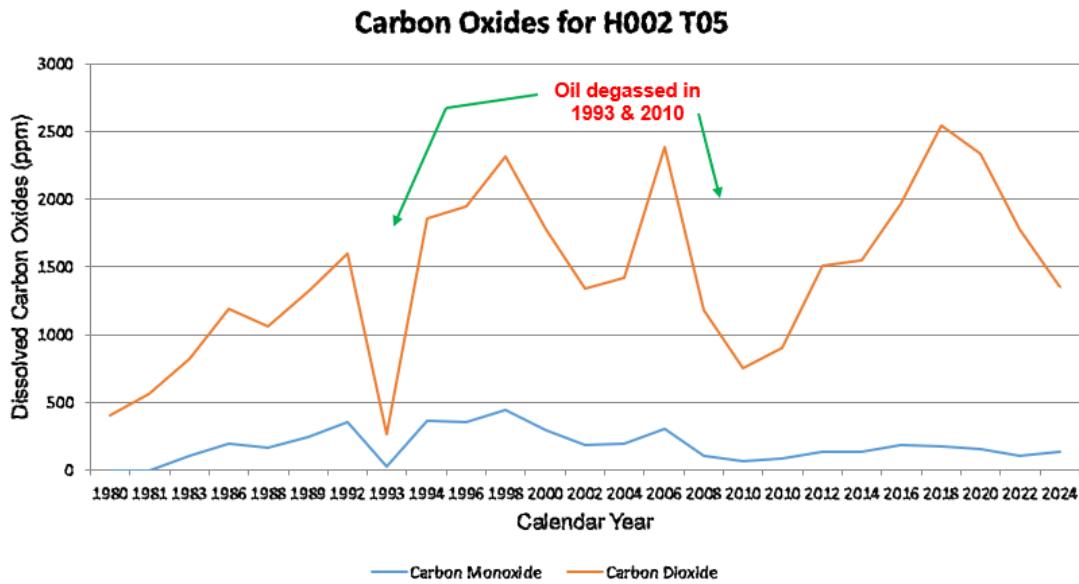
Throughout much of the transformer's life, the DGA data suggested on face value either a thermal in oil without really involving any cellulose material and as time progressed, this appeared to evolve into low level discharge / heating / flashover. In actual fact, these apparent DGA signatures were due to oil from the OLTC diverter switch mixing with main tank oil.

Figure 26: Carbon Monoxide and Carbon Dioxide dissolved gasses over the transformer's life.

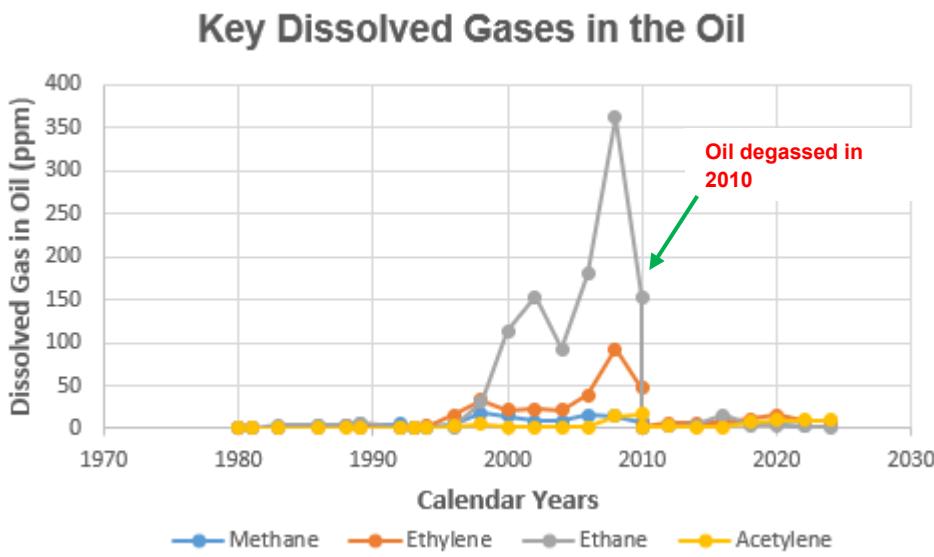
If the contamination of the main tank oil from the OLTC oil is ignored, there are no signs of electrical issues associated with the core and coils of this transformer up to the date when the last oil sample was taken for analysis.

Figure 27: Key dissolved gas in oil activity. This data still reflects some distortion due to the mixing of OLTC oil with the main tank oil.

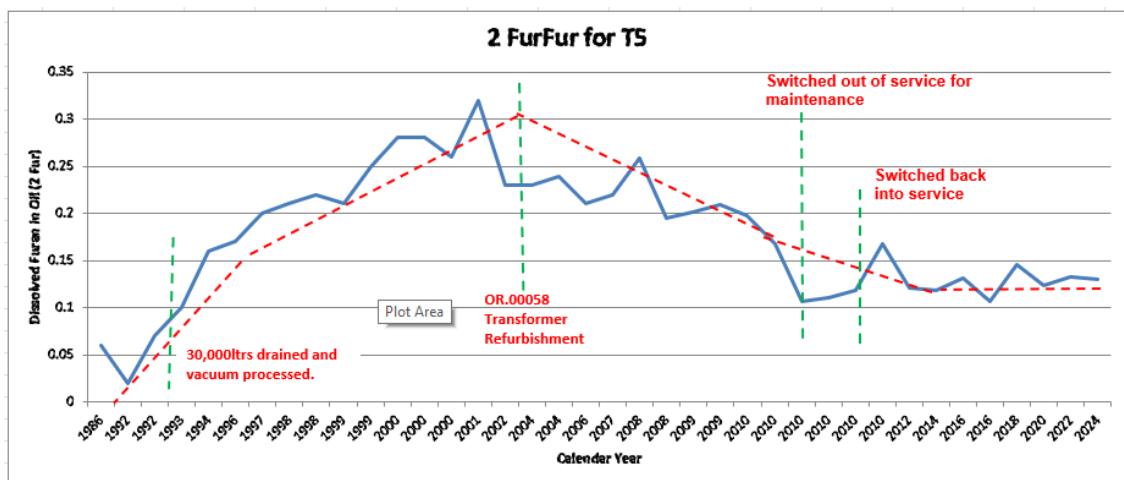
Figure 28: The dissolved 2-Furan in oil level over the life of the transformer.

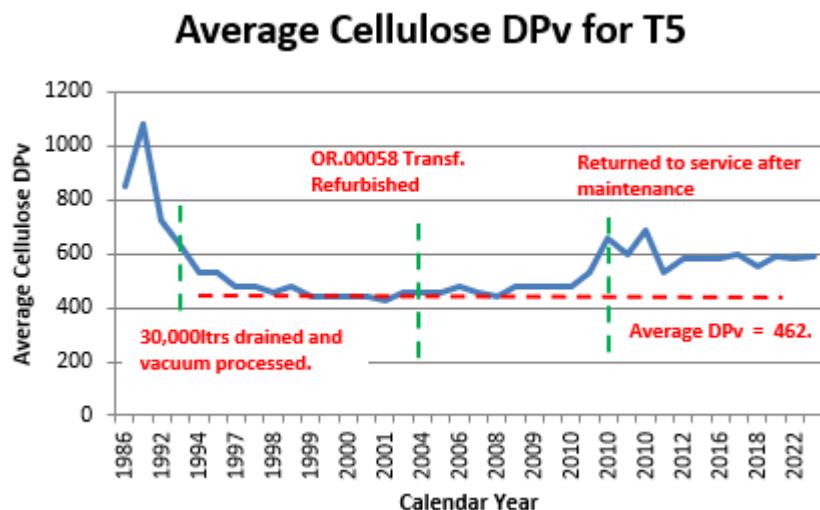
The average cellulose insulation *Degree of Polymerisation* (DPv) was calculated to provide a more tangible feel as to the residual mechanical strength of the winding paper insulation wraps. The average *Degree of Polymerisation* (DPv) of the bulk cellulose insulation system within the transformer is calculated to be approximately DPv = 462 with a chemical age of 22 years.

Figure 30: The calculated bulk cellulose insulation average DPv = 462. Cellulose decomposition sustained during its earlier years can’t be reversed.

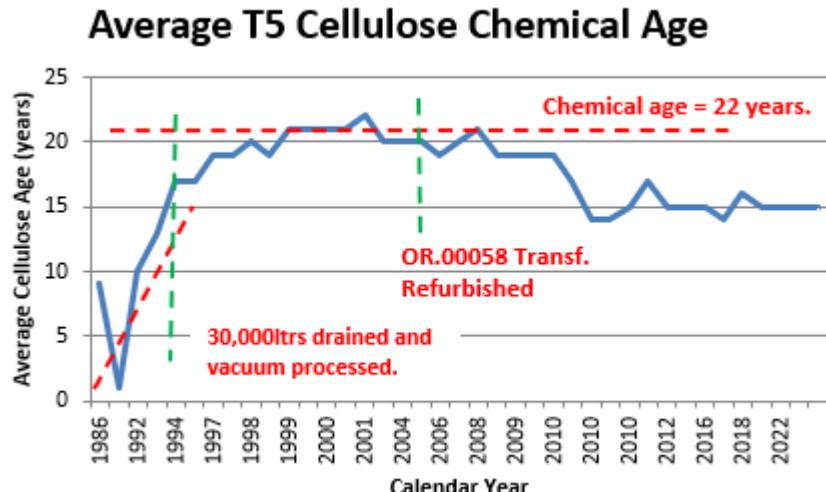
Figure 29: The calculated bulk cellulose insulation chemical age = 22 years. Cellulose decomposition sustained during its earlier years can't be reversed.

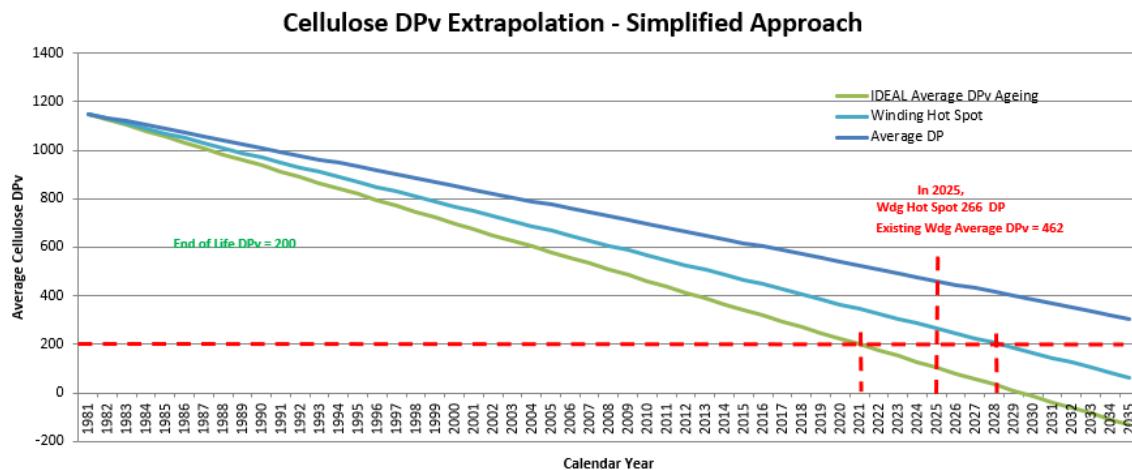
Figure 31: The simplified prediction of residual cellulose insulation life based on initial and present DPv.
