Powerlink 2027-32 Revenue Proposal

CP.02631 Ross to Dan Gleeson 132kV Transmission Line Refit

Condition Assessment Report

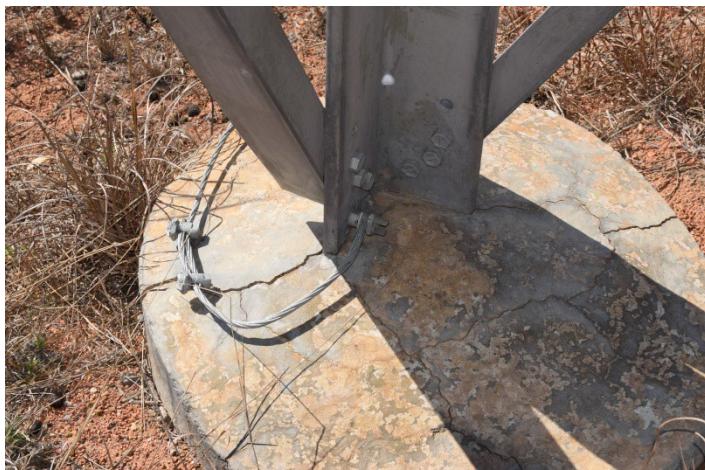
All steel lattice tower foundations in BS 1257 are of the reinforced concrete type and no visible corrosion is apparent, however the foundation caps have radial cracking which will allow moisture ingress and corrosion to develop.

In November 2015, the concrete cap of structures STR-1486 and STR-1498 were removed to observe what corrosion has developed due to the cracking of the concrete. Both structures had Grade 3 or 4 corrosion and a further six structures have large cracks radiating from the interface between the tower leg and concrete cap.

The tower legs are painted and have tested positive to asbestos and will require treatment prior to repair work being carried out.

Tower leg of STR-1498 showing large cracks radiating from the tower leg and the corrosion visible once the concrete cap has been removed

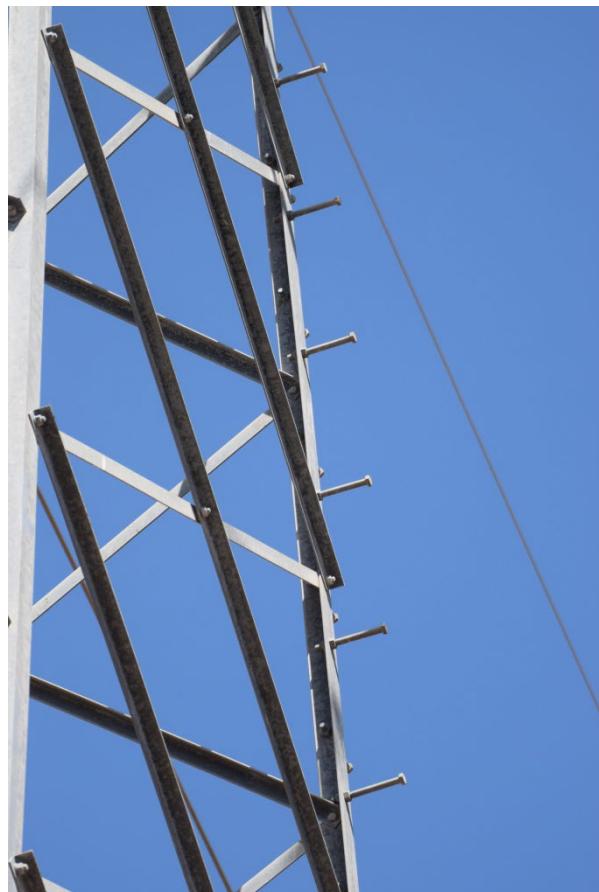
Step bolts are in a good condition with only minimal Grade 2 corrosion present on a small percentage of the bolts.

Typical condition of Step Bolts throughout BS1257

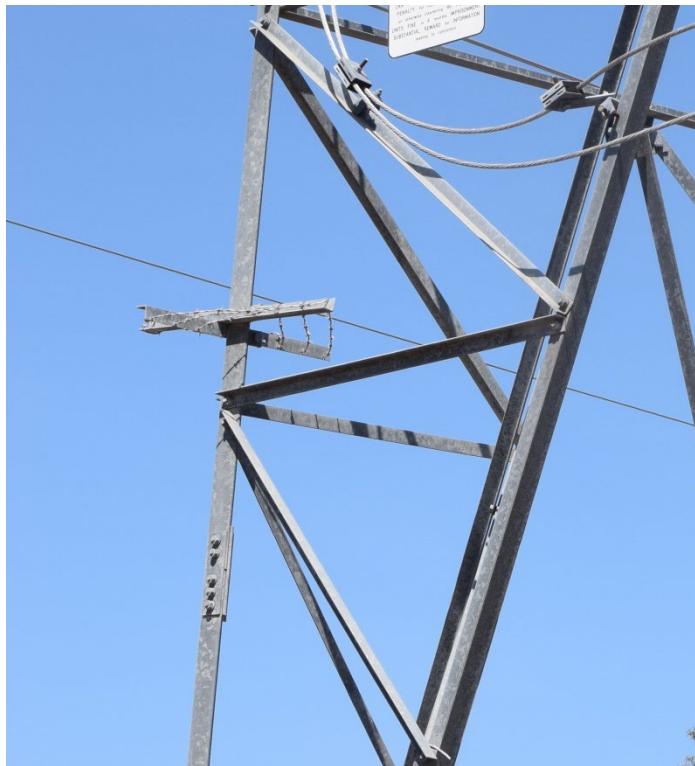
Anti-Climb Barriers STR-1490

Towers have been fitted with a selection of barbed wire and crown-of-thorn type anti-climbing barriers depending upon their location. All anti-climb barriers remain in a serviceable condition.

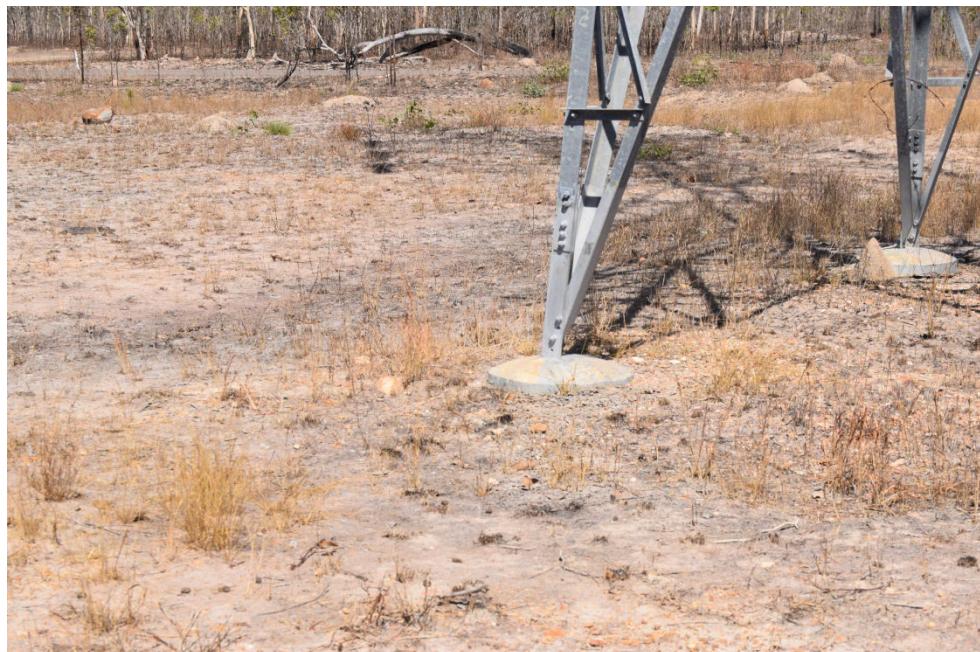
Condition of Tower Legs STR-1490

There is minimal corrosion observed on the bolts and members at the tower base with most sheltered light members and bolts at corrosion grade 1. Heavy members remain relatively unaffected, although cracking of the foundation concrete cap has caused corrosion below the ground level (see section 6.2 Foundations).

There are isolated instances (STR-0098) of Grade 3 corrosion caused by drainage and the build-up of soil.

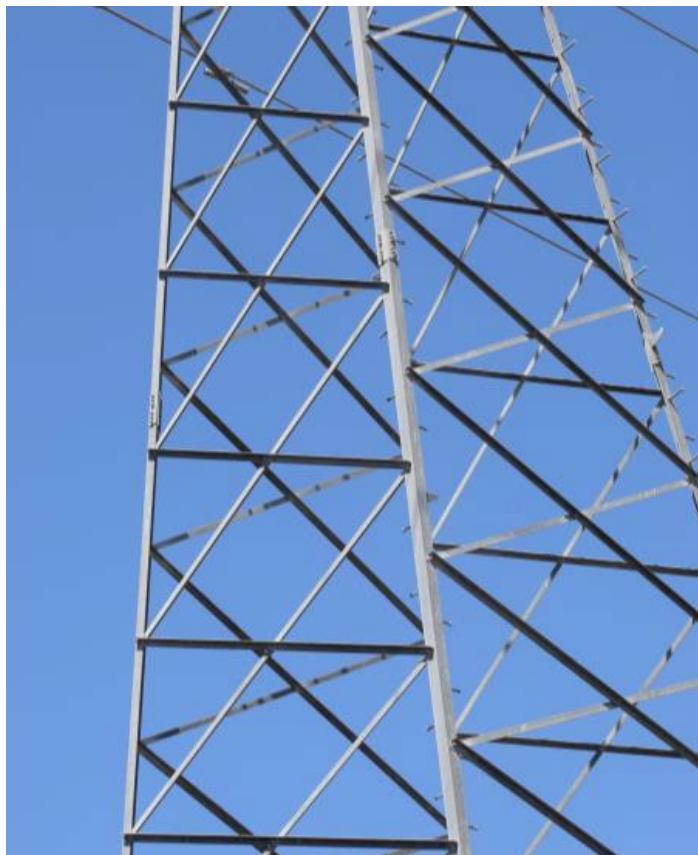
STR-1482 Condition of Tower Body

There is minimal corrosion evident on the bolts and members at the tower base with most sheltered light members and bolts at corrosion grade 1. Heavy members remain relatively unaffected.

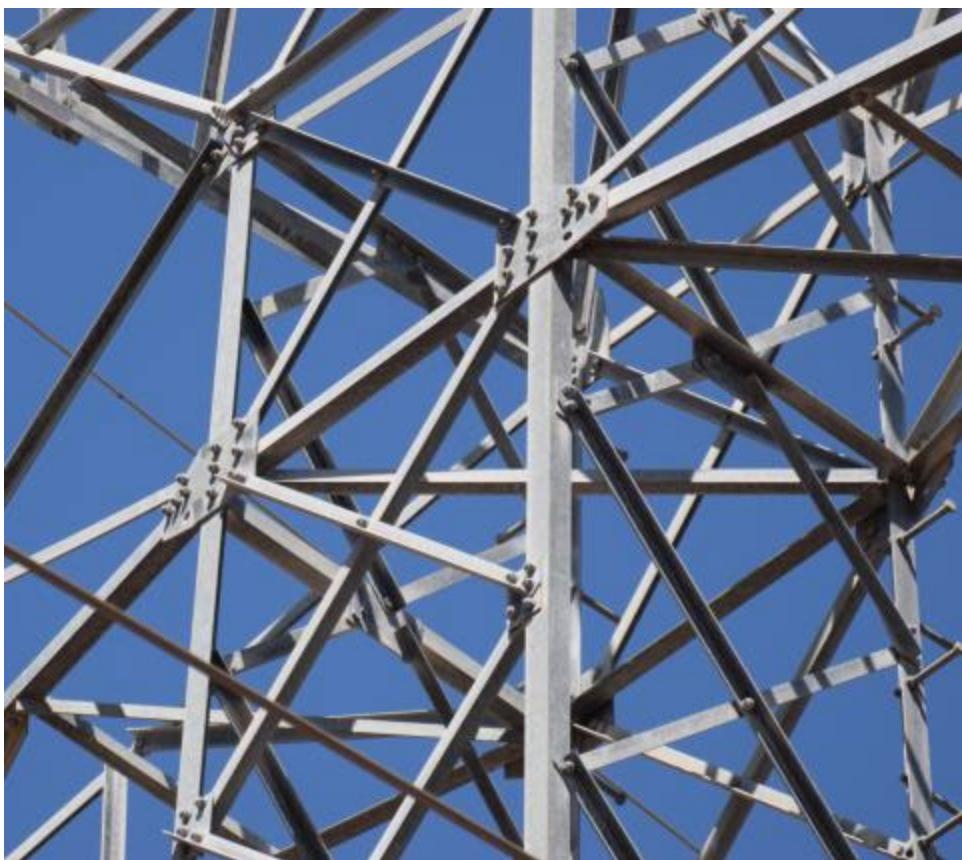
Condition of Superstructure STR-1485

There is minimal corrosion on superstructure members with less than 5% of structures inspected having Grade 2 corrosion. Grade 2 corrosion has been observed on 8% of connecting nuts and bolts.

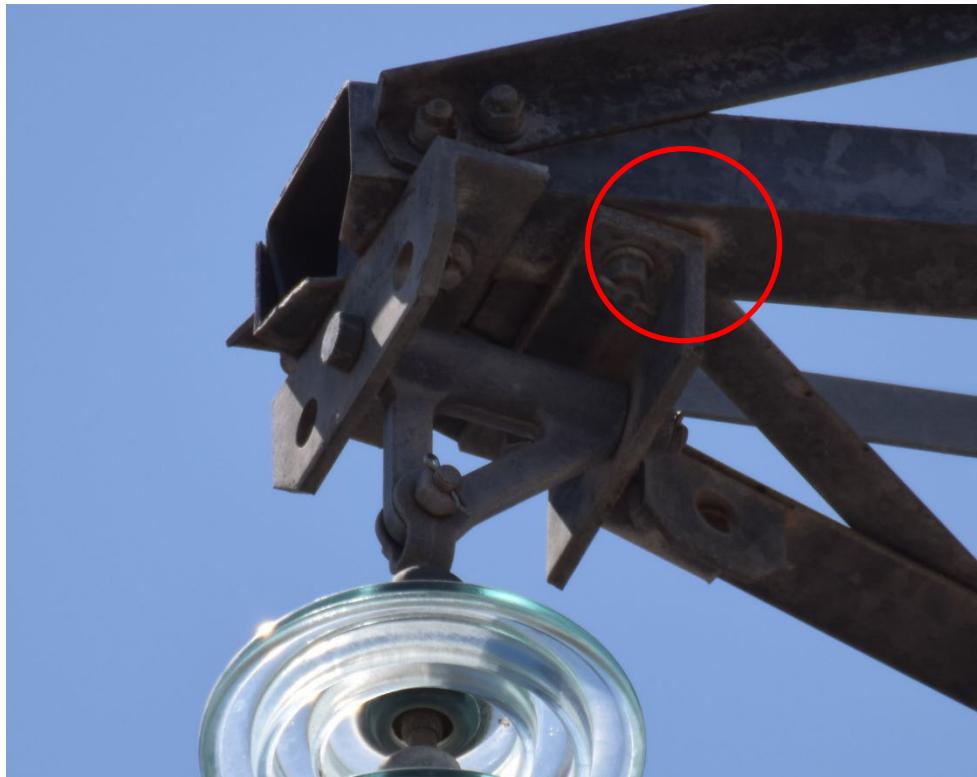
The attachment plates are in a sound condition with Grade 2 corrosion evident. Corrosion at the interface between the conductor attachment and cross-arm members has been observed on several structures and will require periodic monitoring.

Conductor Attachment Bracket with Corrosion at Interface STR-1481

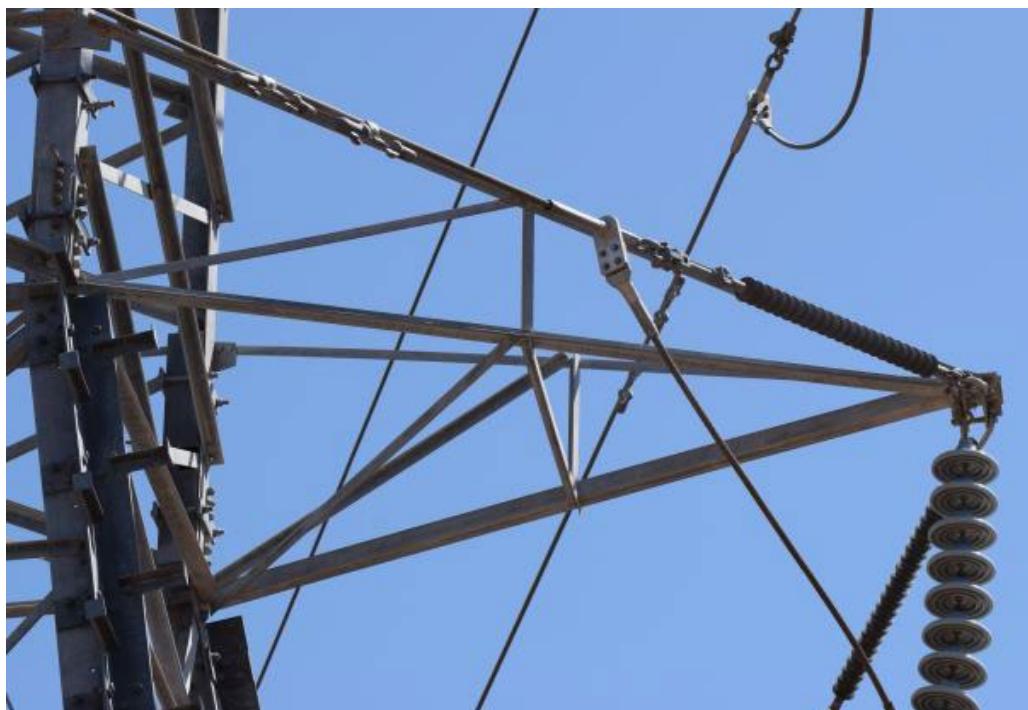
Cross-Arm Condition STR-1043

The cross-arms are generally in a sound condition with Grade 2 beginning to emerge on the cross arm bolts and fasteners. Corrosion on cross-arm members is minimal with less than 5% Grade 2 observed, although structures that have elevated locations (STR-1043 and STR-1499) have a higher exposure to coastal winds and were observed to have a higher percentage of member corrosion.

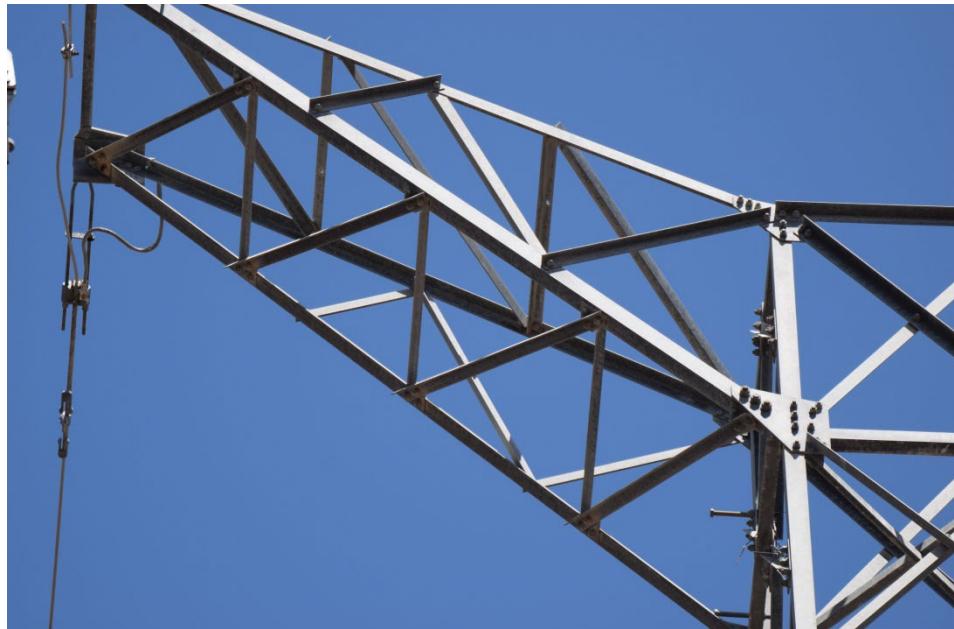
STR-1480 Earth Peak

The earth peaks are generally sound with bolts and members in good condition and only low level corrosion evident on the majority of structures.

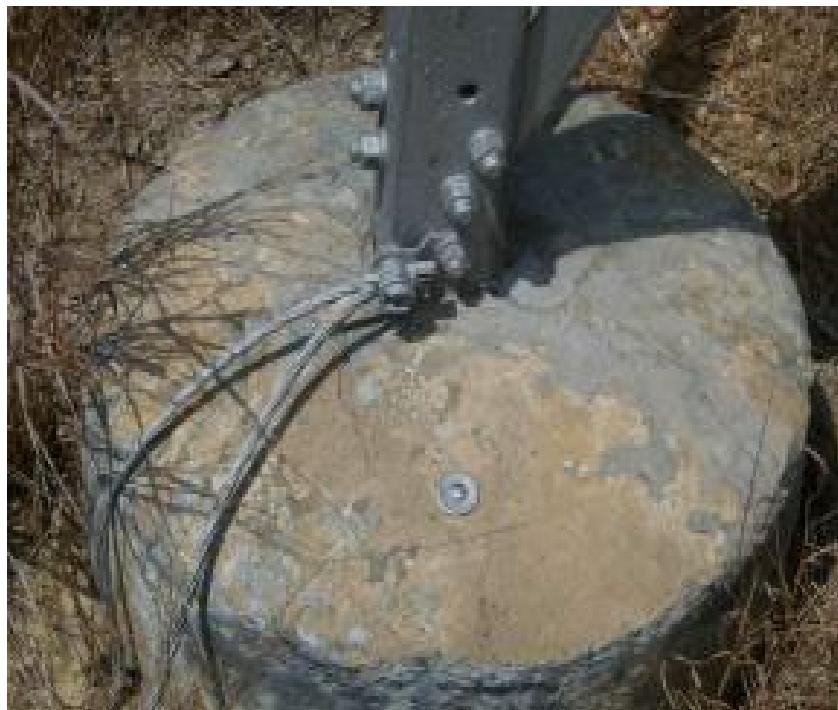
Tower Earths STR-1487

Earthing of the steel lattice towers on the line was with hard drawn bare copper coated with an aluminium based paint earthing conductors and grading rings remain in sound condition. Footing measurements were recorded in 2010 and all structures (except STR-1496 which had a footing resistance of 19.6Ω) were within the design criteria.

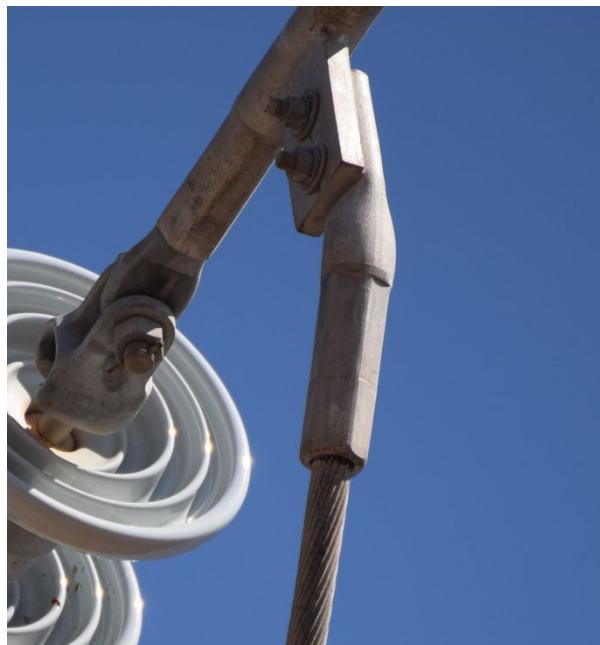
Dead-End Palm STR-1497

The Lime ACSR/GZ conductor is terminated with a two part compression dead-end and jumper bridge fitted by compression connectors. The galvanised bolts on the dead-ends are exhibiting Level 2 corrosion.

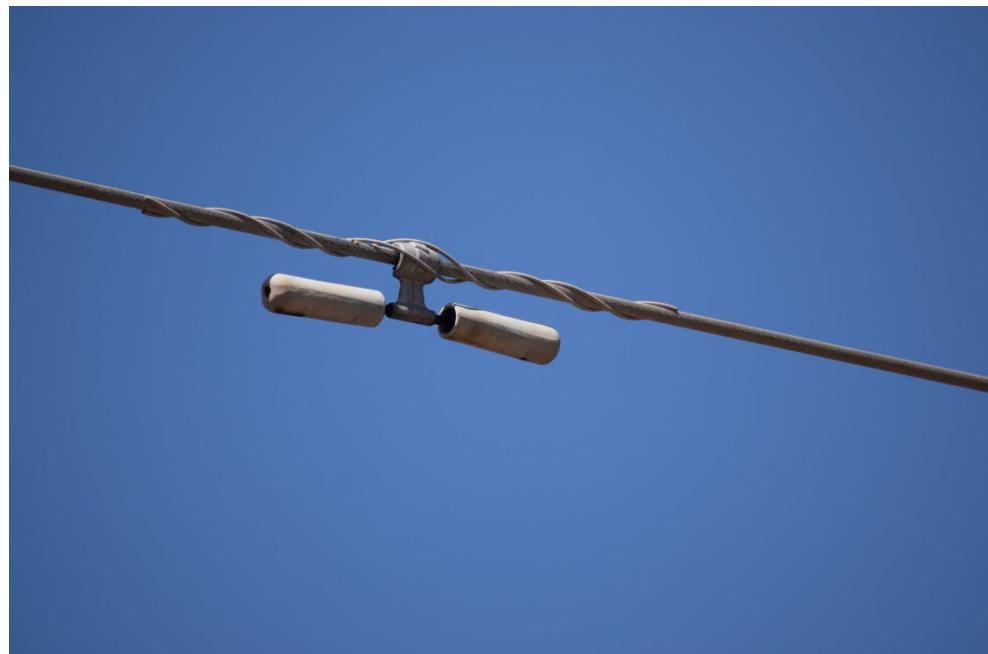
ES-1 Dampers

The transmission line has ES-1 type dampers that were installed during the commissioning of the line. These dampers are now aged and are now exhibiting signs of mechanical deterioration. The dampers no longer meet operational requirements and will require replacement.

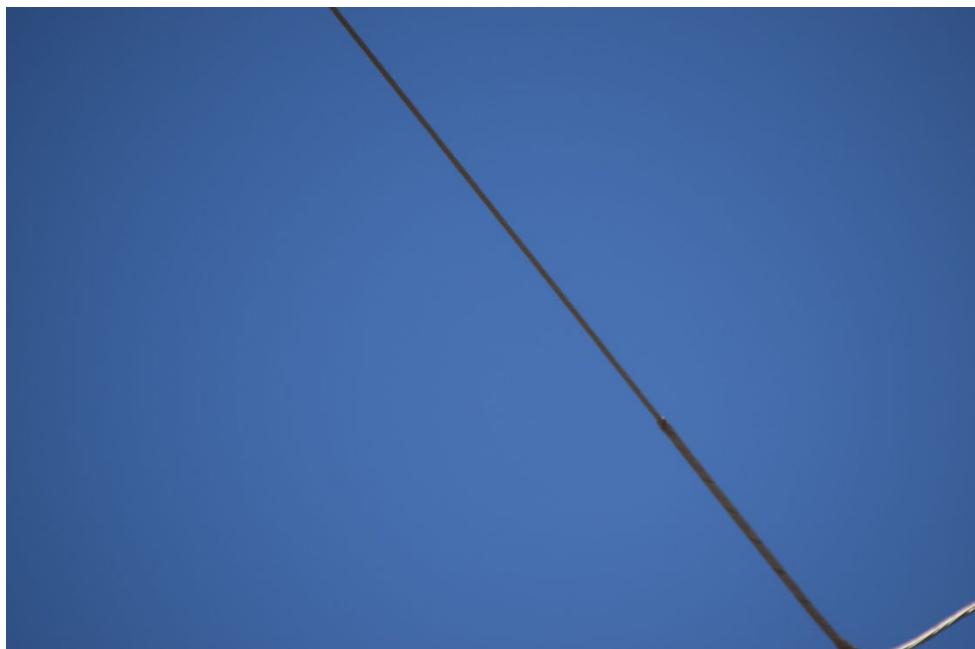
Condition of OHEW STR-1501

Both the OHEW and OPGW were replaced in 2004 and remain in good condition.

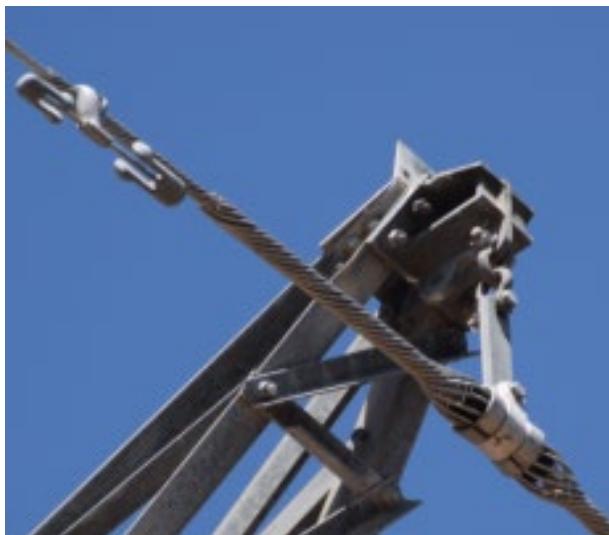
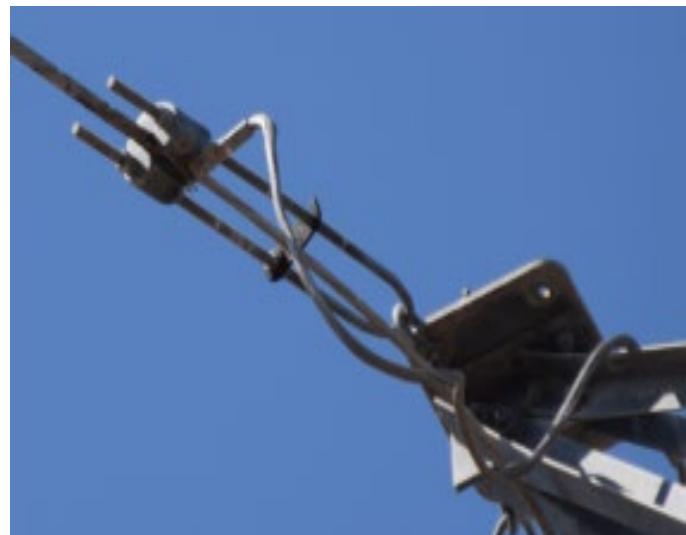
Condition of OHEW & OPGW Hardware on BS1257

*OPGW download clamps have Grade 3 bolt corrosion on all clamps and will require replacement in 5 – 7 years.

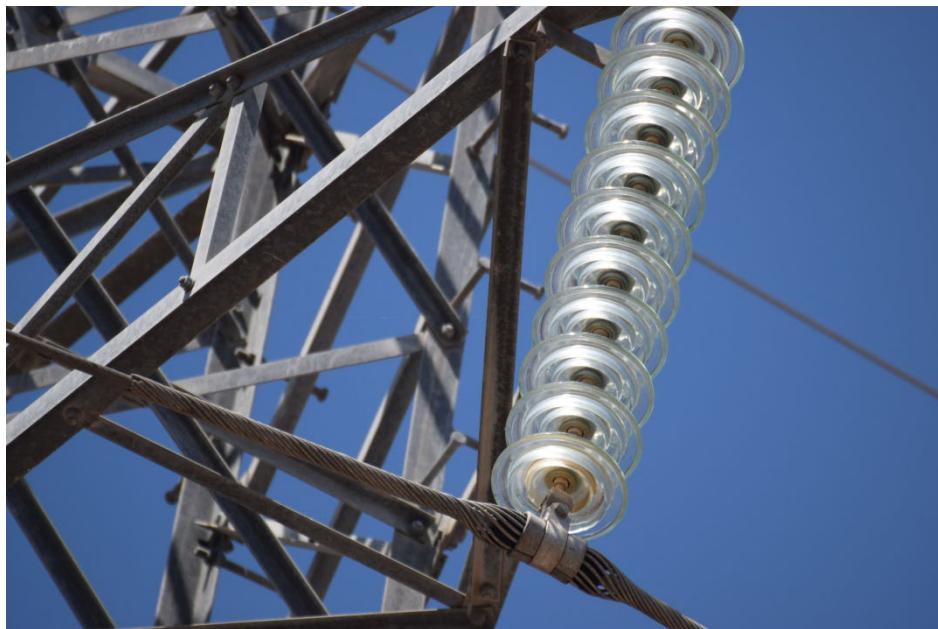
Glass Suspension Insulators STR-1482

There is a mix of glass and porcelain insulation throughout the line that had been replaced in 1998 and 2001. SAP has replacements dates between 2021 and 2028, but based on the condition of the insulators, a service life of at least 15 years is remaining. Chinese porcelain insulation is listed in SAP as being installed in 1985, but it is possible that in some cases these insulators have been replaced and SAP has not been updated.

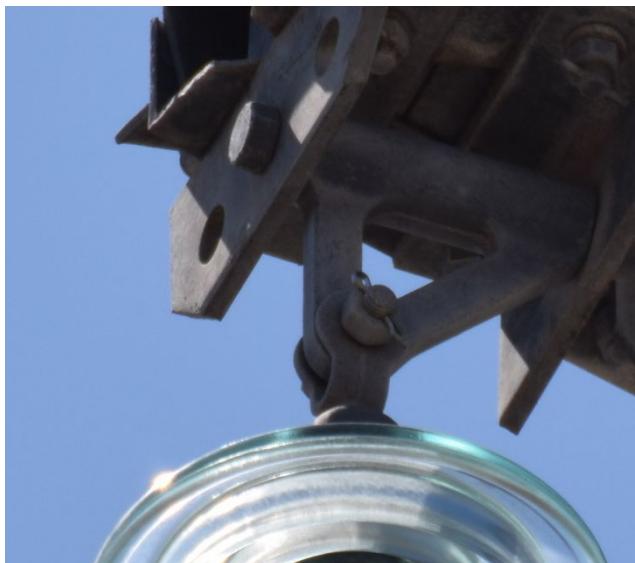
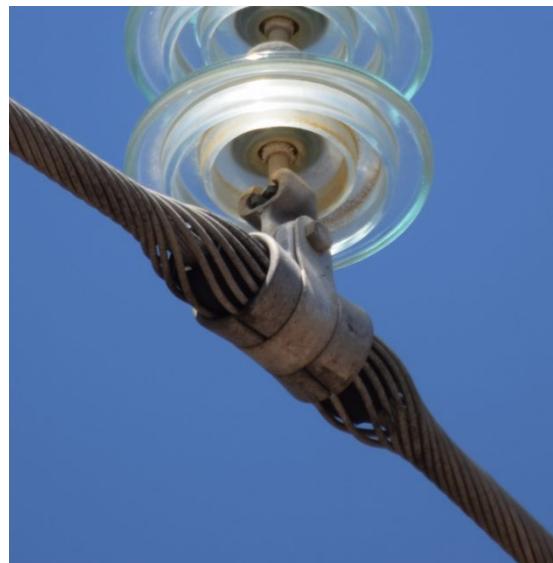
Suspension Hardware Condition on STR-1481

The AGSUs are in good condition with little to no corrosion evident, however the AGSU bolt is beginning to show signs of early Grade 2 corrosion in some cases.

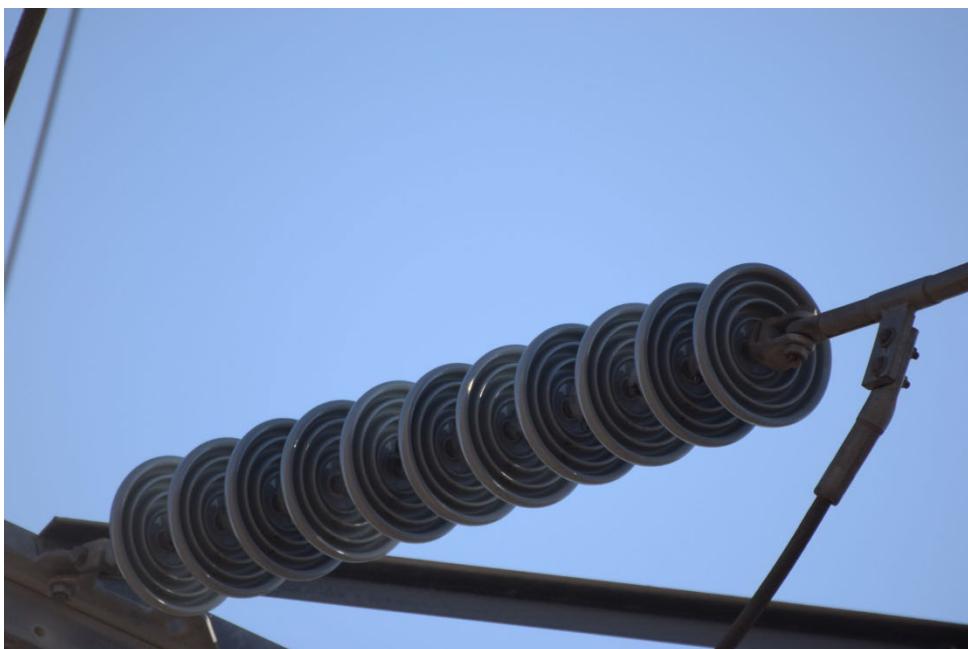
Tension Insulators STR-1499

The tension structures in Built Section 1257 have a mix of porcelain insulators (installed in 1993) and composite longrods installed in 2004. Structure 1499 also had insulators replaced in 2015 under maintenance. All tension insulators are in good condition and have at least a further 15 years of service life remaining.

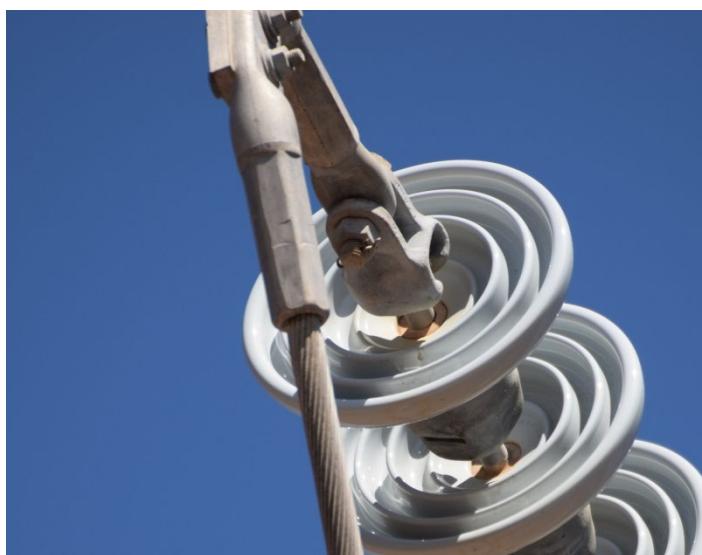
Condition of Hardware on Tension Insulators STR-1497

Hardware on all tension strings insulators was installed in 1978 and has Grade 2 corrosion throughout. The hardware is in fair condition and it is recommended that periodic monitoring continue.

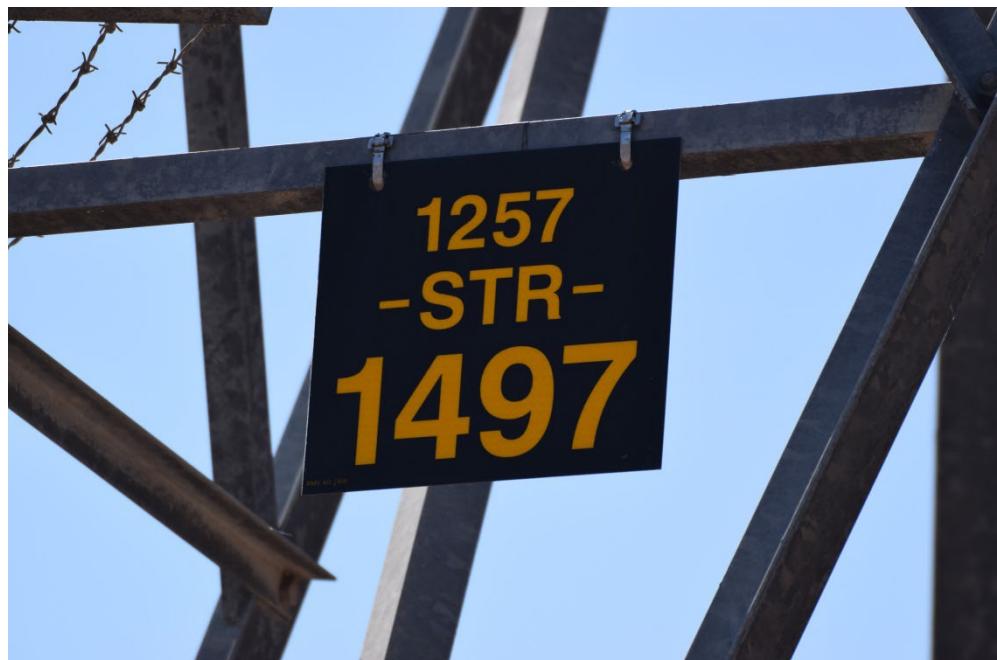
Warning and asset identification signs are in sound condition and meet current Powerlink standards.
