Powerlink 2027-32 Revenue Proposal

CP.02750 Ross to Chalumbin Life Extension

Transmission Line Condition Assessment Report

**Transmission Line Condition Assessment – Report****Built Section 1220 – Ross to Chalumbin 275kV**

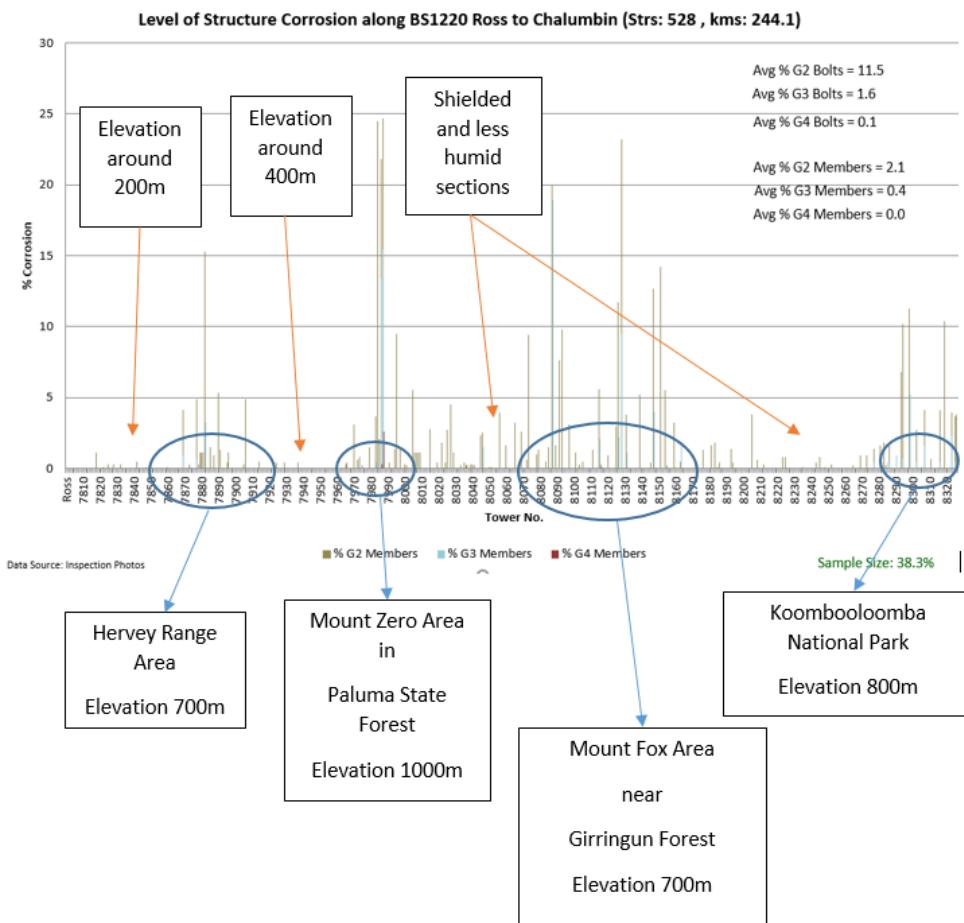
Figure 3: Line sections with towers exhibiting higher member corrosion levels

As a result, particularly in approximately six more exposed and elevated locations, galvanised tower bolts and members are exhibiting significant evidence of grade 3 and grade 4 corrosion. Between these areas of poor condition, corrosion levels vary from low to medium; relatively normal for the age of the line. Given the criticality and length of the feeders, and the difficulties of access to maintain the line in serviceable condition, it is necessary to consider when and how to maintain these structures in order to avoid reaching the point where extensive replacement of steelwork is necessary. If left untreated the maintenance costs could drive replacement of structures.

Elevated sections of the line more exposed to salt laden winds appear in a more corroded condition than lower sections protected by natural shielding of terrain topography.

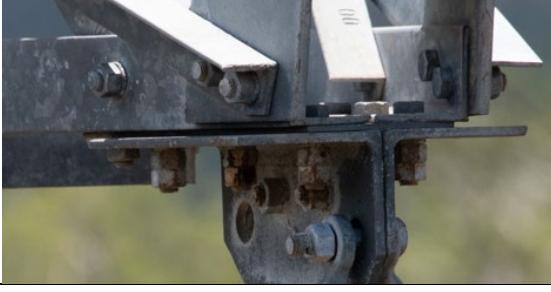
Cross Arms	Similar condition to that of the Superstructure.
Cond. Attachment	The worst area of the tower where more than 3% of bolts have G3 and G4 corrosion.

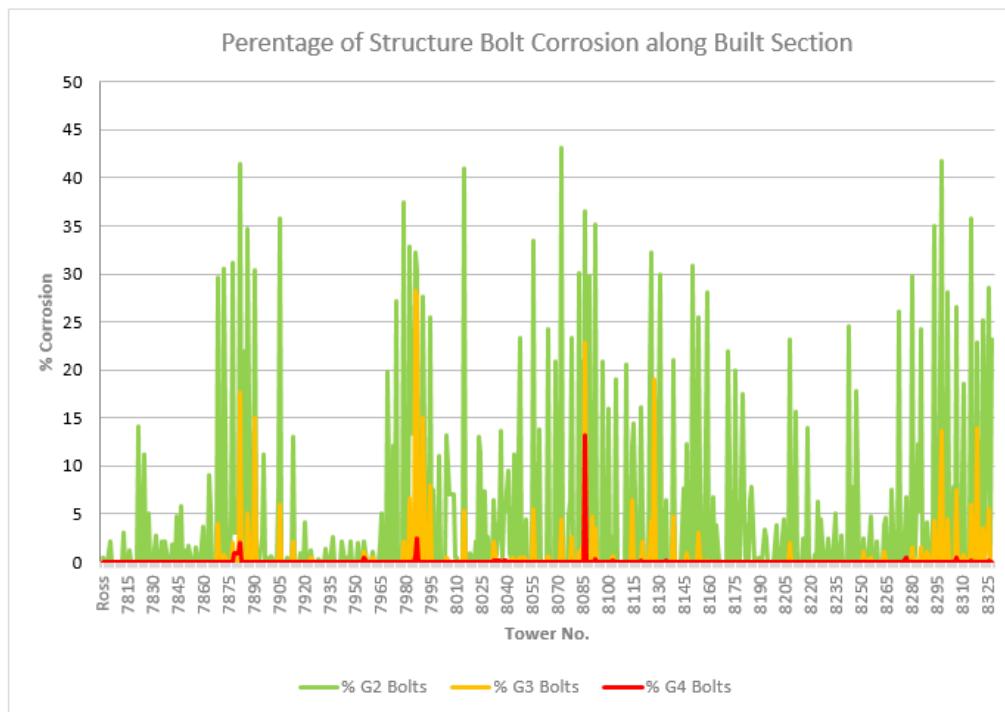
Below is the percentage corrosion of structures along the built section based on visual estimates on a sample of towers. The locations of structures with high nut, bot and member corrosion percentages along the line stands out clearly and correlates well with the SAP notifications graph (Appendix 7).

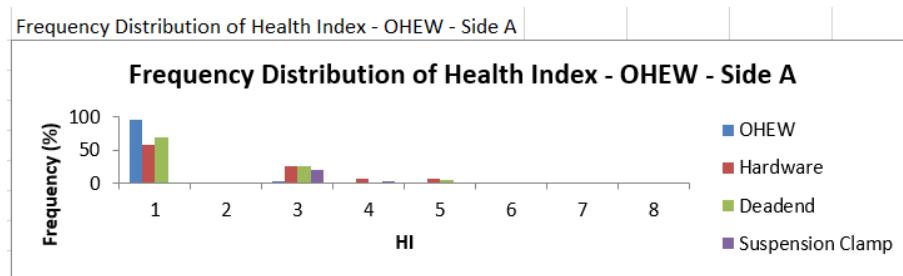
During 2015 and 2016 project OR.02017 replaced 181 spans of OHEW found to be in the worst condition (G3H and G4). An additional 21 spans of OHEW were replaced before the project under maintenance due to the damage, meaning that there are around 326 originally installed spans of the OHEW remaining on the line (around 62%).

Based on the latest visual inspection of the remaining original spans it is estimated that remaining service life of the OHEW system is 4 years.

Component	Installation Date	Comment	Estimated Remaining Service Life (years)
Earthwire	1989	Low grade 3	7
Earthwire Hardware	1989	Low grade 4	4
Earthwire Dampers	1989	Some sagged dampers.	4-7
