Powerlink 2027-32 Revenue Proposal

CP.02919 Broadsound Primary Plant Replacement

H020 BroadSound Substation

Primary Plant Condition Assessment Report

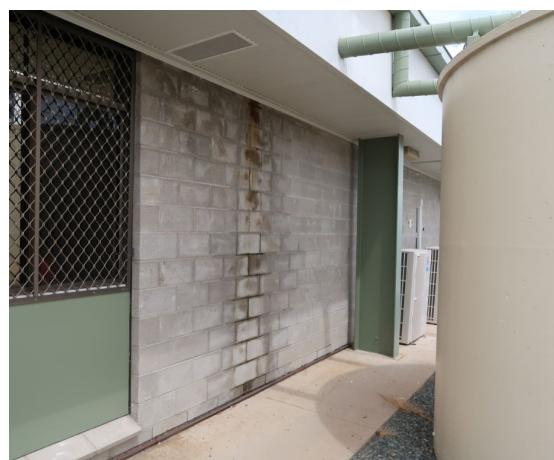
Figure 5: Building +1 Water Leak

The building wall was stained at the water tank connection as shown in Figure 5. Based on the stain it is likely that there is a leak from the connecting pipe. The leak should be investigated and fixed to prevent further damage. This building has a remaining service life of 20+ years.

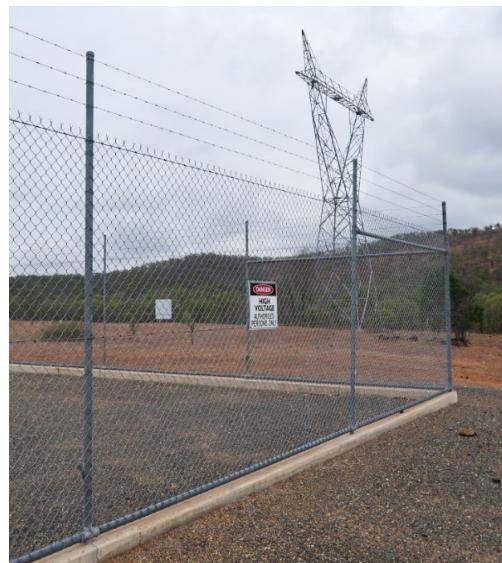
Figure 7: Security Fence – Newer Section

The substation security fence has two parts. The newer part is generally in line with the current requirements. The fence is approximately 3m tall, has a bottom rail and barbed wires at the top. At the base of the fence is a concrete strip in line with Powerlink's standard requirements. See Figure 1.

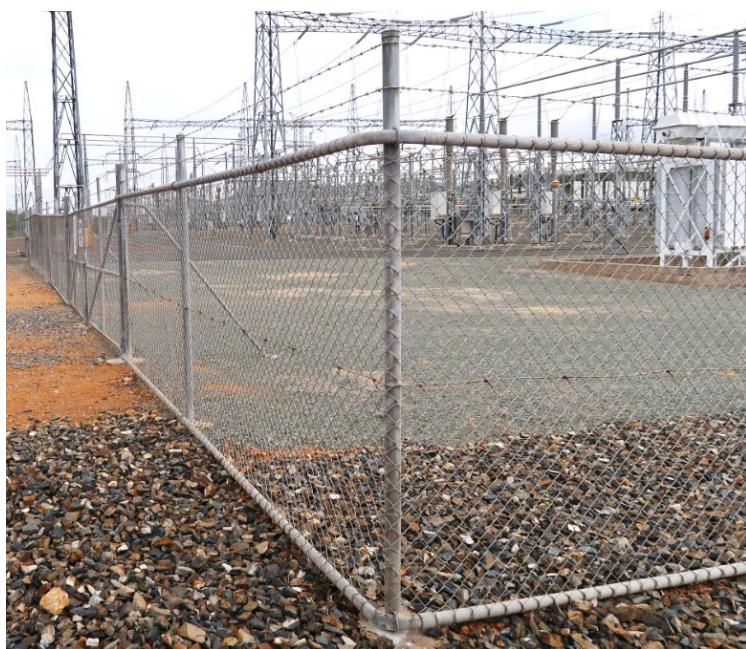
Figure 8: Security Fence – Older Section

The older part is only around 2.2m tall, has chain wire fence with top and bottom rails and two barbed wires on the top as shown in Figure 2. There is no concrete strip at the base of the fence. The newer part of the fence is in very good condition and should last for at least 20 years. The older part of the fence is still in reasonable condition without advanced above ground corrosion. The remaining life of the older fence is estimated to 10 years.

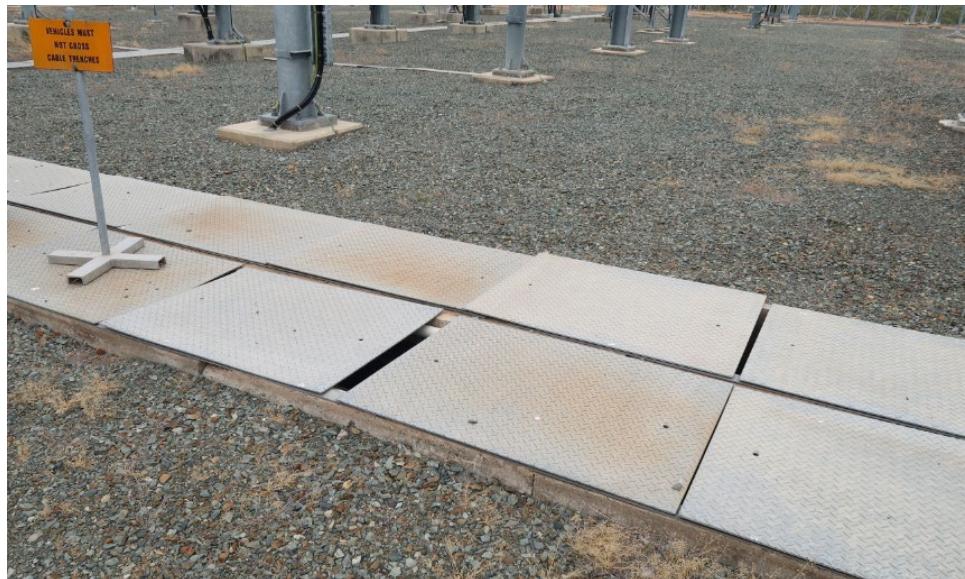
Figure 9 – Cable trenches

The cable ducts and the associated cable duct covers were in good condition however in places the covers were misplaced and could present a tripping hazard as shown in Figure 37.

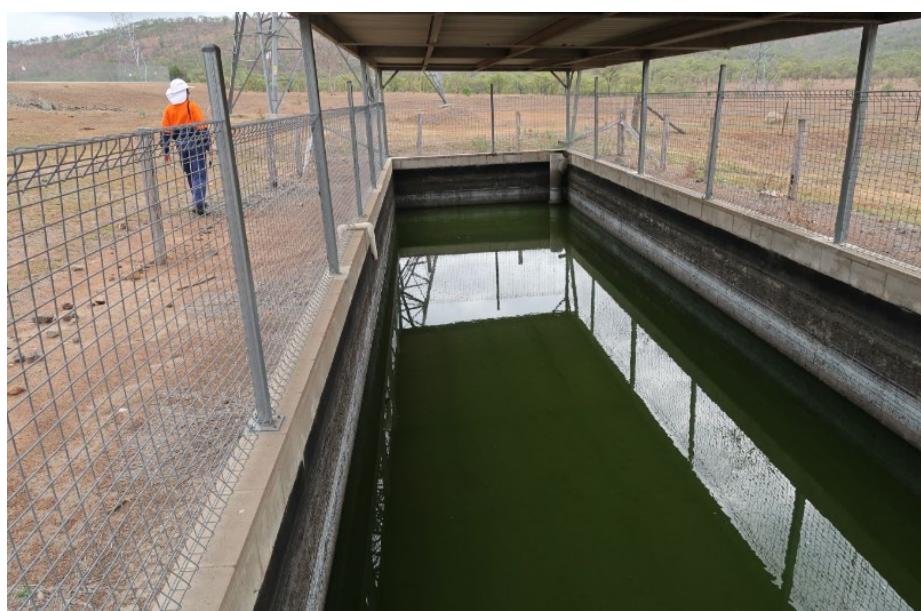
Figure 10: Oil Separation Tank

Reactors 1 and 2 bunds drain into an oil containment tank. The tank is an old open type tank, as shown in Figure 15, and it is believed that only one of such tank in Powerlink's system. This type of oil containment tank is considered less reliable.

The tank should be replaced as early as possible and it is very unlikely that the water discharge quality would comply with Powerlink's requirements if there is a presence of oil in the oil containment system.

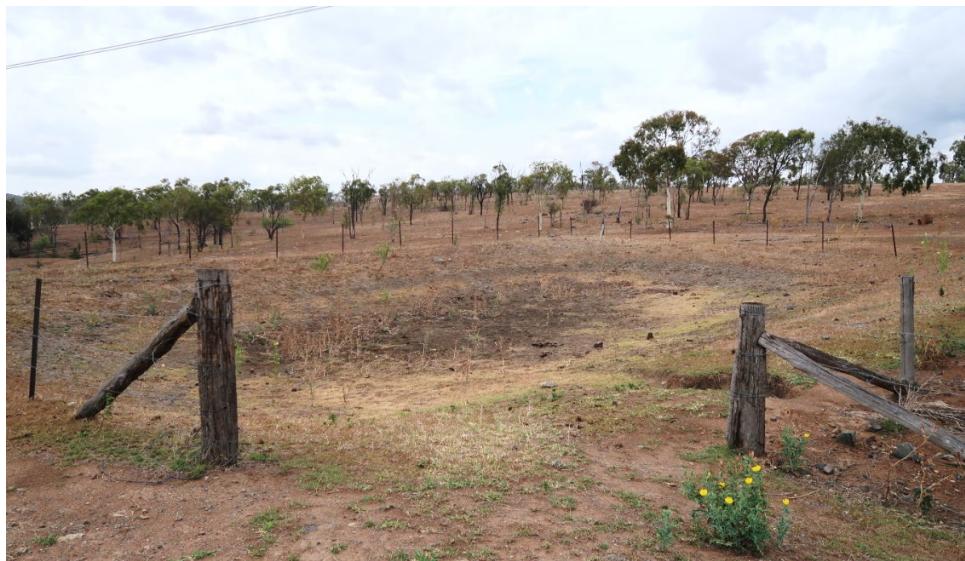
Figure 11: Retention Basin

The tank drains into a retention basin shown in Figure 11. The retention basin is surrounded by a stock proof fence, however the fence was open in one section and the basin is accessible to cattle. It is suspected that the local farmer is using the basin as a source of water for his/her cattle. The fence should be closed to prevent cattle accessing the basin.

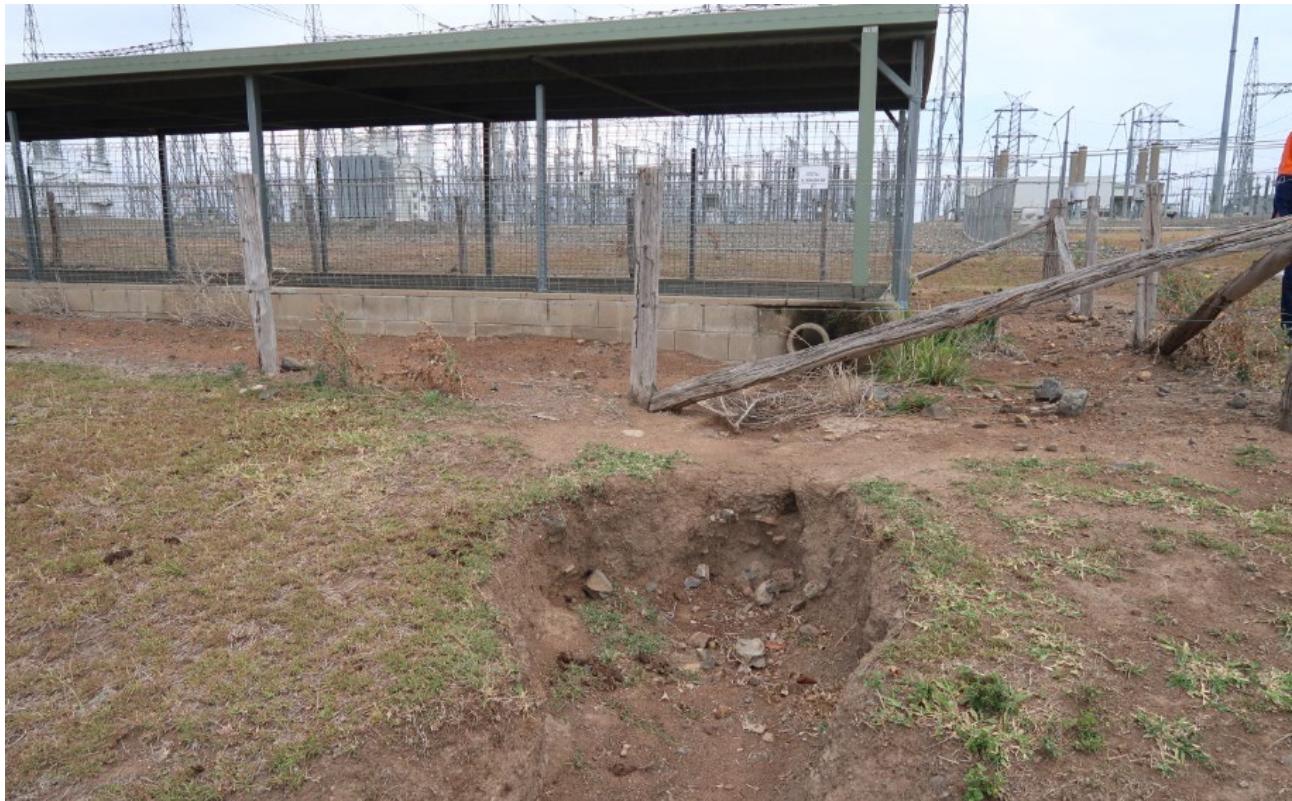
Figure 5: Existing Oil Separation Tank to be replaced

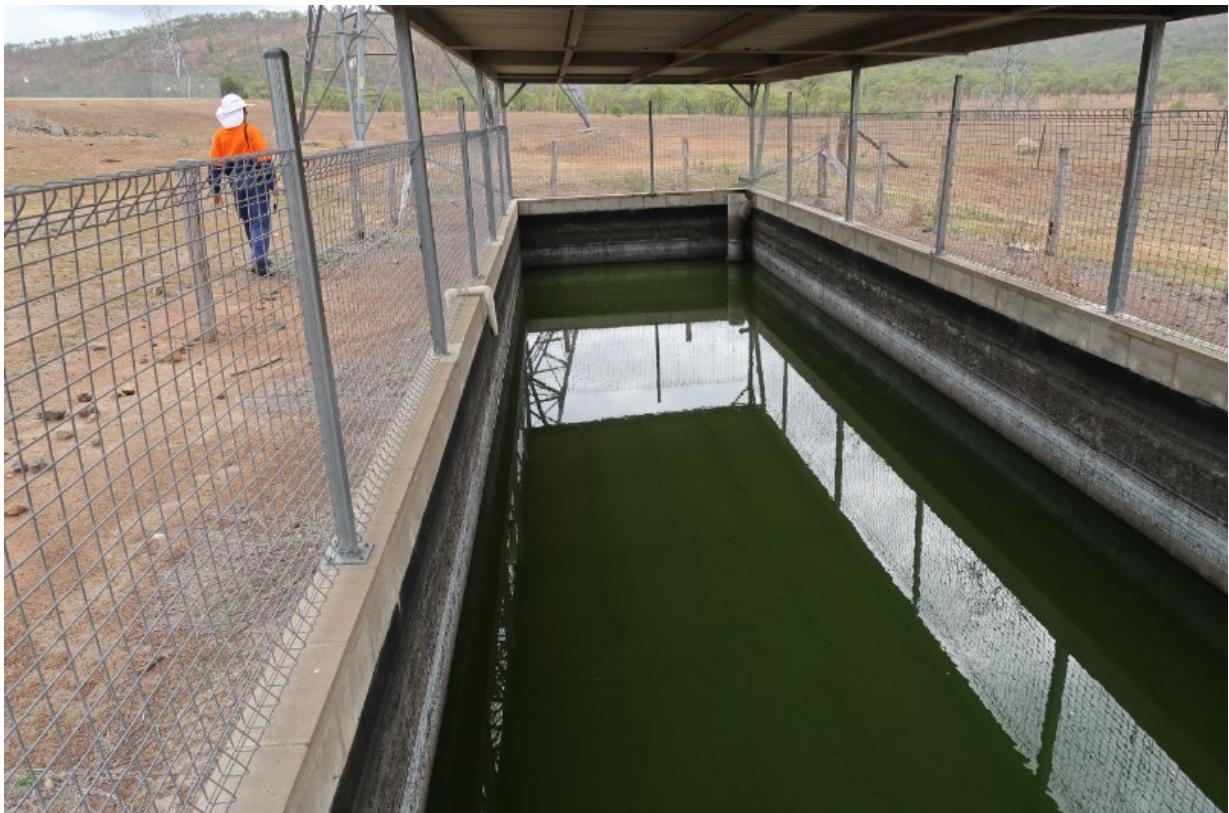
Figure 6: Existing Oil Separation Tank to be replaced
