# Powerlink 2027-32 Revenue Proposal

CP.02922 Calvale Selective Primary Plant Replacement

# SITE CONDITION ASSESSMENT REPORT

## H024 CALVALE

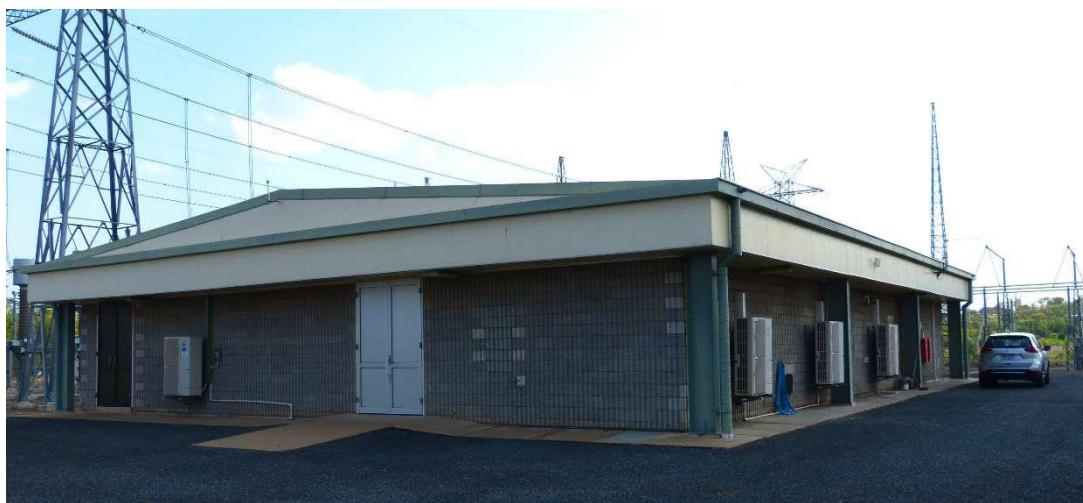
Figure 5 - Control Building 1

There is one control building and a work shed on this site. The original control building is brick construction with a steel metal roof and was commissioned in 1987. This building houses Powerlink 275/132kV control panels, the 125V and 50V DC supply systems and telecommunication equipment. It consists of a control/relay room, communications room, battery room, amenities room and toilet. The control, battery and comms rooms are all air conditioned. The majority of windows have bars installed. The building is reasonably well maintained, and no significant issues were noticed during site inspection in 2020.

**Recommendation:** Based on the condition it is recommended that this brick building is fit for purpose for another 40 years with regular maintenance.

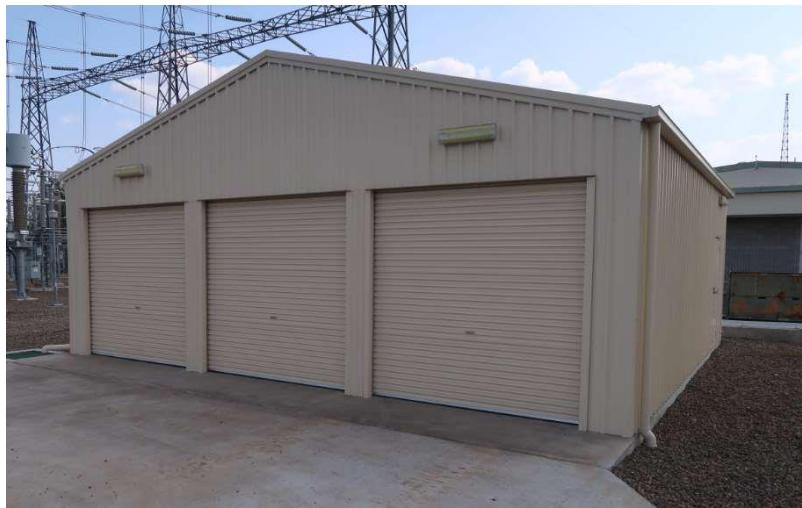
Figure 7 - Work Shed

A storage shed is located in vicinity of the control building. The shed exterior is in good condition, and no issues were noted during site inspection in 2020.

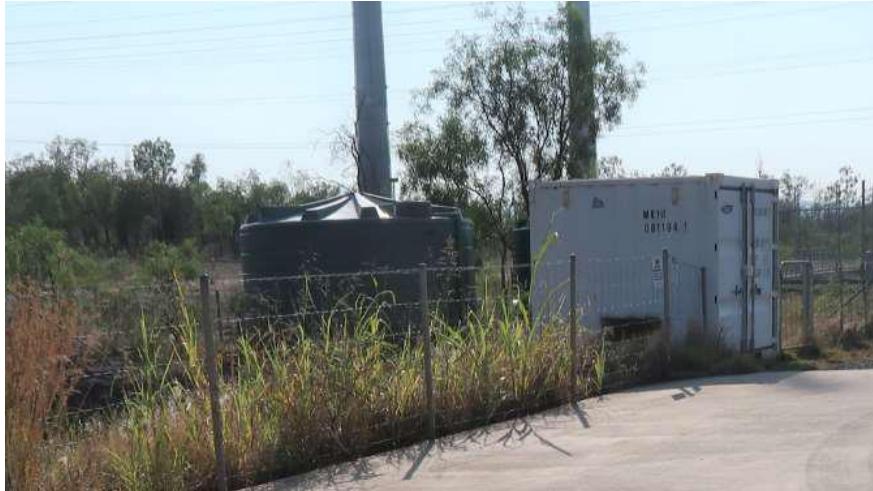
Figure 8 - Water tanks

There are no permanent water tanks within the yard. Two water tanks are positioned outside the yard at the wash-down station. The tanks are made from polyethylene and were in good condition during site inspection in 2020.

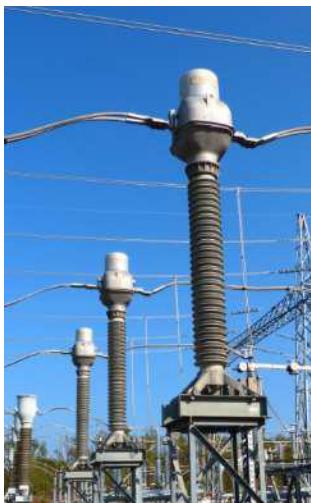
Figure 9 – Circuit Breaker

The circuit breaker in this bay is a Mitsubishi 250-SFM-340B manufactured in 1987 and installed in 1988. It has pneumatic operating mechanism with air and spring used for energy storage and SF6 gas for insulating medium. SFM type Mitsubishi CBs of this vintage have asbestos impregnated washers of friable nature associated with the heater inside the mechanism box which have been removed. Mitsubishi does not produce this type of circuit breaker anymore and sourcing of spare parts has become a major issue. Wiring inside the mechanism box is cracked due to UV penetrating through viewing window. Maintenance records show that this CB had issues with unloader valve and pressure relief valve of the air compressor system. In 2023 pole discrepancy times were found to be out of specification which were attributed to a high resistance of the trip coil. The resistance of the trip coils is marginally outside of manufacturer specification (tested at  $34.7\Omega$  with manufacturer specification indicating an acceptable range of  $31.35\Omega$  -  $34.65\Omega$ ). During re-testing the CB pole discrepancy was within nominal pole discrepancy times and was returned to service. The degradation of the trip coil will cause slow trips and pole discrepancies to occur more frequently. The recorded trip timing tests conducted in 2023 are all within specifications. Recently in 2025 the Kajo compressor was found to be leaking oil and was replaced in the same year. PI data monitoring of the SF6 pressure indicates that there are no leaks present. This CB has been in service for 38 years and it is estimated that it has a remaining service life of 3 years.

**Recommendation:** Based on the above observations, it is recommended that CB and CTs incl. structures and foundations are replaced within the next 3 years preferably using dead tank CB. The rest of the HV plant is in good condition and no replacements are required in the next 10-year outlook.

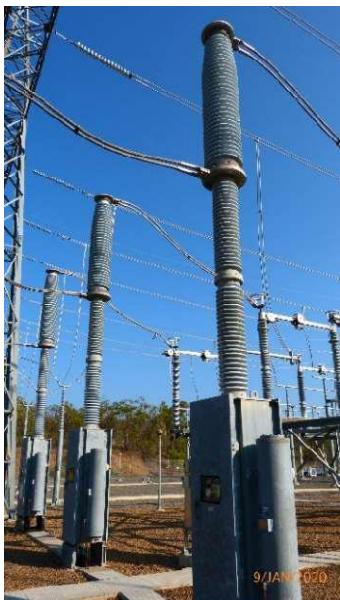
Figure 13 - Circuit Breaker

The CB in this bay was installed in 1988 and was manufactured by Mitsubishi. It has a pneumatic operating mechanism with air and spring used for energy storage and SF6 gas for insulating medium. This type of CB is no longer manufactured by Mitsubishi. The maintenance records show minor issues with wiring inside the mechanism box is cracked due to UV penetrating through viewing window and shielding installed on the cables to prevent UV damage. This model of breakers also has asbestos impregnated washers of friable nature associated with the heater inside the mechanism box which have been removed. The opening trip times #1 indicate that the breaker is marginally outside of manufacturer specifications, however the opening time #2 is within this spec. This model of CB has been updated by the manufacturer since its manufacture and as such no spare parts are available. This CB has been in service for 38 years and it is estimated that it has a remaining service life of 3 years.

**Recommendation:** Based on the above observations, it is recommended that the isolator, earth switch, CB, CT and CVT including structures and foundations are replaced within the next 3 years preferably using a dead tank CB. The rest of the HV plant is in good condition and no replacements are required in the next 10-year outlook.

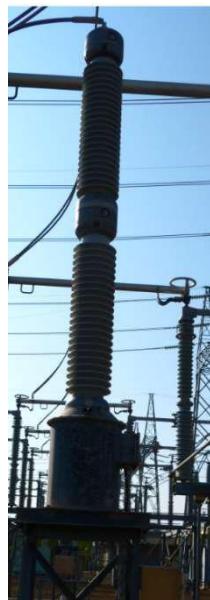
Figure 11 - CVT

The capacitor voltage transformer is oil filled and manufactured by Haefely. No defects have been raised against this CVT, however due to the CVT being 42 years old, it has been deemed to have reached end of technical life. This model is only in service at Calvale and Broadsound substations with 82% of the in-service population being retired due to poor condition. It is expected that failure of this CVT could occur within the next 5 years and should be replaced within this timeframe.

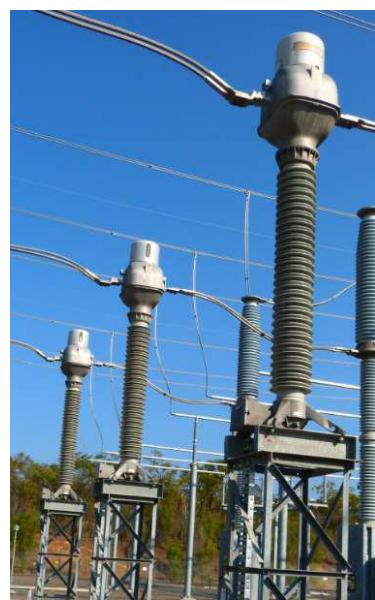
Figure 12 - CTs

The oil filled current transformers are in reasonable condition physically considering they have been in service for between 33 - 38 years. This model of CTs have been identified to have a high failure rate and as such are on yearly oil testing. The A & C phase CT test results have identified that overheating <300 degrees Celsius has developed. There were no identified issues with oil seal integrity when inspected on site. Considering their age, oil test reports and the fact these have porcelain housing, it is recommended to replace the CTs in 3 years to manage safety risks associated with their potential catastrophic failures. Current transformers with paper and oil have an increased probability of explosive failure occurring after 36 years in service.

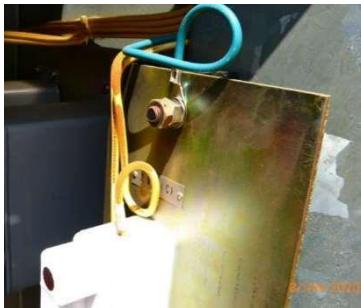
Similar to the other Mitsubishi 250-SFM-340B circuit breakers in this substation, there are a number of issues identified in the maintenance records. This CB had issues with compressor oil leak, unloader valve, UV damaged control cable and SF6 gas leaks. The trip timing results of the CB have all tested within specification. This CB is currently 38 years and it is estimated that it has a remaining service life of 3 years.

Figure 15 - Wiring UV damages

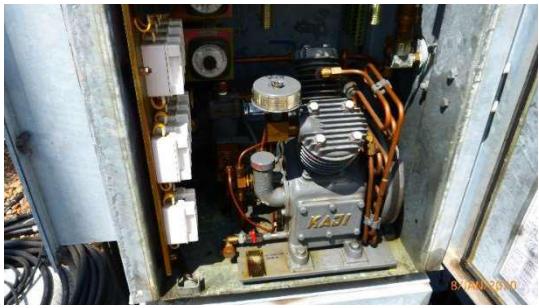
Figure 14 - CB Mech box oil leak

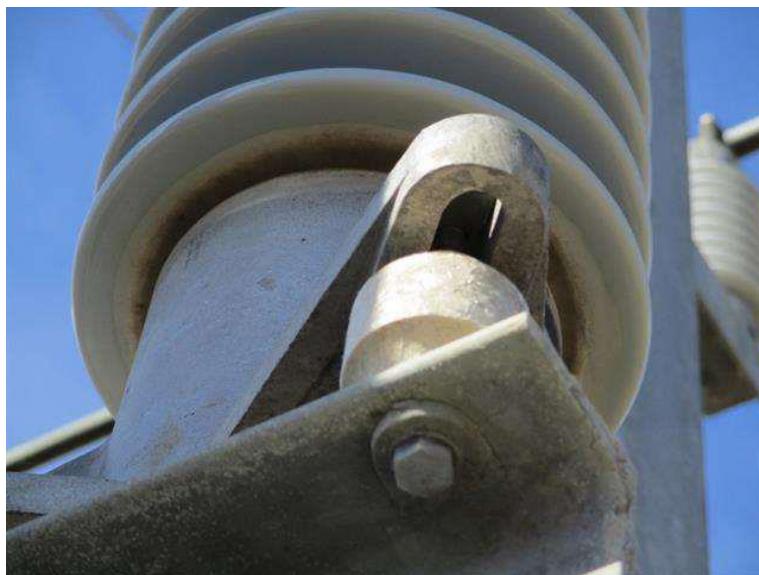
The underground cable was commissioned in 1987 and is a 33kV, consisted of three single core 185mm<sup>2</sup> cables with copper conductor and max continuous current of 345A in each core. The sheath insulation resistance tests for all cores are within acceptable limits. It has been reported that the cable has rusting on the washer of the cable termination, deteriorating coating on the associated insulators, leaking oil from the C phase cable termination/pothead. It is estimated that the cable has 10-15 years of service life remaining based on its condition. The fault level of this cable however is underrated for the site and as such this should be replaced as soon as possible.

Figure 16 - Deteriorated coating on associated insulator

**Recommendation:** Based on the above observations, the underground cable is in good condition for its age however given its fault level is below the calculated fault level at this site, this underground cable should be replaced as soon as possible.

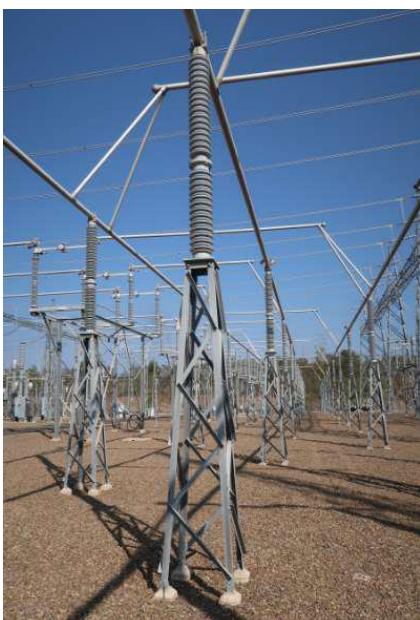
Figure 15: 275kV Lattice Bus Support Structure

Lattice structures were used as bus supports in the initial construction while in the late 1990s and 2000s tubular structures were used. All structures are in good condition when inspected in 2020 and no significant issues were found. Examples of the lattice and tubular structures are shown in the figures below.

**Recommendation:** The corroded bolts on all structures are recommended to be replaced immediately. The surge arrestors should also be replaced within 3 years. Apart from this, based on the above observations, the rest of the primary equipment in these bays is in good condition and no replacements are required in the next 10-15 year outlook.

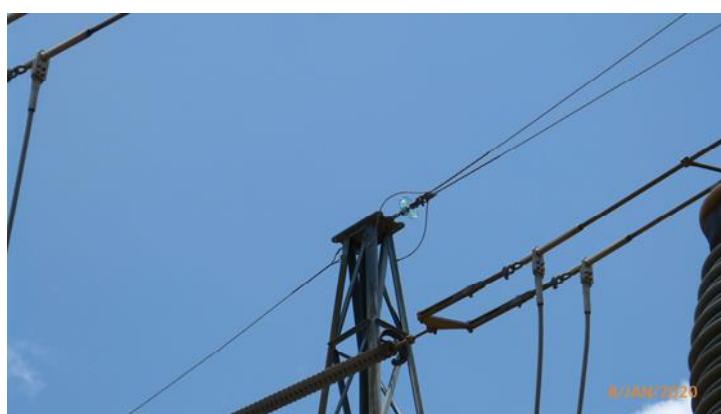
Figure 19: Earth wire

The overhead earth wire appears to be in good condition. The connections of the earth wire to their strain towers vary in configuration but these are also in good condition when inspected in 2020.

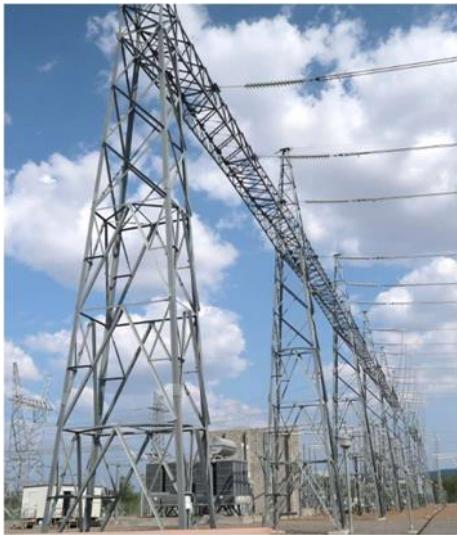
Figure 21: 275kV Strain Structure

The 275kV strain structures were established between 1984 and 2013. All 275 kV strain structures are the same lattice type as shown in the figures below. No issues related to the structures were found in 2020.

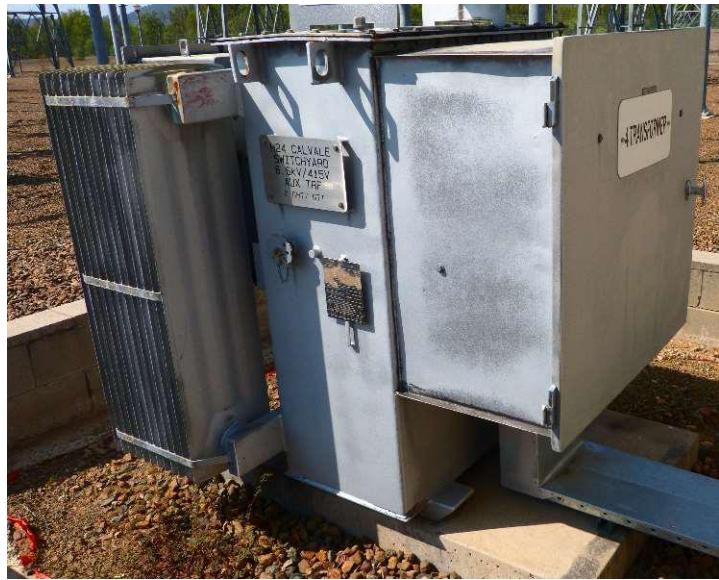
Figure 24: 4 Stn Transformer

These two station transformers are in good condition. However, the 4 station transformer is 50 year old and has approached the end of it's service life.

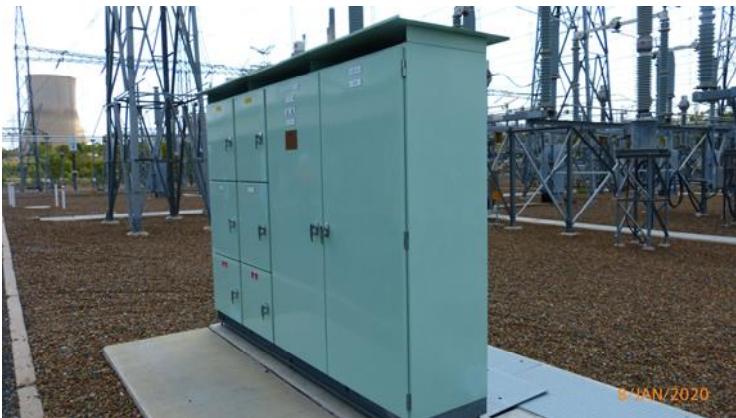
Figure 26: AC changeover board

The AC changeover board was installed under project CP.01151 and is in good condition. The arc flash studies completed under OR.02429 found that the ACCO board is category 3 and that the incomer MCCBs F1 & F2 Isd should be changed to 1512A (though noting this will still result in a PPE category 3 for the board).

**Recommendation:** Based on the above observations and records, the only action required is for the MCCBs Isd to be changed, apart from normal maintenance.

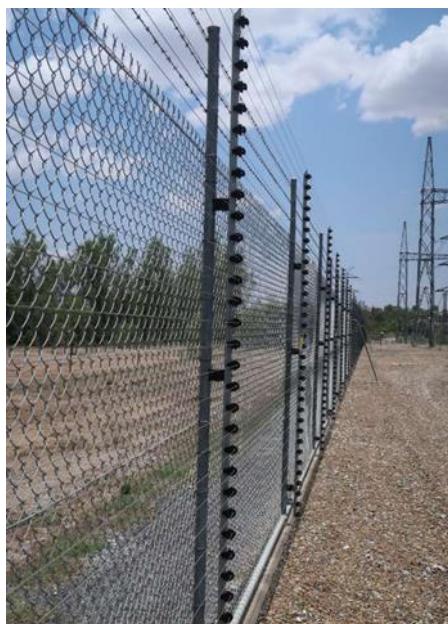
Figure 27: Security Fence

The substation security fence consists of a standard chain wire fence and an electrical fence mounted on the inside of the chain wire fence. The chain wire fence is approximately 3m tall, has a bottom rail and barbed wires at the top. At the base of the fence is a concrete strip in line with Powerlink's standard requirements. The fence is in good condition and its civil aspects should provide about 20 year life before significant repairs are required. A section of the fence is shown in Figure 27.

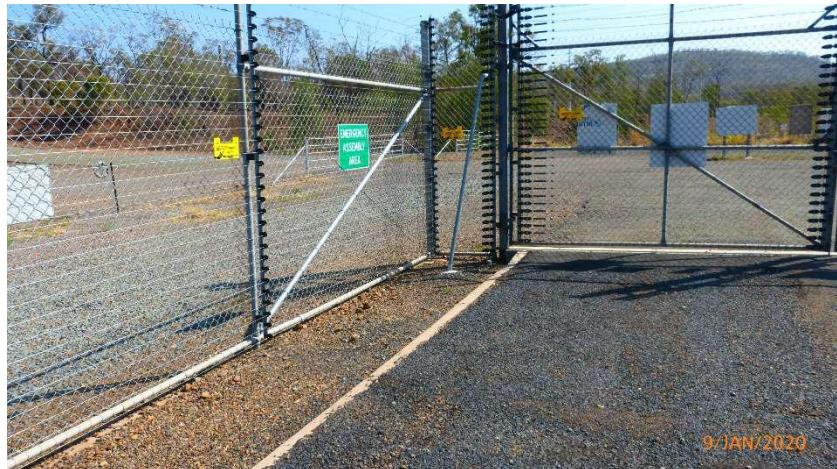
The substation internal roads are in a reasonable condition although broken in some areas. In particular the road surface is broken in the vicinity of the entry gate as shown in Figure 29.

Figure 29: Broken road surface

**Recommendation:** Based on the above observations and records, there is no action required in the next 10-15 year outlook, apart from normal maintenance.

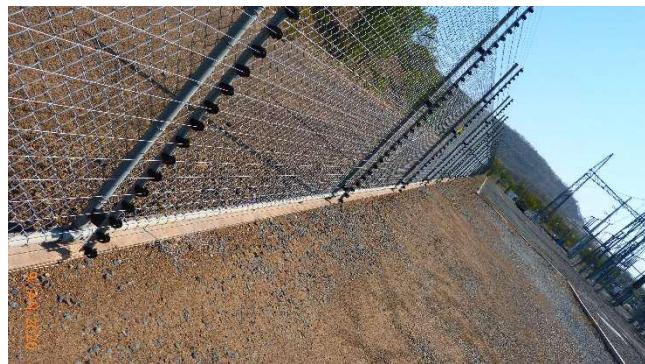
Figure 30: no tail to fence

The fence post should be connect to the main earth grid at the grid crossings, it was noticed on site that this was not the case.
