Powerlink 2027-32 Revenue Proposal

CP.02948 Chalumbin 275kV Substation Reinvestment

SITE CONDITION ASSESSMENT REPORT

H032 Chalumbin

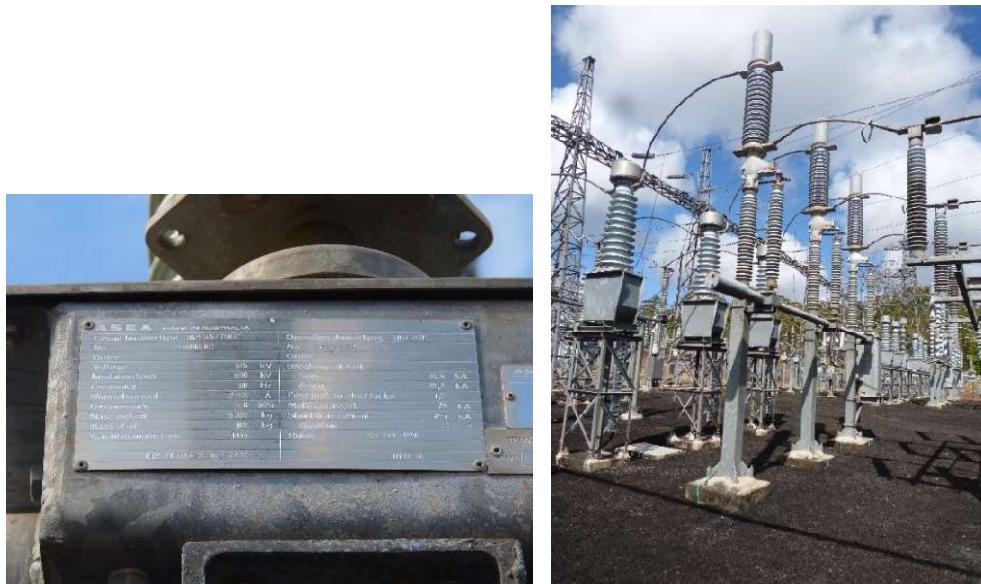
Figure 9 – HLR Circuit Breaker

In addition, the circuit breaker in this bay is a minimum oil circuit breaker containing 165 kg of oil rated for 2000 operations (according to SAP record had done only 155 operations). Although it is in good condition for its age, it is recommended to replace it within next 5-10 years to reduce presence of oil and to enable installation of dead tank circuit breaker to reduce maintenance associated with current transformers. Dead tank circuit breakers contain toroidal CTs which are maintenance free.

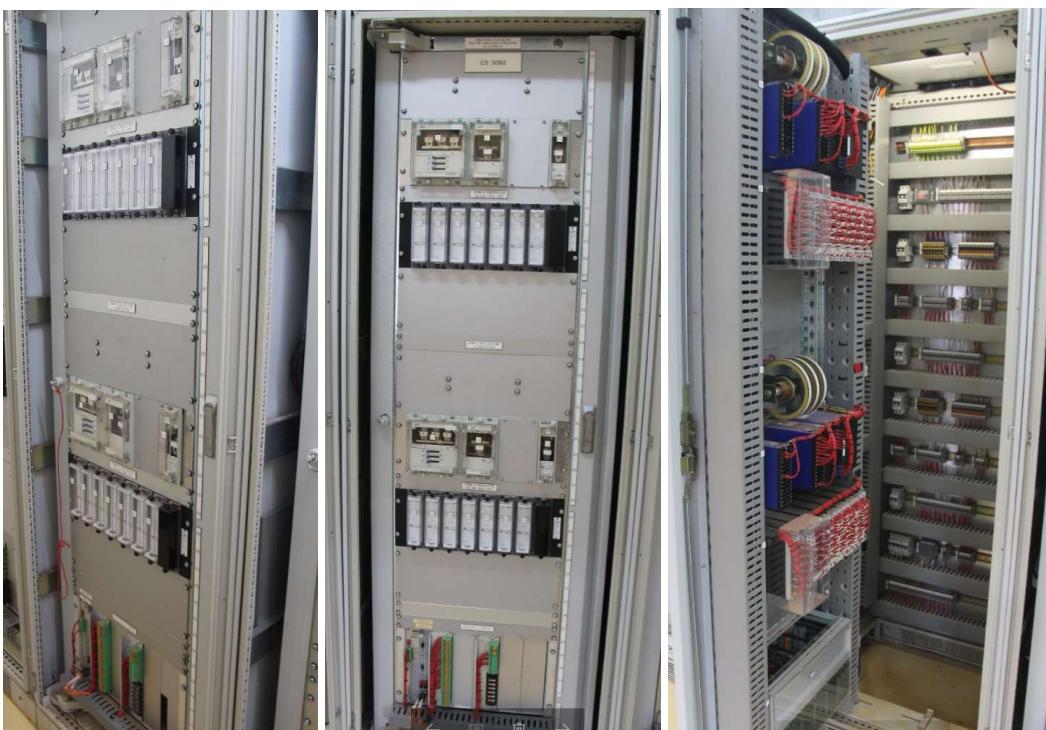
275kV 1 & 2 Bus protection and CB fail bus trip panel

High impedance differential relays ALSTOM MFAC34 relays are used to protect 275kV 1 and 2 bus. Powerlink has recovered modules of C50 RTU such as the CPU, ACT and ADI card. But these cards have been in service for more than 20 years and the capacitor electrolyte might have been dried out. These recovered parts would be utilised only for emergency replacement. Powerlink has conducted a last buy in 2014 and are relying on these RTUs for maintenance spares. Health Index indicates that all protection and control systems for 275kV 1 and 2 Bus will reach the end of technical asset life and need to be replaced by 2024.

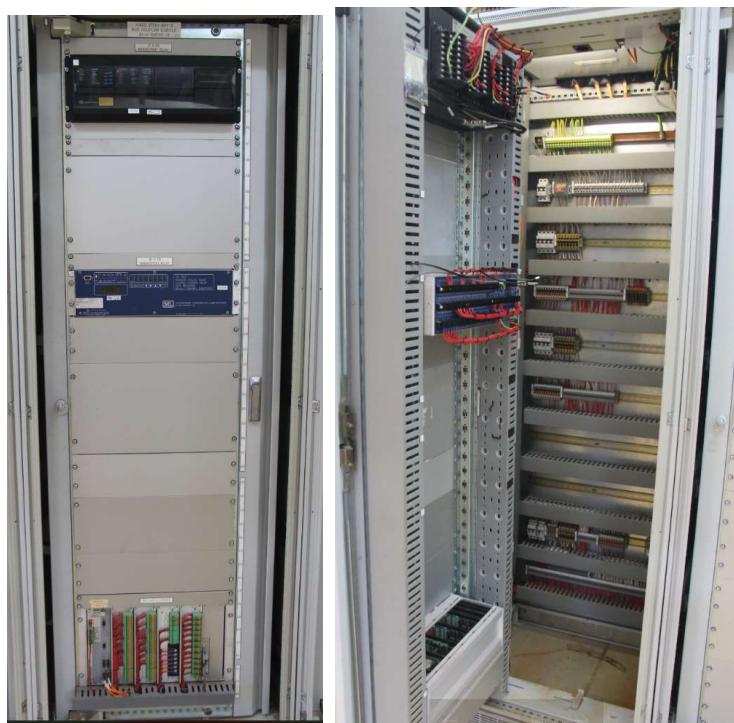
Coupler 506 protection/control panel

Secondary systems for 275kV coupler 506 were commissioned in 2004. Health Index indicates that all protection and control systems for 275kV Coupler 6 will reach the end of technical asset life and need to be replaced by 2024.

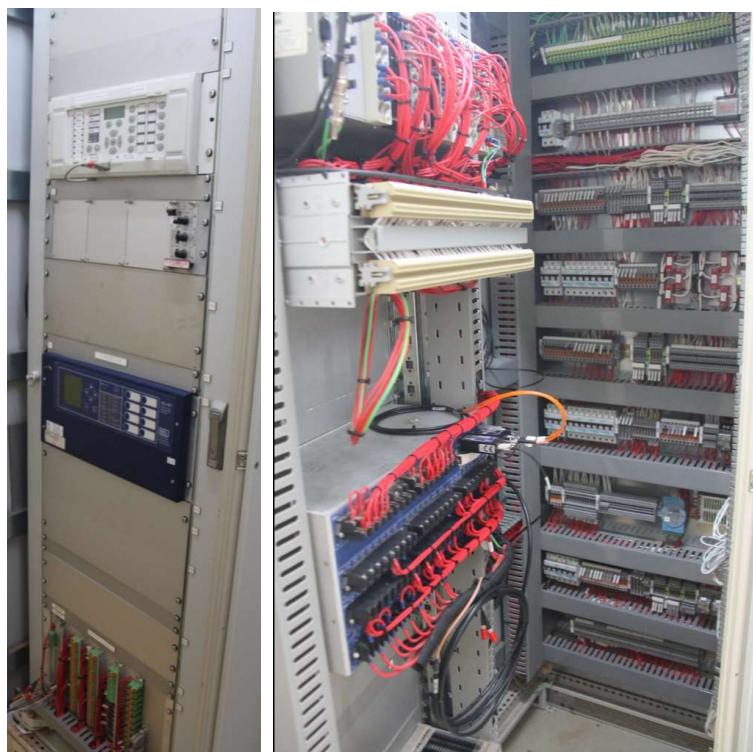
Feeder 877 bay protection/control panel

Secondary systems for feeder 877 were commissioned in 2004 (except X protection [REDACTED] was replaced under CP.02059 Woree-Chalumbin SPAR in 2012). Health index indicates that these equipment (Communication interface [REDACTED] relay and [REDACTED] RTU) will reach the end of technical asset life and need to be replaced in 2024.

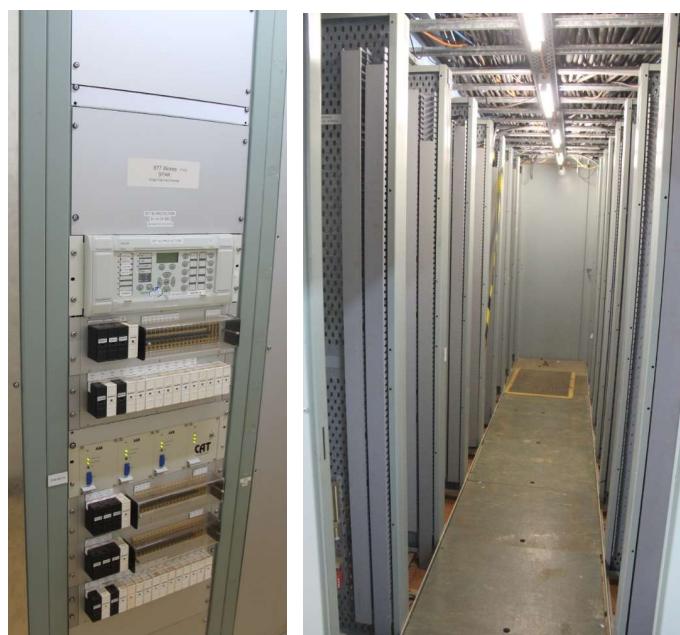
Feeder 877 SPAR scheme panel

There is a special arrangement for Woree-Chalumbin feeder 877 on Single Pole Auto-reclose (SPAR) due to the underground cable section. Associated protection [REDACTED] and protection signalling [REDACTED] were installed in 2012 and are in fair condition. But associated protection and comms devices are housed within a tunnel type of construction which has constrained spaces. The panel has exposed terminal in the rear of the panel which could cause safety issues. This type of construction is vulnerable to cause human error on mis-tripping of primary plant when maintenance is conducted and it is also expensive to modify because of the inter panel wiring. These equipment with the panel should be replaced with major secondary system replacement on that bay.

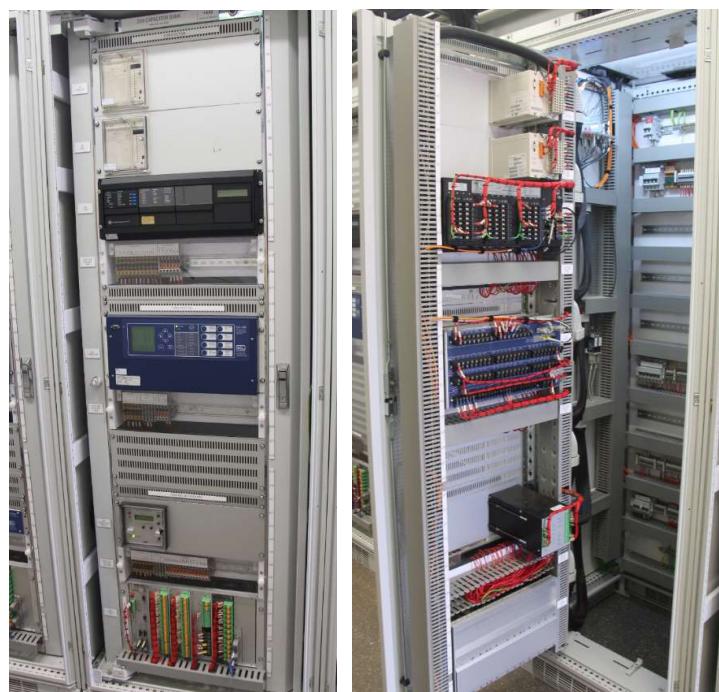
1 CAP protection and control panel

Secondary systems on 132kV 1 Capacitor bank were replaced in 2013. There are no condition-driven replacements required (except SPAJ140C O/C relay) until 2033. The O/C relay, [REDACTED] needs to be replaced in 2024 based on associated health index.

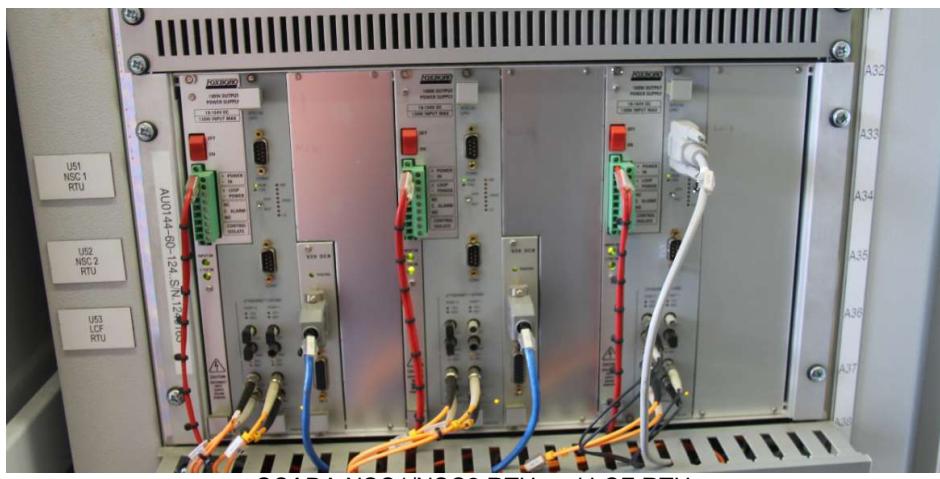
SCADA NSC1/NSC2 RTU and LCF RTU

Dedicated SCADA paths have been implemented for 275/132kV secondary systems at H032 Chalumbin. The SCADA system has independent NSC1 and NSC2 RTU to implement 2 x dual SCADA paths based on DNP serial protocol. The serial SCADA is being phased out because of expensive serial infrastructures and will be migrated to DNP over IP under major secondary system replacement.
