# Powerlink 2027-32 Revenue Proposal

Project Pack

CP.03005 T142 Tennyson T3 Replacement

## Transformer Condition Assessment T142 Tennyson Substation

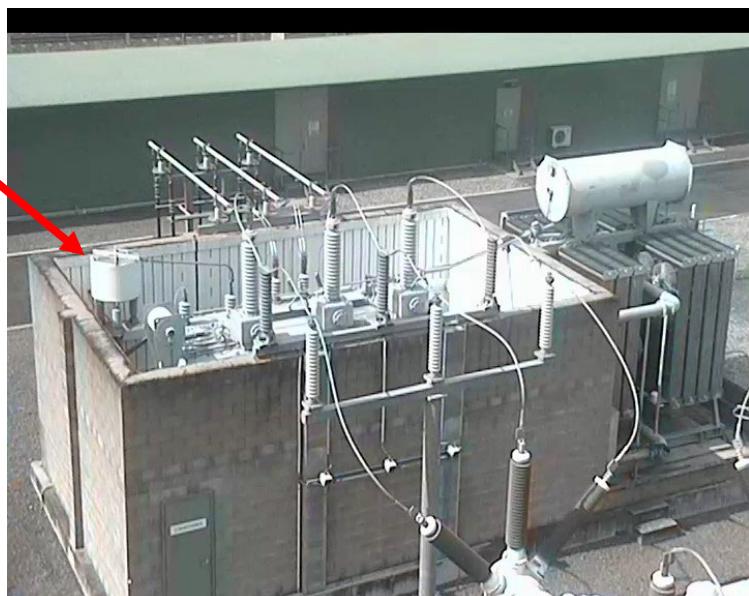
**Figure 6:** T142 Tennyson transformer T03 installed inside a sound wall enclosure. Note the NEX installed on a steel post near the OLTC oil conservator.

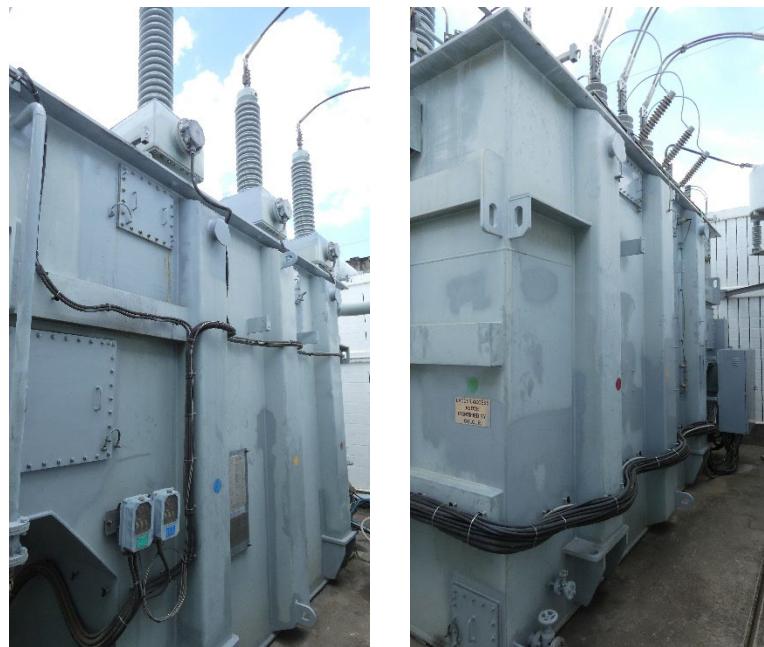
The main issues identified on this transformer main tank at present are the failed paint system and some minor oil leaks. There are signs where the paint coating has been touched up in local areas where necessary after removing corrosion. Overall though, the main tank is in fairly good condition only requiring routine maintenance to address the issues identified and to keep localised corrosion under control as it develops.

**Figure 8:** (LHS) Tennyson T03 HV side. (RHS) A view of the LV side. Note the paint touch-ups.

- (b) Due to (a) above, there is little long-term benefit in doing anything other than ongoing normal scheduled routine maintenance sufficient to keep the transformer serviceable until a replacement can be arranged or the transformer is scrapped. This will address existing oil leaks and localised corrosion that may develop in the future. No extensive repaint of the transformer should be considered.

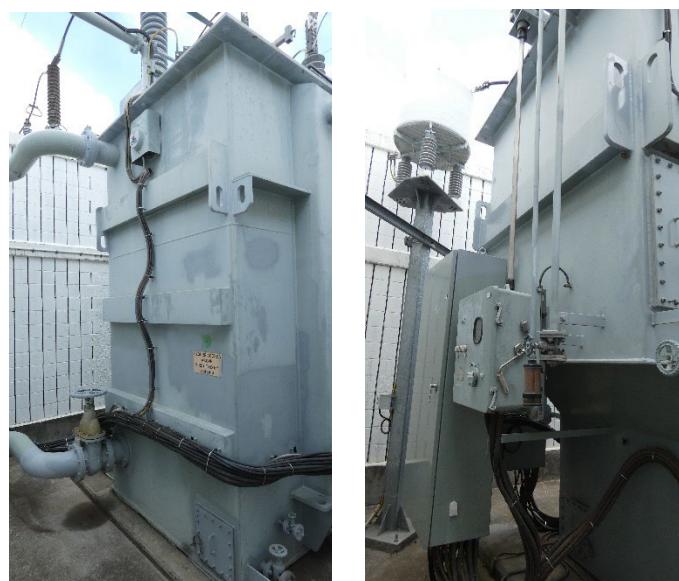
**Figure 9:** (LHS) Cooler bank end of T03. (RHS) Tap changer end of T03.

The concrete apron surrounding the transformer main tank appears to be clean apart from a couple of oil stains under the main isolating gate valve (refer to figures 8 and 9).

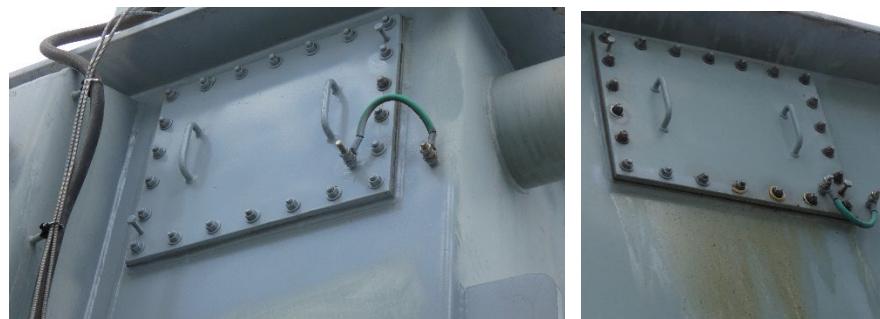
**Figure 10:** Corrosion repairs and paint touch-up on side access hatch as well as oil leaks on another hatch.

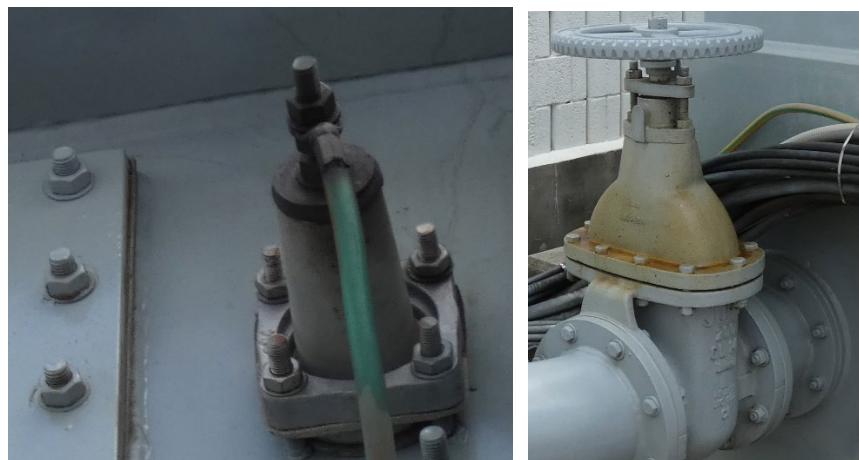
**Figure 11:** (LHS) Oil leak from the top seal on the bushing used to externally earth the internal magnetic core. (RHS) Oil leak from main gate valve spindle shaft seal.

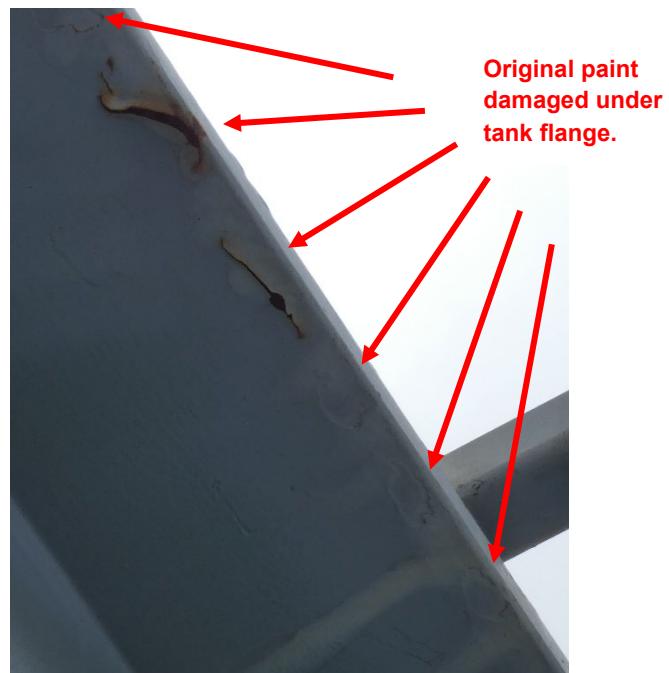
It is interesting to note in the figure below the damage caused to the final tank paint by large 'G'-clamps used in the factory to hold the main tank and lid flanges together while the transformer is going through test. If the transformer passes all tests, then the lid is welded to the main tank. This paint damage is not repaired correctly and just the application of a colour coat allows corrosion to start in these locations.

**Figure 12:** The final paint coating under the main tank flange has been chipped in the factory by the application of large 'G'- clamps.

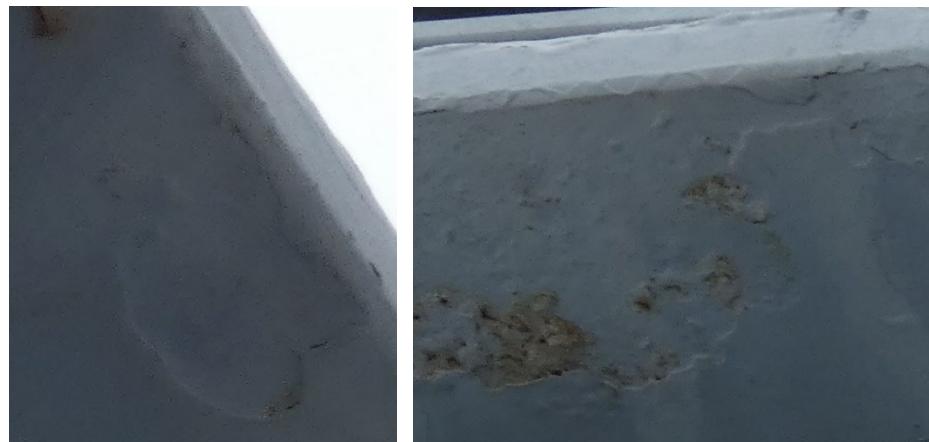
**Figure 13:** A close-up of the paint damage under the main tank flange is visible.  
Damaged area has just a colour coating applied over it.

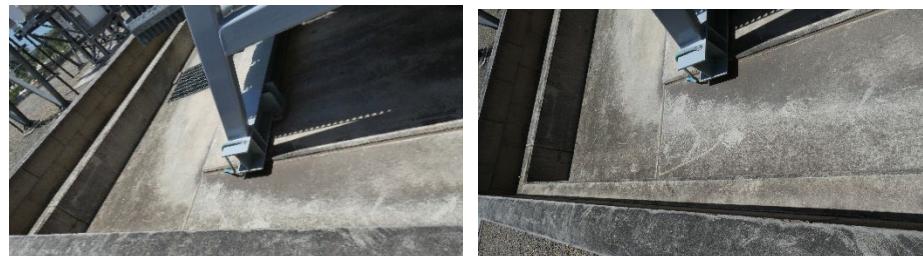
**Figure 16:** View under and around the Cooler Bank. No oil residue or pooling.

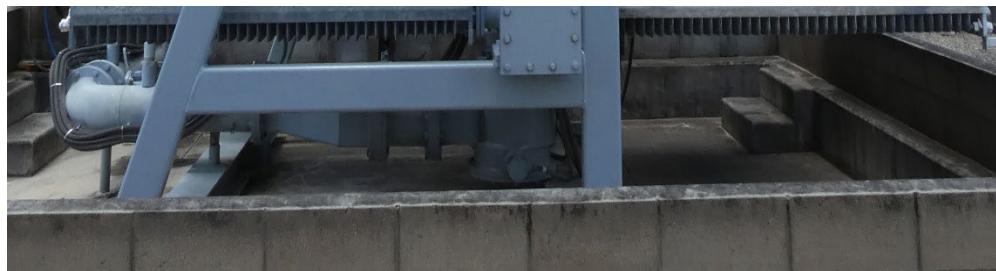
**Figure 17:** View under and around the Cooler Bank. No oil residue or pooling

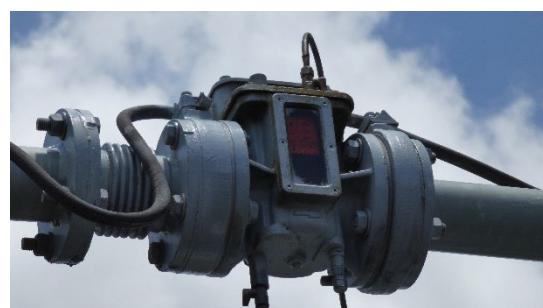
A minor oil leak was visible from the Buchholz Relay. The likely sources of the leak are the seal on the sight glass, the manual plunger for testing the electrical alarm and trip contacts, or the lid seal or plumbing fittings.

**Figure 18:** Minor oil leak from the top of the Buchholz Relay.

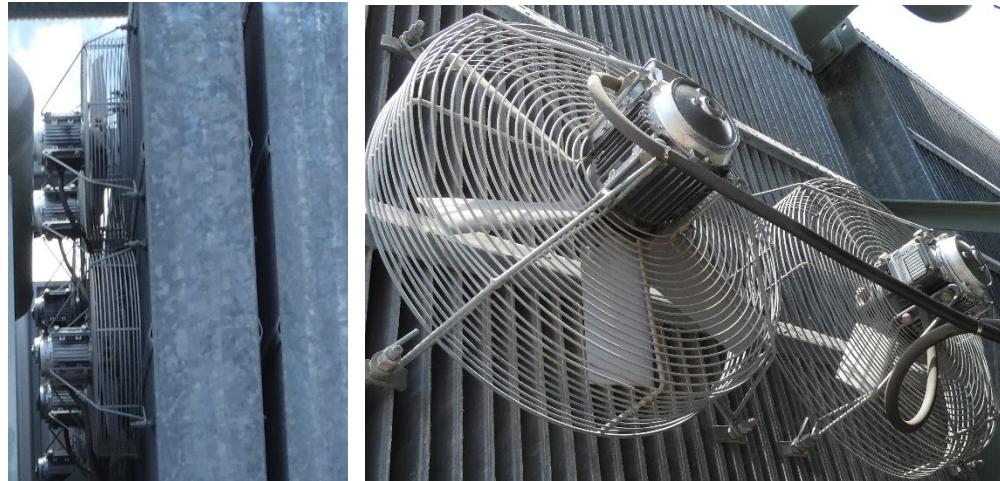
The galvanising on the radiator panels was still in good condition which is expected after only 25 years of service. The cooling fans and their protective cowls showed no signs of corrosion, however, a couple of fan motors have experienced motor bearing failure in 2006 causing their MCB to trip due to excessive motor armature drag.

**Figure 19:** Galvanised radiator panels and cooling fans are in good condition.

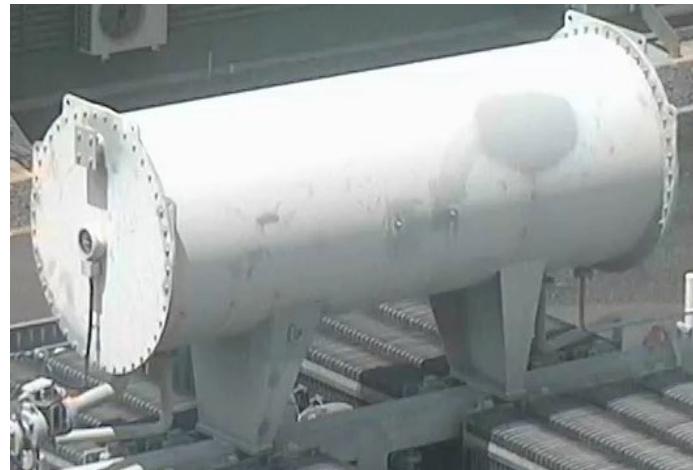
**Figure 21:** The main oil conservator showing oxidised paint and some local paint touch-ups.

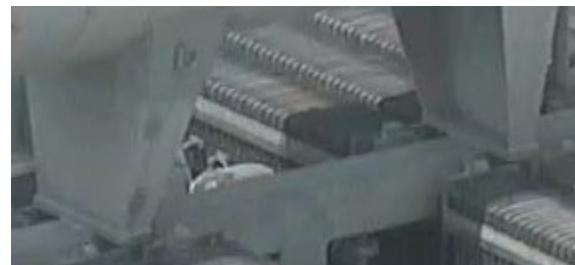
**Figure 22:** There is no sign of corrosion where the main oil conservator support structure is welded to the top main oil header.

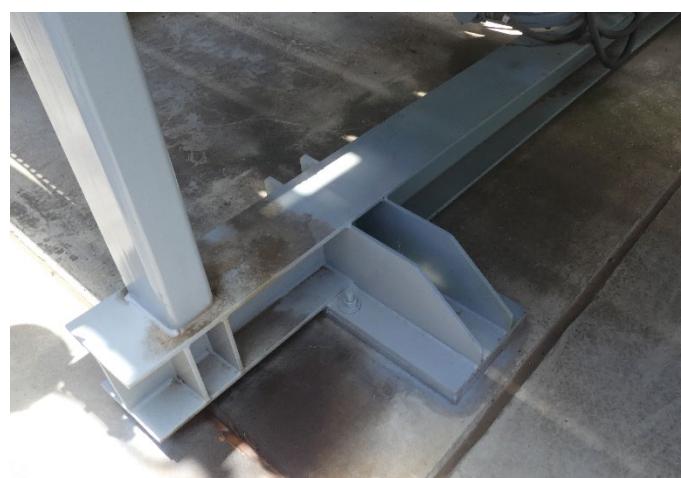
**Figure 23:** Typical condition of the cooler bank support structure feet showing no visible signs corrosion.

The grouting under the steel footplates is non-compliant with present design standards because it is problematic due to water retention in the grout material. This can result in necking of the hold down bolts and corrosion of the underside of the steel footplate.

Whilst this potential corrosion issue needs to be monitored in the future, at this stage, there does not seem to be any obvious signs that would require the hold down bolts and steel footplates on the support structures to be acoustically tested to confirm the degree of necking of the bolt shanks.

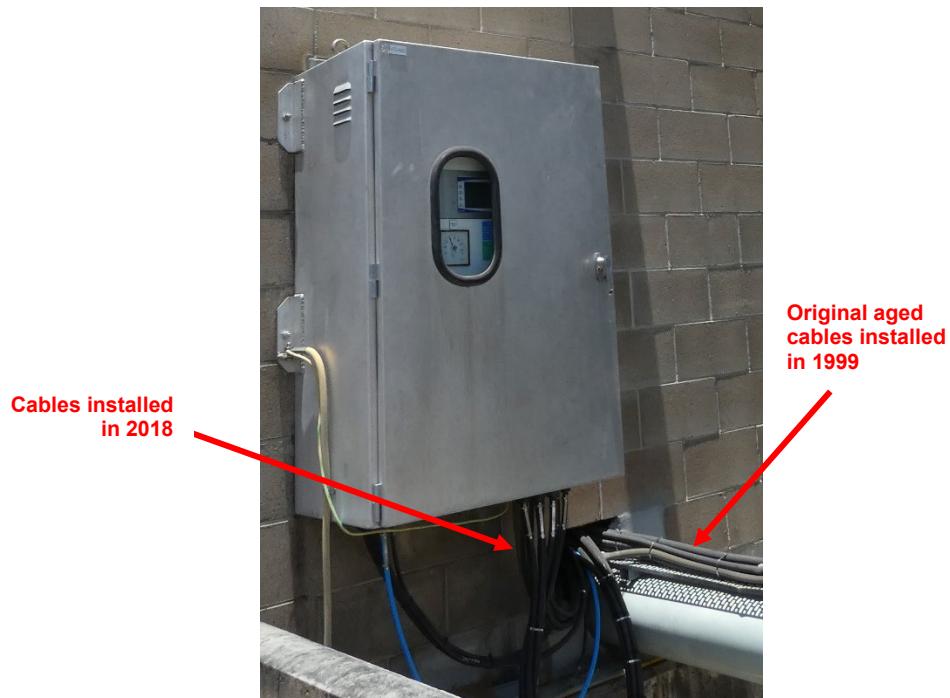
The external black PVC/PVC multi-core cables have not been painted in the past and due to the replacement of the substation secondary system in 2018, there are some relatively new multicore cables now installed on the transformer. This is evident in the figure shown below.

**Figure 24:** The old and new black PVC/PVC external multicore cabling. Note the aged original cables.

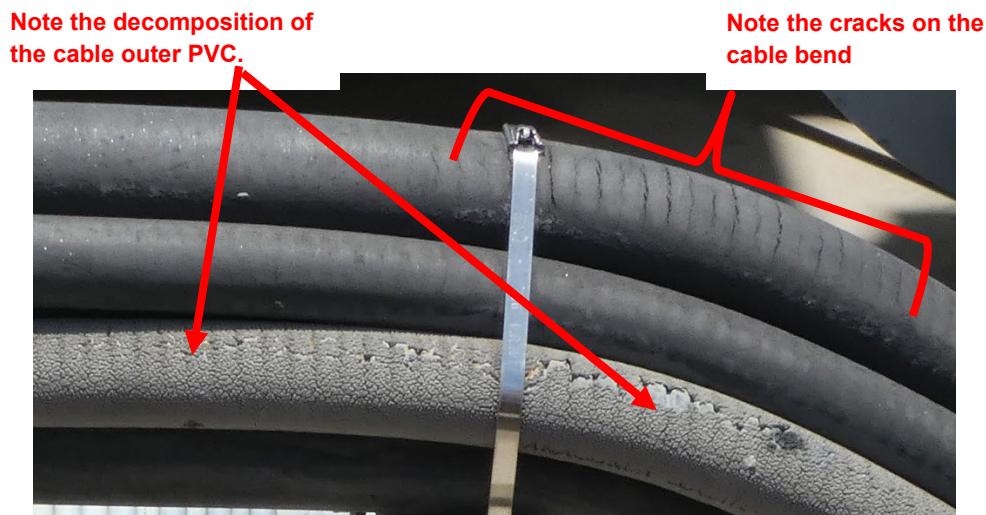
After 25 years, the original internal insulation of the cables should still be in reasonable condition and have retained some degree of flexibility, however, the external PVC on the original cables has aged excessively as shown in the figure below.

**Figure 25:** The original black PVC/PVC external multicore cabling showing the UV damage.

The multicore cables will not last for too many more years once the UV radiation starts to deteriorate the inner PVC insulation. Ignoring any other issues identified in this transformer, if a 40 plus year life is expected, these original multicore cables will have to be replaced. This would have to include the testing and recommissioning of the rewired transformer secondary system.

(f) The condition of the UV damaged multicore cables needs to be periodically monitored in case they need to be replaced prior to the transformer being scrapped or replaced.

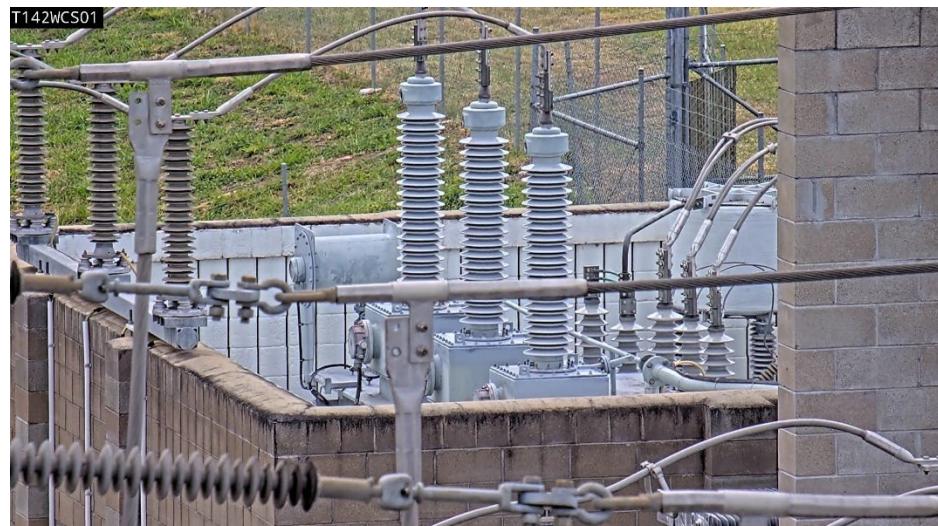
**Figure 32:** 110kV OIP HV bushings and 33kV LV bushings are shown.

These HV and LV bushings are non-compliant with Powerlink's bushing policy in as much as if the bushing were to fail catastrophically, two outcomes are more likely to occur due to their design, namely;

- (a) The OIP inner HV insulation can result in the entire transformer burning to the ground rather than just losing a bushing.
- (b) When the bushing explodes, sizable irregular pieces of sharp and weighty porcelain can be ejected outwards for up to 50 metres creating a recognised potential safety hazard for field staff within the substation as well as collateral damage to other HV plant.

- (d) The original HV and LV bushings do not need to be replaced.
- (e) The lightning surge counters installed on the 110kV surge arresters should be bypassed during the next scheduled routine maintenance.

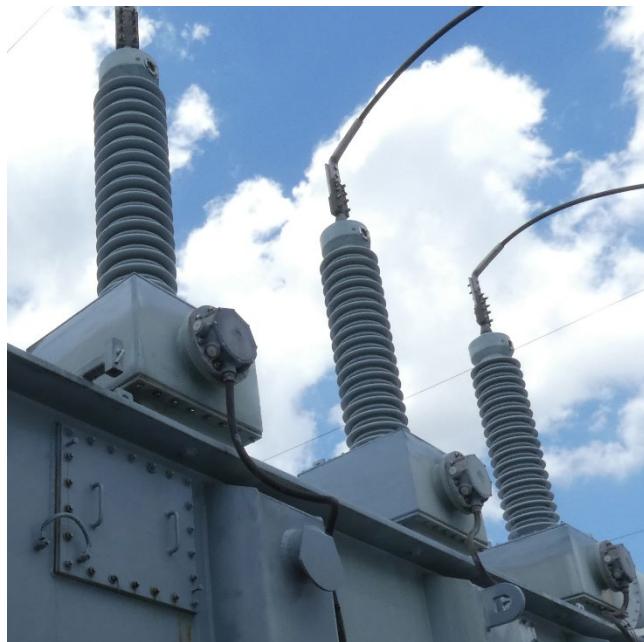
**Figure 33:** 110kV OIP HV bushings are shown.

The oil level could not be verified in all of the HV bushings. There did not appear to be any external oil leaks coming from the HV bushing themselves.

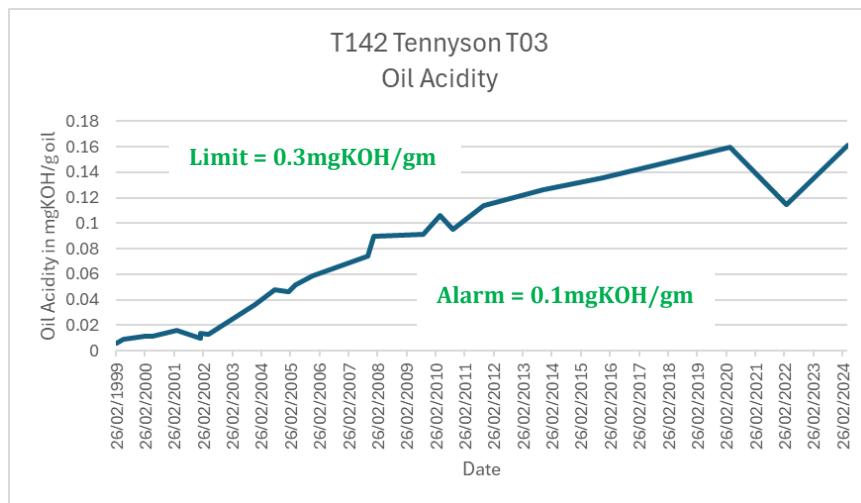
**Figure 37:** T142 Tennyson T03 oil acidity characteristics over its service life.

- (c) If this transformer is to be replaced or scrapped within the next few years, there is no advantage in performing an oil change to lessen the effects of the high oil acidity on the core and winding insulation.

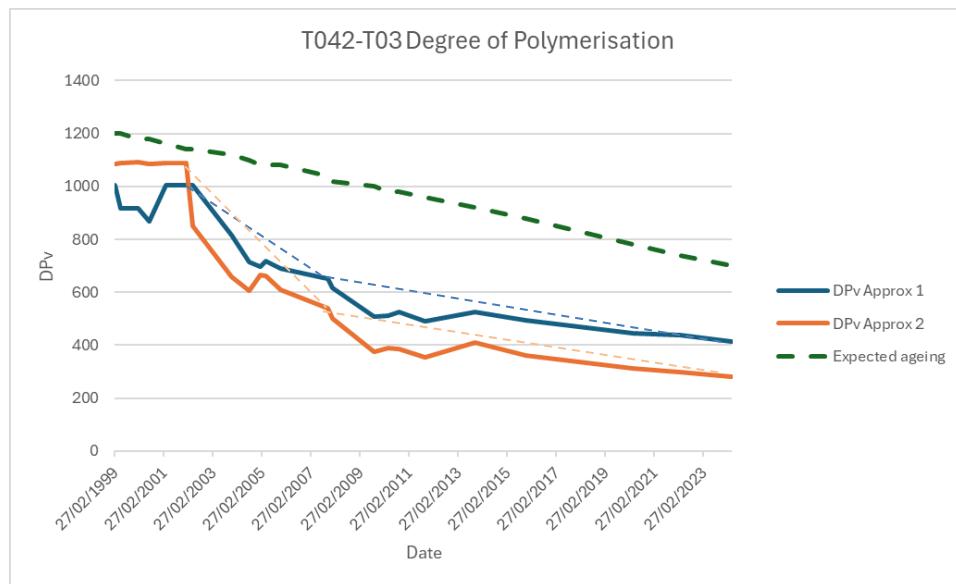
**Figure 47:** Calculated bulk insulation Degree of Polymerisation (DPv) over the transformer's life.

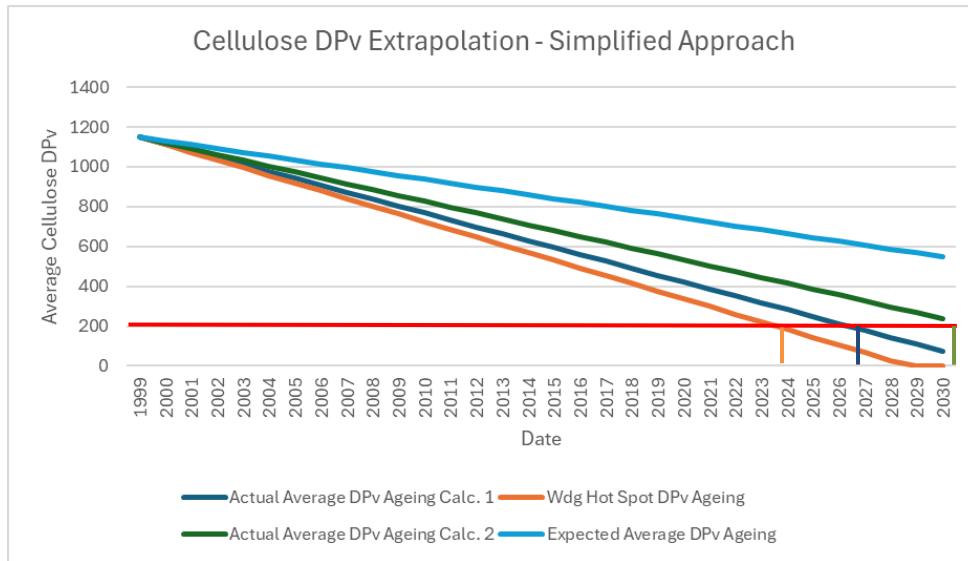
service life remaining given no change in loading conditions or severe fault conditions.

**Figure 49:** The simplified prediction of residual cellulose insulation life based on initial and present DPv calculations for Tennyson T03.

- (a) Because this transformer's internal winding hot spot insulation system has reached statistical end of reliable service life, if the functionality of this transformer is required into the future at Tennyson substation, the transformer replacement is required as soon as possible. Its external physical condition is reasonable for its age

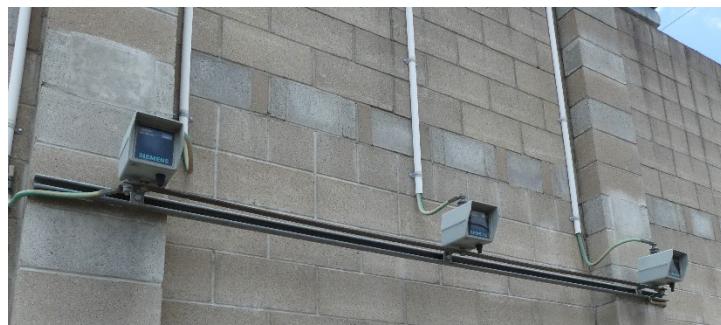
**Figure 52:** Lightning surge counters installed on the 110kV bushings.

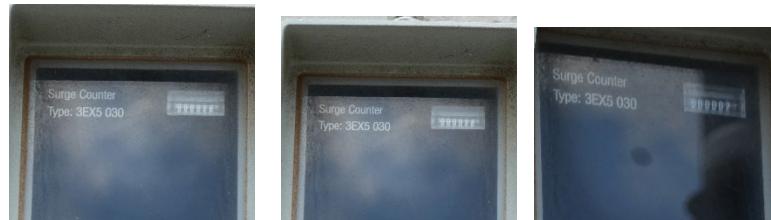
**Figure 53:** Readings on the lightning surge counters installed on the 110kV bushings from left to right are 26, 07 and 07.
