Powerlink 2027-32 Revenue Proposal

CP.03144 Chalumbin 132kV Substation Reinvestment

SITE CONDITION ASSESSMENT REPORT

H032 Chalumbin

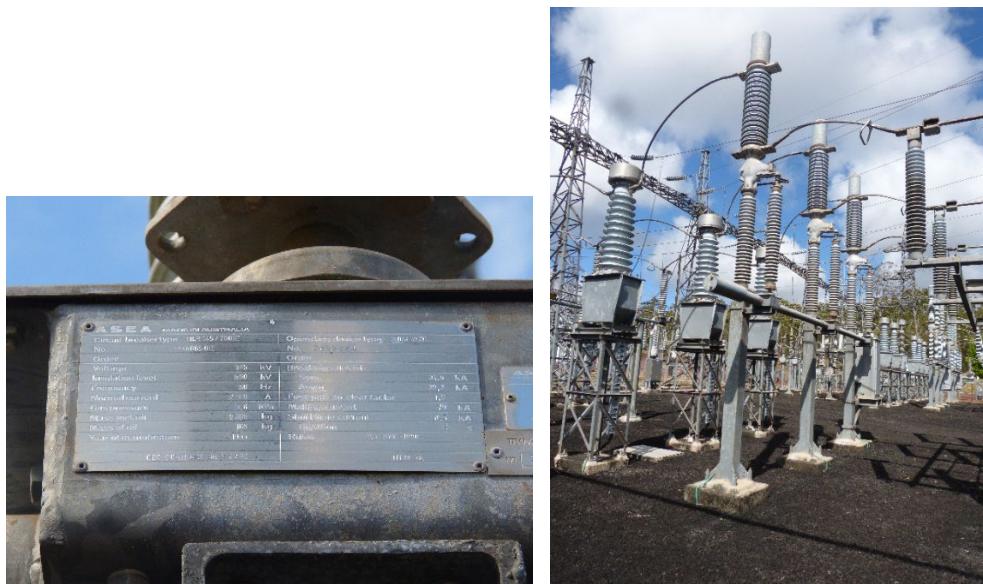
Figure 9 – HLR Circuit Breaker

In addition, the circuit breaker in this bay is a minimum oil circuit breaker containing 165 kg of oil rated for 2000 operations (according to SAP record had done only 155 operations). Although it is in good condition for its age, it is recommended to replace it within next 5-10 years to reduce presence of oil and to enable installation of dead tank circuit breaker to reduce maintenance associated with current transformers. Dead tank circuit breakers contain toroidal CTs which are maintenance free.

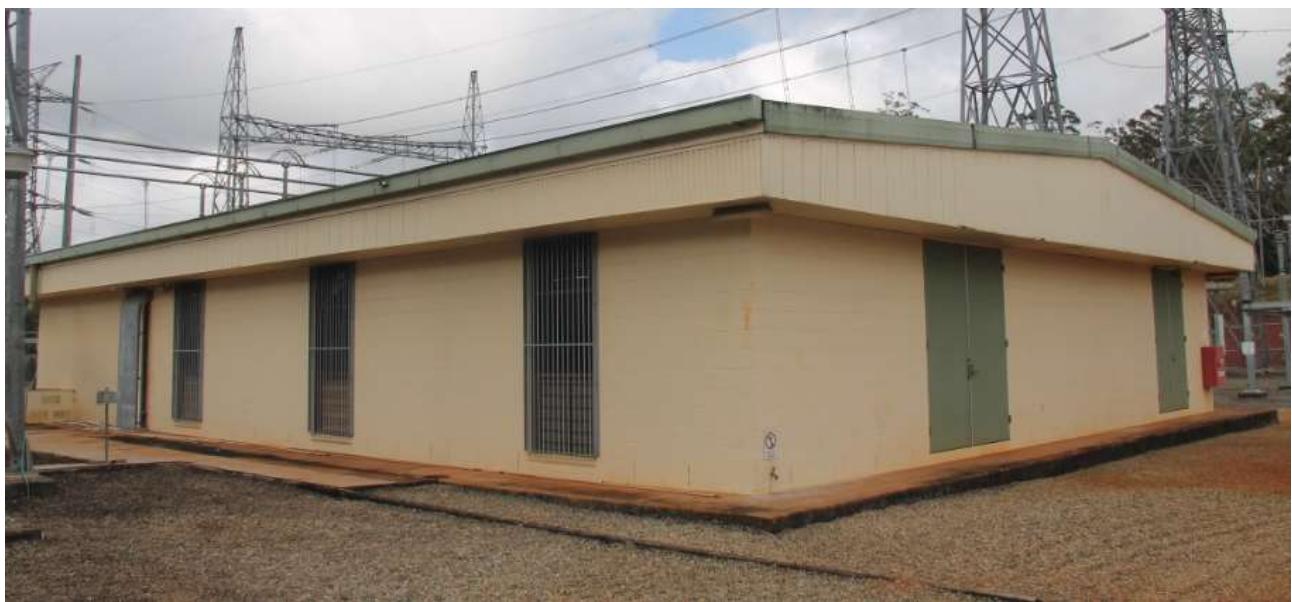
Chalumbin control building +1

There are two buildings at H032 Chalumbin, besser block building +1 (including a communication room) and demountable building +4. Building +1 is a one level besser block construction that contains a protection/control room for secondary systems for 275kV network, communication rooms, battery room, and toilet. The building was built in 1988.

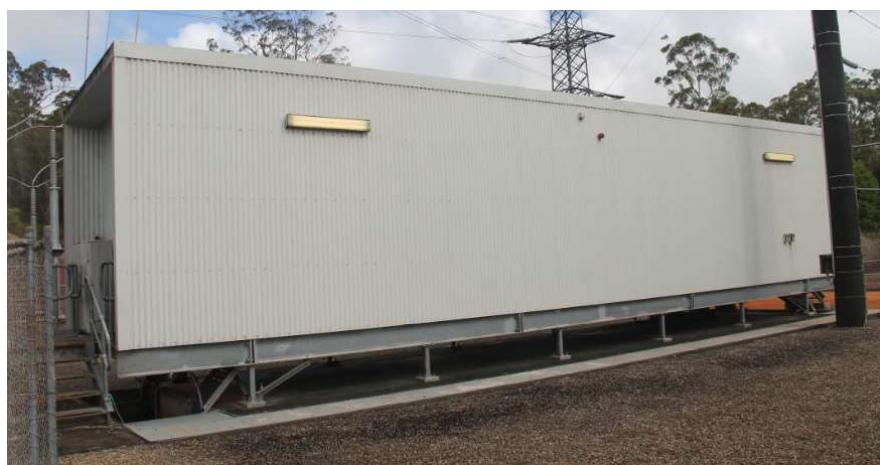
Chalumbin control building +4

The 132kV demountable building, Building +4 was built in 2012 and is air-conditioned.. It houses all secondary systems for 132kV bays, including 132kV bus zones, feeder 7165, 7166, 755, 7191 and 7192.

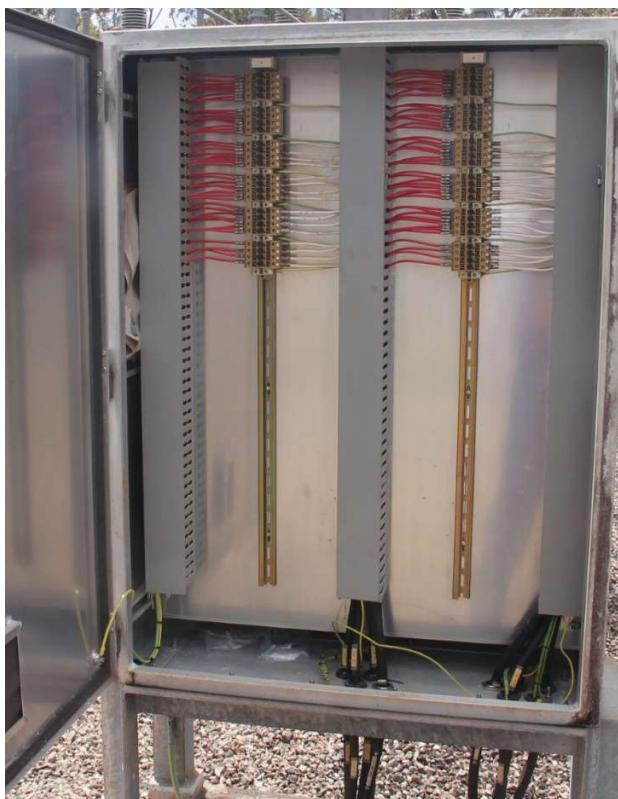
**275kV bus 1 CT marshalling kiosk**

275kV bus marshalling kiosks and VT boxes were installed between 2003 and 2004. Marshalling kiosks and associated control cables are in fair condition. There are no condition driven replacements required until 2043-2044.

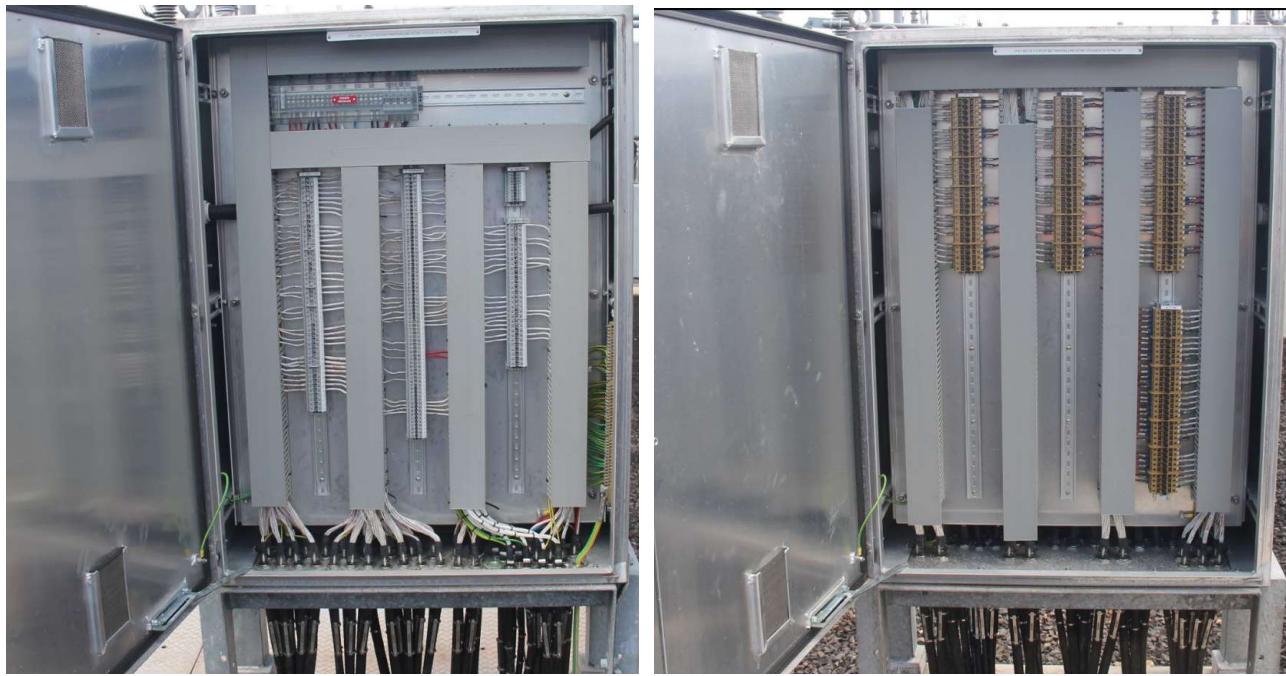
275kV Bay 3 coupler bay marshalling kiosk

Marshalling kiosks for 275kV bus coupler 503 and 504 were replaced under CP.01566 Chalumbin secondary system replacement in 2011. Marshalling kiosks and associated control cables are in good condition. There are no condition driven replacements required until 2051.

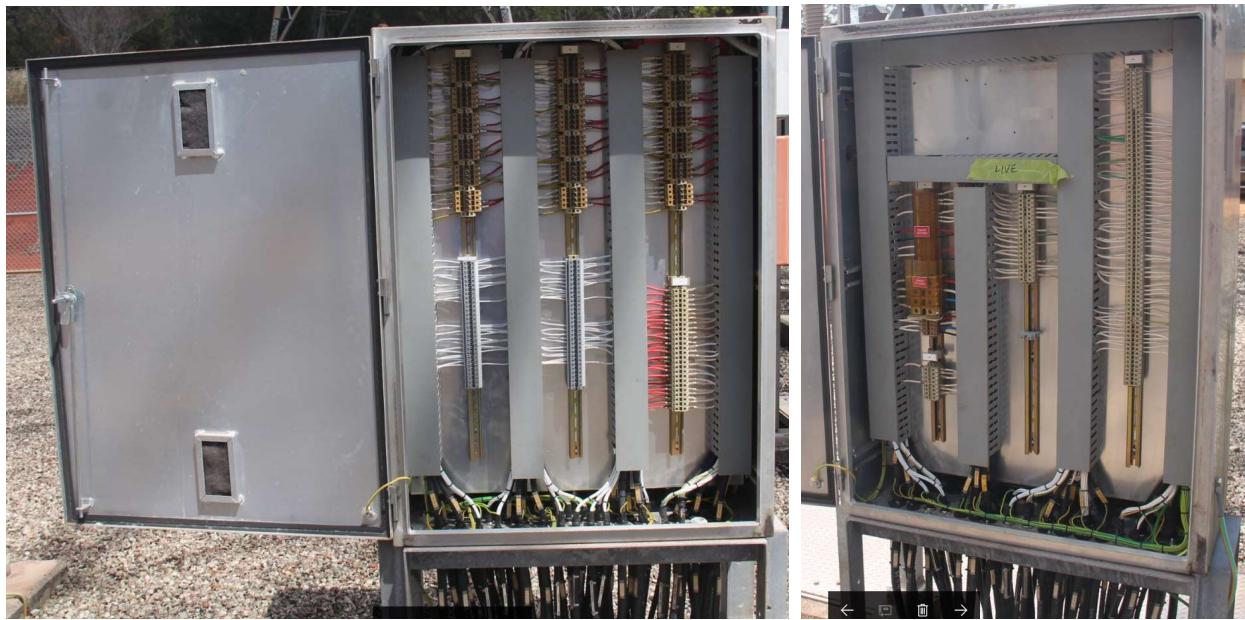
275kV Bay 6 coupler bay marshalling kiosk

Marshalling kiosk for 275kV bus coupler 506 was installed in 2003. Marshalling kiosks and associated control cables are in fair condition. There are no condition driven replacements required until 2043.

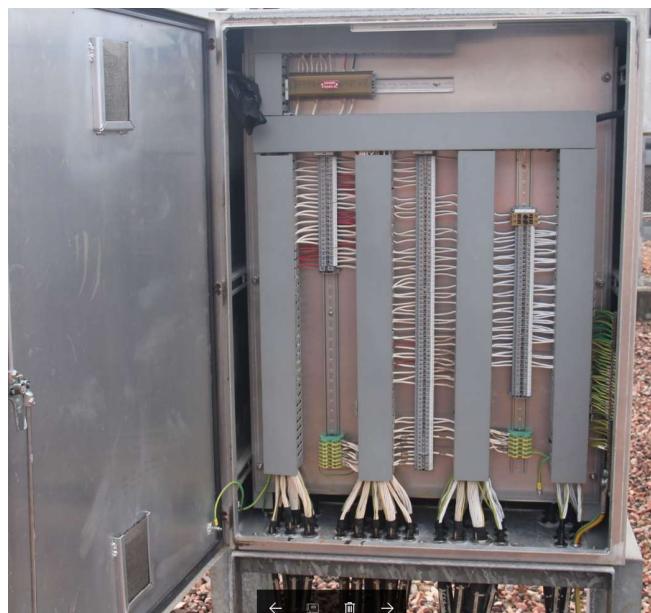
275kV Feeder 876 bay marshalling kiosk

Marshalling kiosks and VT boxes for 275kV feeder 876 were installed in 2007 and are in good condition. There are no condition-driven required replacement until 2047.

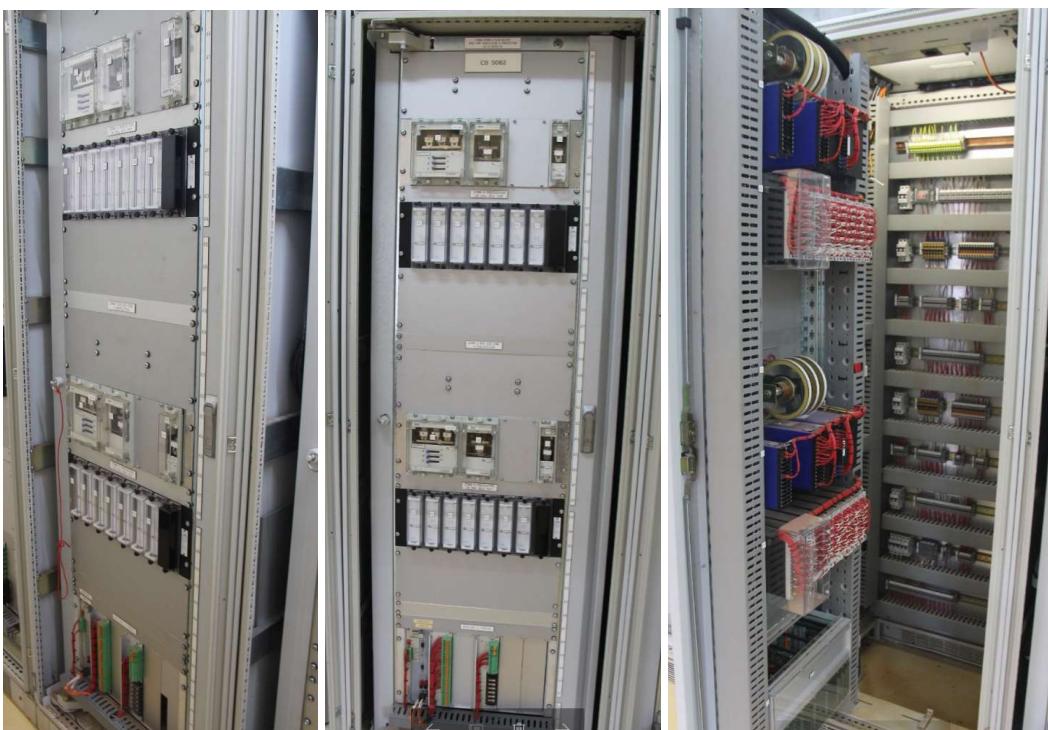
275kV 1 & 2 Bus protection and CB fail bus trip panel

High impedance differential relays [REDACTED] are used to protect 275kV 1 and 2 bus. Powerlink has recovered modules of [REDACTED] RTU such as the CPU, ACT and ADI card. But these cards have been in service for more than 20 years and the capacitor electrolyte might have been dried out. These recovered parts would be utilised only for emergency replacement. Powerlink has conducted a last buy in 2014 and are relying on these RTUs for maintenance spares. Health Index indicates that all protection and control systems for 275kV 1 and 2 Bus will reach the end of technical asset life and need to be replaced by 2024.

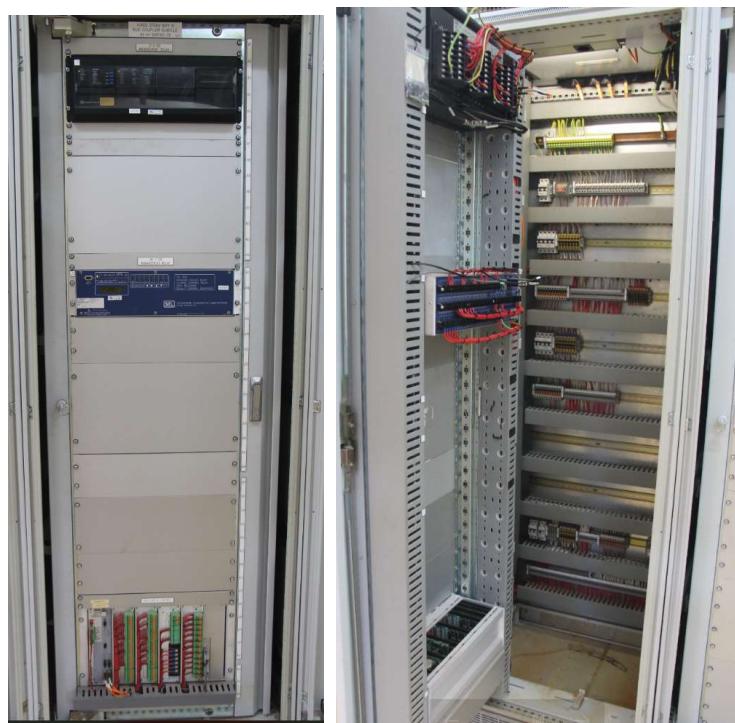
Coupler 506 protection/control panel

Secondary systems for 275kV coupler 506 were commissioned in 2004. Health Index indicates that all protection and control systems for 275kV Coupler 6 will reach the end of technical asset life and need to be replaced by 2024.

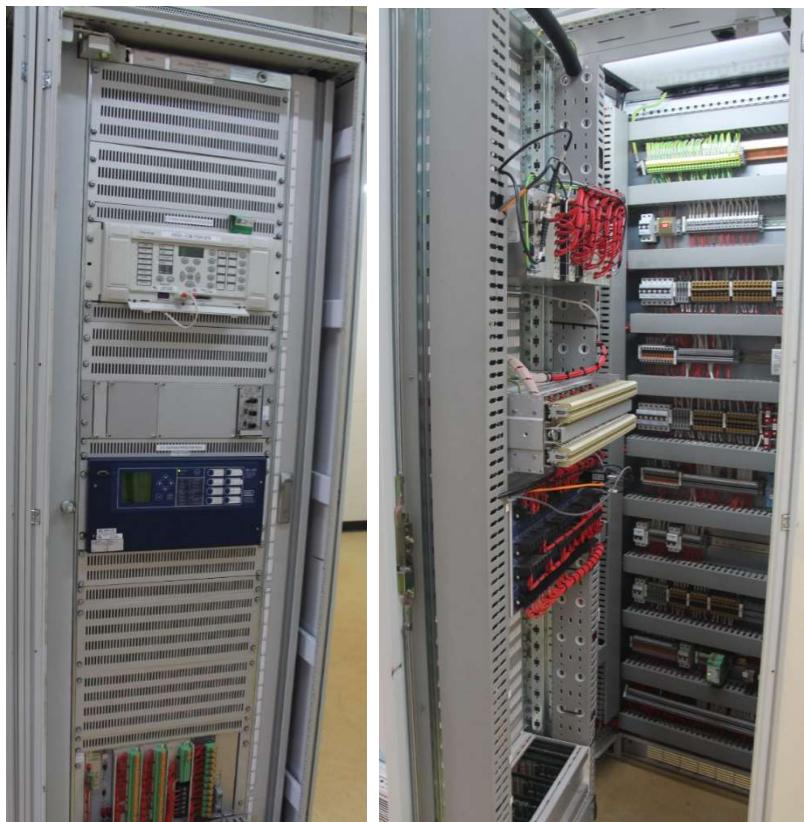
Feeder 876 bay protection/control panel

Feeder bay 876 was built as part of Woree 275kV reinforcement in 2007. X protection was replaced under CP.02613 Walkamin Sub in 2018. The bay controller RTU and Y protection were installed/refurbished between 2007 and 2009. Associated health index indicates that both Y protection and [REDACTED] RTU will reach the end of technical asset life and need to be replaced between 2027 and 2029.

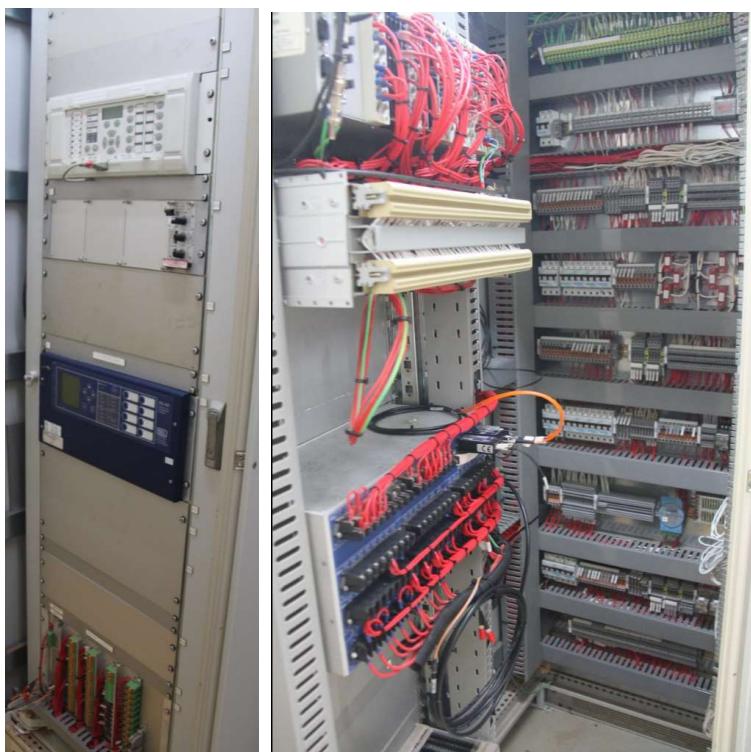
Feeder 877 bay protection/control panel

Secondary systems for feeder 877 were commissioned in 2004 (except X protection P546 was replaced under CP.02059 Woree-Chalumbin SPAR in 2012). Health index indicates that these equipment (Communication interface [REDACTED] RTU) will reach the end of technical asset life and need to be replaced in 2024.

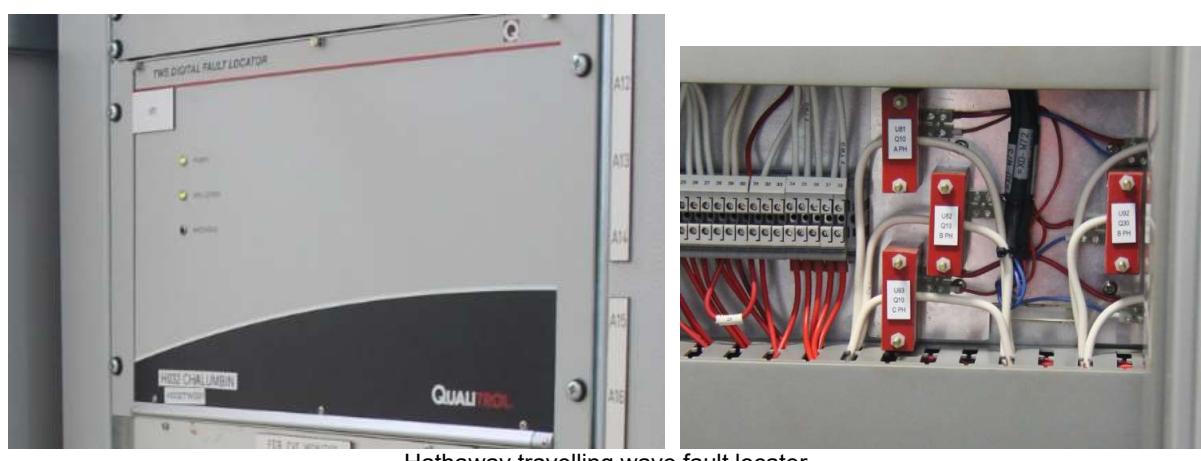
Hathaway travelling wave fault locator

Travelling wave based fault locator was installed in 2010 and is in fair condition. Health index indicates that there is no condition-driven replacement required within 10 years.

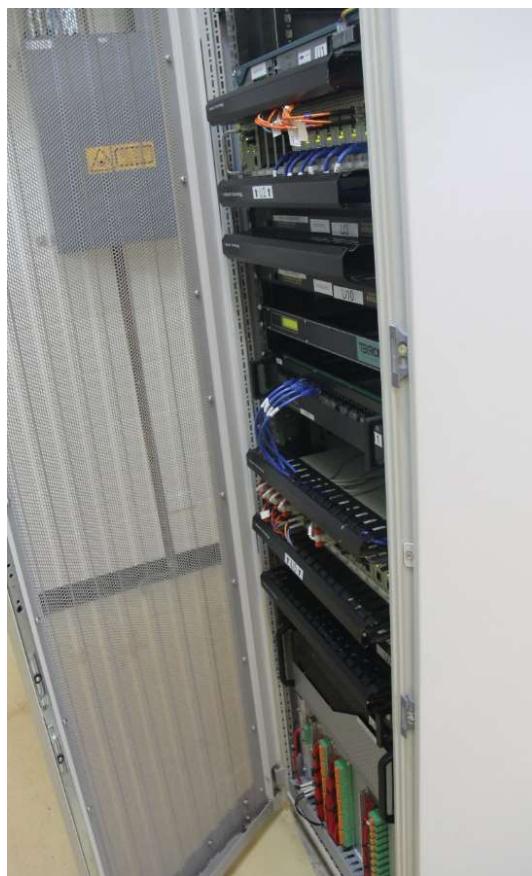
Master OpsWan panel in Building +1

Master OpsWAN network in +1 was installed in 2001. Health index indicates that these equipment have reached the end of technical asset life need to be replaced in 2020. Powerlink's strategy is to carry out associate replacement with major secondary system replacement projects.

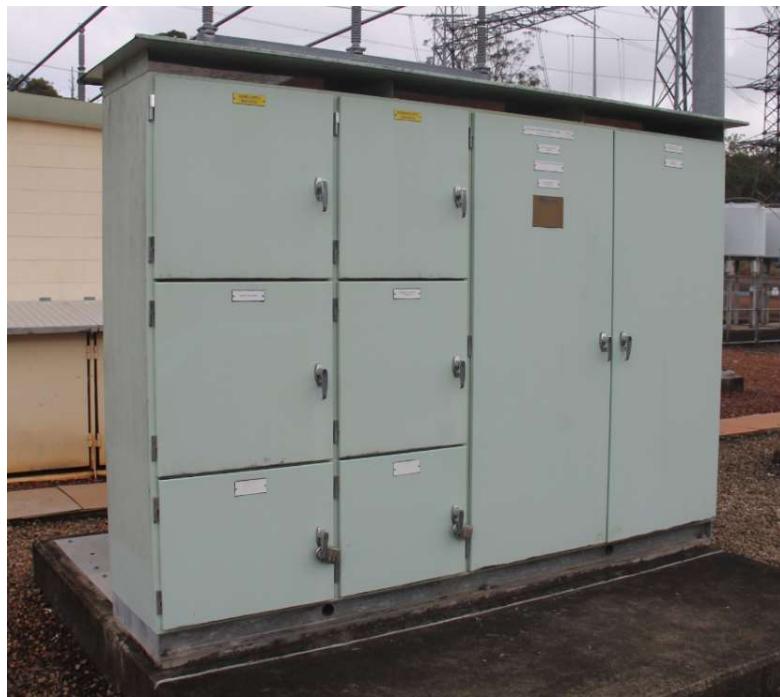
AC changeover board

AC change over board was installed in 2009 and is in fair condition.
