Powerlink 2027-32 Revenue Proposal

CP.03149 Newlands Transformer 1 Life Extension

T1 Transformer Condition Assessment

T069 Newlands Substation

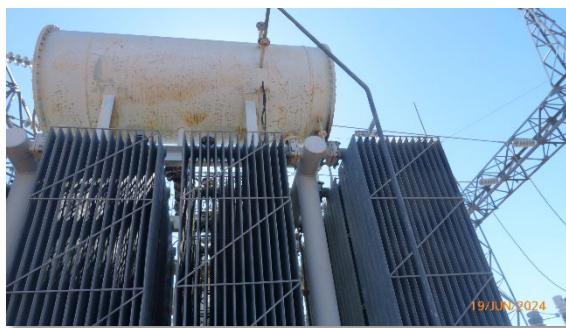
The maintenance records from September 2023 indicated that surface corrosion on the transformer main oil tank and conservator had been addressed. However, the recent onsite inspection (refer to Figures 3-11) revealed multiple areas where corrosion persists, with severity ranging from Grade 1 to Grade 3. Notably, the conservator tank (see Figures 3-5) exhibits more extensive corrosion than previously documented in 2023. This raises concerns about whether the conservator tank was effectively painted or if the applied protective coating has failed to mitigate the corrosion. The extent and progression of the corrosion, as shown in the close-ups (Figures 6-11), suggest that the anti-corrosion measures may have been inadequate or that the paint application did not adhere properly, necessitating further investigation and potentially more robust remediation efforts. Additionally, Figure 11 reveals a missing bolt at the top lid of the transformer, and protruding gasket. Replacing and tensioning the bolt without replacing the gasket poses a significant risk. The old gasket is likely stuck to both flanges, and any compression could compromise this adhesion, potentially resulting in an oil leak. Therefore, it is not recommended to carry out corrective work before replacing the transformer.

Figure 2- Conservator Tank with Visible Corrosion (June 2024)

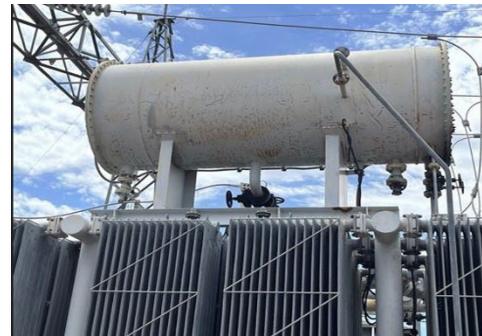
Figure 3- Conservator Tank Prior to Painting (2023)

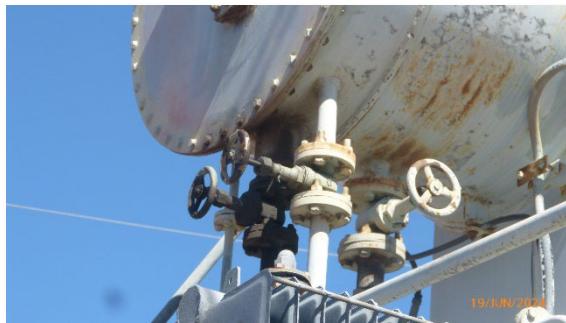
Figure 4- Close-up of Conservator Tank Corrosion

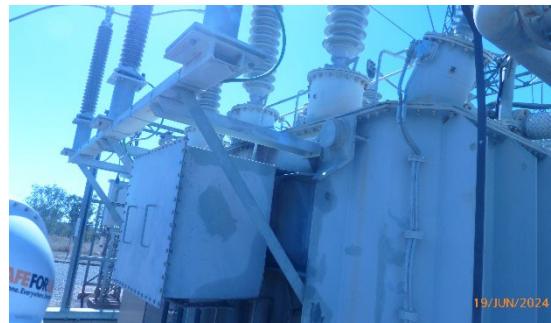
Figure 5- Touch-Up Paint Marks on Transformer

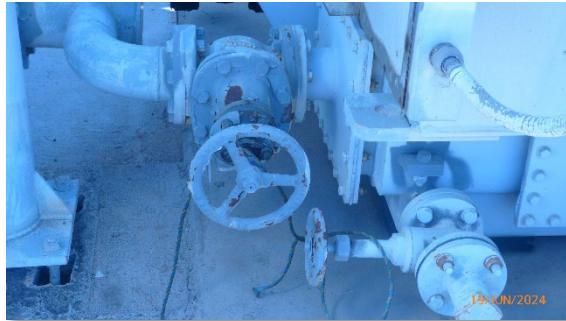
Figure 6- Grade 2 Corrosion and paint flake on Oil Valves

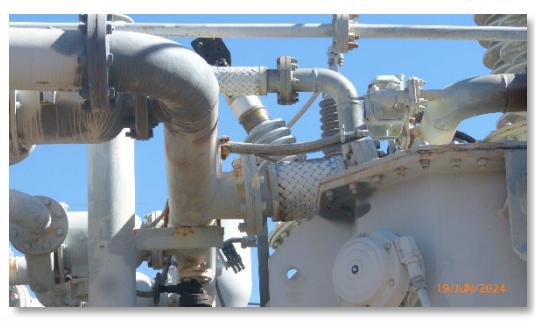
Figure 7- Corrosion and paint deformation

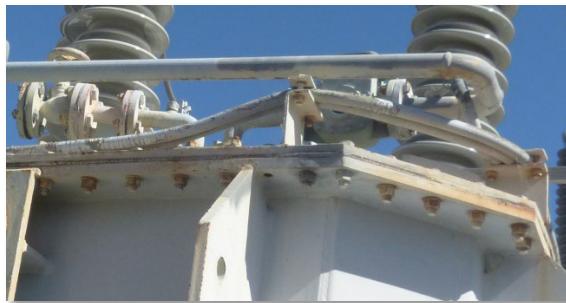
Figure 8- Bolts on Transformer Main Oil Tank with Grade 1 Corrosion

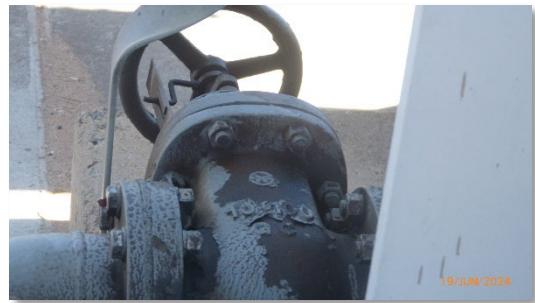
Figure 9- Corrosion and paint flake

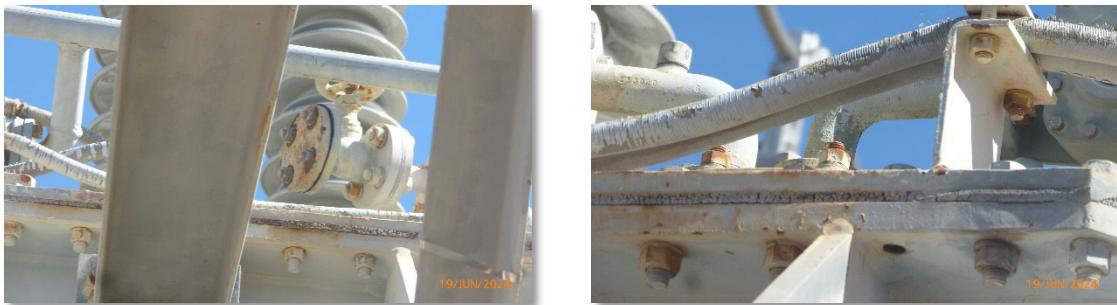
Figure 10- Corrosion on Transformer Components (Grades 1 to 3)

Whilst corrosion is present on many parts of this transformer, it is primarily associated with replaceable and repairable components. These issues are unlikely to pose a significant risk until the transformer is replaced.

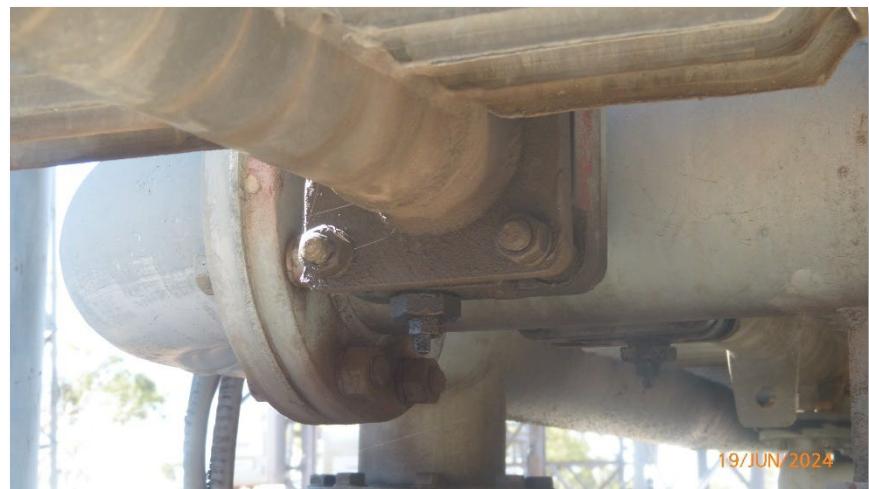
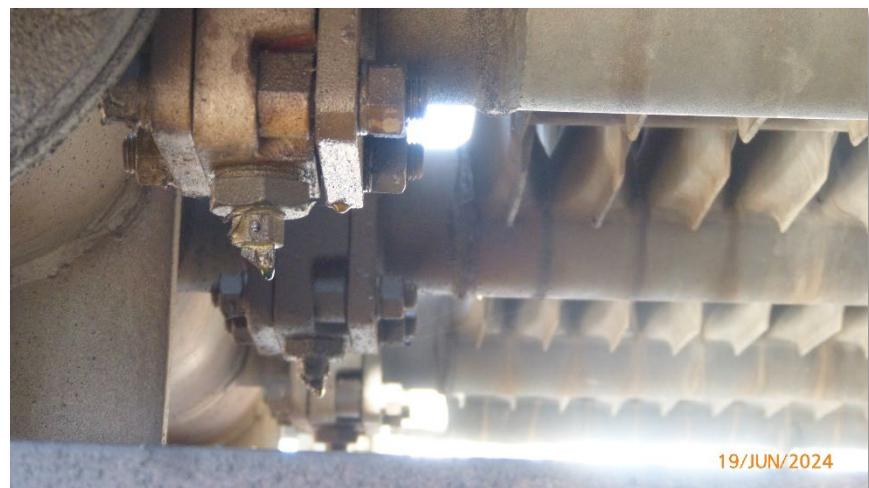
- In 2022, 250 litres of oil were added to the transformer.
- During the recent site visit inspection, various active oil leaks were observed, including those from the oil cooler banks receiver pipe flanges, as well as multiple leaks from the conservator tank, main oil tank, and associated pipework, as indicated in Figures 12-22 below.

Figure 11- Oil Leak from Transformer Cooler Flanges

- Given the transformer age and insulation condition, it is recommended to fix oil leaks that do not require lowering the oil level below the top of the winding, extending the transformer's operation for an additional 10 years until its replacement. Additionally, all accessible leaking butterfly valves should be either replaced or removed. To address all oil leaks, the transformer oil would need to be completely drained and all gaskets replaced which is not recommended.

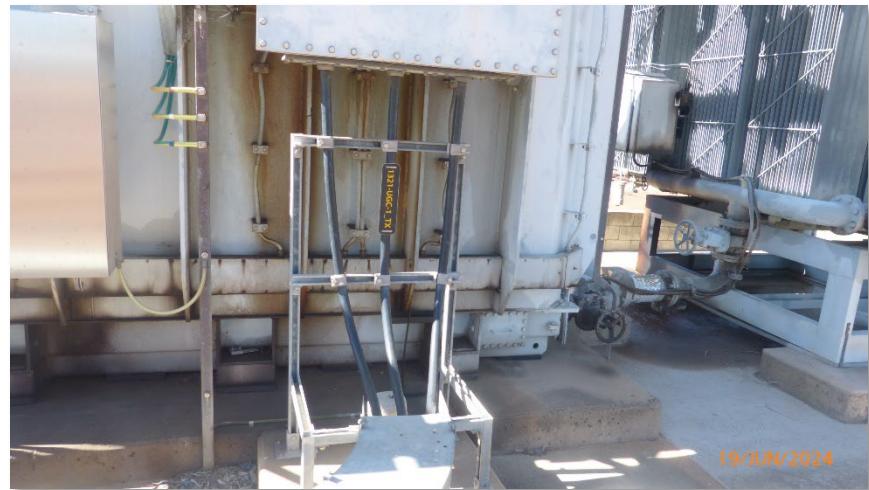
Figure 12- Oil on Transformer Surface from Active Leaks

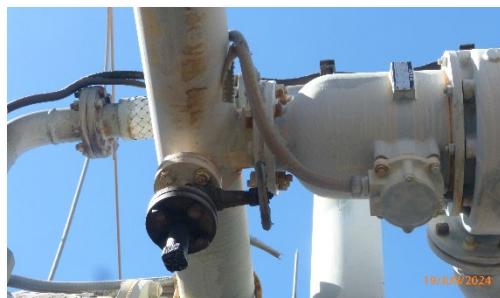
Figure 13- Oil Leak from Drain/Fill Flange

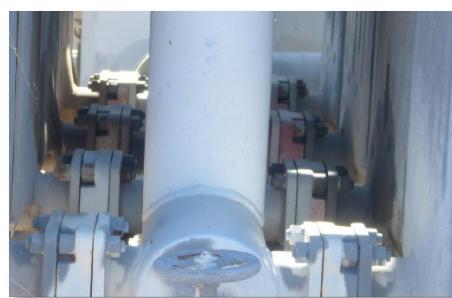
Figure 14- Oil Leak from Oil Cooler Bank Receiver Flanges

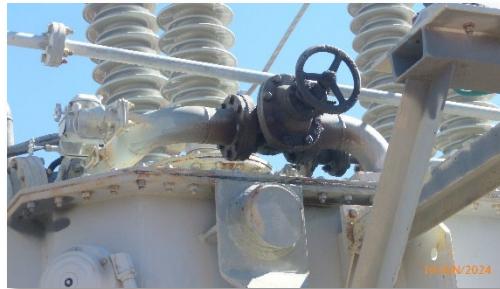
Figure 15- Oil Leak from Oil Isolation Valve

- **Oil Leak Remediation:** Fix the existing oil leaks that do not require lowering the oil in the main tank below the top of the windings. Additionally, all accessible leaking butterfly valves should be either replaced or removed.

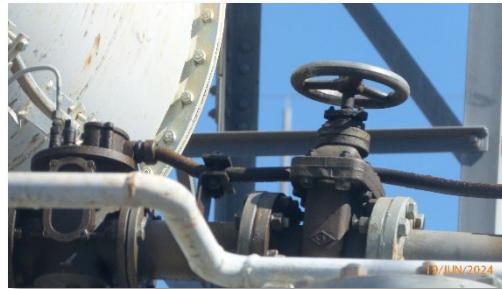
Figure 16- Oil Leak from Transformer Lid

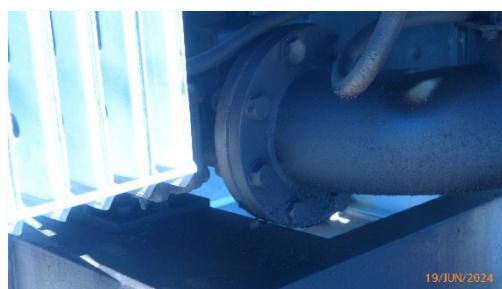
Figure 17- Oil Leak from Cooler receiver pipe flange

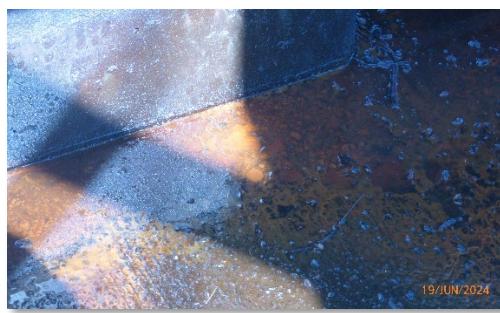
Figure 18- Oil on Transformer Bund Floor

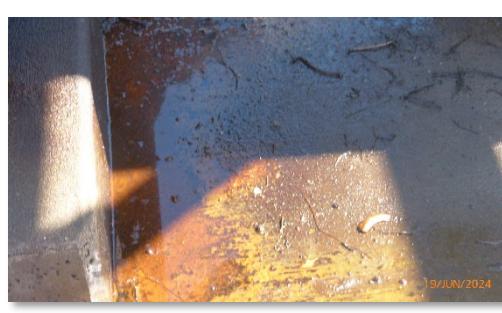
Figure 19- Oil Leak on Cable Tray Showing Corrosion

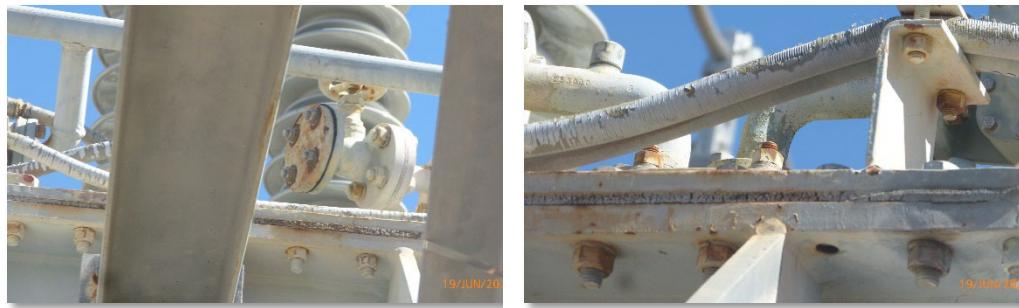
- Several gaskets on the transformer lids, and flanges show signs of deformation and cracking, which are likely to exacerbate oil leakage over time if not addressed.

Figure 20- Flange with Significant Gasket Deformation

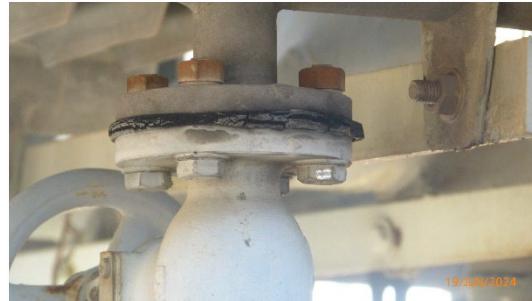
Figure 21- Flange Gasket Deformed and Deteriorated

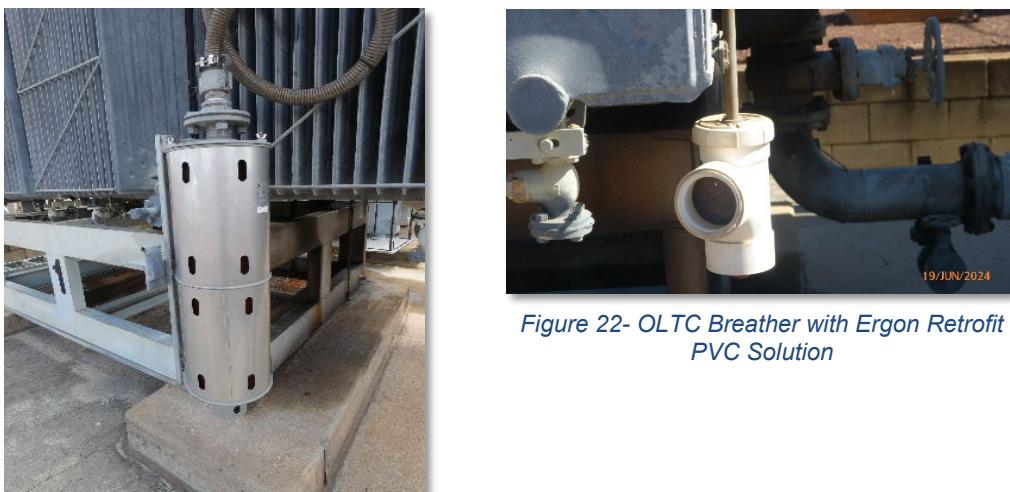
The maintenance records indicate that the main transformer PVC breather was replaced in 2019 by the new Powerlink standard breather, while the OLTC breather is still the retrofit solution made from PVC pipe, which is recommended to be replaced with a Powerlink approved OLTC breather that has a minimum of 7.5kg of desiccant if the transformer is to be refurbished.

Figure 22- OLTC Breather with Ergon Retrofit PVC Solution

- **Silica Gel Breathers:** Replace the OLTC PVC breather with a Powerlink approved OLTC breather that has a minimum of 7.5kg of desiccant.
- **OLTC Maintenance:** Address corrosion on OLTC fasteners and linkage. Upgrade the OLTC control cubicle to ensure compliance with AS3000 Standard (for example, install electrical safety barriers to cover the live terminals).

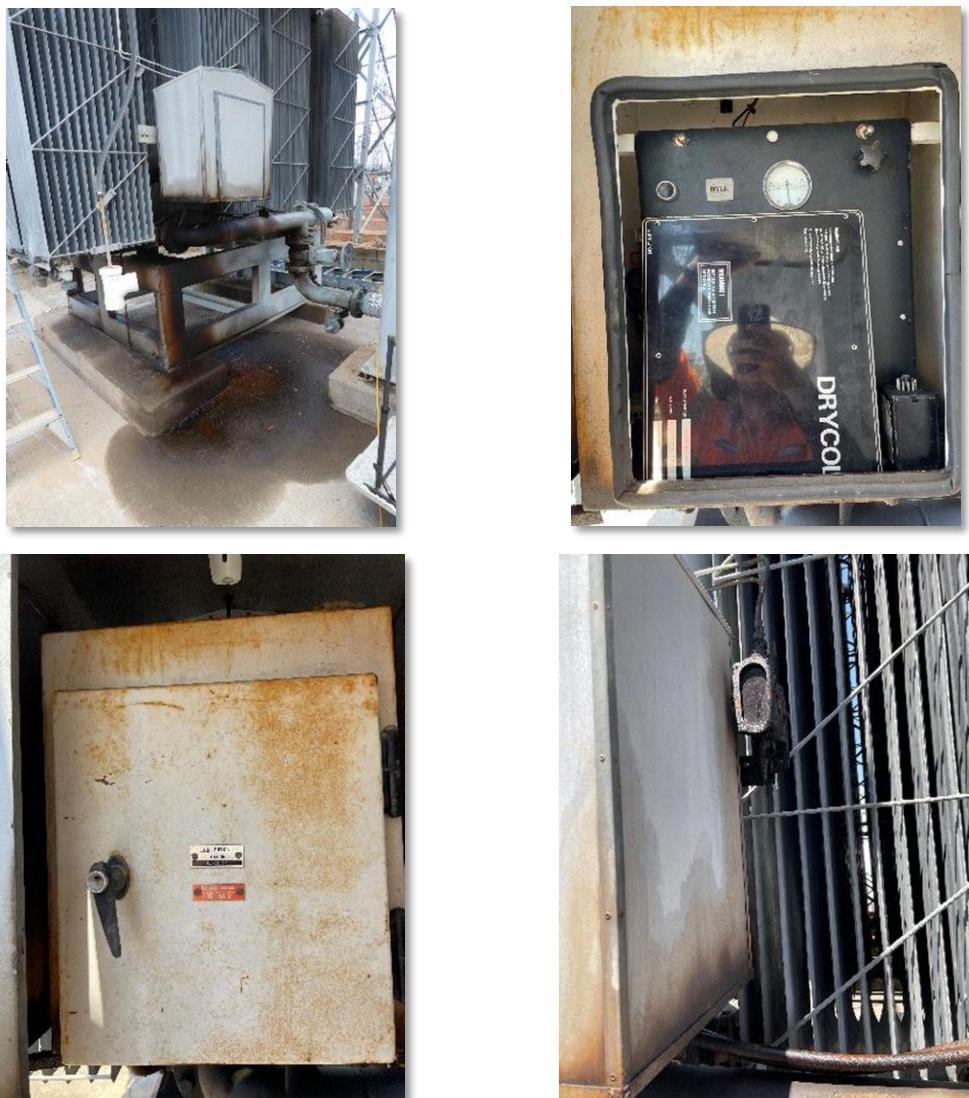
The transformer was initially equipped with a Drycol breather, which was mounted on the side of the conservator. Subsequently, this breather was removed and replaced with a conventional desiccant breather. However, the control box for the Drycol breather remains affixed to the radiator bank.

Please note that the oil stains visible in the accompanying photographs are believed to originate from a leak or spilt oil during sampling at the ground-level gas receiver and the associated pipework/valves located above.

Figure 24- Drycol Breather Control Box

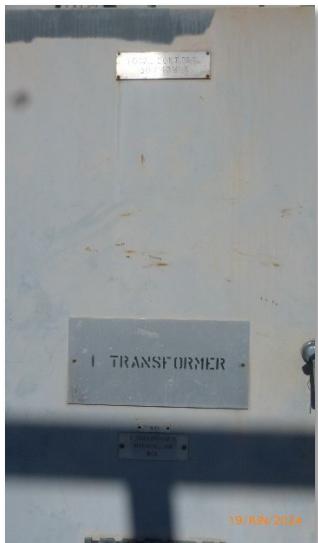
- The control cubicle door exhibits minor corrosion (refer to Figure 27).
- There is evidence of oil ingress into the control panel, likely resulting from nearby leaks. This has led to contamination of control components, terminal blocks, and wiring within the cubicle (refer to Figures 28 and 29). Such contamination poses a risk to the functionality and reliability of the control systems.
- The control components, terminal blocks, and wiring inside the panel are visibly contaminated with insulating oil, which, despite its dielectric properties, could lead to compromised insulation integrity over time, increased maintenance requirements, and potential operational safety risks if not properly managed (see Figure 29). In addition it is not compliant to the AS3000.

Figure 26- Minor Corrosion on Control Cubicle Door

To mitigate the risks associated with oil contamination and to ensure compliance with current safety standards, it is recommended that the control cubicle be replaced.

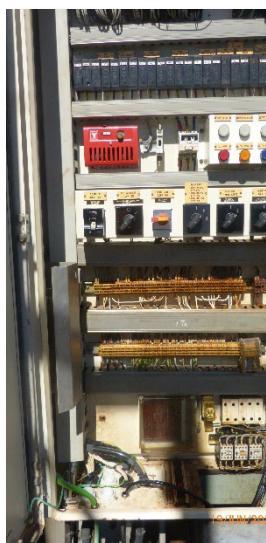
Figure 27- Oil-Contaminated Control Components

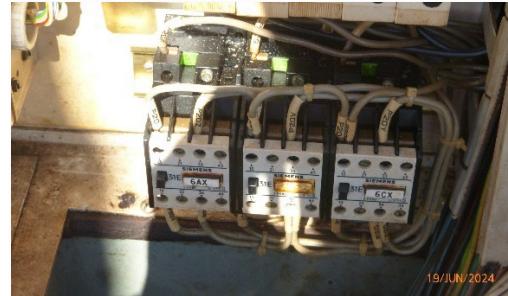
Figure 28- Terminal Blocks and Wiring with Oil Contamination

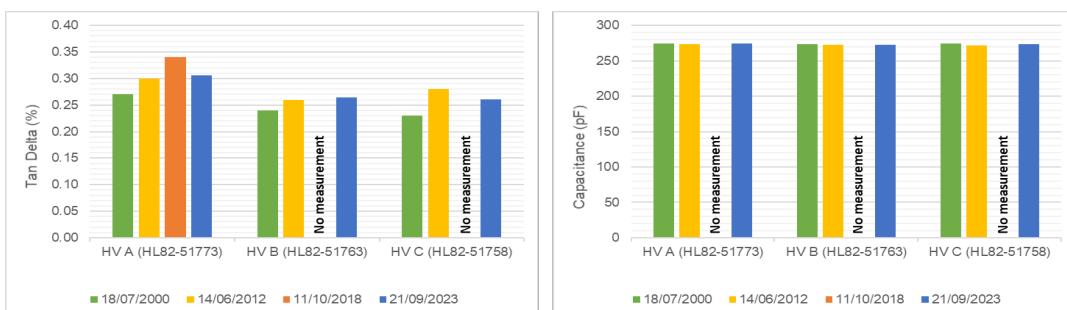
Although the 2000 test results recorded in SAP indicate that all HV bushings exhibited DLA values exceeding 20 mrad—significantly above the 7 mrad defect level necessitating bushing replacement as defined by Powerlink ASM-SPE-A2675743. The trend in Figure 31 for the historical test results reveals that these values were incorrectly entered in SAP and require correction. The results demonstrate that the measured Tan- δ and C1 capacitance values are consistent with previous measurements and fall within the acceptable criteria for high voltage OIP bushings. Further details on the test results are discussed in section 2.4.3.

Figure 30- H.V Bushings Tan- δ and C1 capacitance Historical Test Results

The manufacturer recommends a service life of 25 years for OIP bushings. Given the advanced service age (42 years) of both the HV and LV bushings, along with the signs of aging and potential moisture ingress in the neutral bushing, it is recommended that all these bushings be preventively replaced within the next three years. Additionally, an increased monitoring frequency of once per year should be adopted until the bushings are replaced.

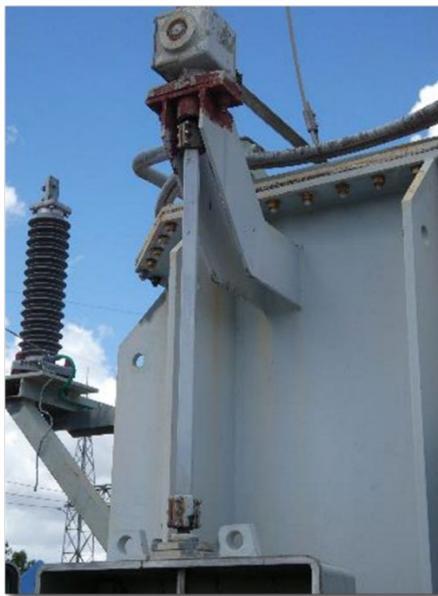
- *No signs of oil leaks from the gearbox or motor drive mechanism*
- *Minor corrosion and previous red-oxide treatment on the drive linkage*
- *Corrosion on various fasteners for oil surge relays and diverter lids*

Figure 32- OLTC Drive Linkage with Minor Corrosion

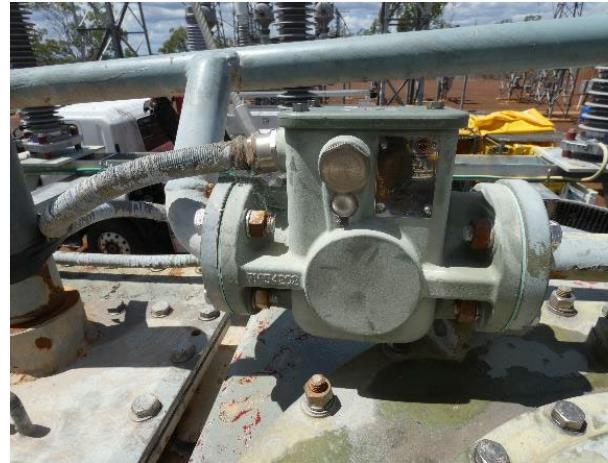
Figure 31- Corrosion on Fasteners for Oil Surge Relays and Diverter Lids

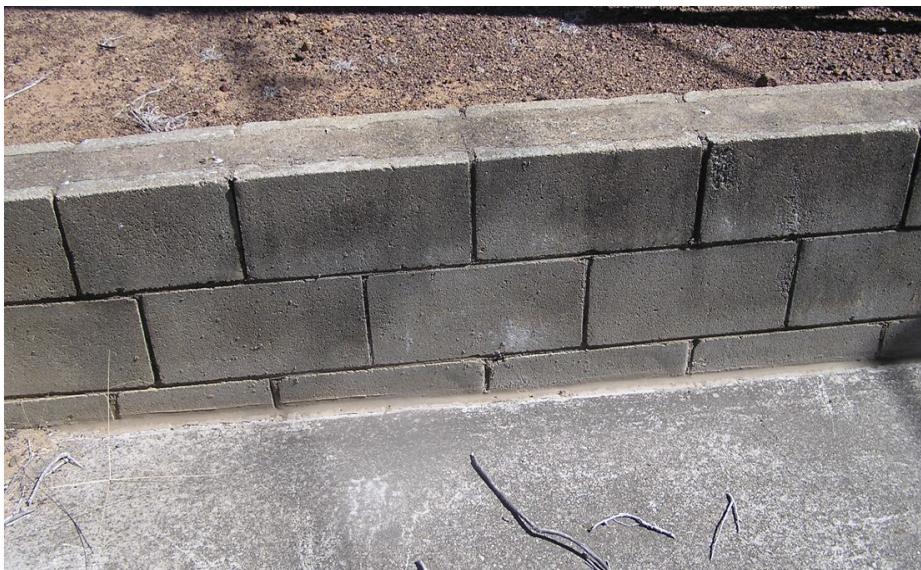
The transformer civil works is approximately 41 years old. The bund walls have been constructed with concrete core filled blockwork and is assessed as being in a functional condition. The oil bund is formed by a concrete apron and concrete block walls.

Figure 33- Blockwork Bund Wall

The bund is in a good condition and should provide a functional service for another 10 years, however, it is recommended that an inspection be performed in 10 years' time. The apron and plinths were in good condition. The bund apron allows drainage into a flame trap drain pit that flows into the oil containment tank. The flame trap appeared intact and functional but contained no water.

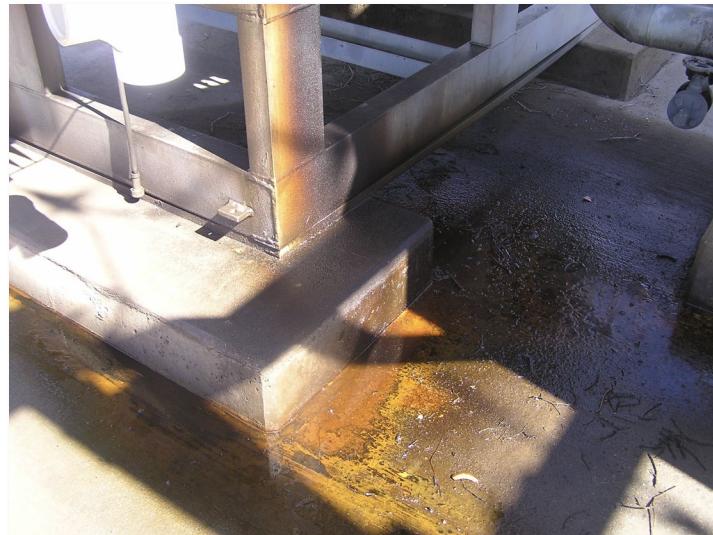
Ongoing oil leak evidence was observed in in the bund which is related to the transformer age.

Figure 34- Apron Crack

- A sealant sub surface probing inspection be conducted to determine remaining flexure properties and side wall adherence. Removal and replaced is advised where found to be deteriorated.
- All sealant holidays are to be removed, prepared and replaced
- Bund wall and apron interface sealant found to be degraded needs to be lightly mechanically ground to remove dirt, sealant and loose material in preparation for application of new sealant.
