# Powerlink 2027-32 Revenue Proposal

CP.03196 BS1009 Mudgeeraba to Terranora Refit

## Condition Assessment Report

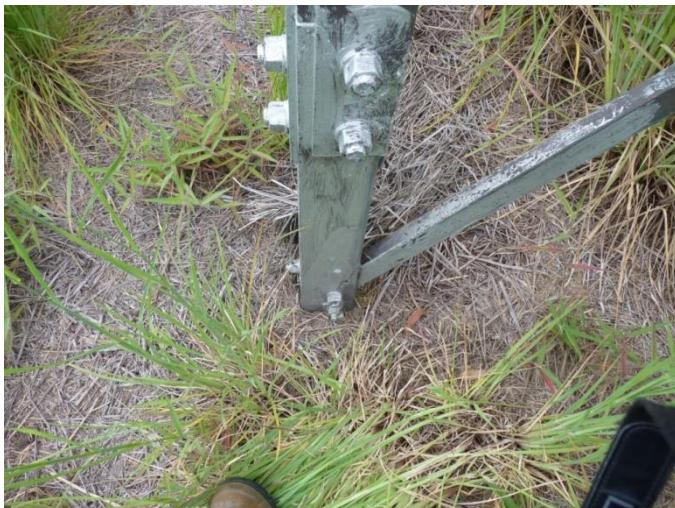
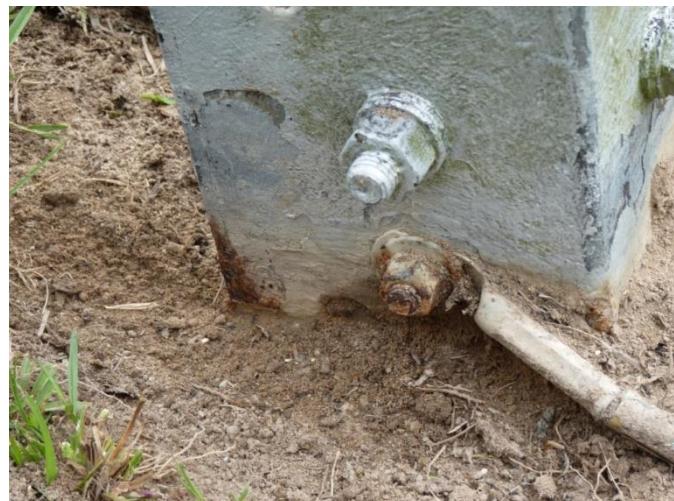
The towers foundations are either mass concrete or bored undercut/straight sided. While the majority show no signs of deterioration, there are isolated instances where a tower leg is showing signs of corrosion at the concrete/ tower leg interface and remedial action will be required. It is also noted that the K-braces on many structures are painted with an asbestos containing paint and before any work can be done, appropriate work methods are required.

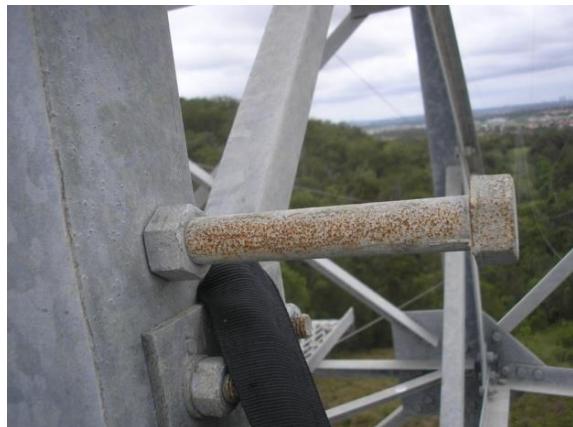
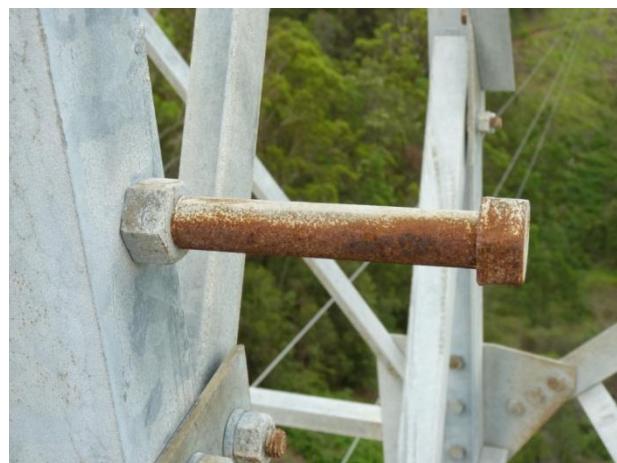
Step bolts are the primary climbing aid used by linespersons to safely ascend and descend the towers. Step bolts are generally in sound condition, although none meet the current fall arrest standard which includes an attachment point for a fall arrest device.

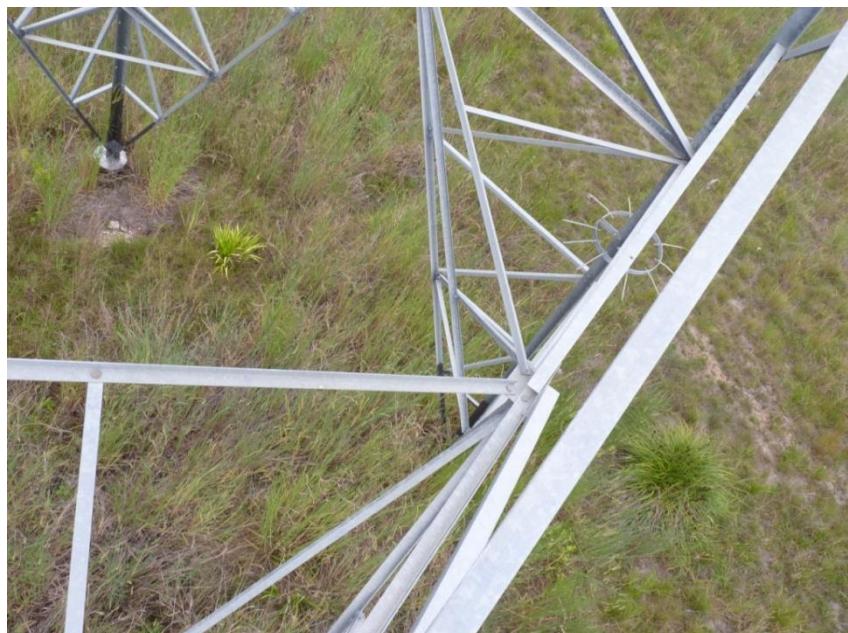
Anti-Climb Barrier at 1009-STR-1706

The majority of the barriers remain in a serviceable condition. The traversing area contains expanding residential estates. Towers impacted by the urbanisation require upgrading to a barbed wire anti-climb barrier and a review of earthing for step and touch potential hazard.

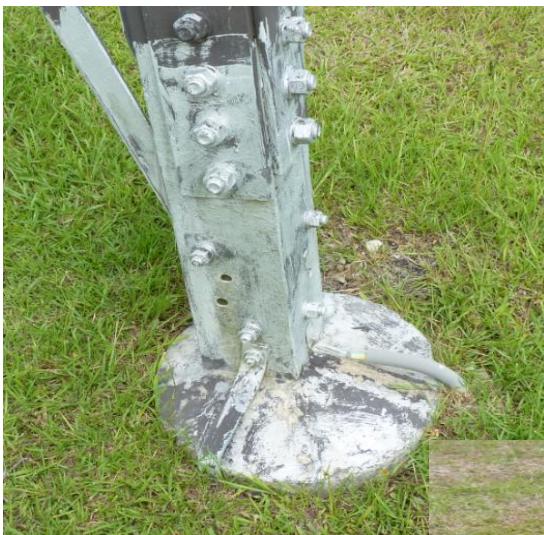
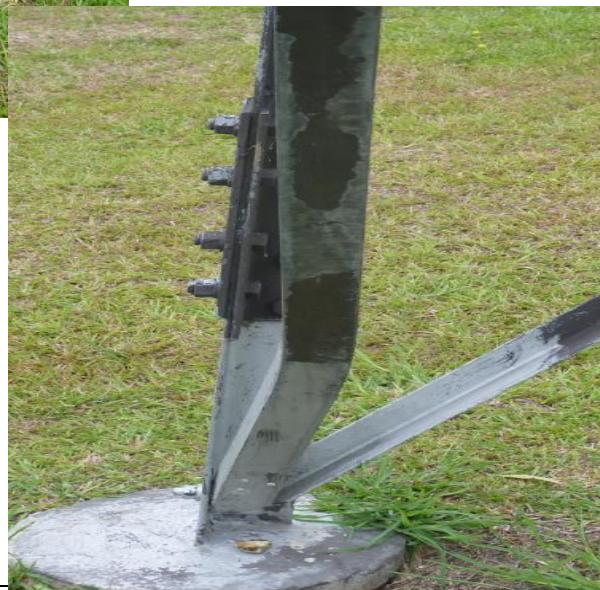
The tower base and legs are generally in good condition with minimal corrosion evident. There are some isolated cases of Grade 3 corrosion on some bolts, which will require replacement. The base of the tower legs has been painted with a silver paint, which has in many cases returned a positive result for the presence of asbestos. Due to the local urbanisation around some towers and probable impact from vehicles, some K-Brace members have been damaged and will require replacement once appropriate work methods for the asbestos containing paint have been developed.

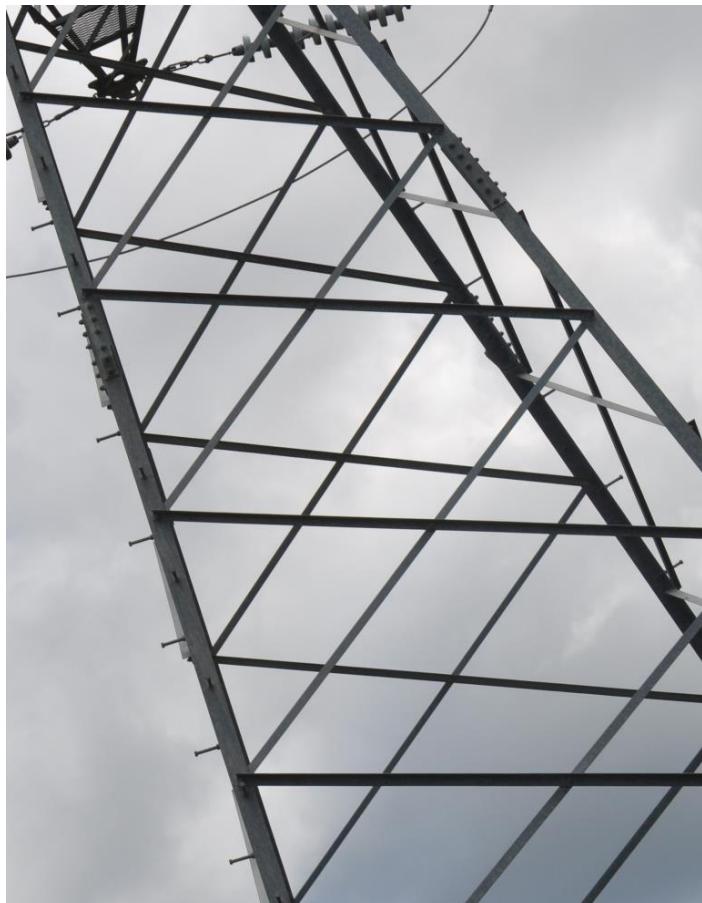
The tower body steel members are exhibiting minimal to no corrosion, with the aging of the structures consistent with 38 years of environmental exposure. Some fasteners (nuts and bolts) are showing signs of Grade 3 corrosion, but the majority remain in a fair condition.

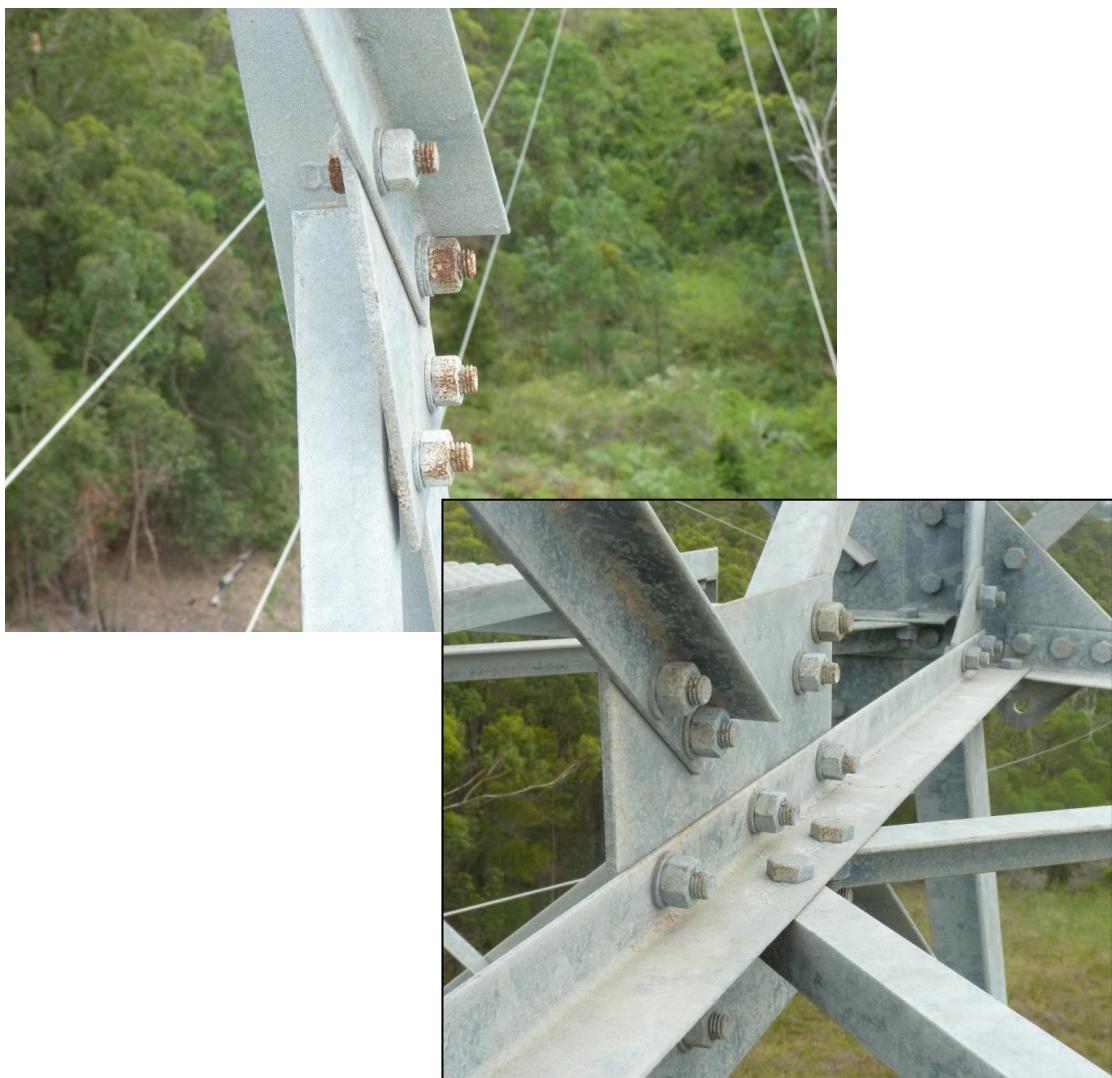
Most superstructure members are exhibiting Grade 1-2 corrosion of the galvanised coating. The galvanised nuts and bolts are more susceptible to corrosion; however, on built section 1009, they are generally in a sound condition. There are isolated cases of fasteners on the structures at Grade 3, but these are not indicative of the general condition.

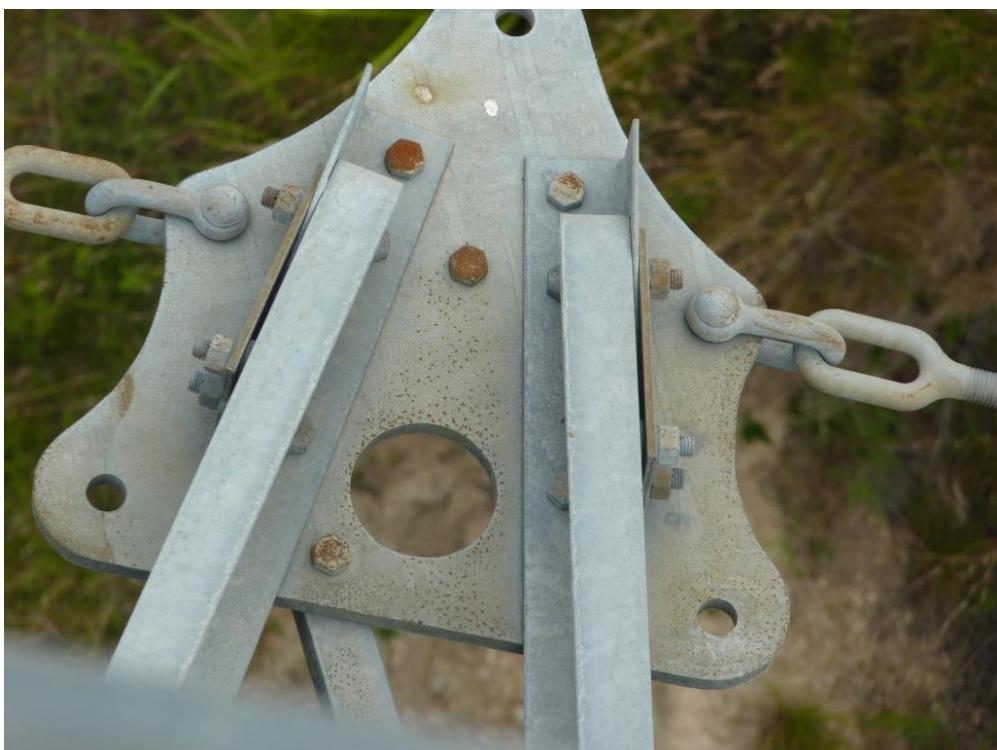
Most attachment plates are in a sound condition with Grade 2 corrosion evident on sections of the attachment plate, bolts and nuts. The figure below illustrates the typical condition of the attachment plate and bolts on built section 1009.

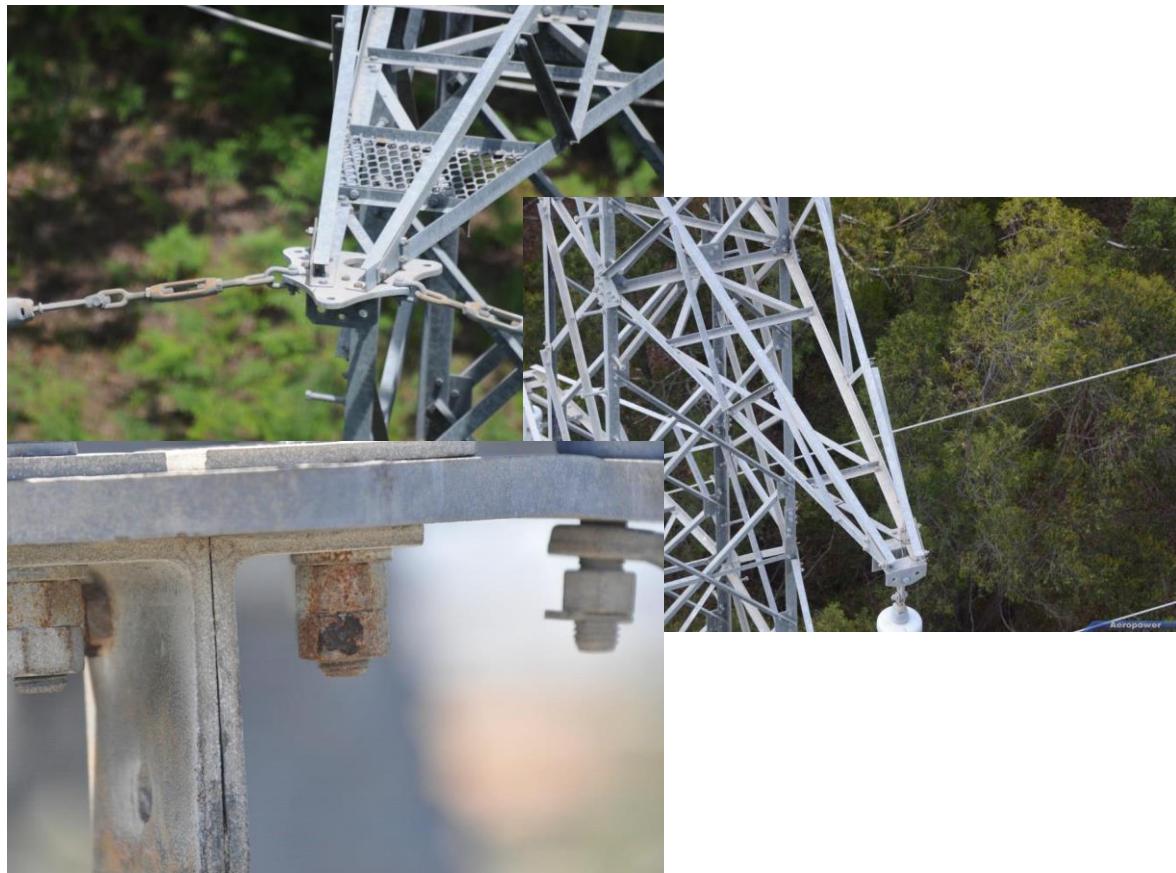
The cross-arm members are exhibiting minimal to no indication of corrosion with only some grade 2 corrosion on the sheltered regions of some members. A larger percentage of bolts have grade 2 corrosion with a small percentage (<5%) with grade 3 level of corrosion. The bolts that are located on the underside of the members in more sheltered locations had consistently a higher degree of corrosion.

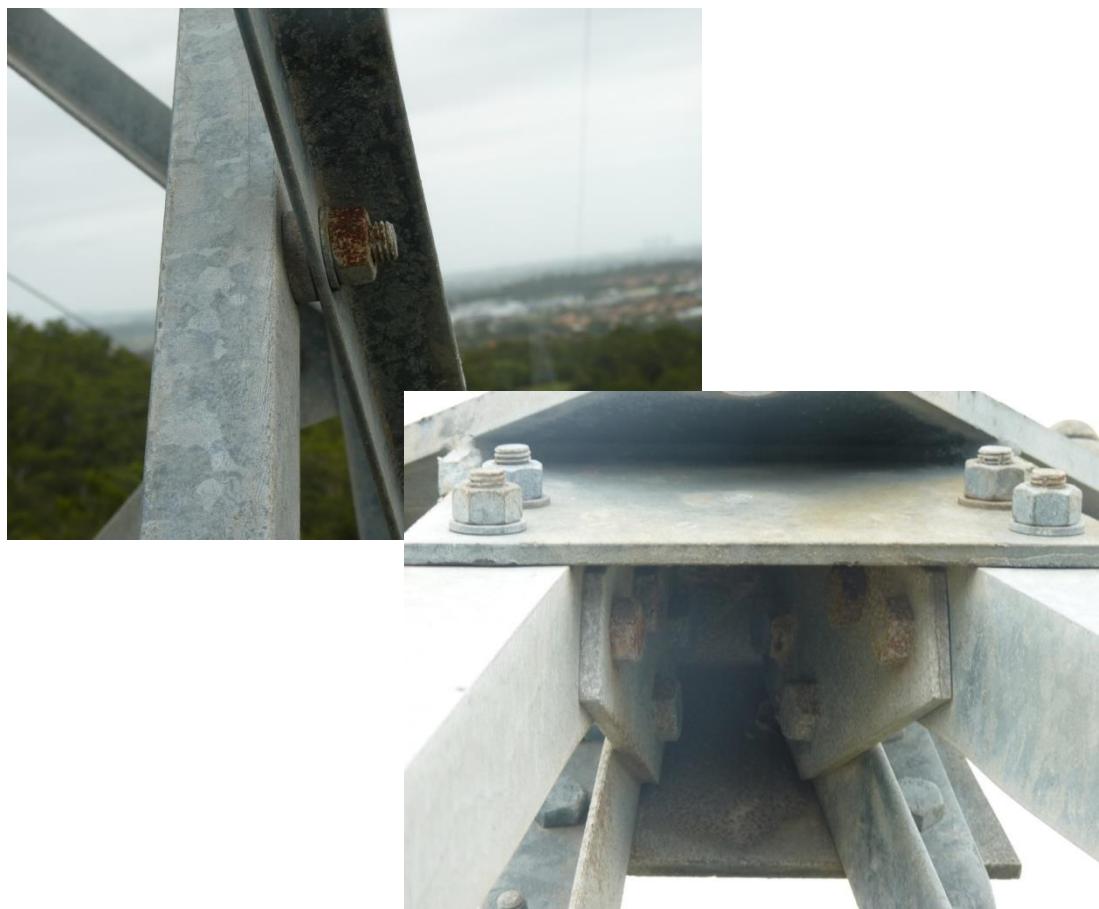
The bolts on the earth peak are more susceptible to corrosion with 60% of the bolts showing Grade 2 corrosion and some isolated examples of Grade 3 corrosion have been observed.

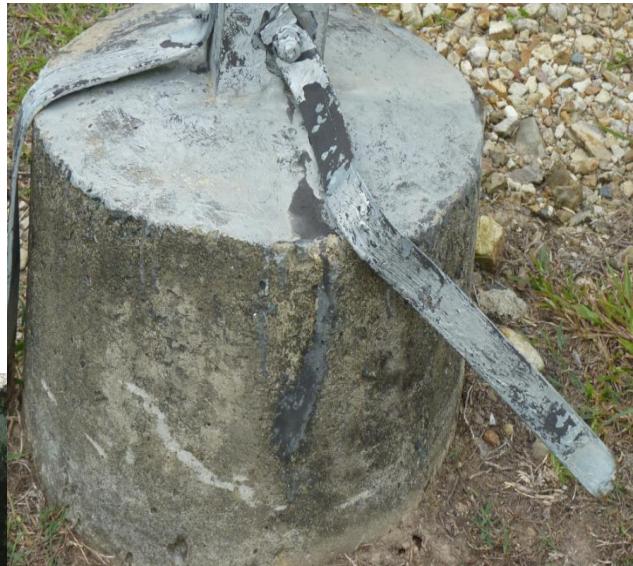
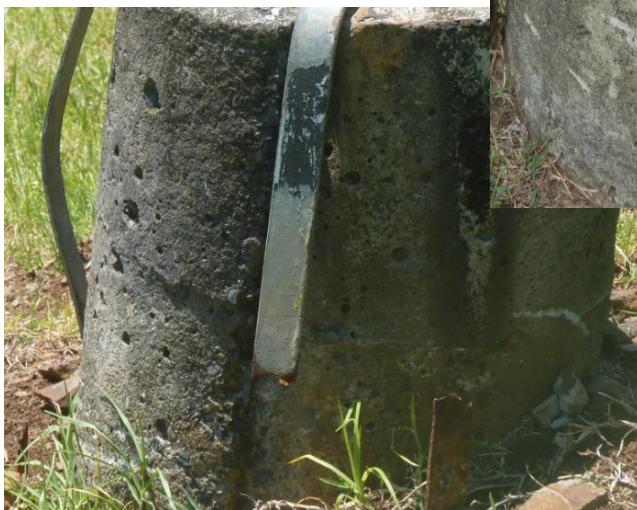
Given that many of the earth straps are coated with asbestos containing paint, the replacement of the earth straps will require appropriate work method instructions to be developed.

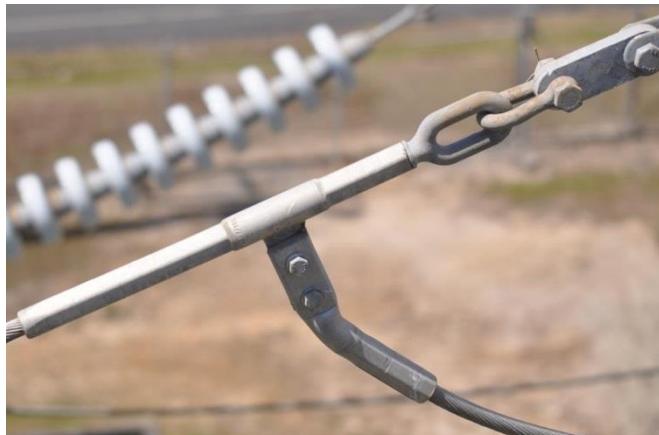
The Panther ACSR/GZ conductor is terminated with a two part compression deadend and jumper bridge fitted by compression connectors. The two galvanised bolts on the dead-ends are exhibiting Level 2 corrosion.

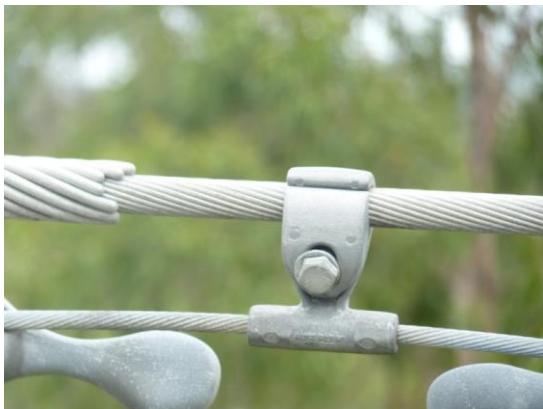
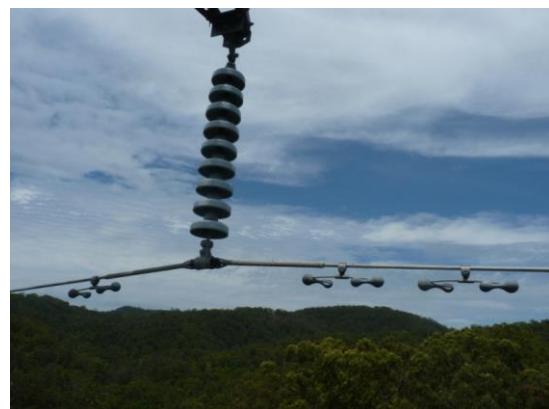
Dampers on the conductor are of a dog-bone construction and the earthwire dampers are spiral vibration dampers. The dampers were installed on the line during its construction and are in a fair condition.

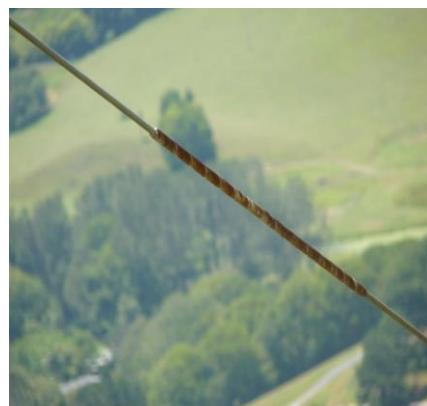
Midspan splices visually appear to be sound but in 2014 the patrol identified corrosion on one midspan splice. It is expected that all overhead earthwire midspan joints will be replaced over the next 5years,

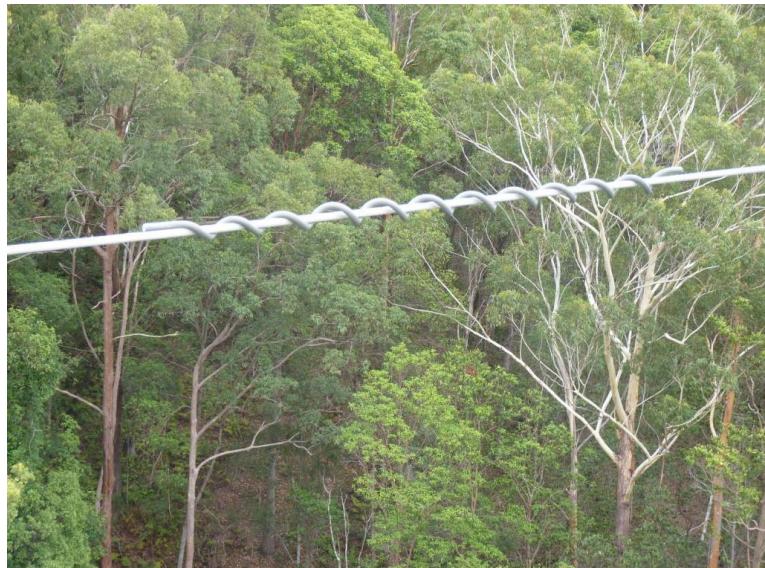
No visible deterioration of the earthwires have been observed

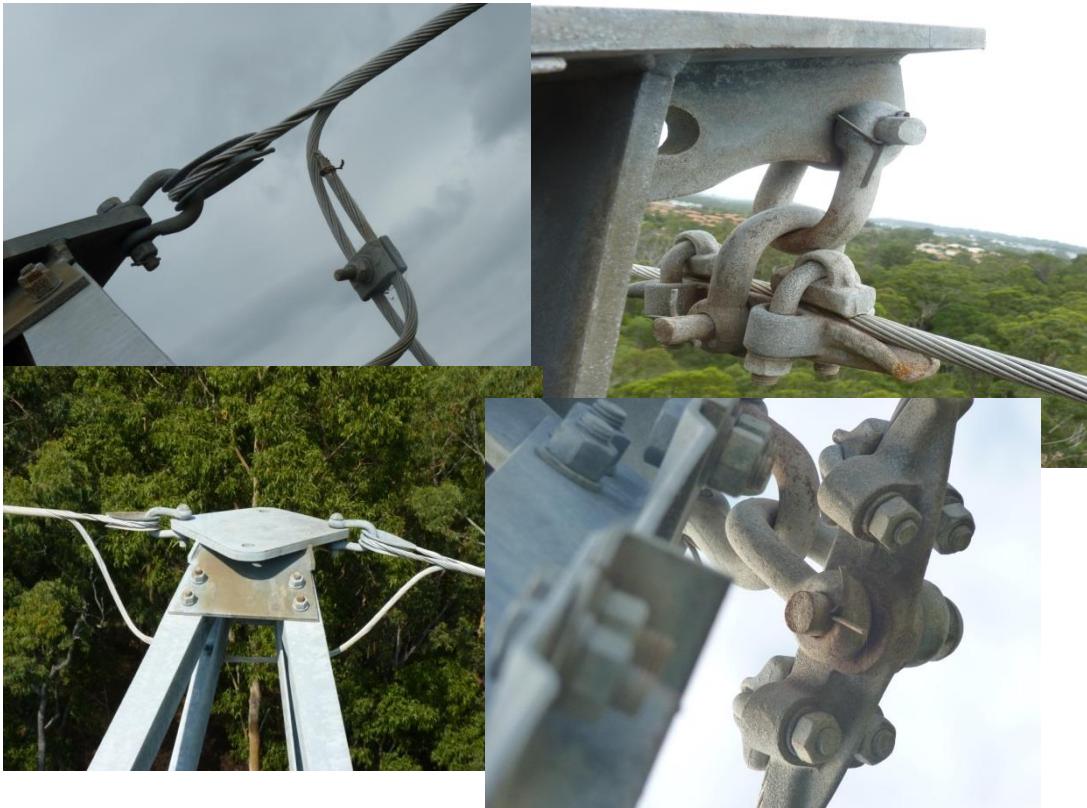
The line's OHEW suspension and tension hardware was installed in 1976 and is showing signs of Category 2 corrosion. The design of the OHEW termination allows fault current to pass through the preformed fitting which has been identified with strand damage on the thimble-preformed interface. Replacement of the deadend assemblies to a more robust design to prevent fault current damage is being assessed. There are isolated cases of grade 3 corrosion on the trunnion clamps and these will require replacement in the next 5 – 10 years.

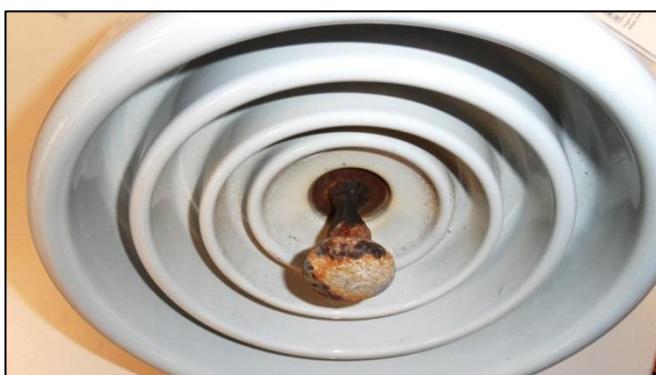
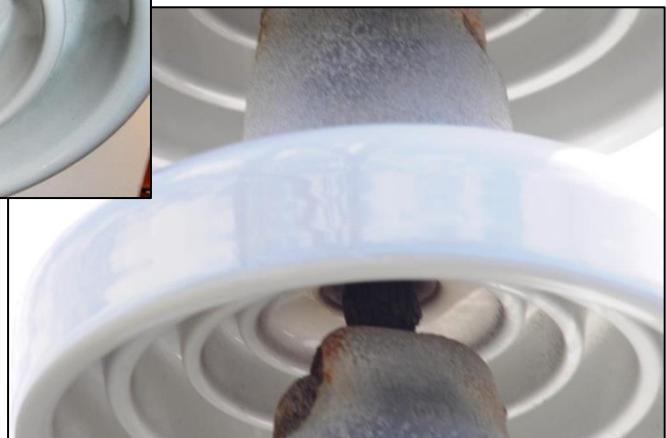
Figure 3: Condition of Removed suspension Insulators

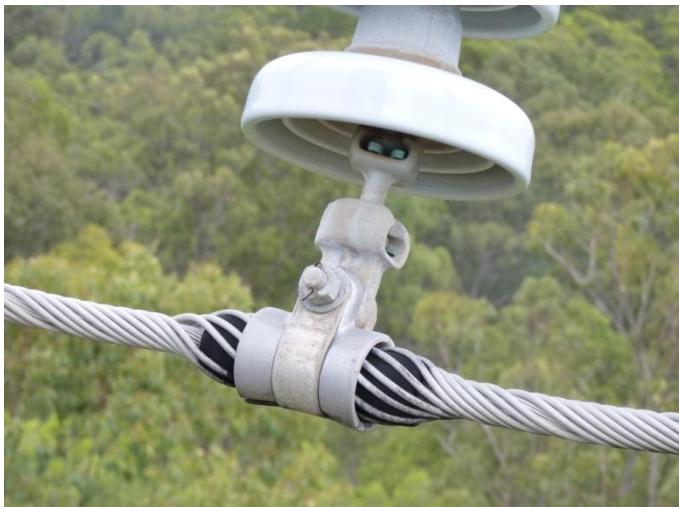
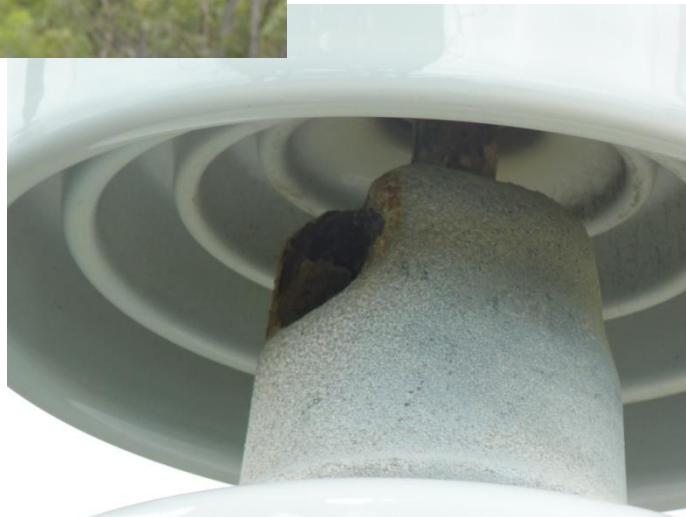
The bridging insulators and hardware were in a similar condition to the suspension insulators and hardware. There are only three structures which contain bridging insulators and these were replaced with NGK fog insulators. These replacements were completed in August 2014.

Figure 4: Condition of Removed Bridging Insulator

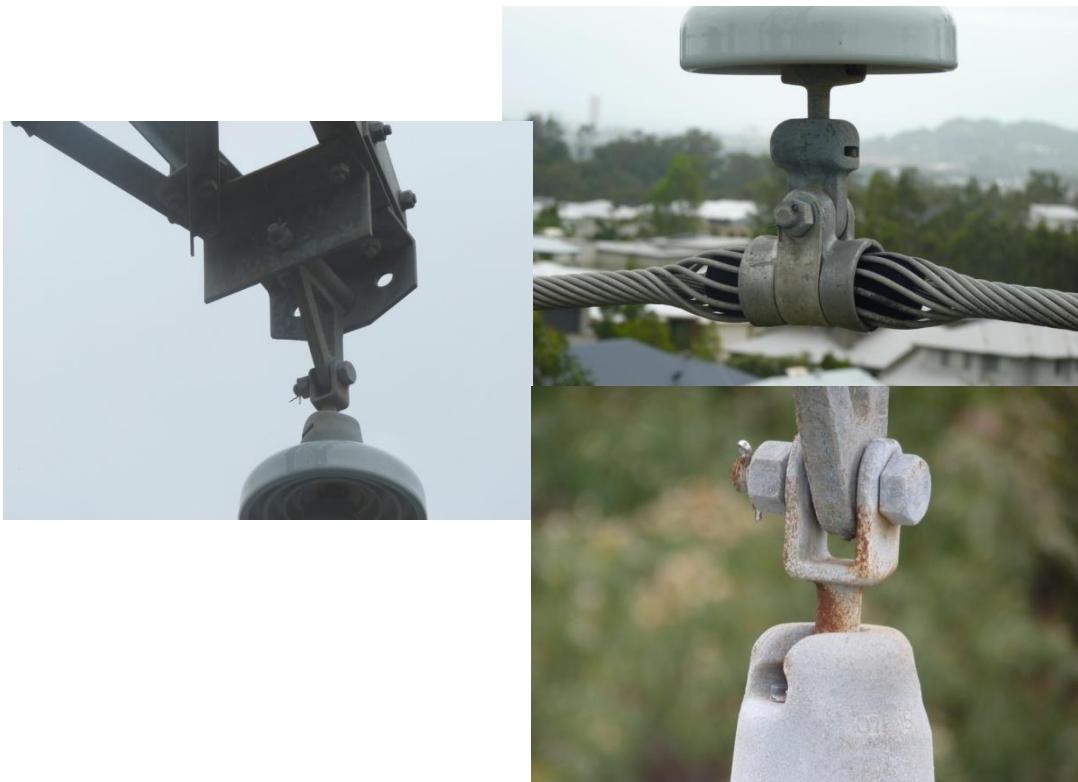
The other hardware at the cold end was replaced along with the insulators. The structures that were not replaced are in a good condition, generally category 2, with some instances where the galvanising on the hardware at the energised end has deteriorated. These can be periodically monitored and replaced under maintenance when required.

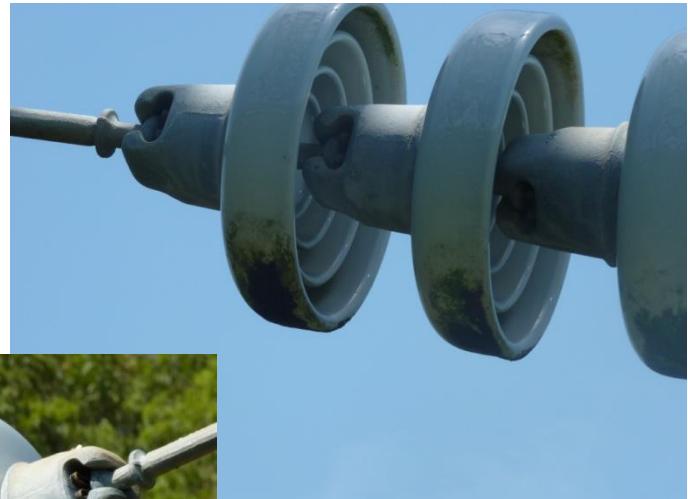
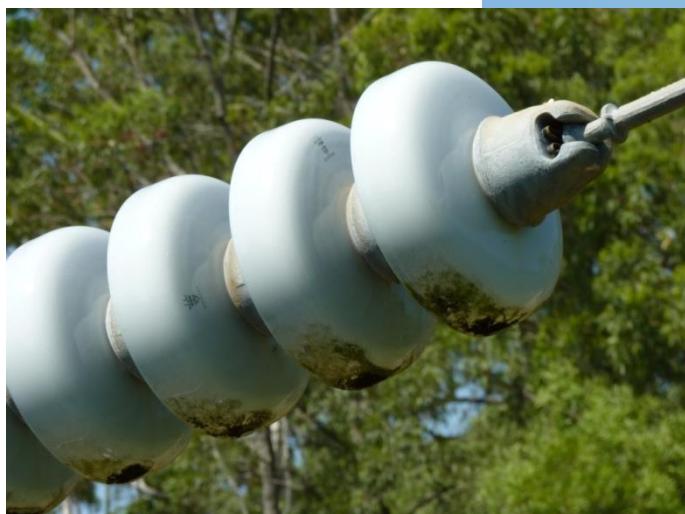
The presence of mould on the insulators should not adversely affect the performance of the insulators and it is recommended to monitor the insulators for any changes.

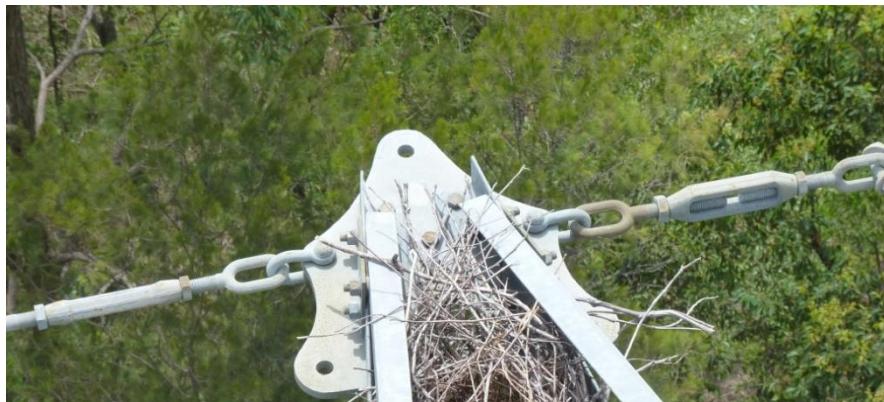
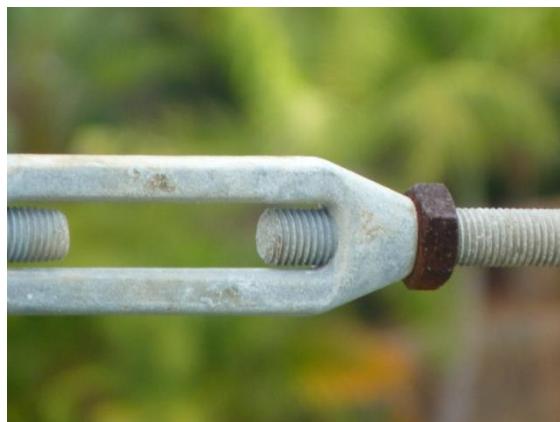
The tension insulator hardware was installed in 1976 and like most components of the line remains in a good condition. In the majority of cases only minor corrosion is evident, but on several turnbuckles, the galvanising on the adjustable nut has deteriorated leaving the bare steel. At this stage there is very low risk to the network, but affected items will need to be replaced in the medium term under maintenance work orders.

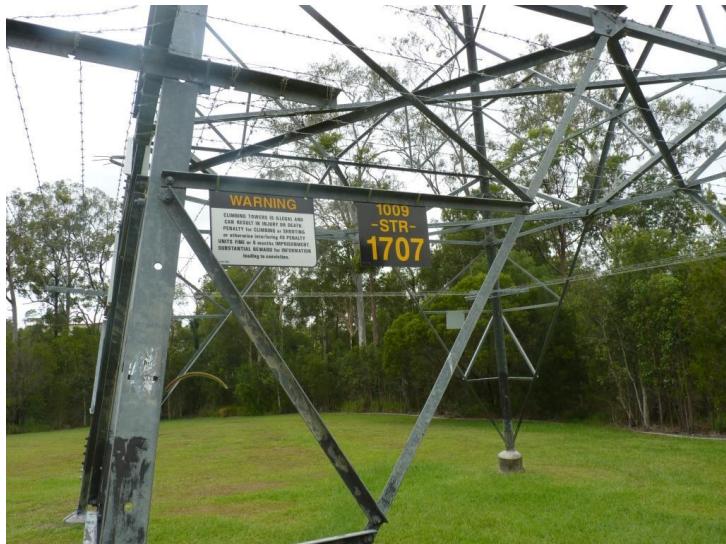
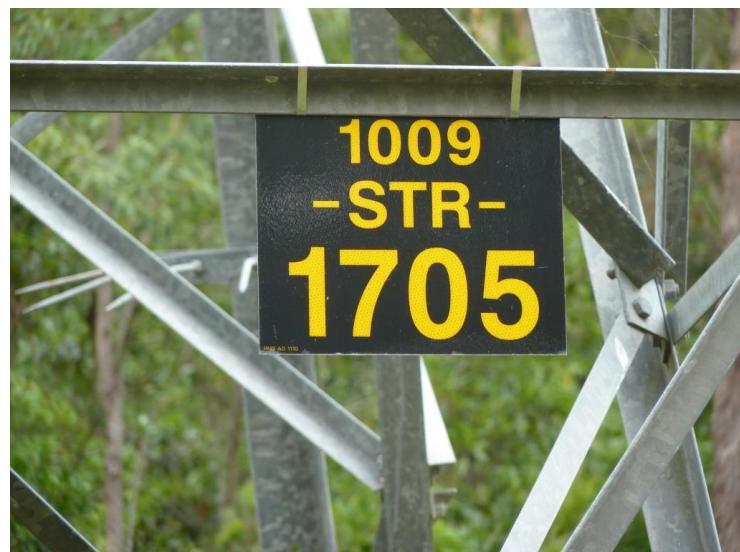
A recent project installed identification and warning signage in 2012/13 to the current Powerlink standard. The patrol undertaken as part of this condition report has identified structure 1009-STR-1700 as not having the current standard and this will be rectified as part of a routine maintenance program.

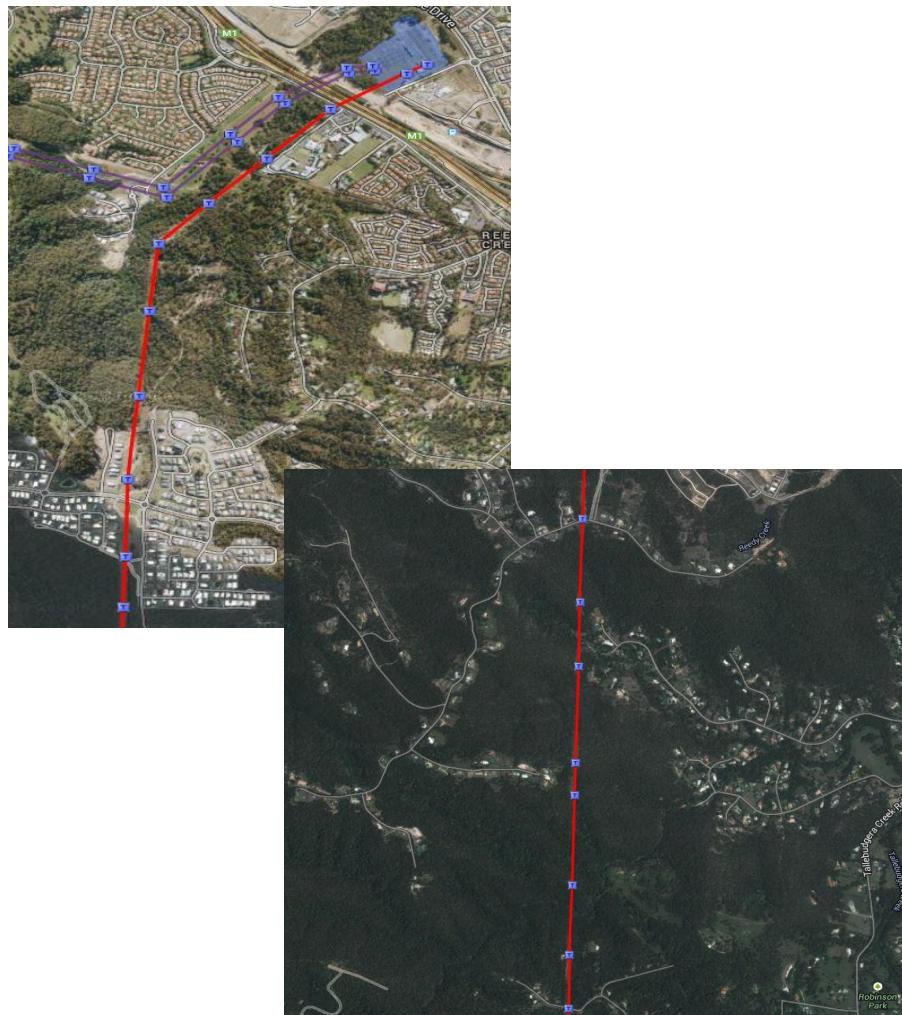
The remainder of the lines easement poses a number of access issues due to its undulating nature, and in places, location in private residences or distance from roads. It also contains a number of heavily vegetated spans with a medium to high fire risk.
