Powerlink 2027-32 Revenue Proposal

Project Pack

CP.03208 Mudgeeraba Selective Primary Plant Replacement

SITE CONDITION ASSESSMENT REPORT

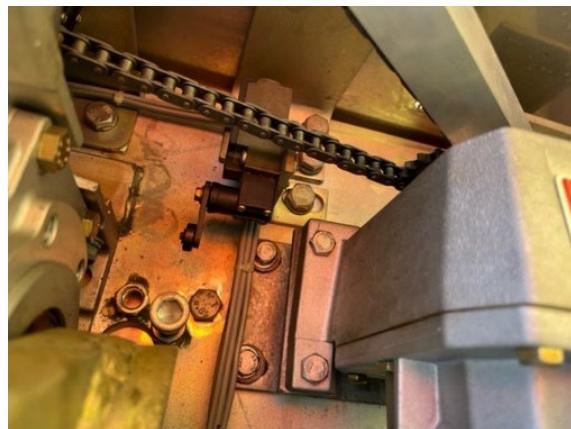
Figure 6--Limit switch and chain drive assembly

AEM earth switch/disconnectors despite being relatively new, have corroded tie rod ends and insulator jacking bolts. In addition, disconnector has issues with limit switch resulting in motorised function not being available as seen in Figure 6 and Figure 7.

Recommendation:

Based on the above observations, it is not recommended to replace any equipment in this bay. It is expected that it will provide reliable service for next 15-20 years.

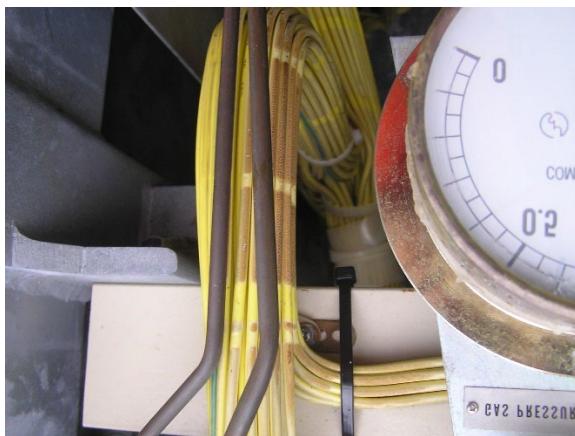
Figure 8- UV damage to internal wiring and the operation counter

The Ruhrtal isolators and earth switches and circuit breaker have been in service now for 33 years. The circuit breaker (CB) in this bay was manufactured by Mitsubishi. It has a pneumatic/ spring type operating mechanism with SF6 gas used as insulating medium. This type of CB is no longer manufactured by Mitsubishi and hence no spare parts support. It is showing signs of deterioration.

Notably, the panel glass is not UV tinted, resulting in UV damage to internal wiring and the operation counter as shown in Figure 8.

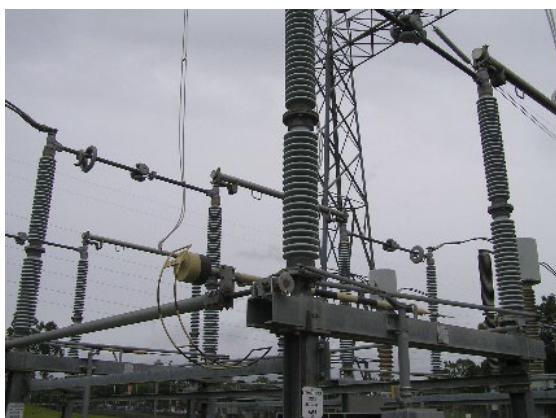
Ruhrtal disconnectors have some lightly corroded nuts and bolts on the structure, and light wear on earth switch rotating axel but otherwise seem to be in good condition. The motor box is equipped with fuses rather than MCBs showing the age of manufacture. However, there are no recorded defects associated with RUHRTAL disconnectors and earth switches.

Figure 9- Visible corrosion on disconnector

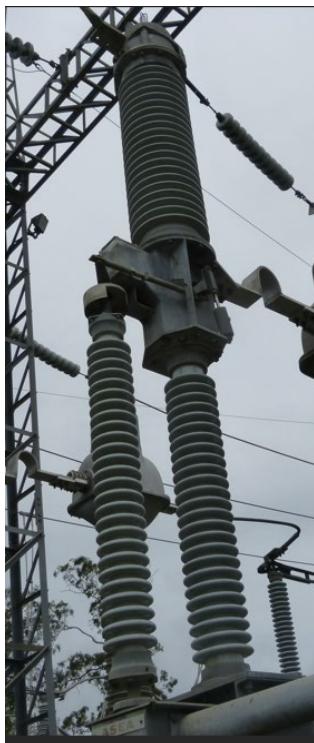
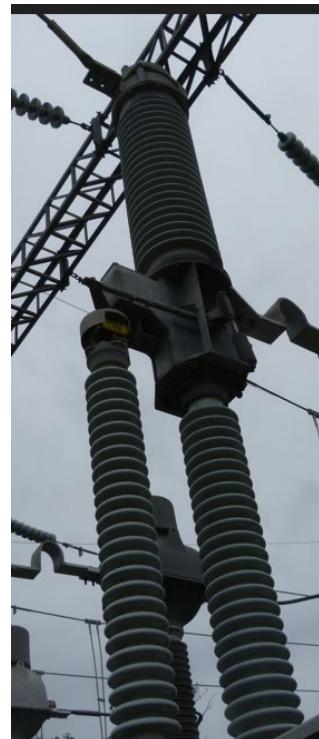
These circuit breakers require specific maintenance skills and oil replacement and clean up every 2 years to maintain satisfactory insulation level.

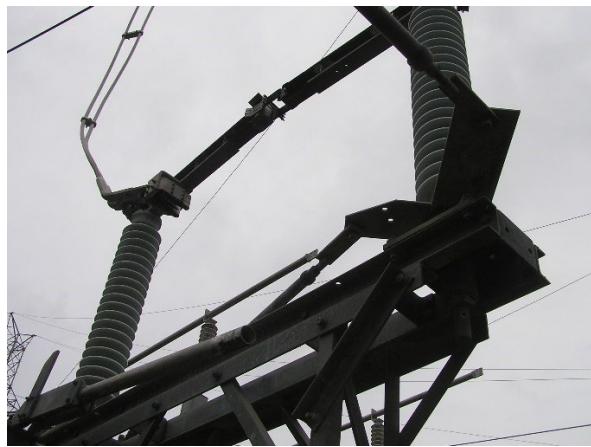
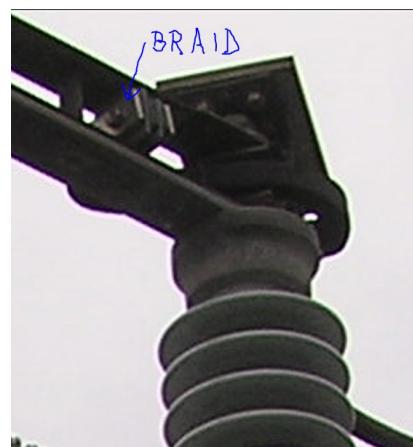
The RC type Taplin disconnectors in this bay have experienced high resistance and overheating associated with the current carrying pivot joints. The original design has the pivot joints exposed to the elements and degradation occurs with these components over time. Under OR.01041 project the installation of new braid assemblies at the pivot joints and included the upgrade of the current carrying contact female contacts fingers system to 8 fingers / resilvering the male contact and the in addition to the new braid assemblies at the pivot joints. The disconnector 7066 has a fault rating of 25 kA which is well below the standard rating of 40kA, and the 110kV fault level is 21.5KA and trending upwards. Last year it was established that due to the shaft rod being bent all cam shaft rotating discs were out of alignment resulting in the status of isolator being undetermined (not open nor closed). This was rectified but it is likely to re-occur.

These Taplin disconnectors also have low continuous current rating of 1250 A.

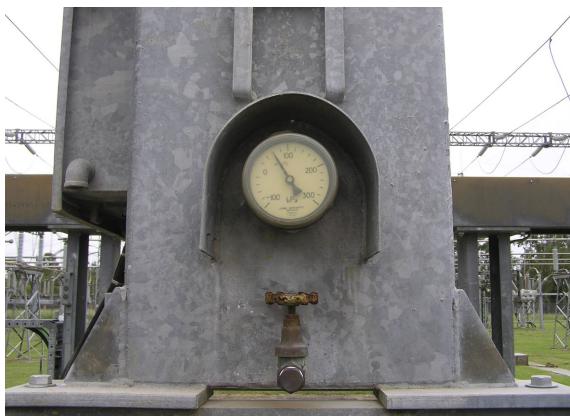
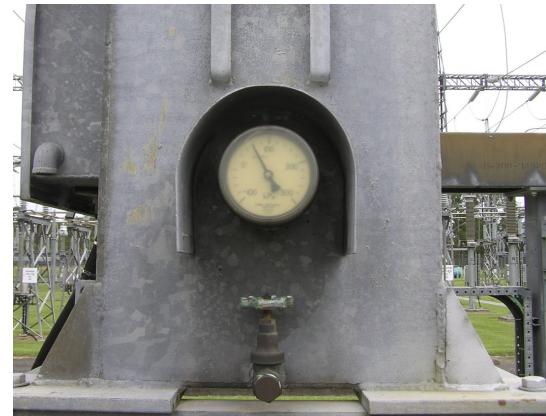
CT A phase was also replaced in December 2013 due to oil leaks from the secondary terminal box. The current transformer used for replacement was previously installed at H003 Belmont since 1996 to 2011 when it was recovered as a part of decommissioning of bay associated with transformer T3 at Belmont. The B&C phase Low-Bonar Stanger current transformers, were manufactured in 1980 and were installed at Mudgeeraba in 1994. There is light corrosion to B and C phase. B and C are both 45 years old. and it is recommended to replace these soon. Statistical data indicate that oil filled current transformers have increased probability of explosive failures after 37 years in service. As they have porcelain housing potentially catastrophic safety consequences can occur and on this basis it is recommended to have these replaced within 3-5 years.

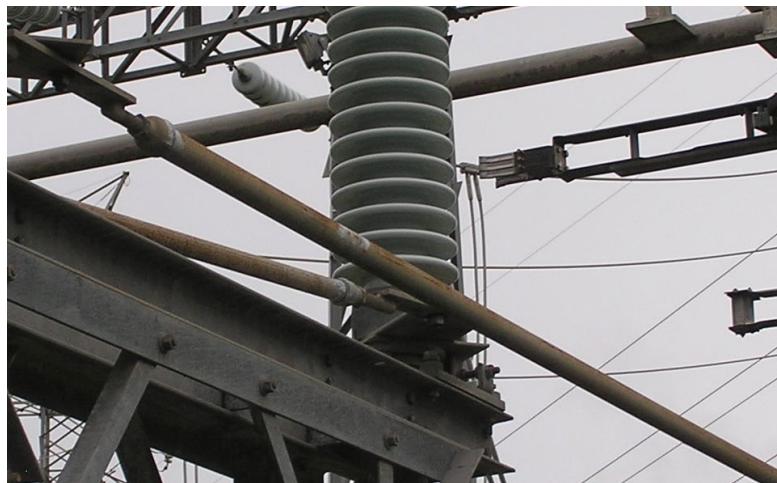
Figure 18- Photo of Equipment

The corrosion was treated in 2020 with a very high costs (using live substation crew) but the corrosion is still present especially on operating rods. These were not replaced in 2018 as decision re bus configuration was not made – this is isolator selectable busbar configuration and requires different and more expensive type of protection. Considering this configuration is kept at this site, these disconnectors now need to be refurbished or replaced.

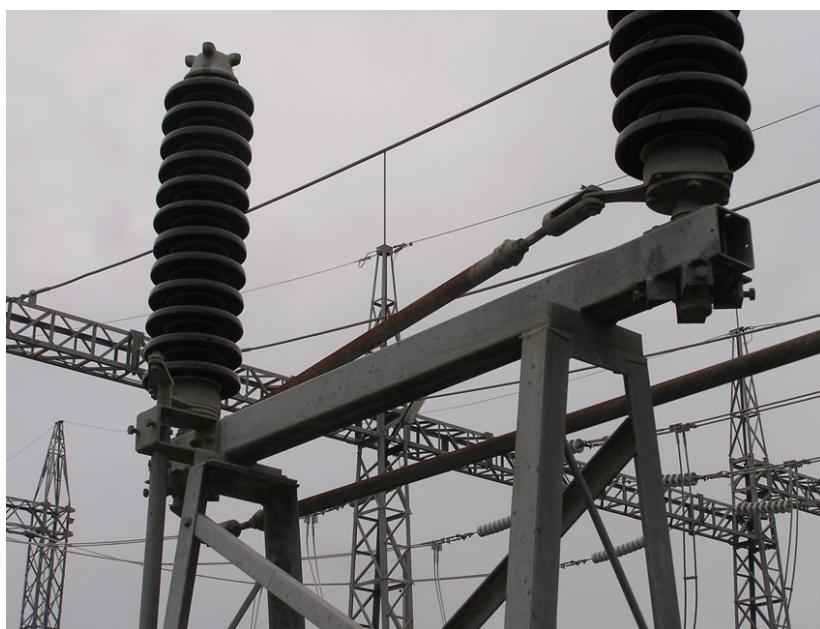
Figure 19- Photo of Equipment

The disconnectors have been disabled and are no longer required from an operational perspective. The arms have been removed for spares. They serve as busbar supports. They need to be monitored to ensure their fault level ratings is not exceeded by fault levels at this site. It is also suspected these are segmented insulators and not passing test.

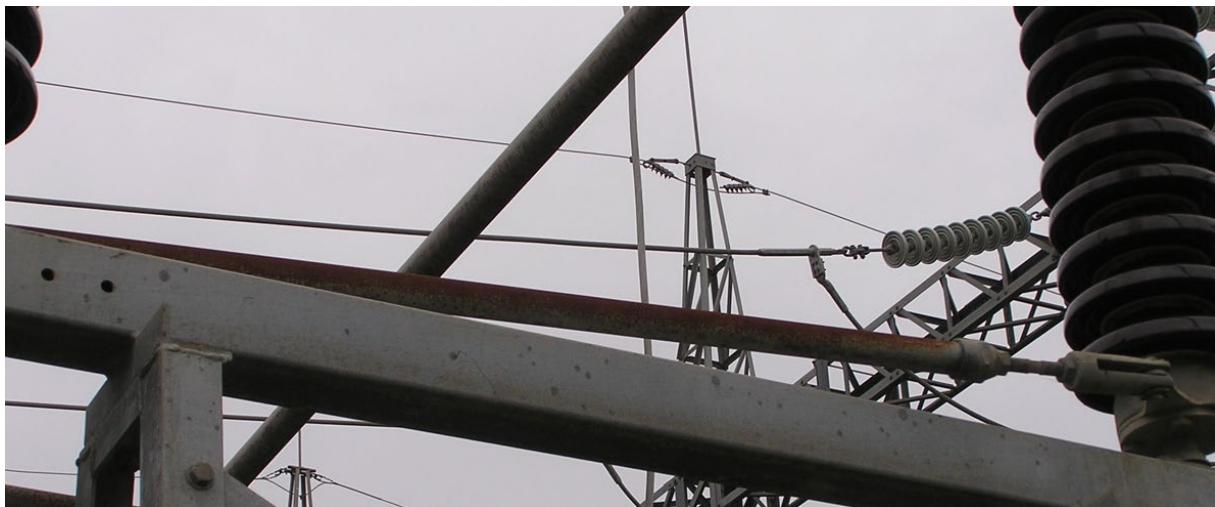
Figure 20- Corrosion on disconnector

Two disconnectors in this bay have significant corrosion of the operating interphase shaft (and its ends) and the civil condition assessment report suggests that the estimated remaining service life for their foundations and structures is 5 years. The 26.3kA fault rating of the disconnectors meets current requirements but does not allow for an increase of fault levels (which may limit the possibilities for network re-configurations). The estimated remaining service life for these disconnectors is 3-5 years.

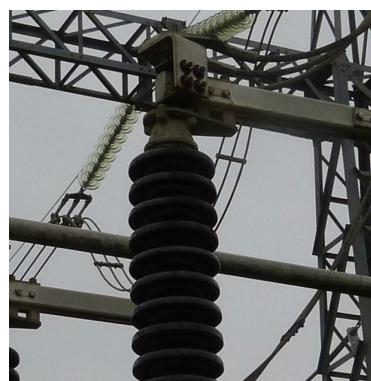
Figure 22- Photo of Equipment

The HCB Stanger bus disconnectors are approaching 55 years old and their fault current rating, although still sufficient, can potentially be an impediment to the network configuration flexibility. Additionally, records show corrosion to tie rod ends and operating arms.

Further, there are many notes of the isolator being extremely difficult to operate between 2015 and the last entry in 2023.
