# Powerlink 2027-32 Revenue Proposal

### CP.02800 Alligator Creek Substation Reinvestment

# PRIMARY PLANT CONDITION ASSESSMENT REPORT

# T065 Alligator Creek 132kV Substation and SVC Secondary Systems Condition Assessment

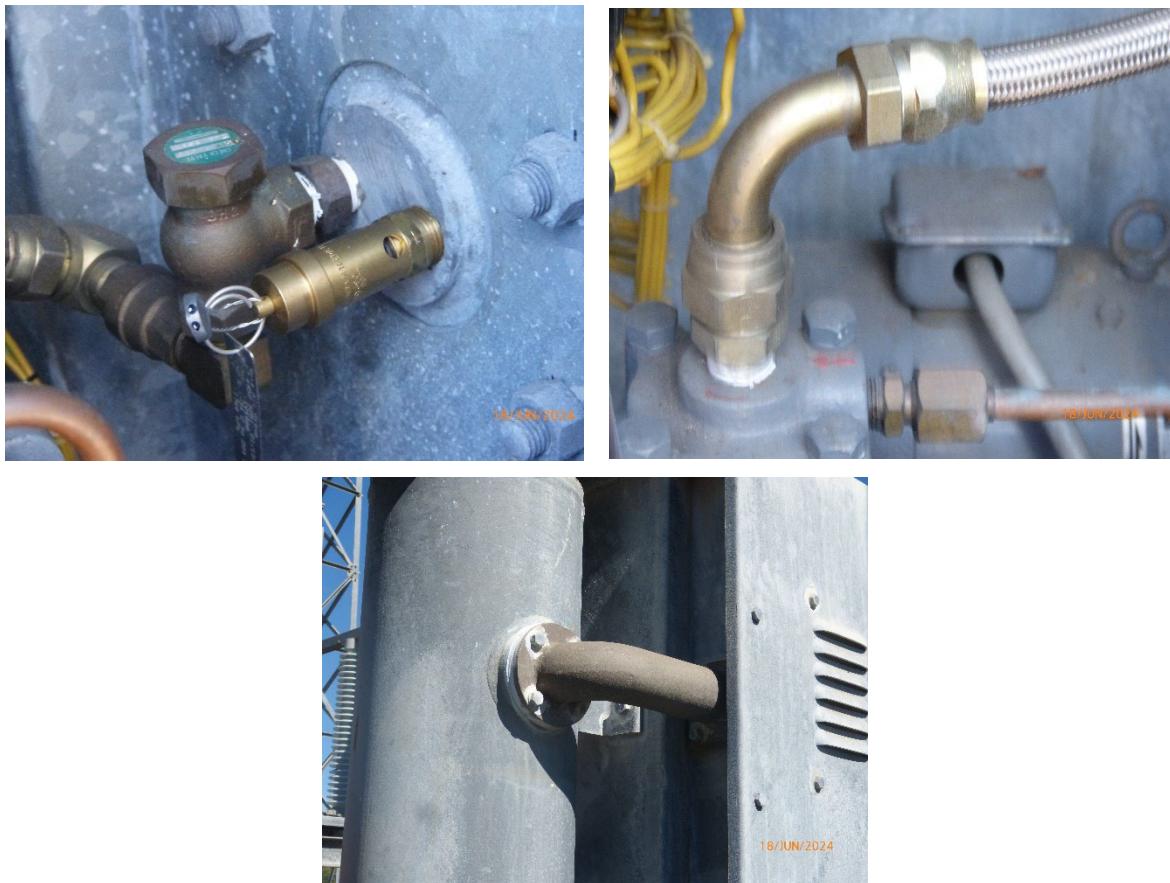
The maintenance records indicate a single air leak which has been fixed by the maintenance crew. During the site visit, repairs of air leaks at multiple locations were noted, as shown in figure 4.

Figure 4- Repair of Air Leaks at Multiple Locations

**Considering the current equipment strategy preference for Dead Tank Circuit Breaker (DTCB), it is recommended to replace this CB along with current transformers (CTs) with DTCB within two years to ensure safety risks associated with current transformers**

remain acceptable. Additionally, the foundation and support structure will also need to be replaced.

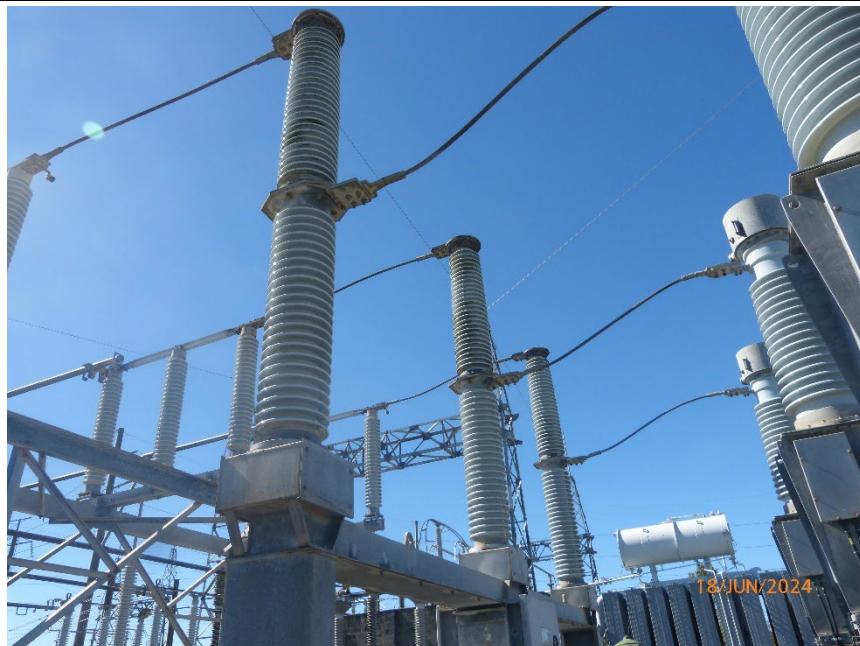
In addition to the fixed air leak, multiple rusted bolts and washers on all three poles were reported and are scheduled to be addressed during the 2025 service. The operation counter also exhibits significant corrosion and needs replacement. These issues were observed during the site inspection, as indicated in figures 5 through 8. There is also internal wiring deterioration as per figure 9.

Figure 5- Overview of 71752 indicate multiple corrosion

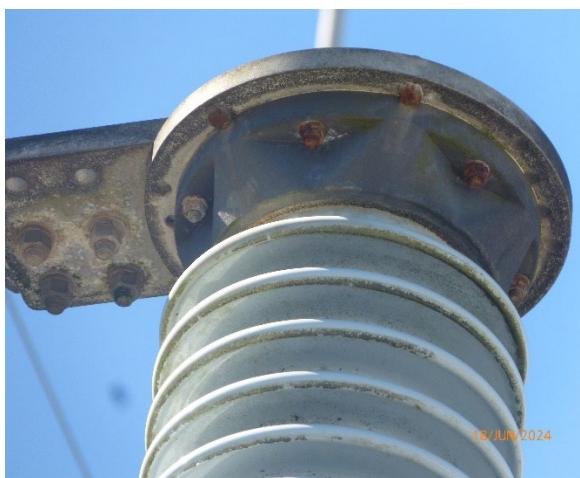
Figure 7- Grade 1 to Grade 3 Corrosion

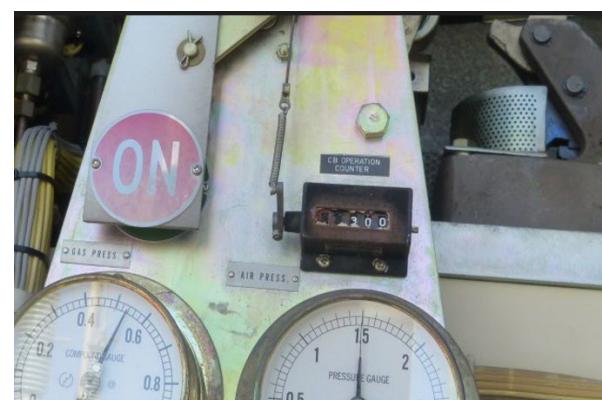
Figure 6- Operation Counter Corrosion

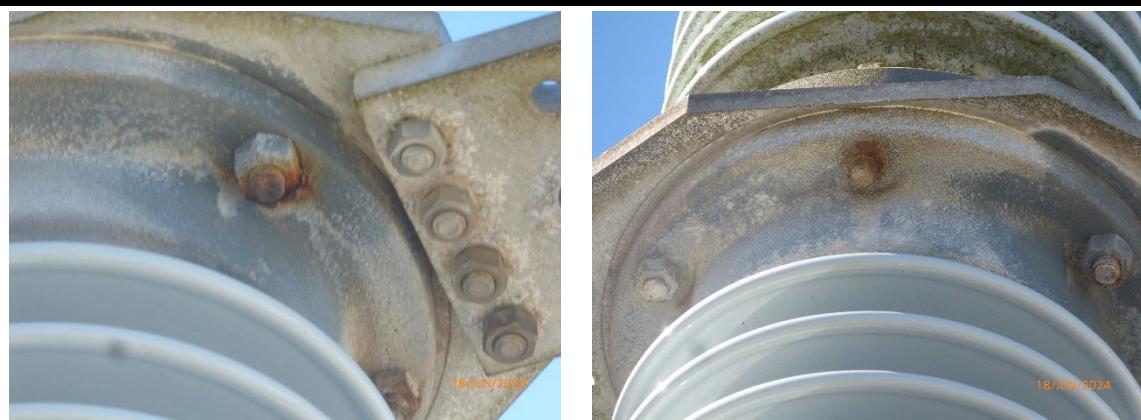
Figure 8- Mid points bolts and nuts corrosion

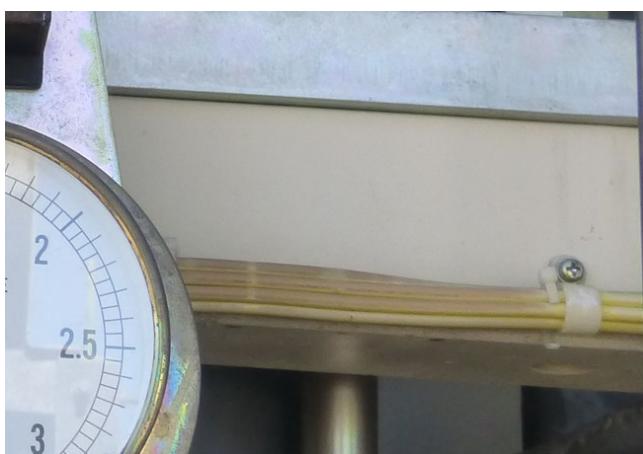
Figure 9- Insulation UV damage

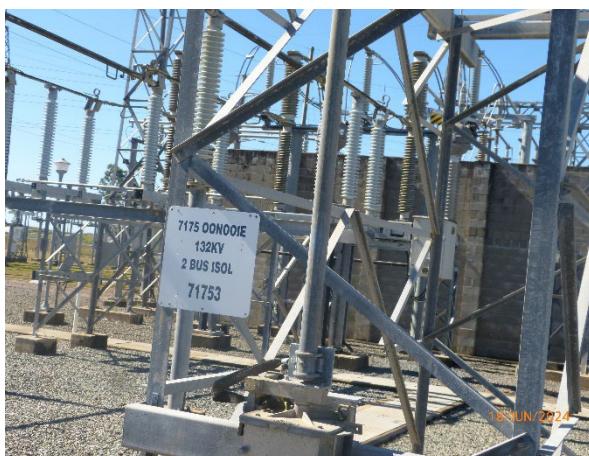
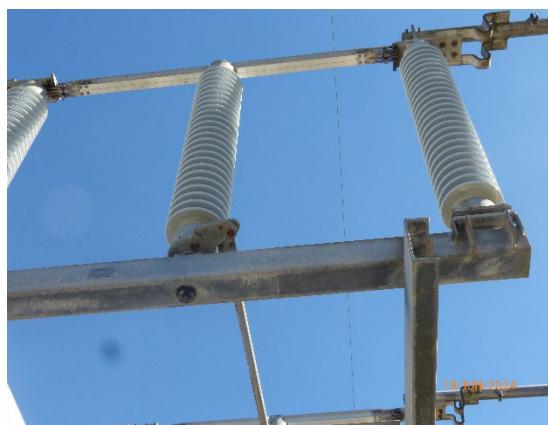
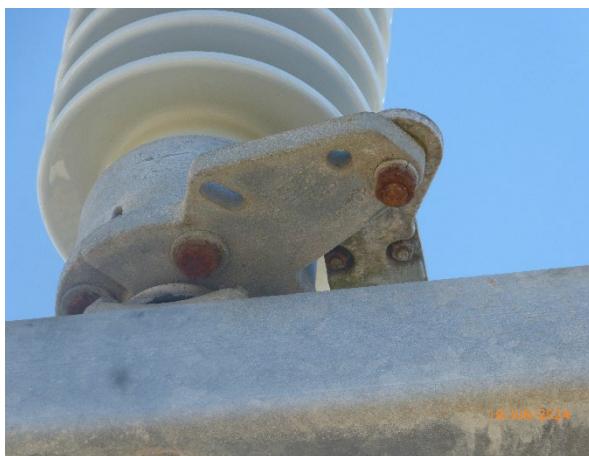
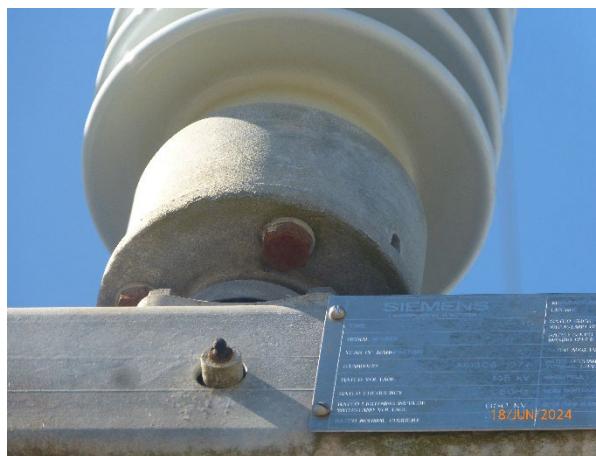
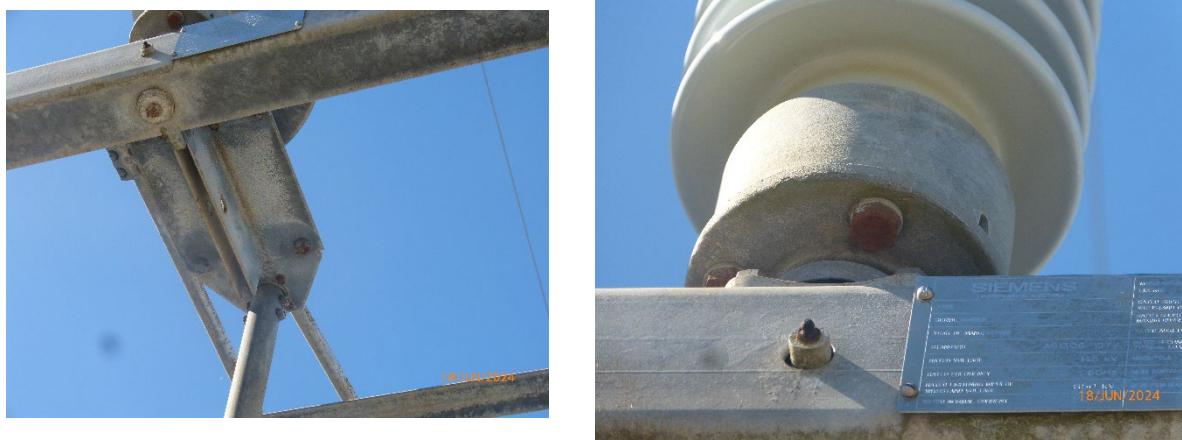
The line and bus isolators are Siemens model SSBIII-145 and have been in service for 38 years. Maintenance records indicate that both the bus isolator 71753 and line isolator 71751 have experienced reoccurring issues, primarily related to corrosion and high contact resistance. For bus isolator 71753, surface rust has been detected on various components, including bolts and nuts holding the fixed insulators to the post plates. These issues were noted in 2012, 2016, 2022, and 2023, leading to periodic treatments and replacements. High contact

Figure 10- Corrosion on 132kV Bus Isolator 71753 Components

Siemens has stopped manufacturing these disconnectors and earth switches, leading to significant challenges in obtaining product support and spare parts. **It is recommended to replace the disconnectors and earth switches, along with their foundations if necessary, within the next two years, in conjunction with the circuit breaker replacement.**

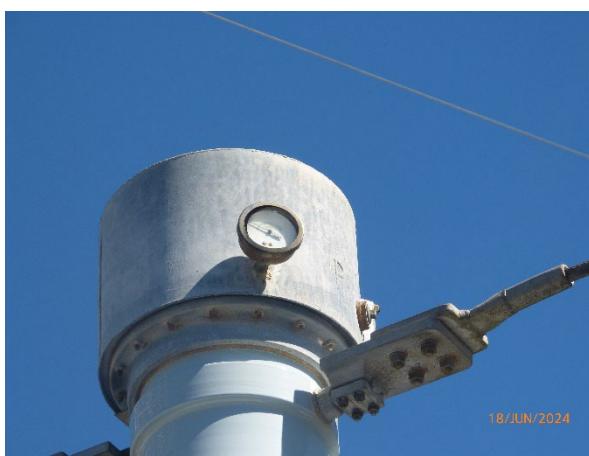
Maintenance records indicate no issues with these current transformers since their installation. The oil levels for all three phases were noted to be normal during the site inspection. Minor corrosion was observed on several bolts and nuts across the three phases (Figures 16-18).

Figure 18- Corrosion on CT Fittings

**It is recommended that these current transformers be replaced within two years.**

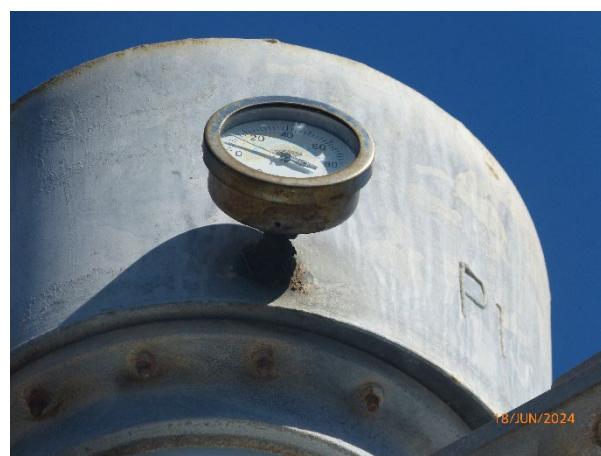
Figure 19- Corrosions on bolts and nuts

While they appear to be in reasonable condition and their DGA analyses are satisfactory, it is known considering their age that there is increased probability of explosive failures. Considering these are oil filled CTs in porcelain housing the potential safety consequences of catastrophic failure represent an unacceptable risk.

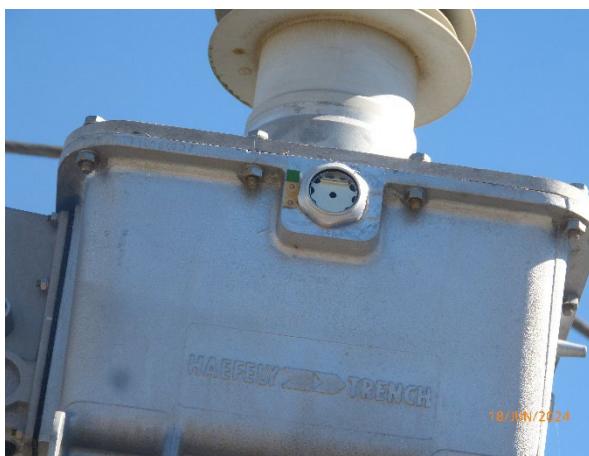
The capacitive voltage transformers (CVTs) are of HAEFELY make, featuring porcelain housing construction, and have been in service for 38 years. Notably, the original porcelain-housed C phase voltage transformer (VT) was replaced with a polymer-housed VT in 2015 and is currently in good condition. Except for the reported oil leak from the A phase gauge since 2022, maintenance records indicate no significant concerns. The oil colour in phases A and B has changed to reddish-brown, indicating potential moisture ingress whereas the oil in phase C remains clear.

Figure 20- C- Voltage Transformer with Clear Oil

**Given the observed condition, it is recommended to replace the A and B phase voltage transformers within the next two years.**

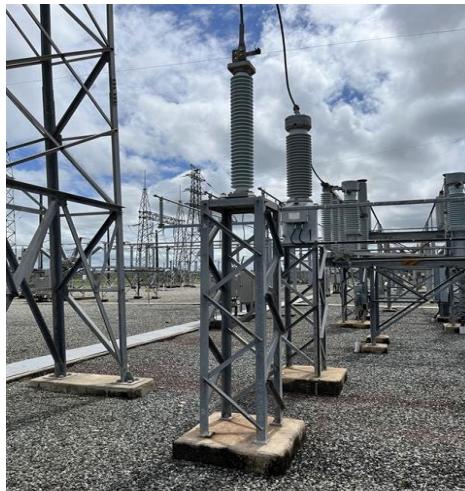
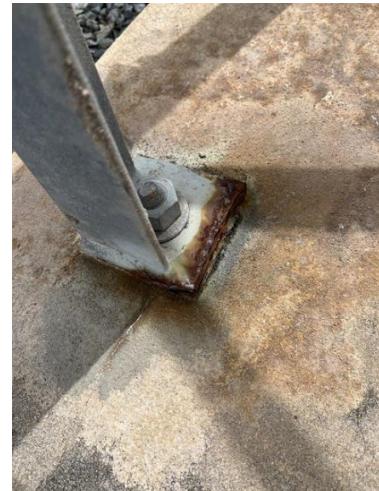
The surge arrestors are of Hitachi make, gapless type in porcelain housing and have been in service for 37 years. Apart from corrosion at the steel work at the base of phase A and some rusty bolts require replacement, the arrestors are in reasonable condition. **Considering they**

Figure 23- Corrosion at surge arrestor bolts and steel work

are in porcelain housing and the need to renew almost all other equipment in this bay, it is recommended to have these replaced. Their potential failure can result in safety risk, damage to the surrounding equipment, causing outages and either supply disruptions or supply to the customer being put on risk.

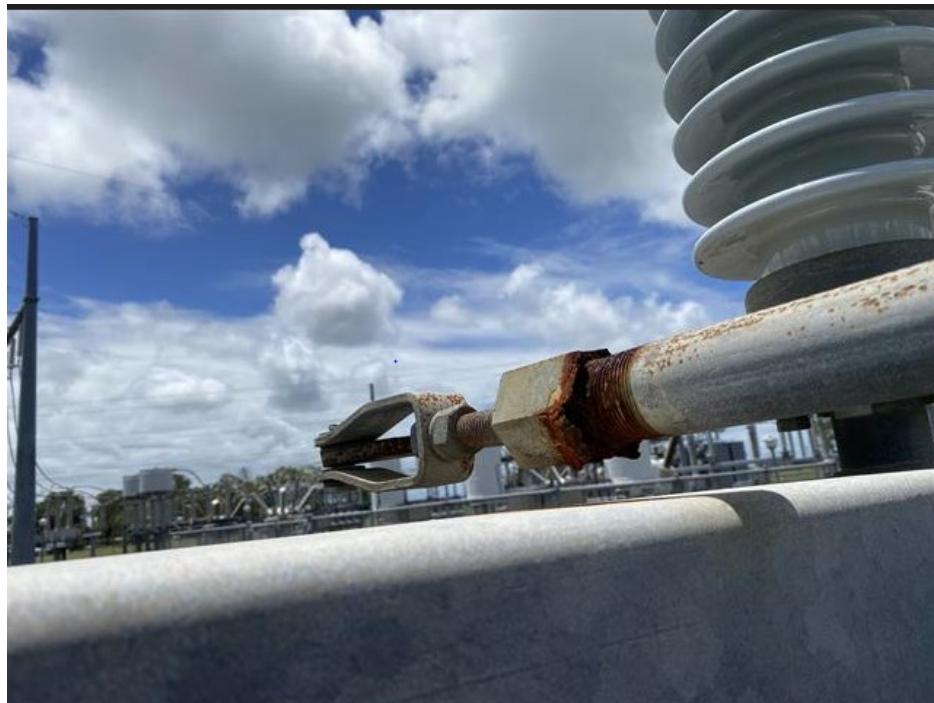
The Earth switch, manufactured by Bonar Stanger (TYPE KL), was installed in 1983 and has been in continuous operation for 42 years. In 2021, SAP records indicated the development of corrosion, specifically at the threaded linkage, as shown in Figure 24 from the SAP notification. This issue was addressed by replacing the A and C phases pivot arms in 2022 and the C phase in 2023. Currently, the fixed contact supports and guides exhibit G1 corrosion (Figure 25) and are planned to be attended to during the next planned outage in 2027.

Figure 25- Corrosion on 132kV ES 73190 Pivot arm

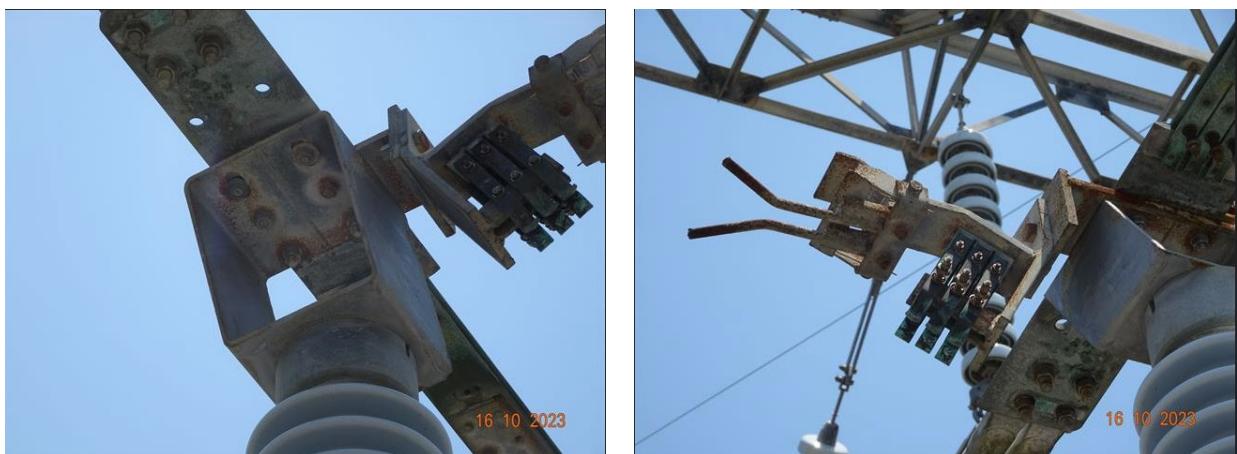
Figure 26- Corrosion on 132kV ES 73190 fixed contact supports and guides

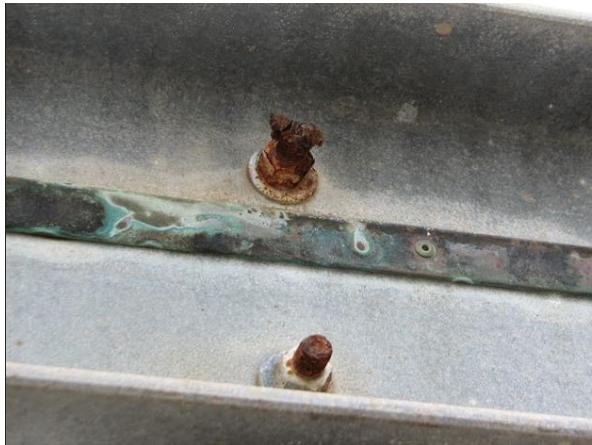
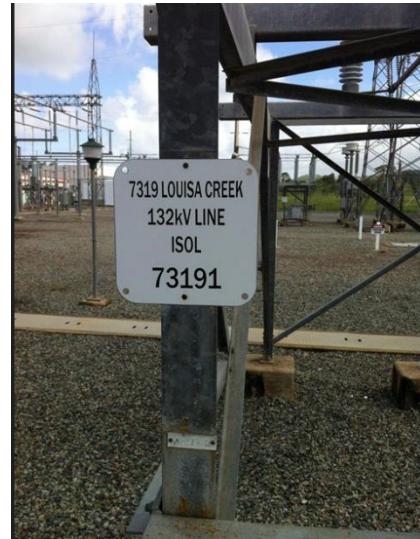
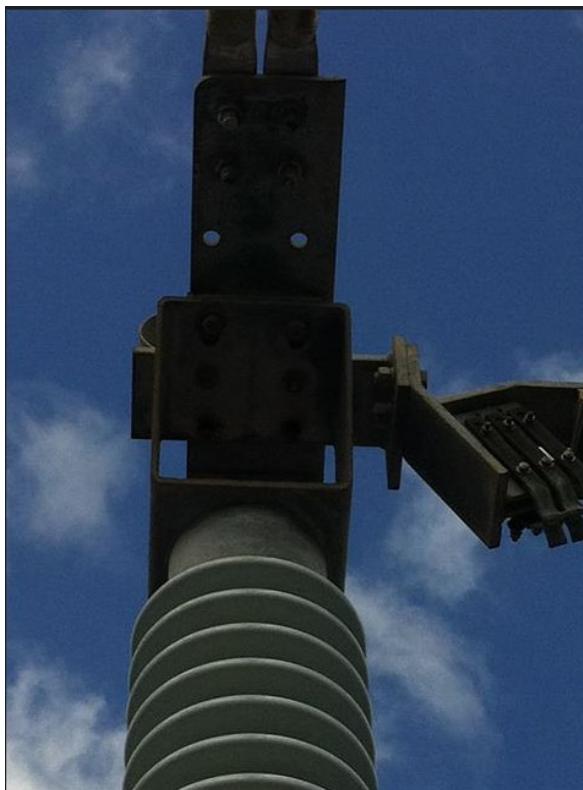
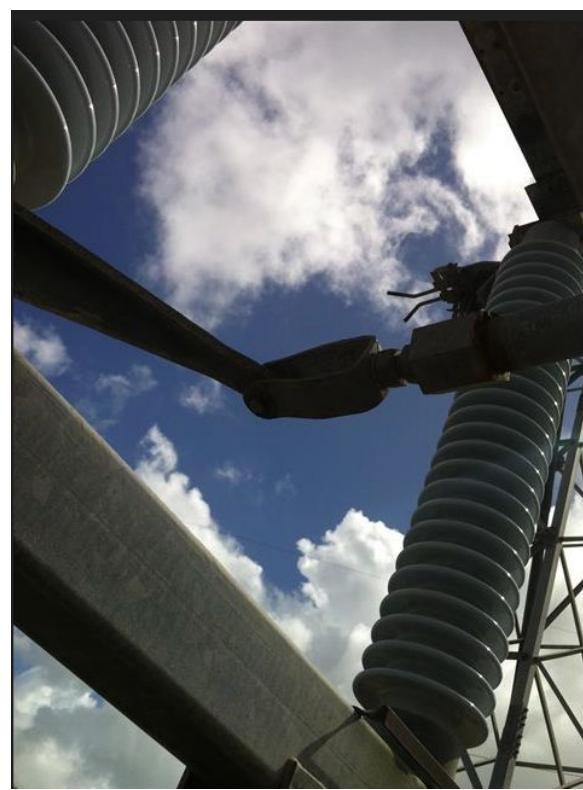
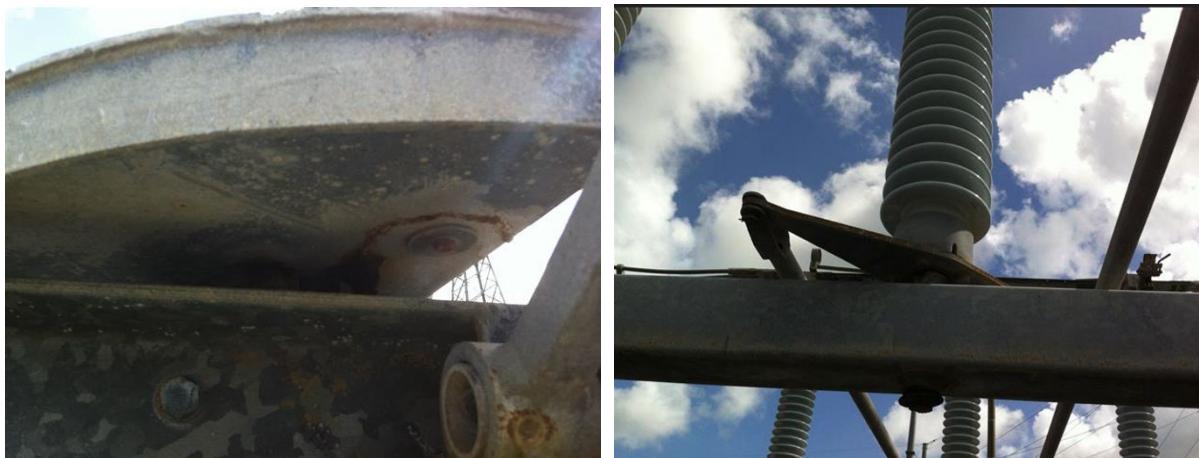
The line and bus isolators are Bonar Stager model RDB and have been in service for 42 years. Maintenance records indicate that the line isolator 73191 has experienced ongoing corrosion issues over an extended period of time. Initial concerns date back to 2013, with multiple observations noting significant rust development on bolts, pivot pins, and contact areas. Over the years, rust severity has varied, with some components requiring immediate replacement while others were monitored for gradual deterioration. In August 2023, rusted bolts and nuts,

were replaced during scheduled outage. Despite these efforts, rust remains a recurring issue, prompting continued monitoring. The next scheduled outage for comprehensive maintenance is planned for February 2027, with provisions to address severe cases beforehand if necessary.

Figure 27- Corrosion on 132kV Isolator 73191

**Although the various corrosion issues reported in the isolators and earth switch being repairable and/or replaceable components, Feeder F7319 is the only supply for Mackay Ports and Louisa Creek substations which are relatively new and expected to be required for many years. Therefore, it is recommended to replace these isolators and earth switches together with replacement of CVTs, to ensure long-term reliability of the feeder.**

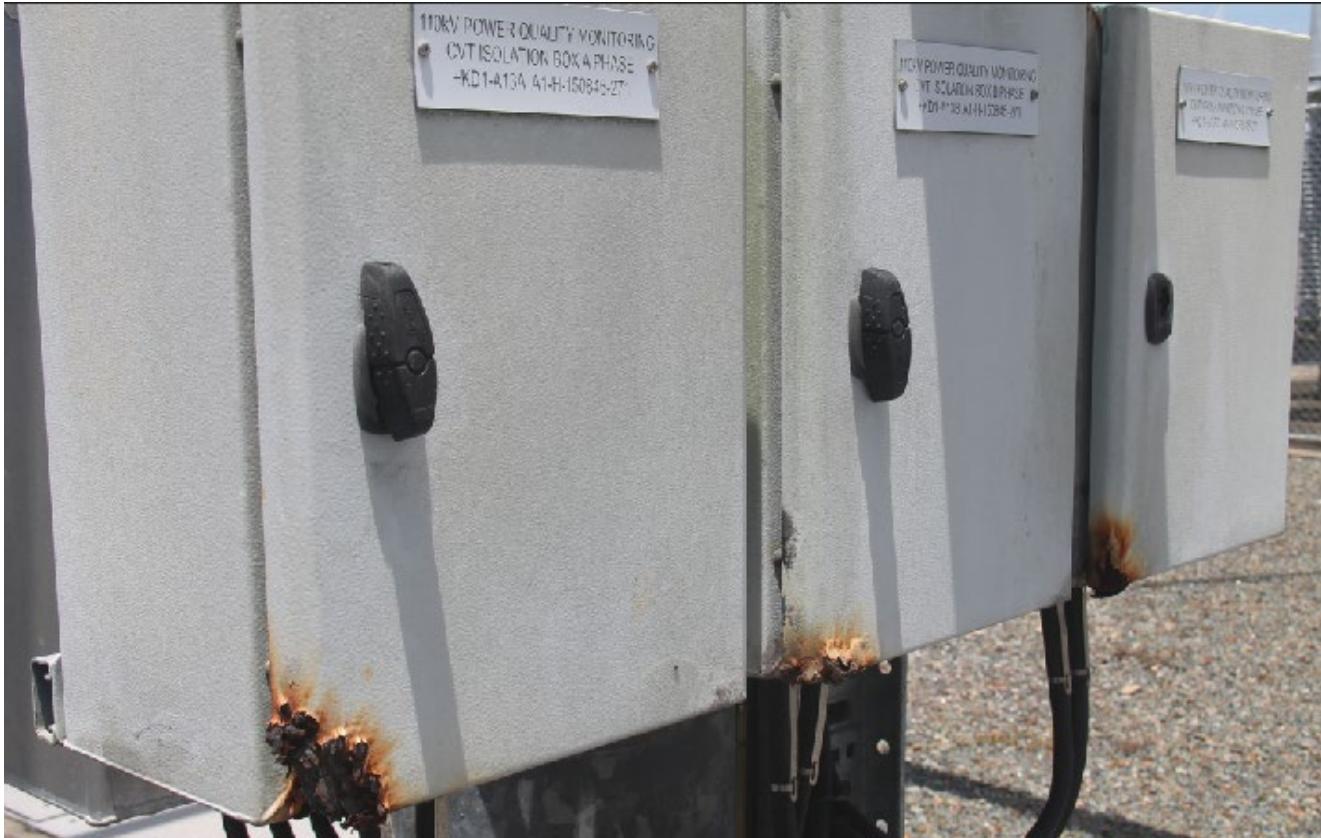
The Power Quality Monitoring isolation kiosks +KD1-A13A, –A13B and –A13C appear of a lower specification and are affected by corrosion. These kiosks shall be replaced as part of a major secondary system replacement in that bay.
