Powerlink 2027-32 Revenue Proposal

CP.02818 Woolooga to South Pine 275kV Line Refit

Transmission Line Condition Assessment Report - 2025

Built Section 1020 – South Pine - Woolooga

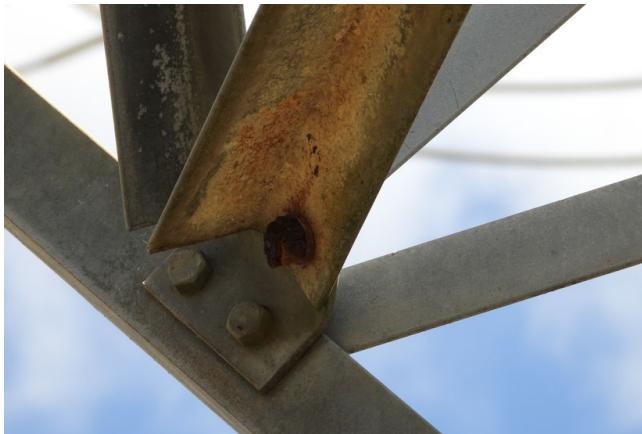
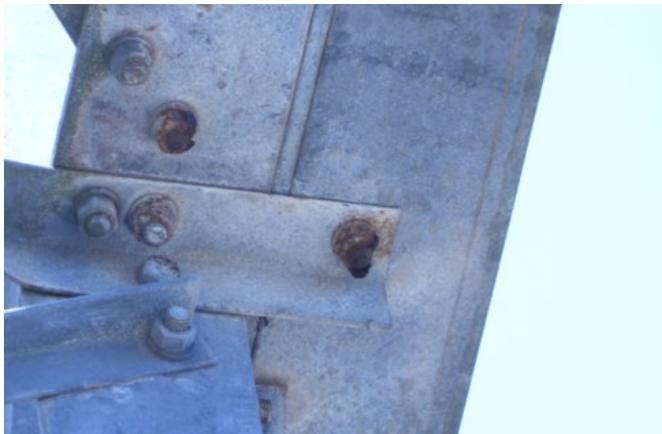
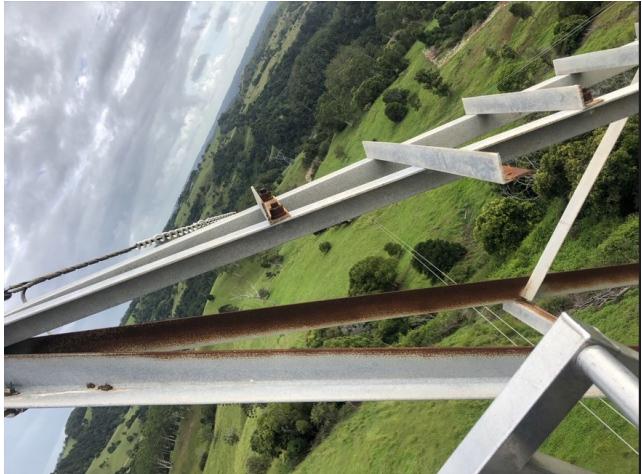
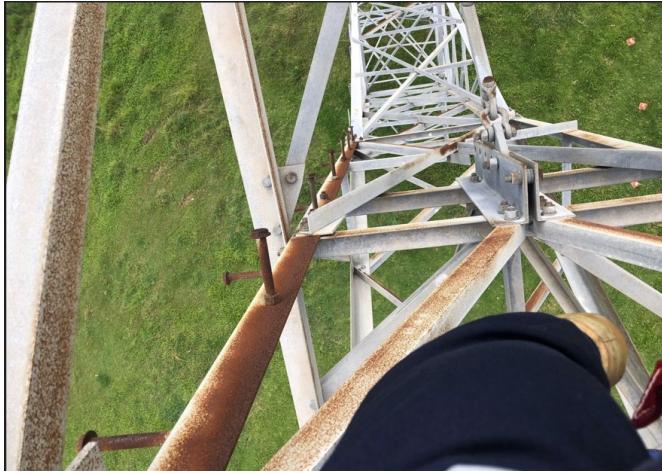
Figure 14 - Example G3/G4 Bolt and Member Corrosion

The feeder runs through varied atmospheric corrosion environments and is subject to micro-climates associated with the landscape. Most areas are classified as C2 / C3, but sections near Maleny/Montville are C4 and subject to increased corrosivity due to high rainfall and exposure to salt laden winds due to elevation. Sections near South Pine Substation experience higher corrosion at C4 levels due to their proximity to Moreton Bay, industrial pollution, and traffic emissions. As a result, many galvanised tower bolts and members in the more corrosive areas are exhibiting evidence of Grade 2 corrosion with a growing proportion classed as corrosion Grade 3 and a significant quantity of Grade 4 bolts.

- Replace tower members and fasteners with G3 corrosion and above.
- Replace OHEW and hardware exhibiting G3 corrosion and above and review OHEW fault capacity in the vicinity of South Pine substation.

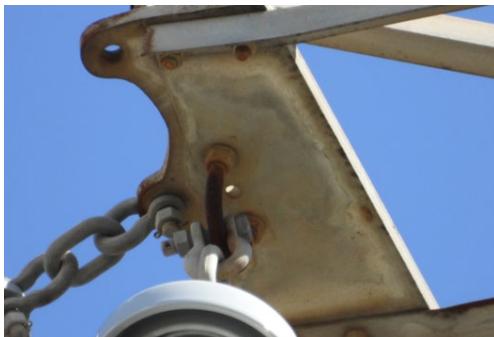
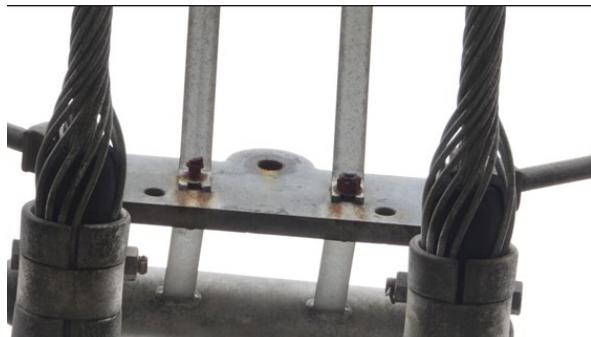
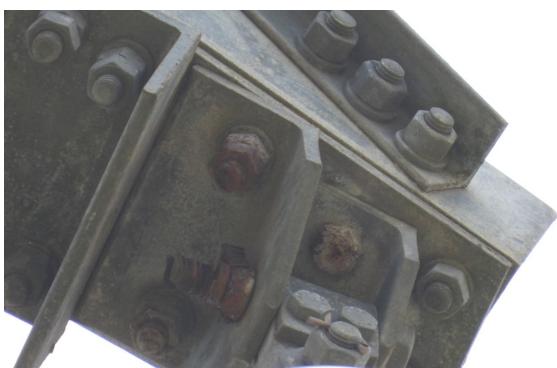
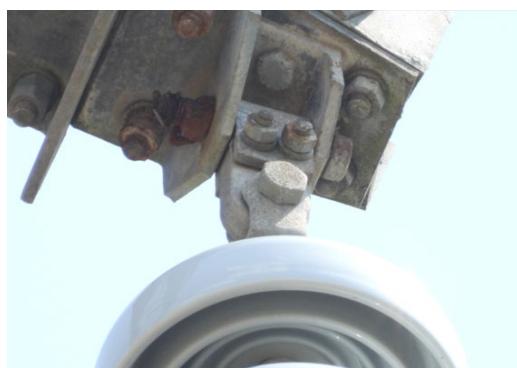
1020-STR-4303
Figure 15 – Indicative Insulator Hardware Corrosion

Most suspension and bridging insulators have been replaced however the associated hardware was not addressed when new discs were installed and is now exhibiting Grade 3 and Grade 4 corrosion. A large population of tension insulators are original to the line and Grade 3 corrosion has been reported on hot end stems and associated hardware.

Insulator String Function	Comment	Estimated Remaining Service Life (years)
Suspension	Suspension insulators have mostly been replaced, with an install date range from 2005 to 2012. As a result, all are in good condition with 4.7% G2H and 39.5% G2L corrosion observed. Suspension insulator hardware, hanger brackets and associated fastener corrosion was not addressed when new discs were installed and are now exhibiting corrosion Grade 3 and Grade 4.	Suspension insulators appear ok. Estimated service life of 6 years on original hardware.
Tension	A small number of tension insulators have been replaced however the majority are original to the line. Grade 3 corrosion has been observed on tension insulators hot end stems and hardware.	Original tension Insulators and hardware have an estimated service life of 6 years.
Bridging	Under OR.01735, most bridging strings were replaced in 2015. Remaining original bridging insulators and hardware are typically Grade 2 and low Grade 3 and will require replacement in the medium term. Photos indicate cold end bridging hardware at high Grade 3 levels.	Bridging insulators and hardware original to the line have an estimated service life 20 years.

- Replace remaining insulators original to the line and original hardware exhibiting G3 corrosion and above.
- Review tower earthing against AS7000 classification, install grading rings as required, resolve any high earth resistances to target maintenance values and perform a detailed engineering analysis of any identified high-risk locations that have not been resolved in accordance with the specifications.

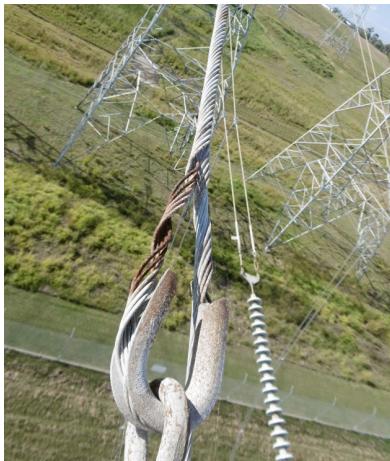
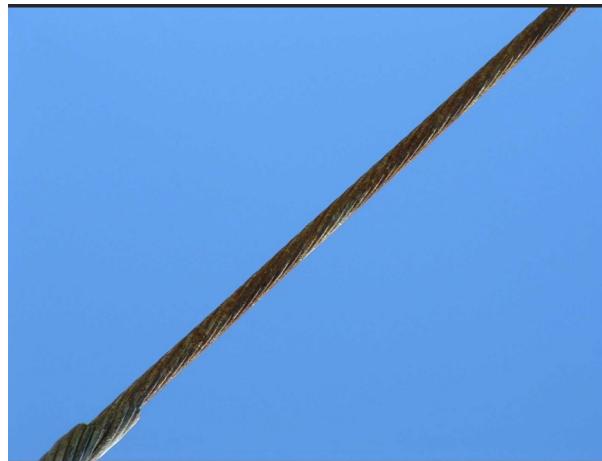
Figure 17 - Indicative OHEW Corrosion

Overhead Earthwire and hardware corrosion has also been observed at Grade 3 and Grade 4 levels in the corrosive environments out of South Pine Substation and the Sunshine Coast Hinterland. Earth wire fault capacity has been assessed and is also a driver for replacement at the South Pine Substation end of the feeder.

Preliminary calculations indicate that fault capacity the Overhead Earthwire at the South Pine Substation end of the feeder is under rated based on 2024 substation fault levels. Advanced corrosion on the earthwire conductor and associated hardware has also been observed in this section of the line.

Component	Installation Year	Comment	Estimated Remaining Service Life (years)
OHEW	1972	SC/GZ/I_19/2.03	3 - 8
OHEW Dampers	1995-2002	Spiral	Replace on condition or with conductor

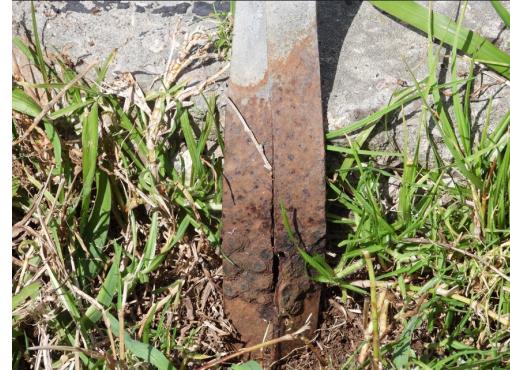
1020-STR-4161
Figure 18 - Indicative earthing strap condition
Table 3 - AS7000 Classification - Grading Ring Status

AS7000 Structure Earthing Classification	Grading Ring Installed	Grading Ring Not Installed
Urban	5	10
Aquatic		1
Backyard	1	3
Remote	32	304
In Substation		2
Grand Total	38	320
