| | A | B | C | D | E | F | G | H | I |
|---|---|---|---|---|---|---|---|---|---|
| 1 | 3.3(a) - STPIS Exclusions | | | | | | | | |

3.3(a) - STPIS Exclusions

### 3.3(a) - STPIIS Exclusions

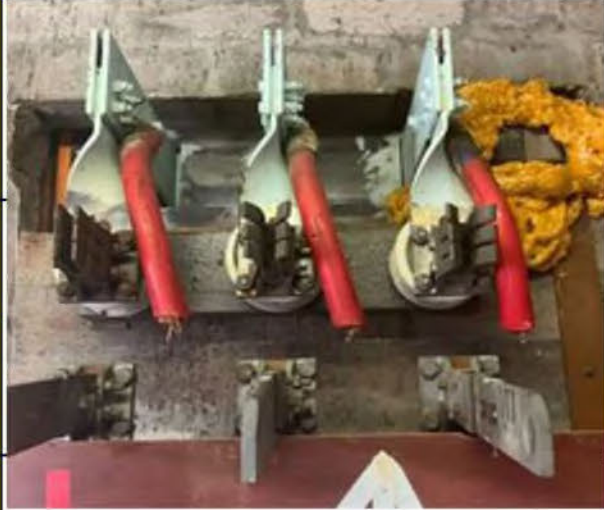
| | J | K | L | M |
|---|---|---|---|---|
| 21 | Vandalism | Vandalism of Endeavour Energy's equipment causes an interruption when it impacts on the safe operation of the network or a member of the public is at risk while undertaking vandalism. e incidents are excluded because Endeavour Energy has an obligation under the Electricity Supply Act 1995 (NSW) in section 52 for "A network operator or retailer may interrupt the supply of electricity ... for such other purpose as the network operator or retailer considers necessary for the safe and efficient operation", in this circumstance the interruption is directly linked to members of the public at risk due to the impacts to safety mechanisms by vandalism or because they are on or near the network | Theft of copper consumer mains. Network isolated for customer to perform repairs - see photo | |

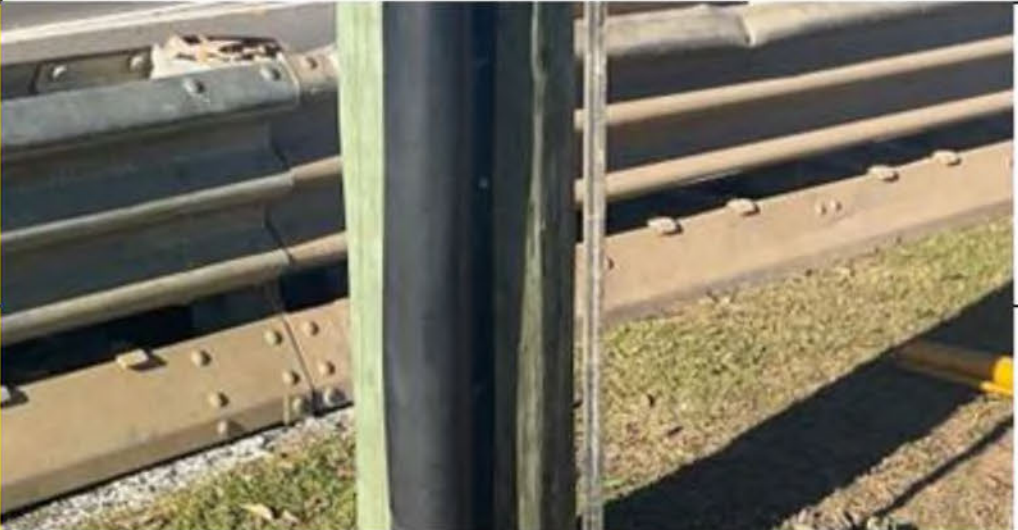
| | J | K | L | M |
|---|---|---|---|---|
| 32 | Excavation Damage | When a member of the public excavates around or into live cables Endeavour Energy will isolate the network (typically with protections schemes or proactively if notified prior to a cable being compromised) in order to minimise injury to the operator and protect the plant. This isolation is considered to be excluded because a member of the public is directly at risk of electrocution in the event of contacting cables during excavation and Endeavour Energy has an obligation under the Electricity Supply (Safety and network Management) regulation which requires Endeavour Energy implement a safety management system with the objective of maintaining "the safety of members of the public" which are directly at risk in this scenario | Civil contractors damage HV cable by driving in star stake. See photo on right | |

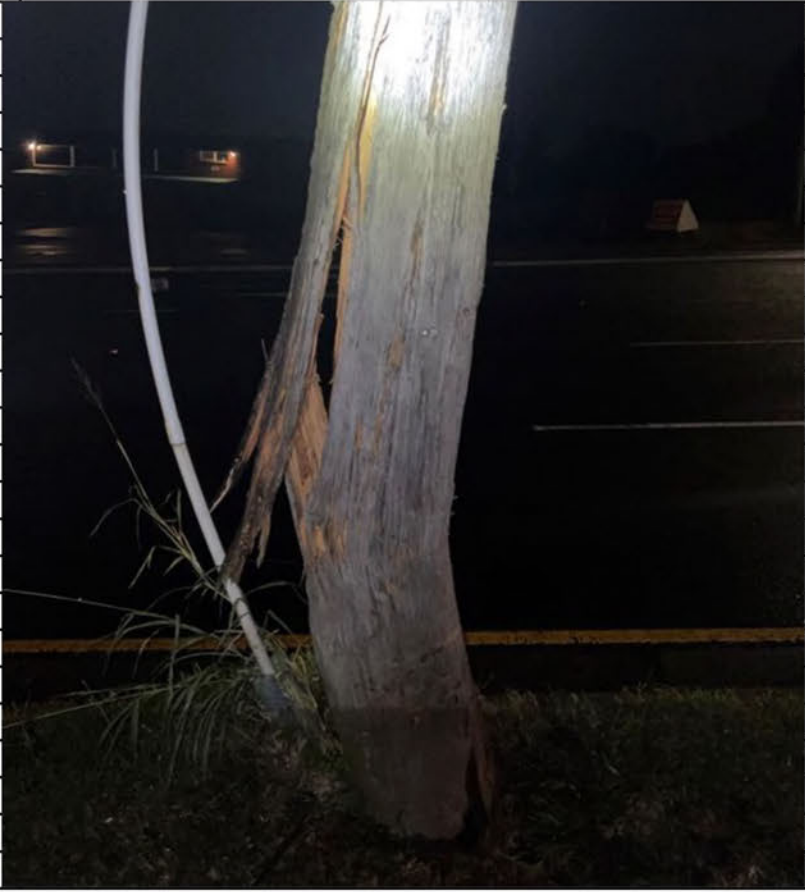
| | J | K | L | M |
|---|---|---|---|---|
| 33 | Vehicle Impact | When a vehicle impacts a pole/column/pillar it compromises the integrity of the structure and the safe clearances it provides to the public. In this scenario protection would typically operate to interrupt the network to maintain the safety of the member of the public driving the vehicle who encroached on safe clearances with the network. This is excluded interruption because Endeavour Energy has an obligation under the Electricity Supply (Safety and network Management) regulation which requires Endeavour Energy implement a safety management system with the objective of maintaining "the safety of members of the public". In this scenario protection would power would be restored when the site is made safe and any relevant investigations are undertaken | Car hit and snapped pole, outage required to replace pole. See photo below | |
