# Overview of 2019-20 Bushfire Damage to TransGrid's Network

Cost pass through application for 2019-20 Bushfire  
season event

13 November 2020

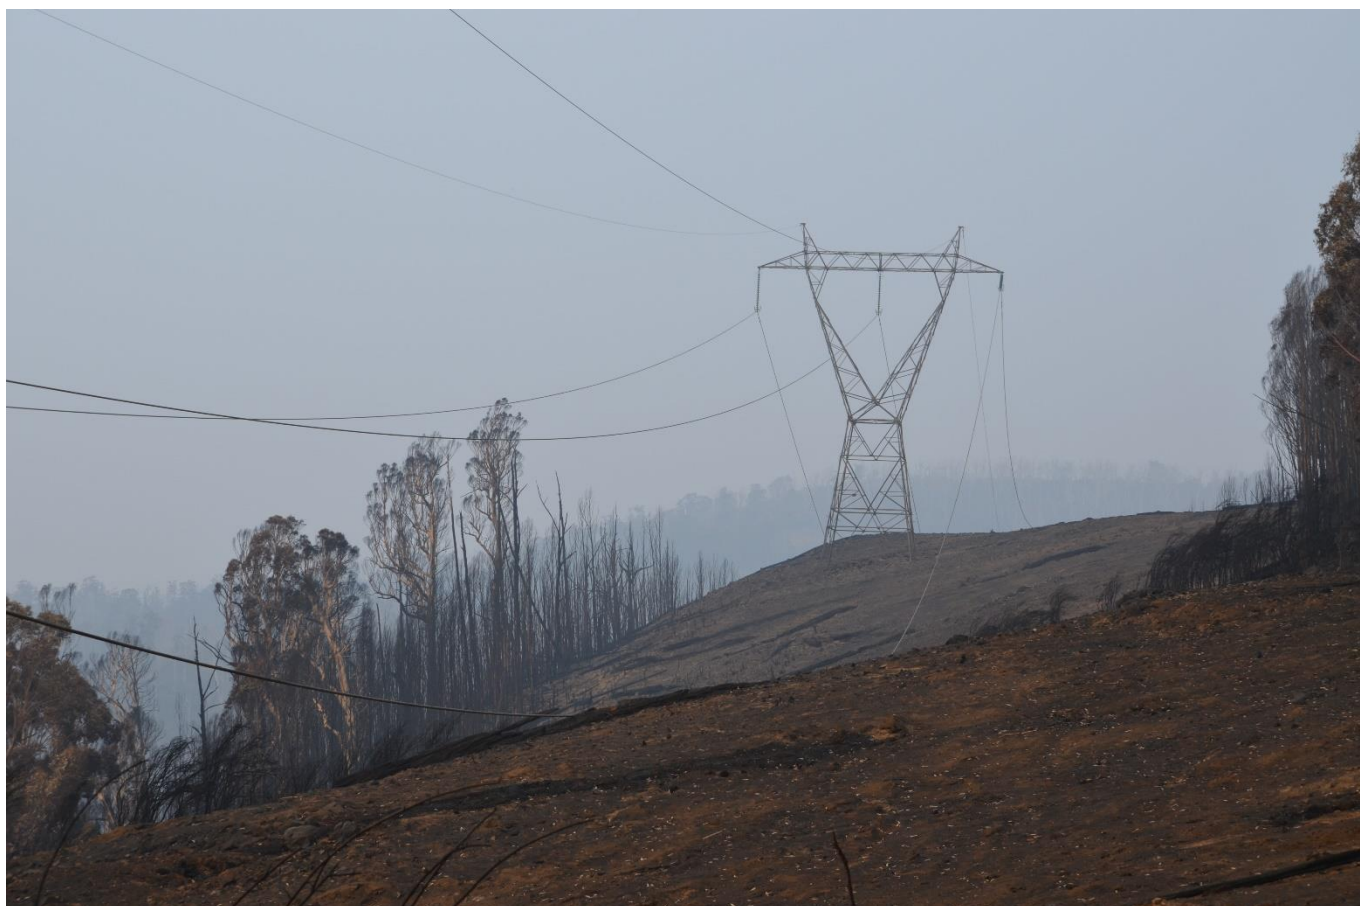
On 8 January 2020 TransGrid received advice from Snowy Hydro of dispatch problems and a possible line fault. A helicopter was dispatched and confirmed that conductors were down between structures 11 and 12 on 330 kV line U3. TransGrid's easement contractor worked throughout the day clearing safe access to the site. The site was accessed from the ground in the late afternoon to assess the extent of damage and prepare to make safe. Extensive damage to the aluminium conductor was found, with much of it melted and one phase with conductor separation.

**Figure 9 – Line U3 Dropped conductor on ground**

Extensive access works were required to be able to perform the repair works. The conductor used on this transmission line is also a size and aluminium alloy which is no longer available from suppliers as a standard. A special order for the conductor size of a similar alloy was placed but had a significant lead time and as such a temporary conductor was strung to replace the damaged conductor and return the transmission line to service on 14 April 2020. The temporary conductor is a different size and alloy to what is required for the ongoing operation of the transmission line.

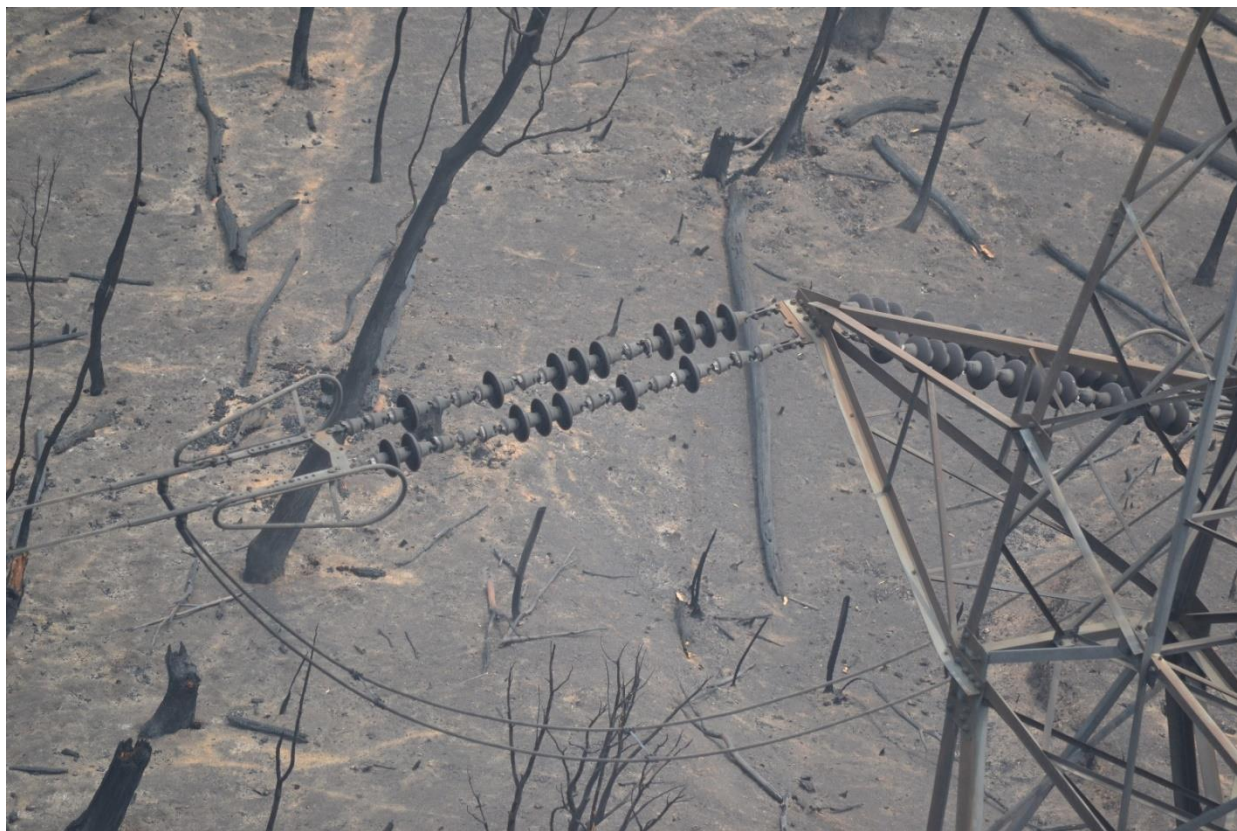
Several structures (three tension, three suspension) were found to have multiple damaged and broken insulators.

The response required safety considerations including risk of falling trees due to heavy timber cover and side-slope, EWP access, climbing towers and added complexity of insulator replacement on tension structures. Restoration was restricted by heavy smoke, with stand-downs required for worker safety and access issues caused by rain. A “skidder” was kept on standby to clear debris and recover vehicles if needed. TransGrid’s vegetation management contractor worked during these repairs to clear the access tracks

Figure 11 – Line 2 Damaged Insulators

The insulators were replaced and the line was returned to service on 26 January 2020.

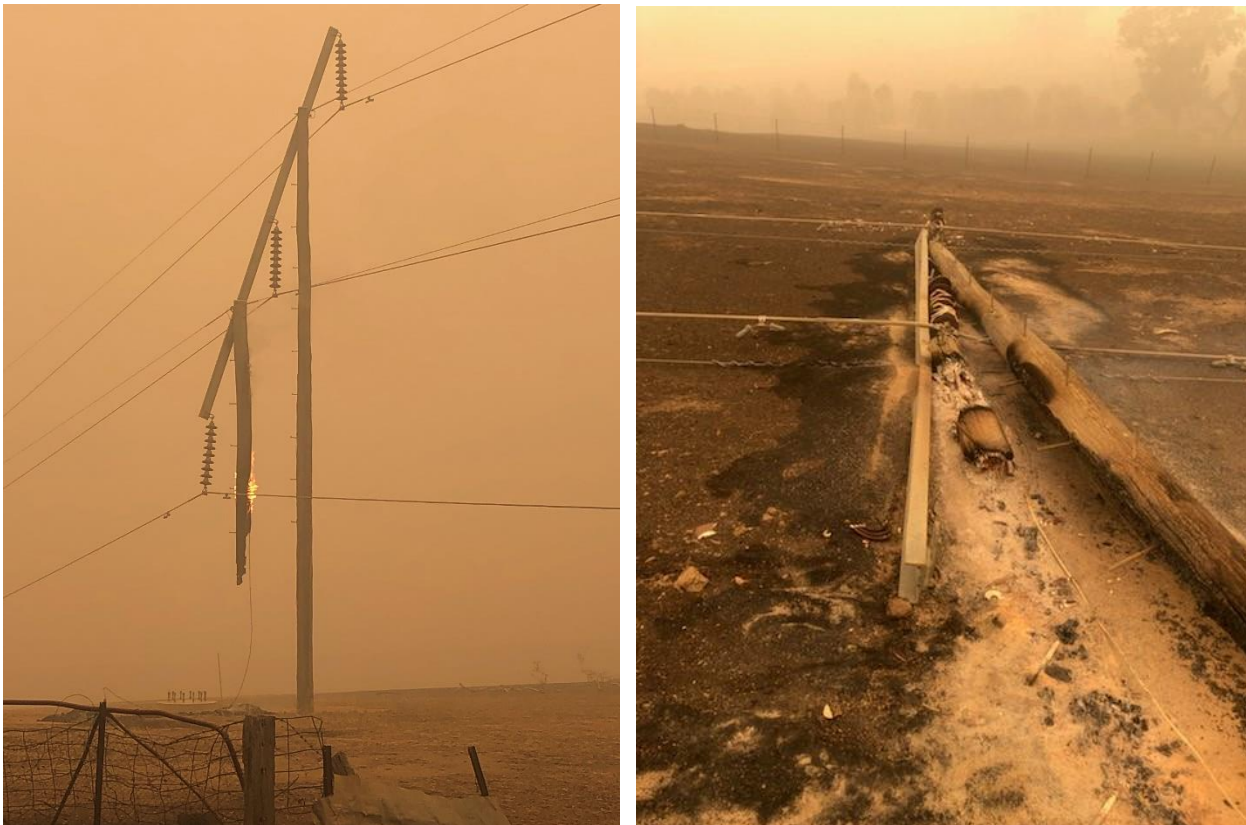
On 4 January 2020 Line 993 faulted in the system separation event with Victoria. The line was unable to be restored during the restoration. The line was subsequently patrolled on 5 January 2020 which found five structures were significantly damaged by the Dunns Road fire.

The damage at structure 85 resulted in downed lines over the Snowy Mountains Highway between Adelong and the Hume Highway. TransGrid undertook urgent temporary repairs to facilitate safe use of the highway being used by the RFS. These repairs included, cutting the conductor and moving away, earthing and making safe to enable the highway to reopen.

Figure 13 – Line 993 Wood Pole Damage

This line was undergoing a line rebuild in the lead up to the bushfires, where all wood pole structures were being replaced with steel poles and one of two earthwires being replaced with OPGW. The foundations for these structures had already been poured. The construction contractor was called to site to replace the remaining damaged structures with the steel poles planned in the project. Some incremental costs due to bushfire damage were incurred by TransGrid due to disruption to the planned project works.

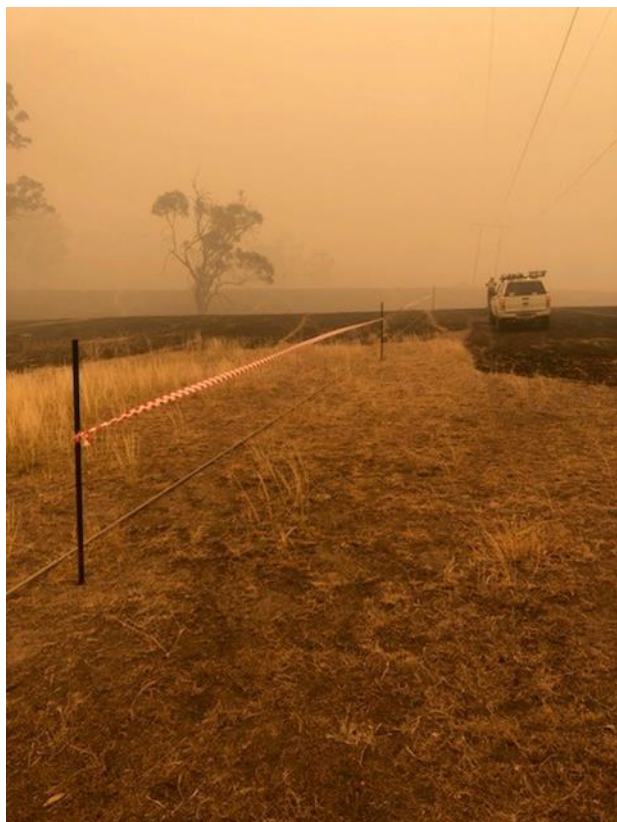
The conductor was also damaged and broken with all there phases requiring restringing between structures 65 to 82, a route length of 5.5 km.

**Figure 14 - Line 993 Failed Conductor on Ground**

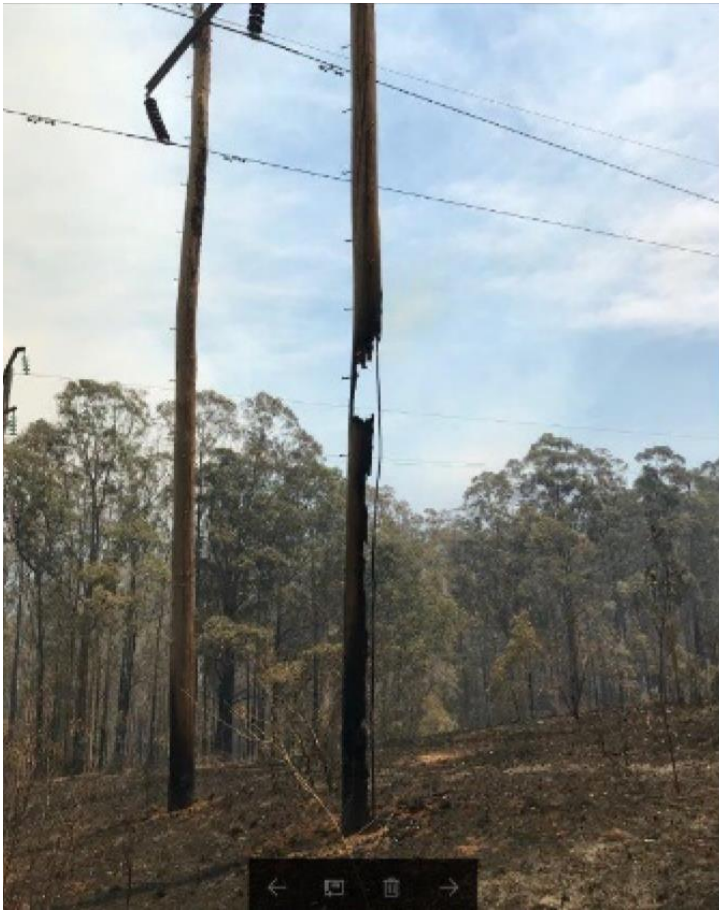
Figure 15 – Line 963 Wood Pole Damage

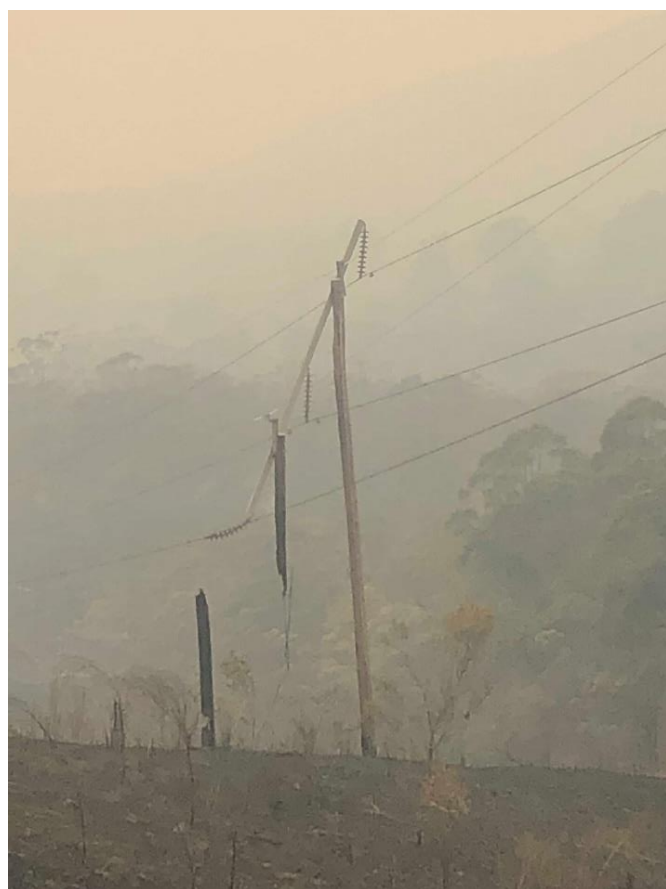
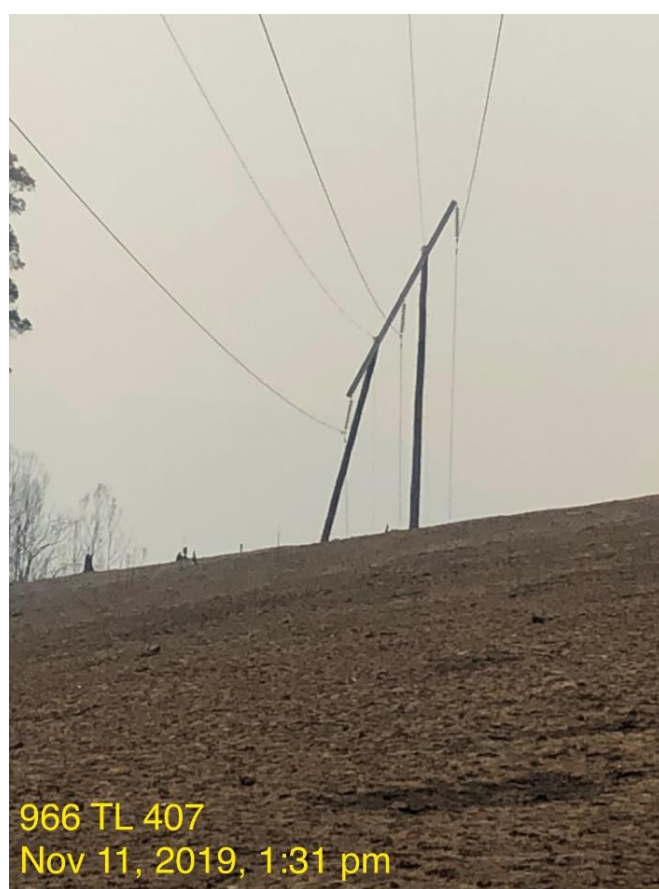
Line 966 was impacted by the Liberation Trail Fire. Multiple fault outages occurred on 8 November 2019. Six structures required replacement to restore the transmission line. Active fires prevented immediate access to all structures. Some access clearing and construction of equipment pads were required. The six structures were restored and the line returned to service on 17 November 2019.

Figure 17 – Line 966 Structures

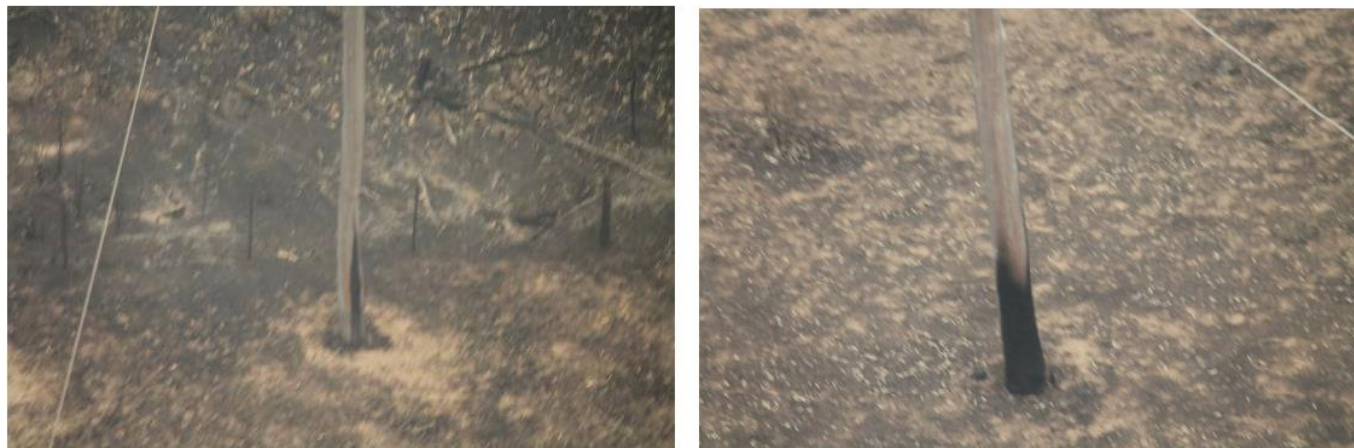
Line 965 was impacted by the Warm Crossing, Carrai Creek and Carri East fires. On 10 November 2019 TransGrid received notification that the base of one pole of a two-pole structure was 50% burned through. Due to all the other line outages and fires in the area, TransGrid decided to keep the line in service with auto reclose disabled. This pole was replaced on 18 November 2019.

**Figure 18 – Aerial patrol Line 965**

At the time of this replacement the next structure was found with fire damage and chunks taken out at ground line. It was replaced 31 January 2020.

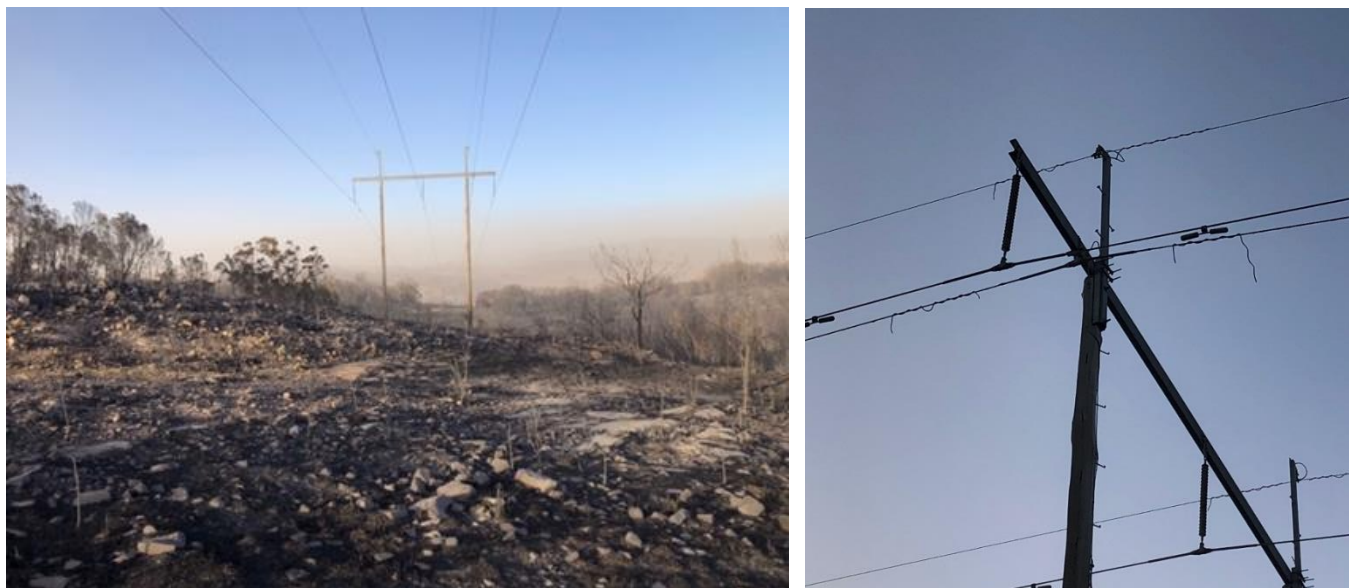
**Figure 21 – Line 96R Fire Impact**

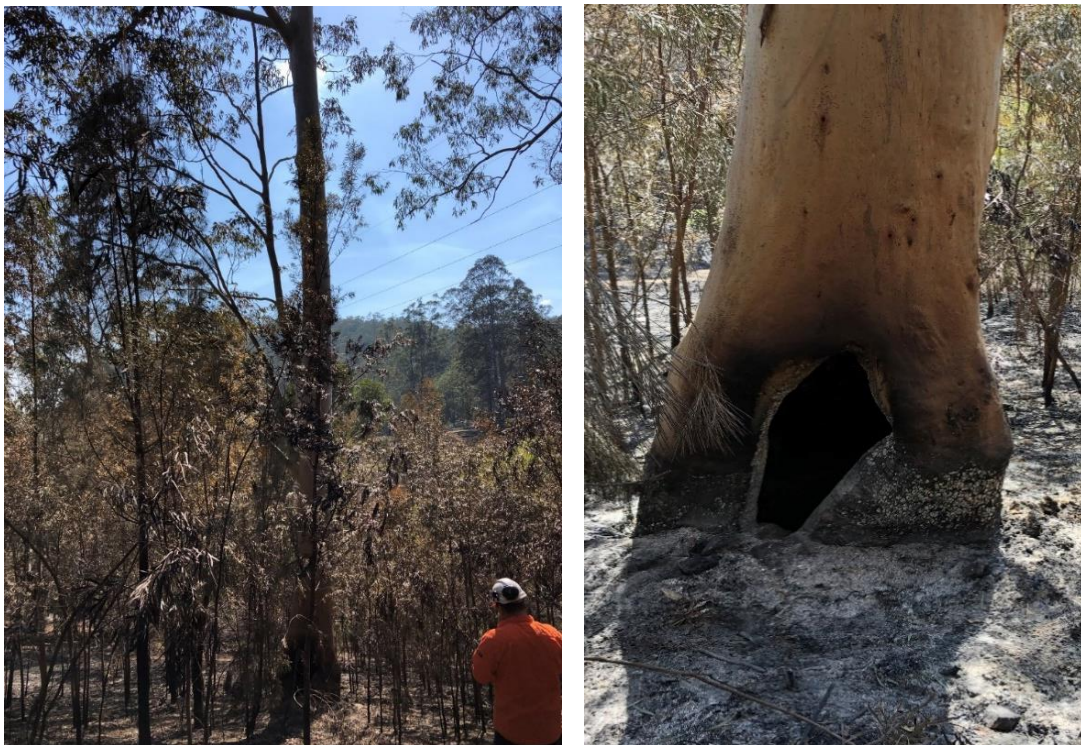
Figure 22 – Fire damaged hazard tree threatening transmission line

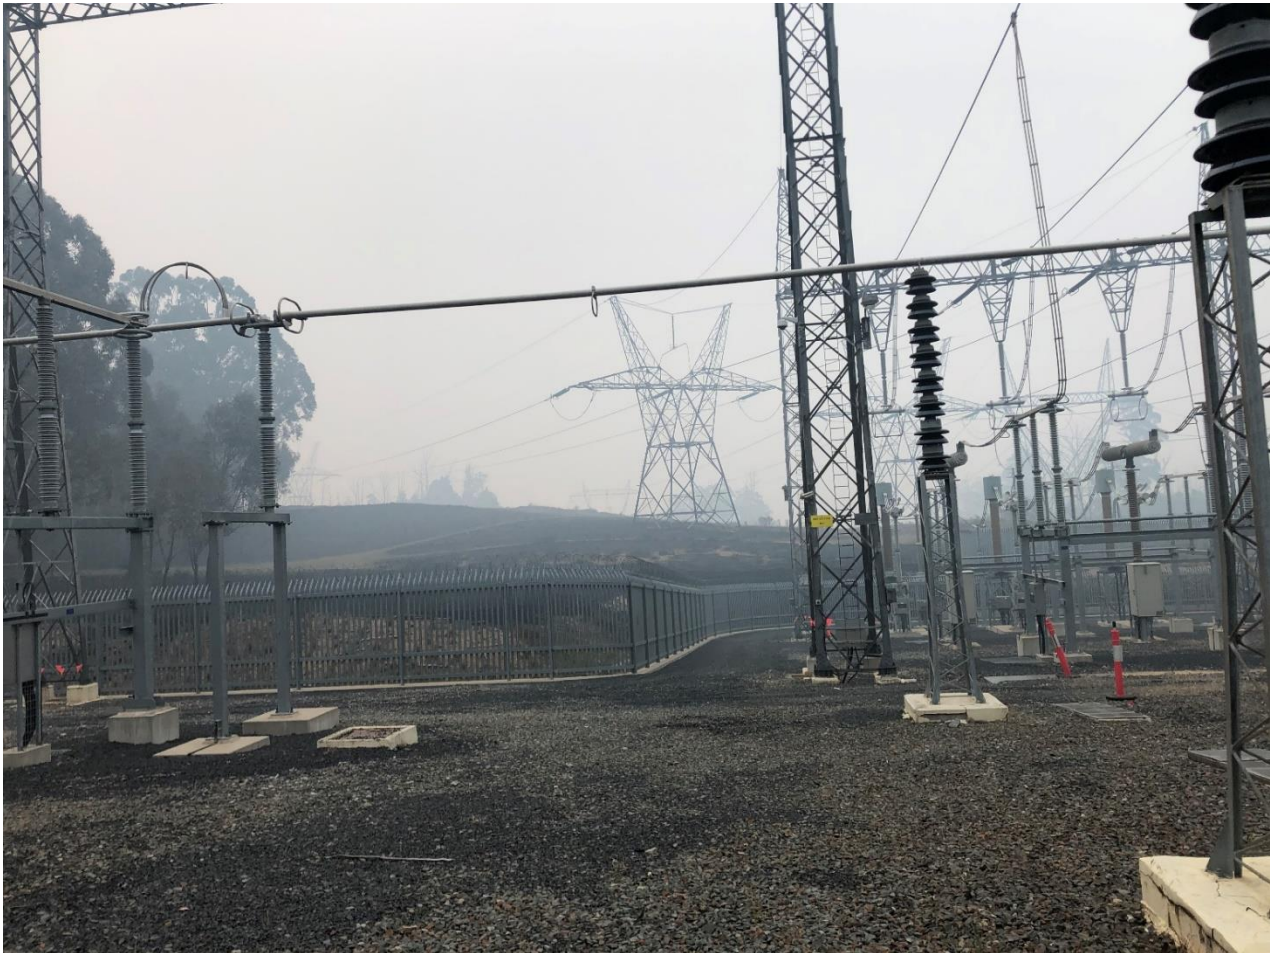
Bushfires damage to Essential Energy and Snowy Hydro assets in the region caused loss of external AC auxiliary supply to Upper Tumut Switching Station and the Snowy Hydro control room, resulting in sites run on batteries and local backup diesel generation (which is as designed). Additional follow up inspections and testing are ongoing to confirm any further asset damage due to smoke or heat, but these are not expected to identify anything significant, apart from burnt-out access stairs which required replacement.

Figure 23 – Upper Tumut Switching Station – Fires burnt to boundary

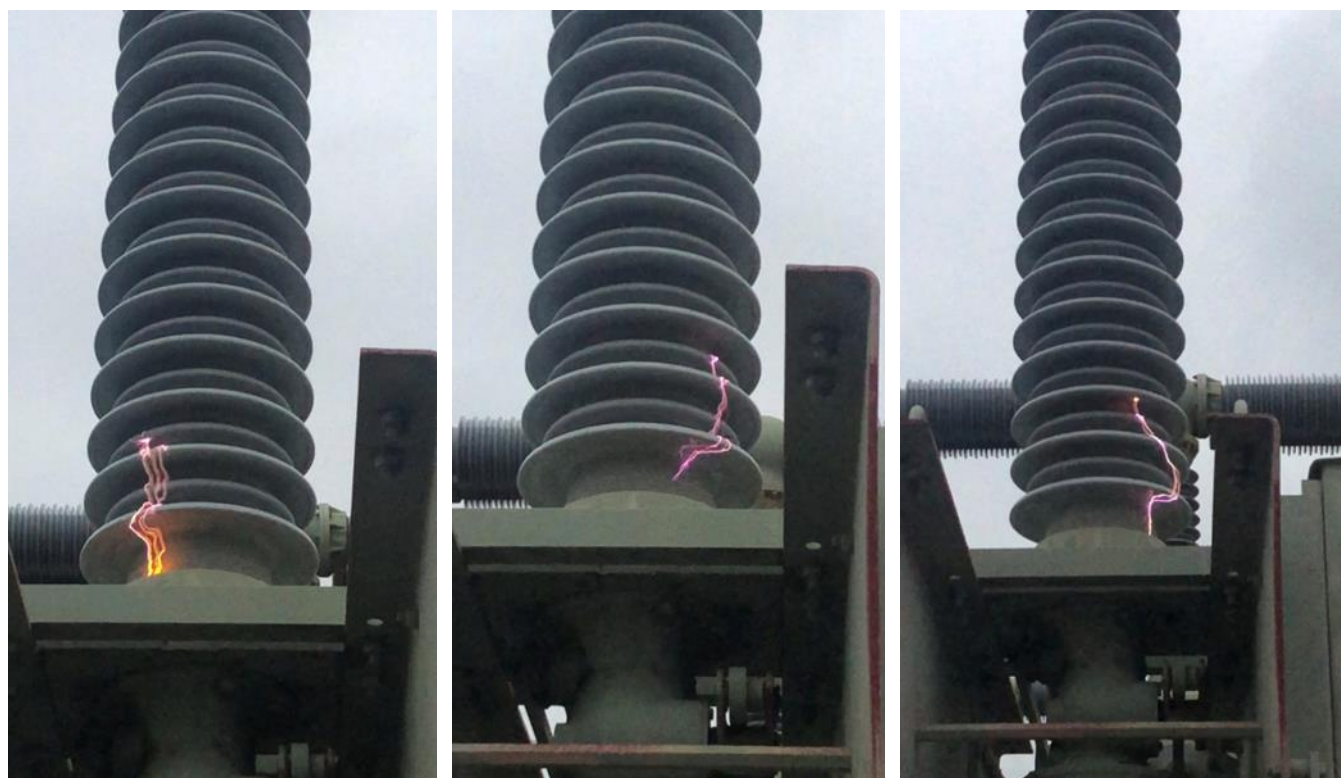
Insulator washing was considered and deemed not necessary. TransGrid nominated sites for inspections to determine the extent of pollution-related discharge activity while monitoring the impact of rain providing natural washing. Localised rain activity in January 2020 followed by extensive rainfall across the state in February 2020 resulted in sufficient washing of insulator pollution, with reports from site inspections identifying discharge activity was back at normal levels.

Figure 24 – Tracking on CB insulators at Munmorah Substation

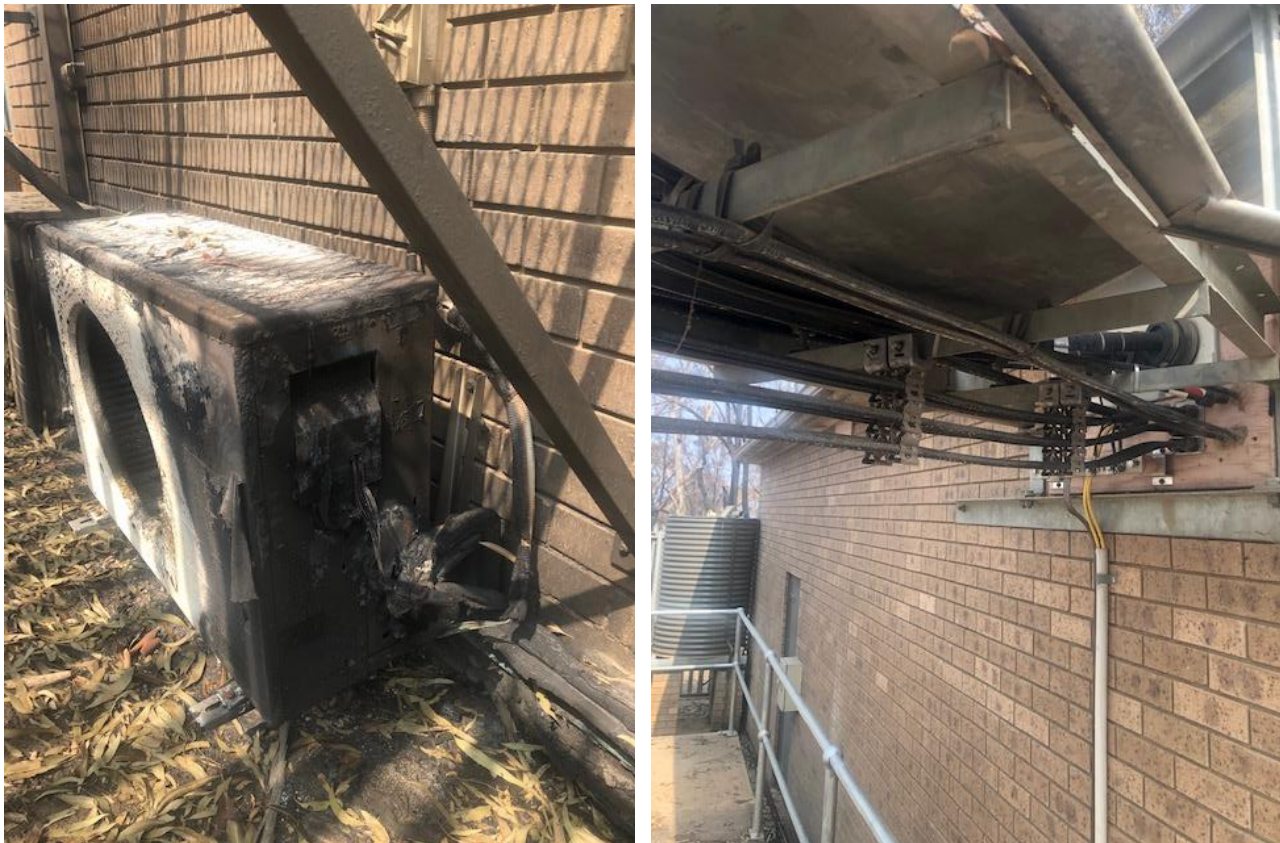
Snubba Radio Repeater Site (RRS) was impacted by the bushfires. The 415 V supply to the site was interrupted and damage to the air conditioning unit, building guttering and tower cable was evident. Several diesel generators were mobilised to Snubba RRS whilst Essential Energy repaired the mains supply.

Figure 25 - Snubba RRS damage

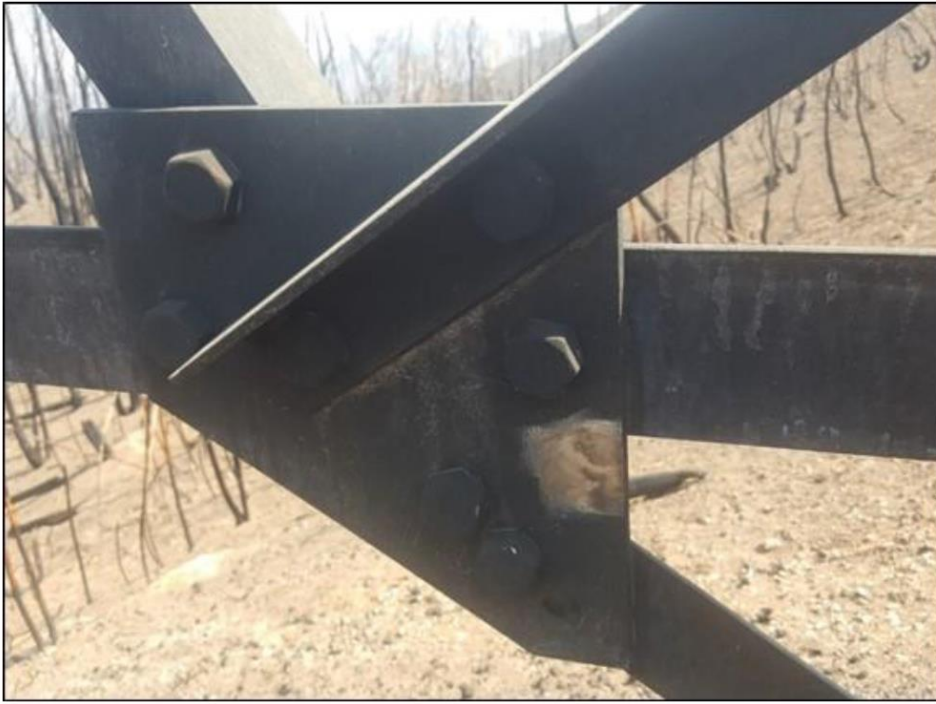
Figure 26 – Tower gusset plate with blackened appearance on Line 2

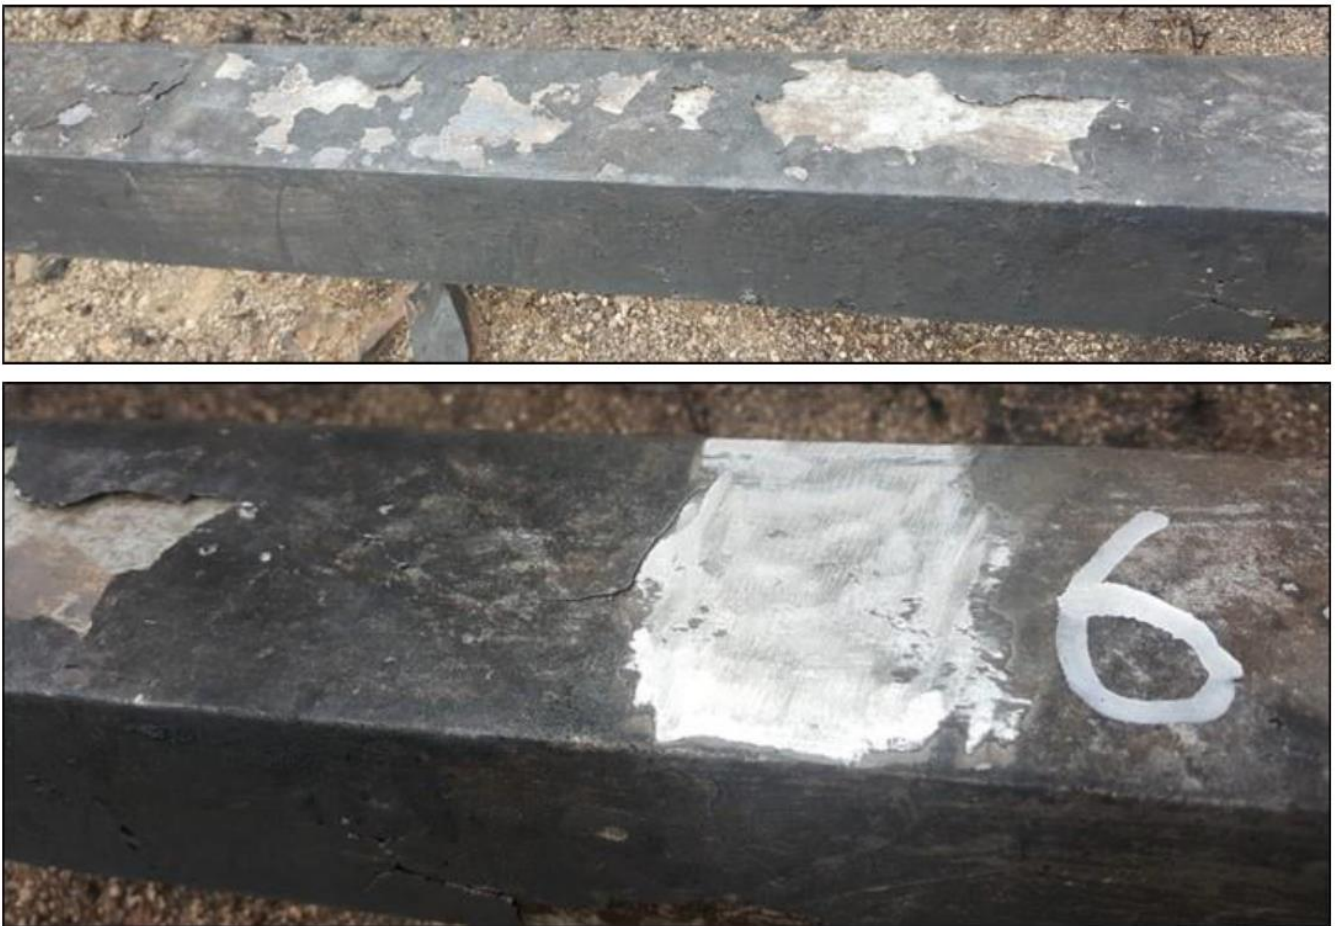
Figure 27 – Flaking of galvanising on the surface of a structure on Line U3

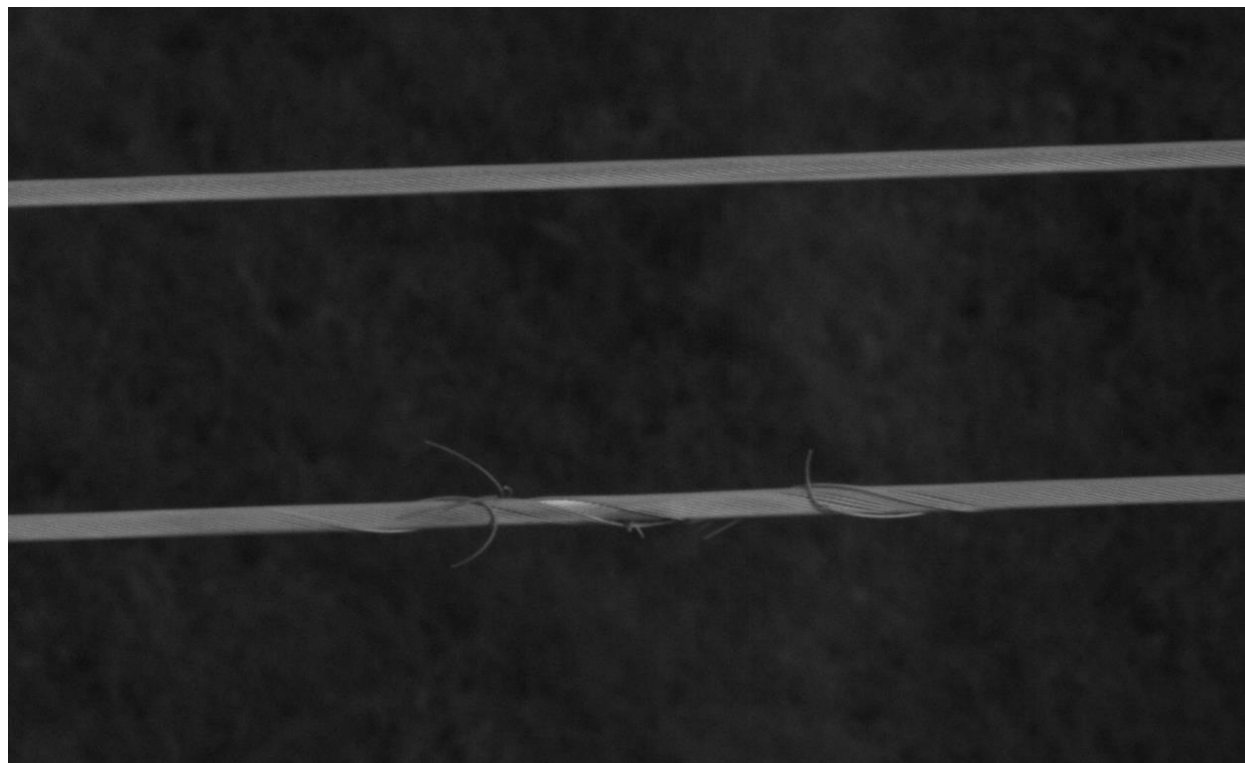
SAIP was successful in identifying significant defects that were not picked up on the aerial inspections. No significant conductor damage was noted on [REDACTED] by the visual inspection from air; all bar [REDACTED] had defects identified in SAIP that require remediation in the short term.

Figure 31 – SAIP Image on [REDACTED]. Initial visual inspection noted no significant conductor issues.

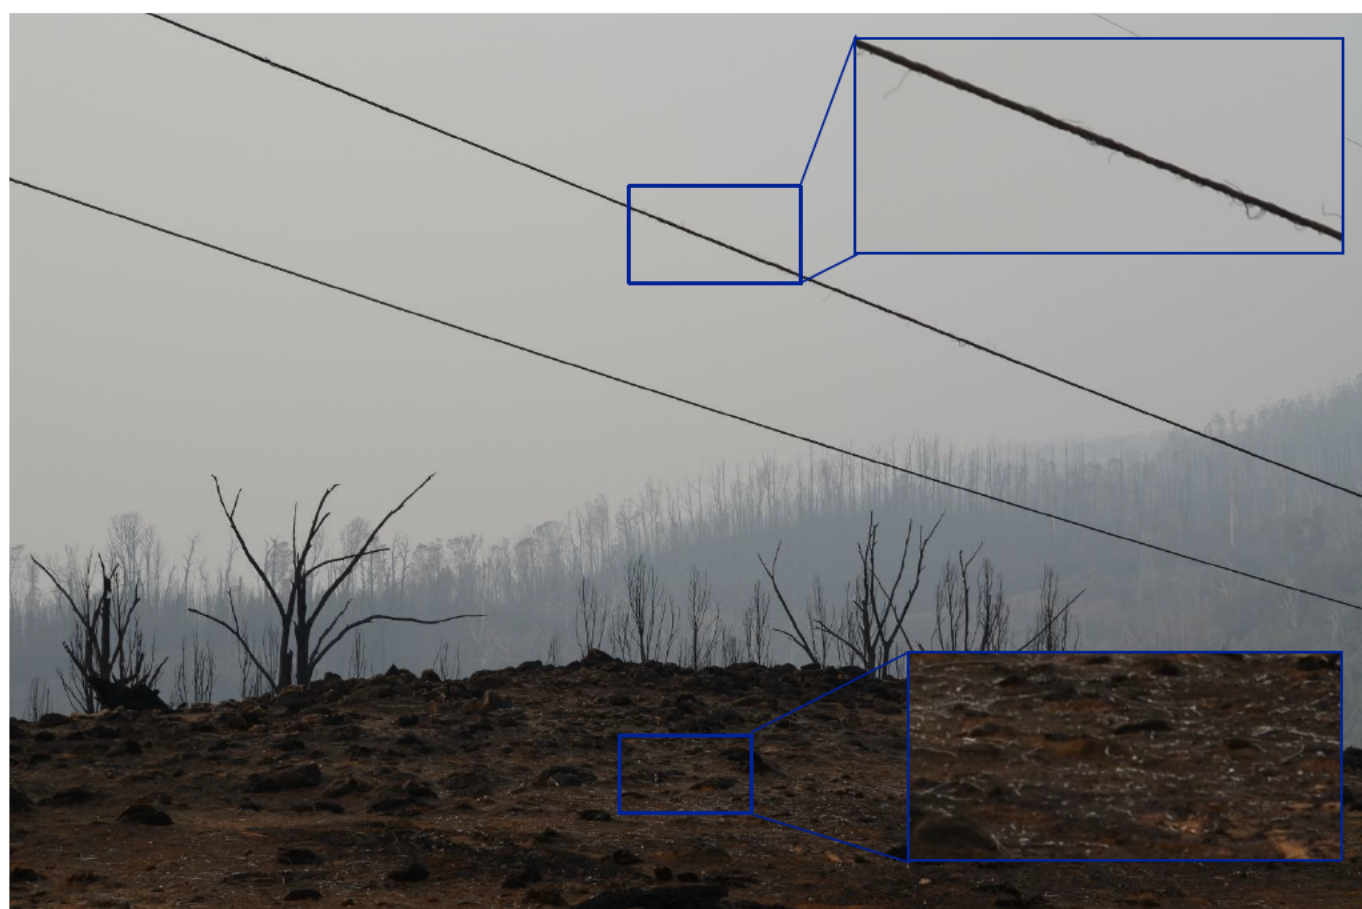
Extensive conductor damage had been identified in the Snowy Mountains region where the bushfires were most intense. There is evidence of conductor temperatures exceeding 645°C, with extensive conductor damage observed and what was molten aluminium on the ground below the conductor.

**Figure 33 - Extensive conductor damage with melted aluminium**

Priorities for remediation have been allocated in line with the maintenance plan, however, the extent of damage and outage constraints on key power transfer paths between Victoria, Snowy and NSW regions means it will take multiple years to remediate the damage. Remediation will be prioritised based on extent of the damage and criticality, and the condition will be monitored. Operational controls are being implemented for summer 2020-21 to monitor conductor temperatures to prevent asset failure. Further mitigations, such as de-rating transmission lines until the damage is remediated, may be required to manage short term risk of failure.

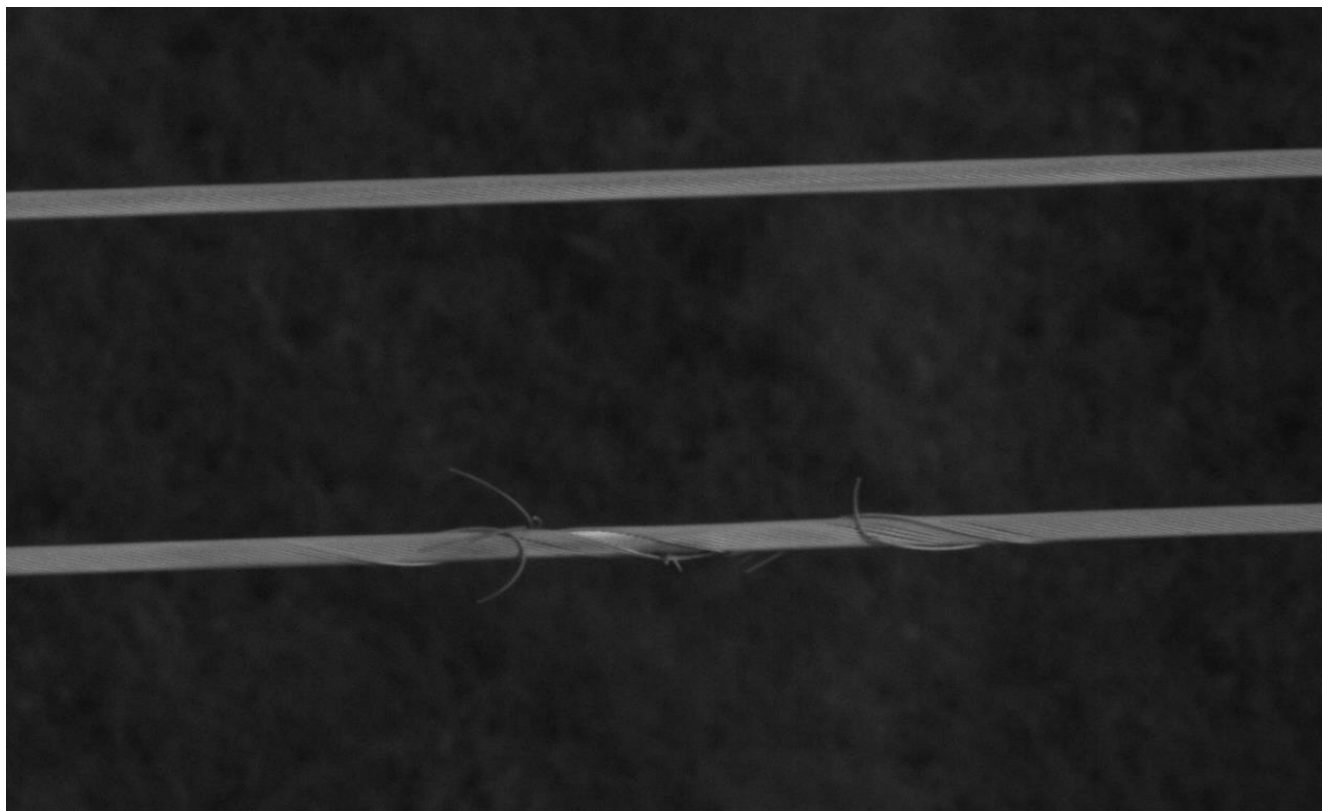
Figure 35 – Conductor damage example on ACSR conductor [REDACTED] identified in SAIP

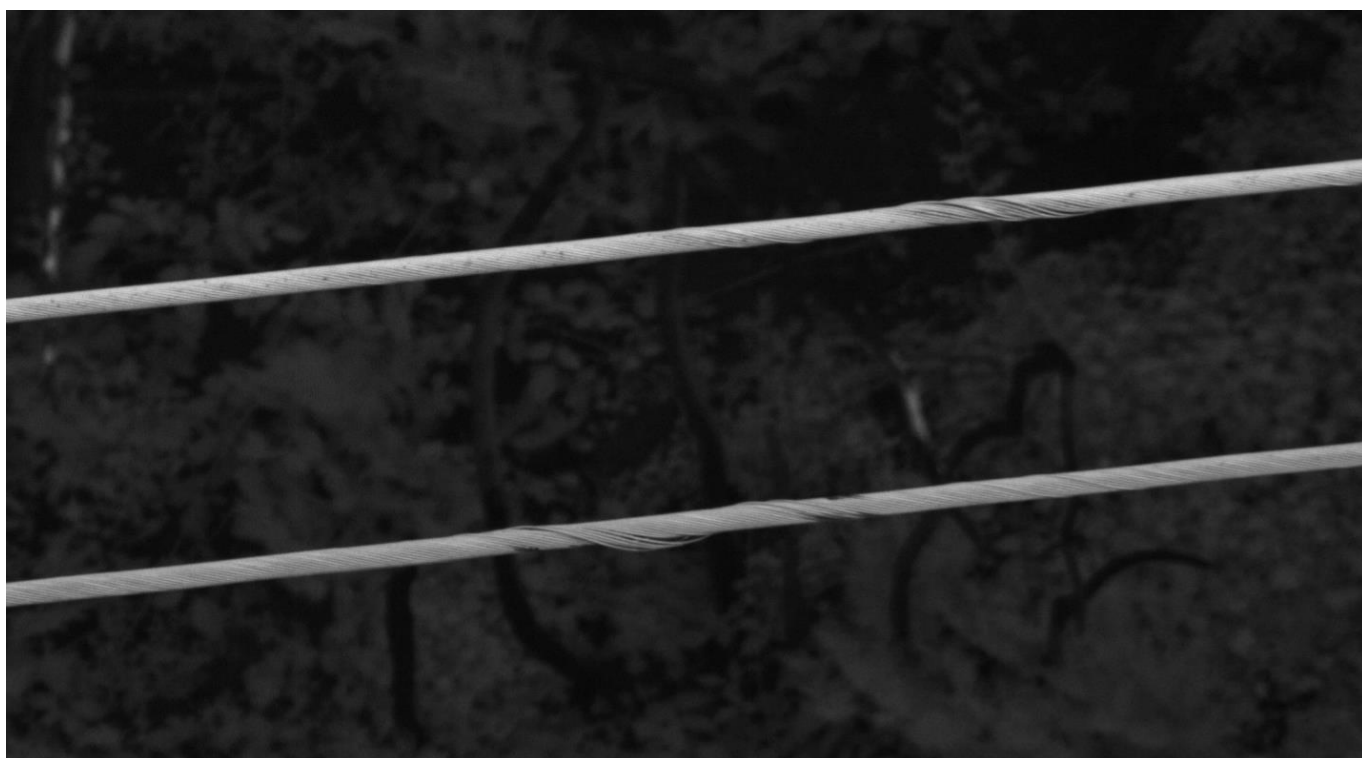
Figure 36 – Conductor damage example on ACSR conductor [REDACTED] identified in SAIP

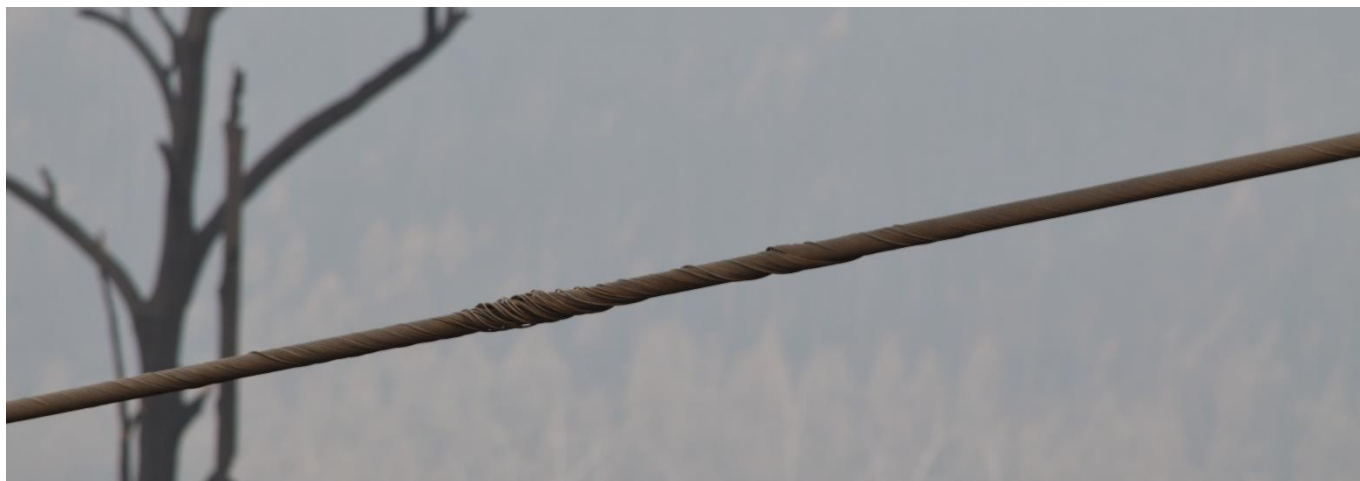
Figure 37 – Conductor damage example on AAAC conductor [REDACTED] identified visually

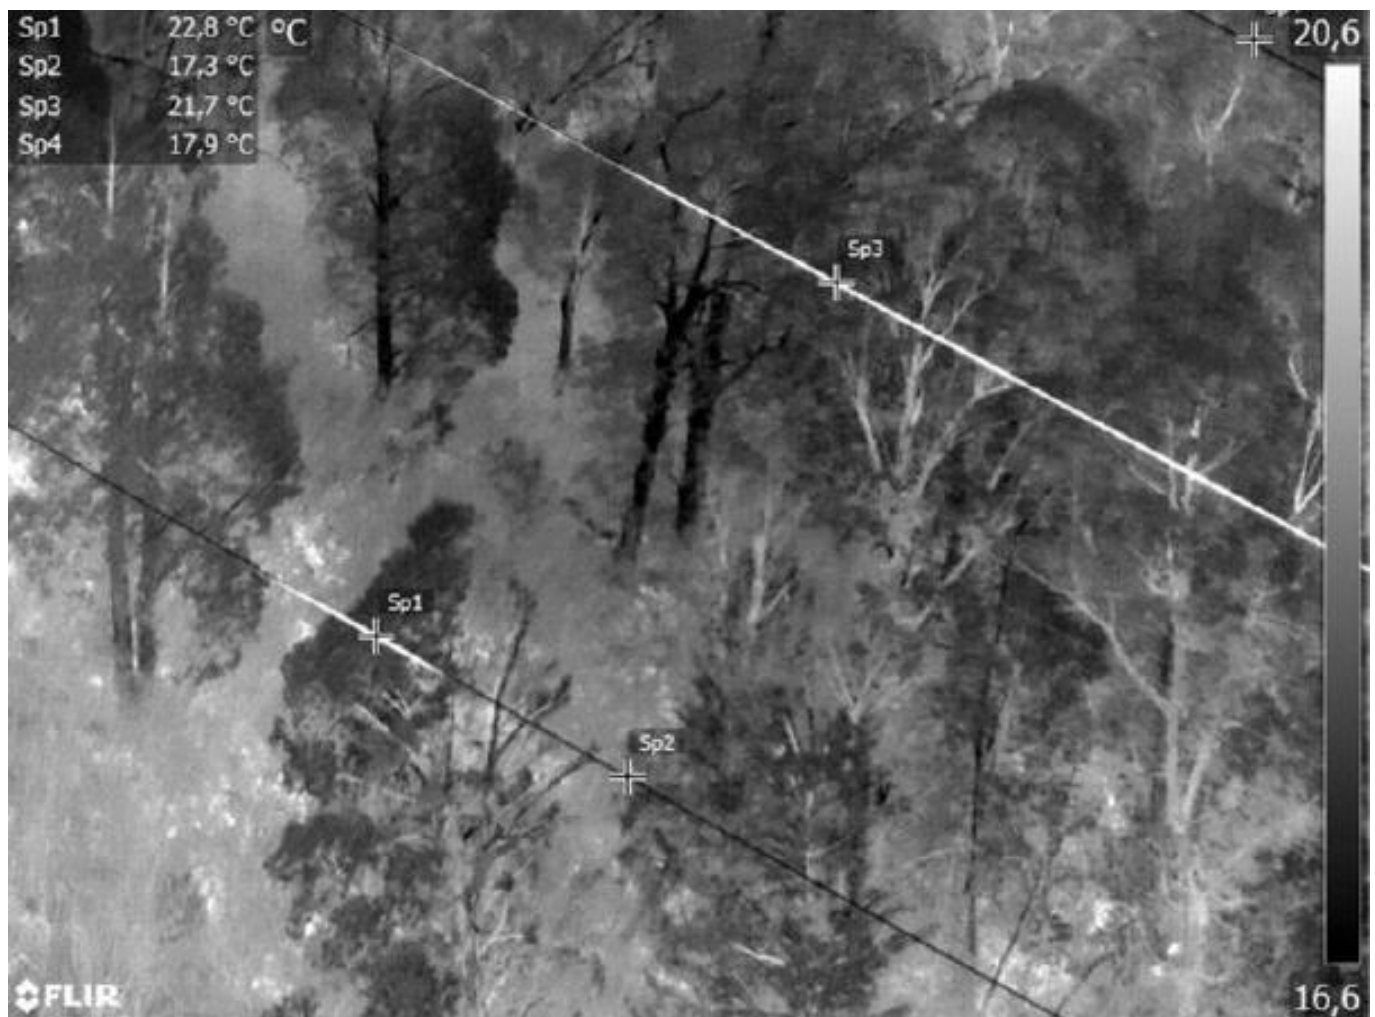
Figure 38 - Conductor damage example of 'hot spots' [REDACTED] identified in multispectral (IR) inspection

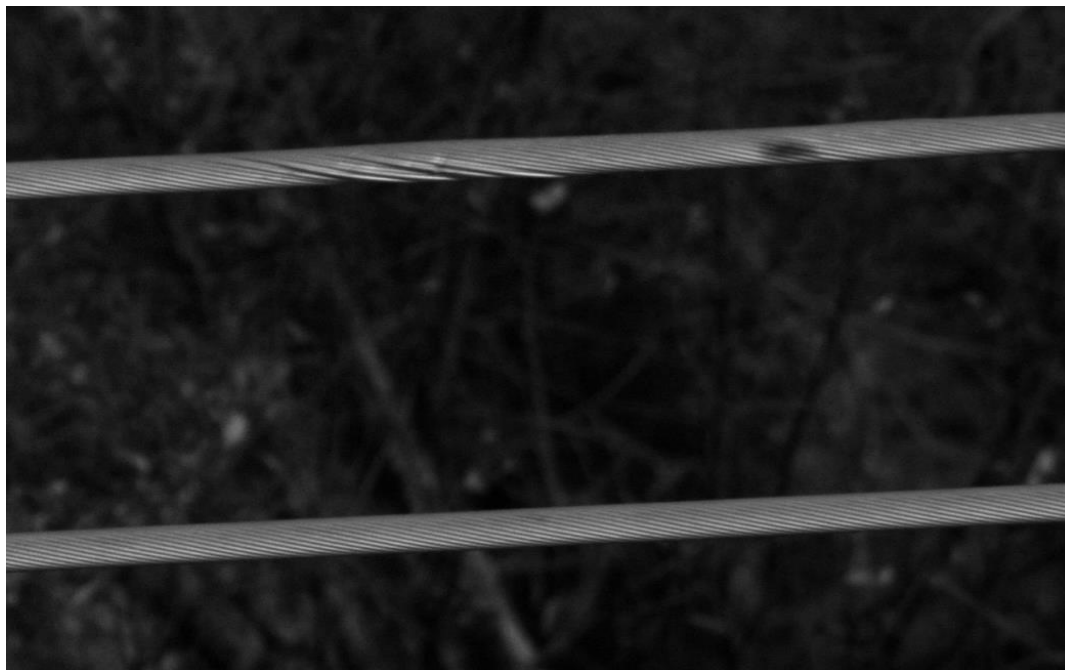
Locations with minor damage are not proposed to be monitored during routine inspections. As example of loose strands can be seen in Figure 39 and conductor discolouration in Figure 40.

Figure 39 – ACSR conductor damage – loose strands
