# Overview of 2019-20 Bushfire Damage to TransGrid's Network

Cost pass through application for 2019-20 Bushfire  
season event

13 November 2020

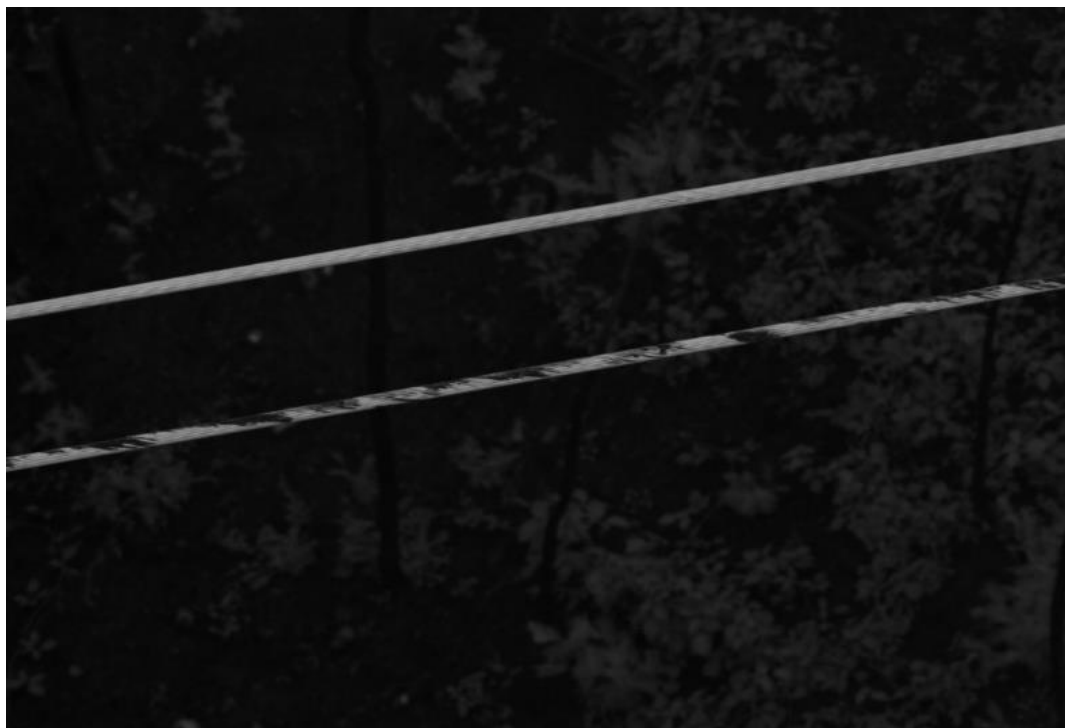
Locations with minor damage are not proposed to be monitored during routine inspections. As example of loose strands can be seen in Figure 39 and conductor discolouration in Figure 40.

Figure 40 – ACSR conductor damage – discolouration

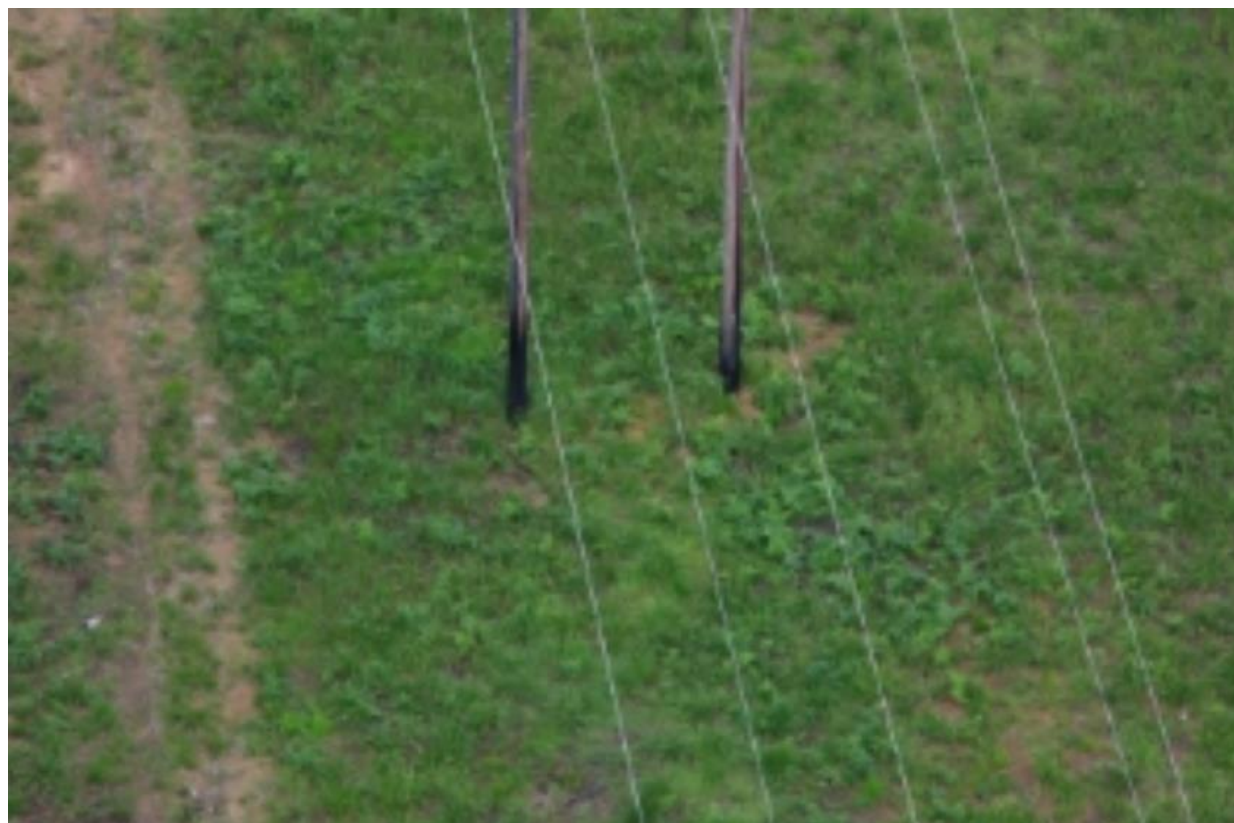
A further 8 structures have been noted as “base of structure burnt” for detailed inspections to determine long term serviceability.

Figure 42 - Example burnt wood poles

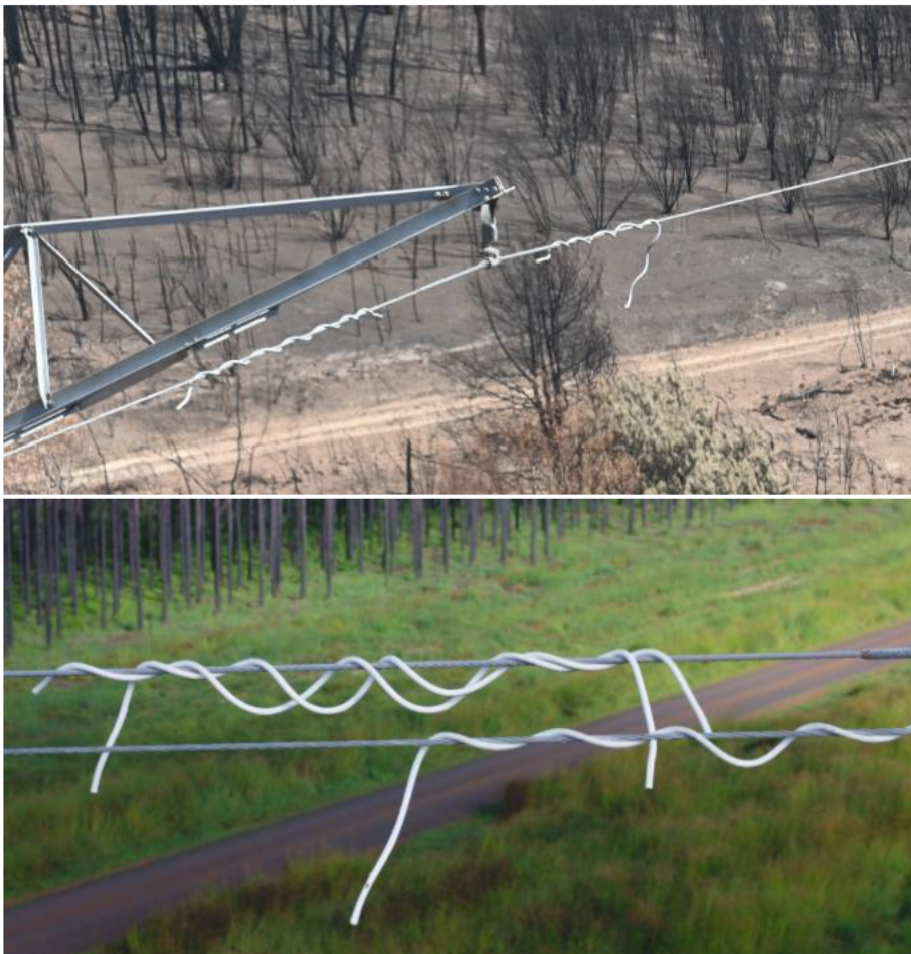
For defects on earthwire dampers TransGrid states a one-year (P4) remediation and three months (P3) in the case of OPGW, due to the potential for fibre damage. The extent of damage for spiral dampers was widespread.

Figure 45 – Melted spiral vibration dampers

Where efficient, vibration damper replacements have been excluded from the listing in this table and included in the conductor remediation scope.

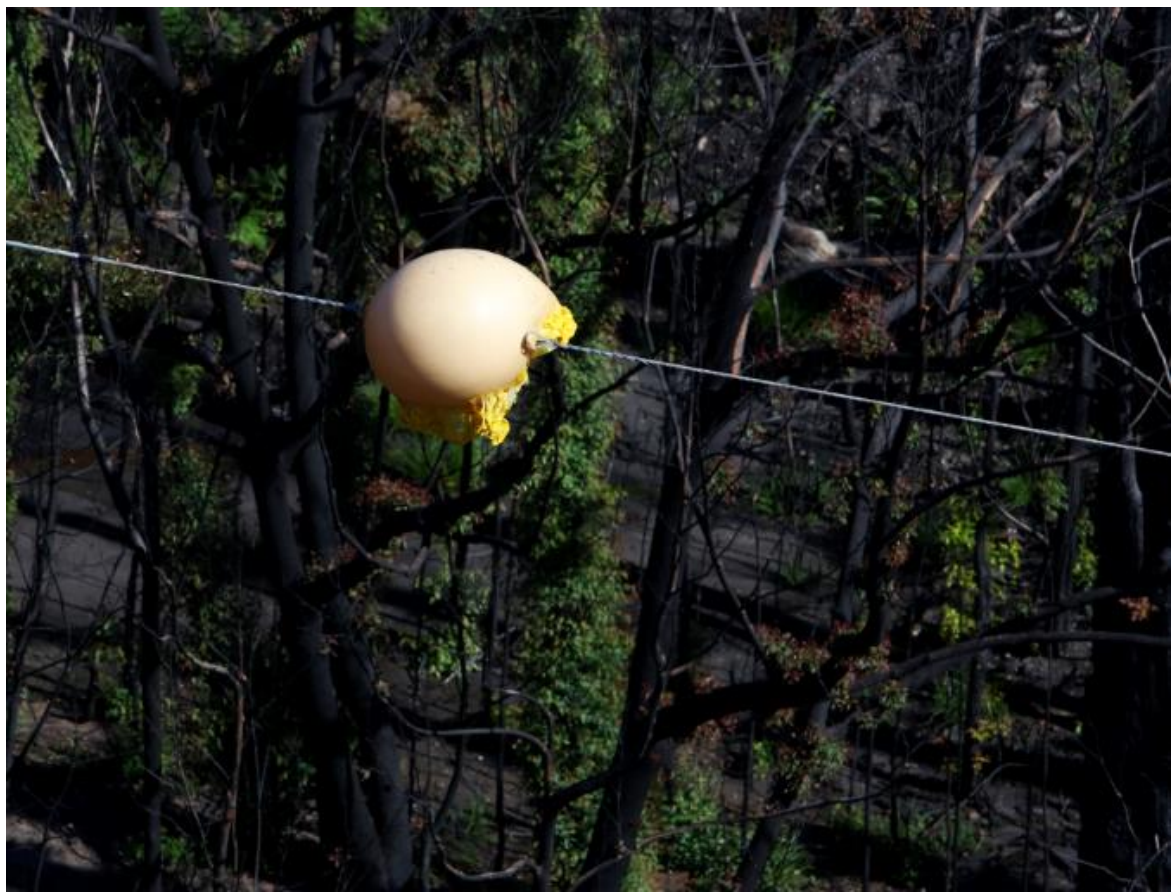
Three spans were identified with melted aerial markers (refer Figure 46). Two spans were on Line 3W Capital to Kangaroo Valley (refer Figure 47) are installed for low level operation safety. One span, on Line 64 (refer Figure 48), is installed due to the 90 m requirement. This is significant due to the distance of the ball from the ground to be engulfed with enough heat to cause damage.

Figure 47 – Melted aerial marker Line 3W

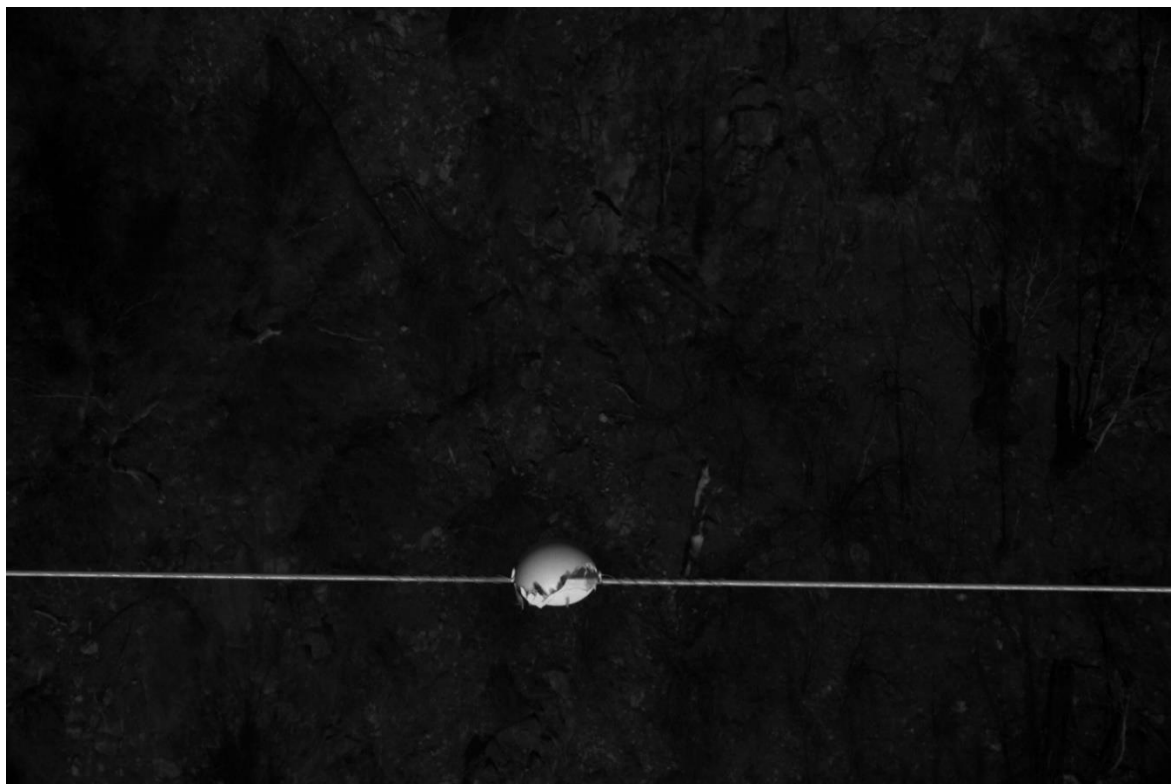
Figure 48 – Melted aerial marker Line 64

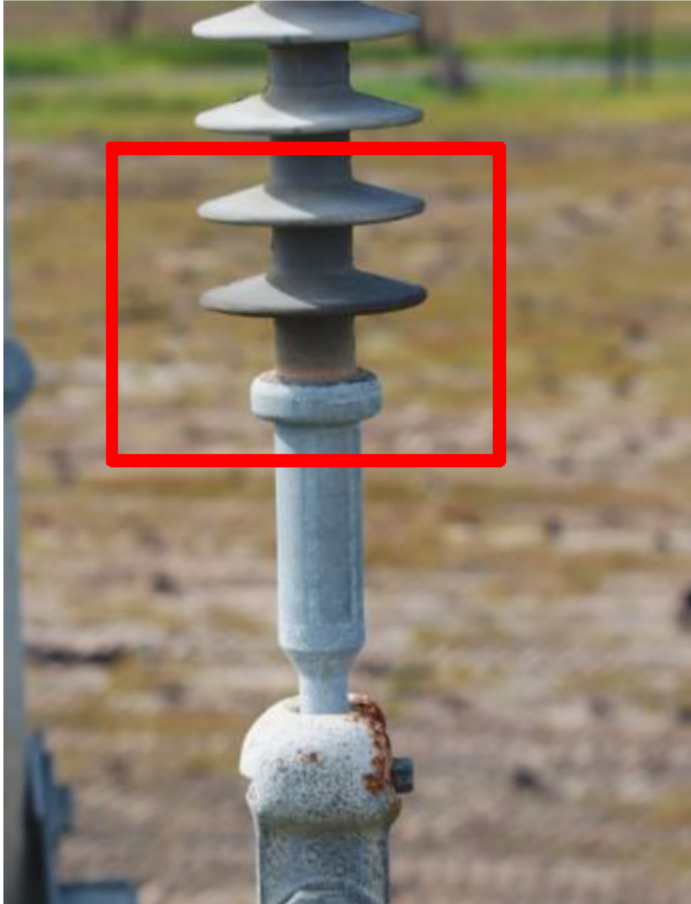
There were no permanent fault outages that could be attributed failed composite insulators. There were a small number (three structures) of composite insulators on Line 967 that were identified with minor chalking or discolouration which is indicative of heat damage to the silicone sheds. An example of this is shown in Figure 49. This does not present an immediate risk, but may lead to deterioration of the insulation properties and require replacement at a later date, pending the outcomes of further testing as described in Section 5.1.2.7. No allowance for replacement of these insulators has been included in the pass-through application.

Figure 49 – Possible damaged composite insulators

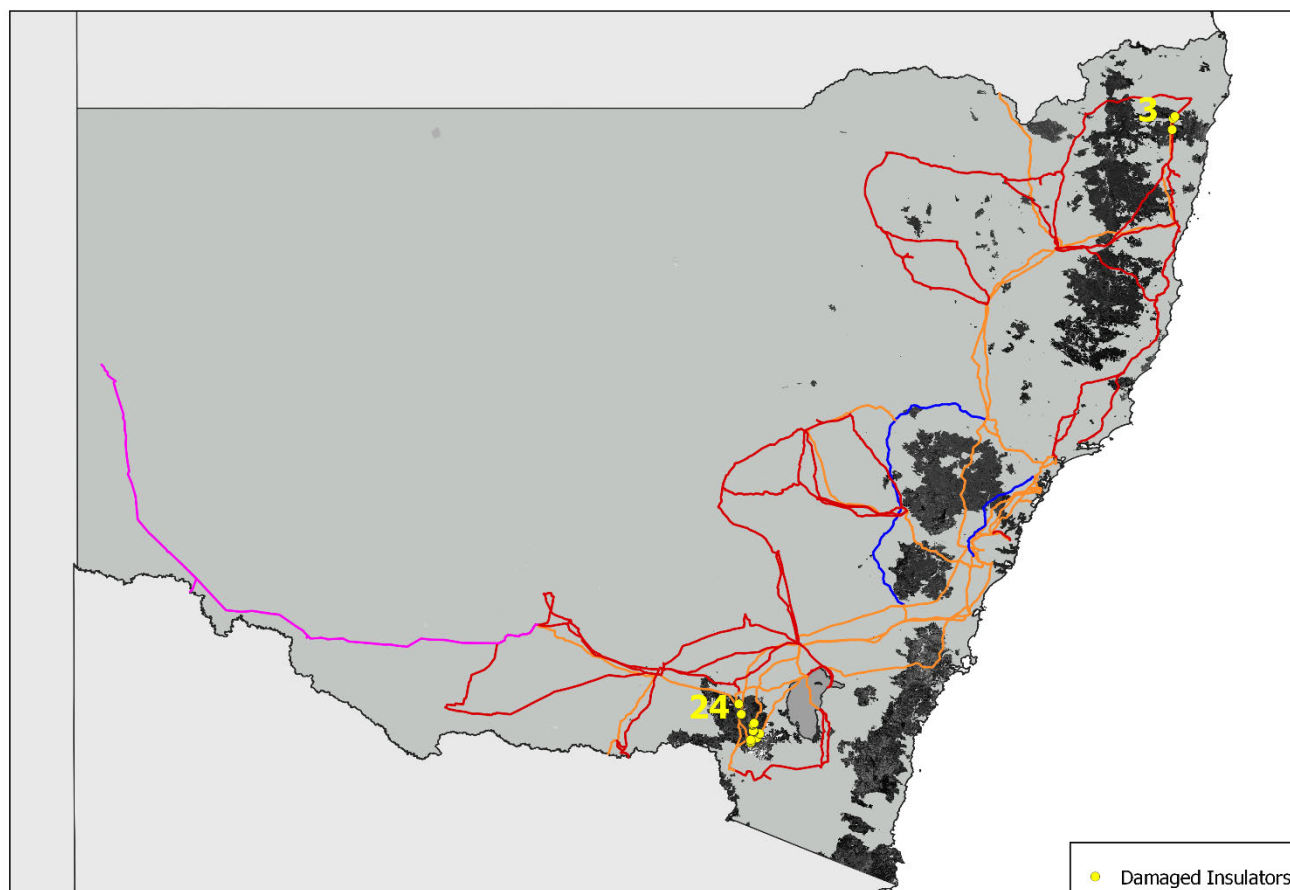
As described in 4.2.1.2 Line 2 suffered multiple areas of damaged insulators. The extreme heat and energy released from the flashovers resulted in many discs being damaged. Testing has shown that unless the discs are visibly damaged, damage from the bushfires is unlikely as described in Section 5.1.1.3. All disc insulators that were broken in the fire are required to be replaced. Any pre-bushfire flashed, broken or cracked discs have not been included in the pass-through application.

Figure 50 – Insulator damage
