Ardent Architect Report

# API Thomastown

## Site Audit and Master Planning

January 2015

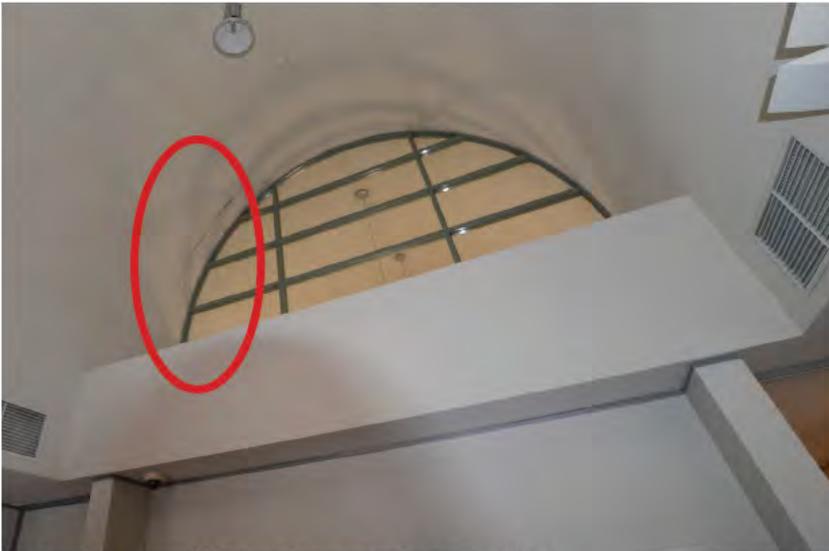
According to the plumber the roof issues stem primarily from failed flashings and sumps that require replacement. Until the water ingress issue is address and tested with flood testing measures other refurbishment works should not be undertaken due to the risk of damage.

Photo 1. Water damage to reception

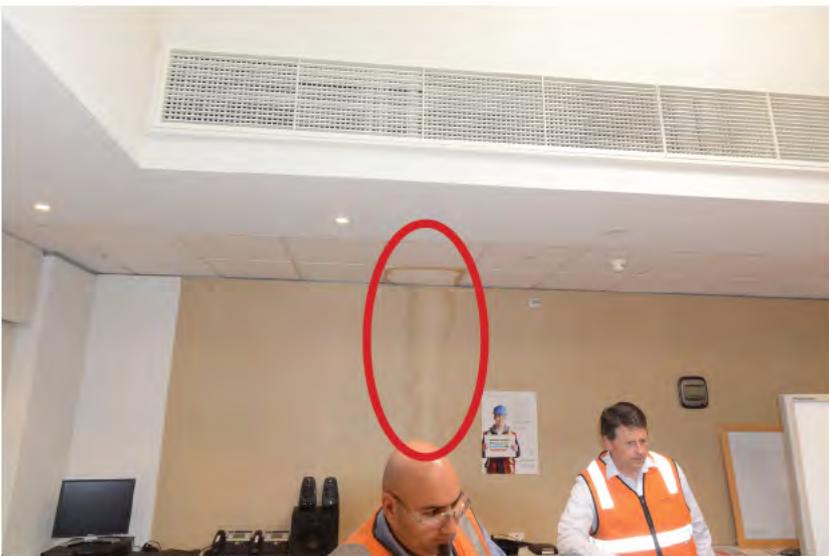
Photo 2. Water damage to boardroom

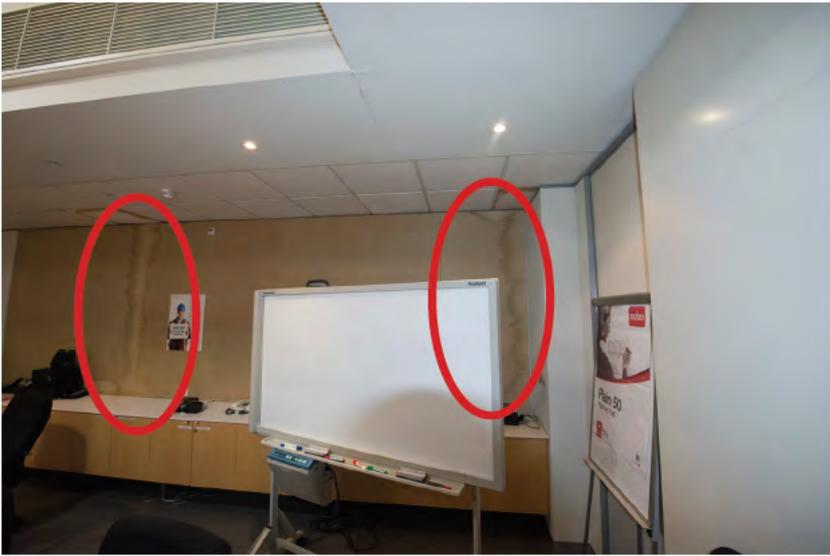
Photo 3. Water damage to boardroom

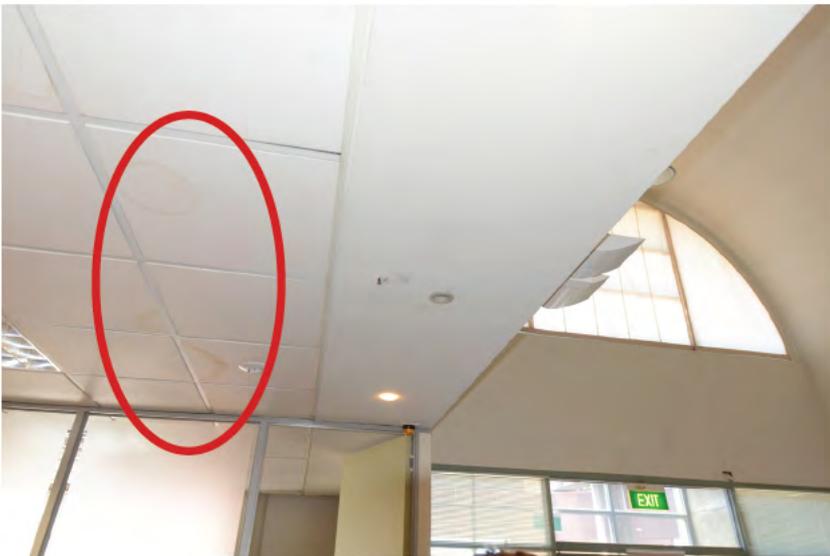
Photo 4. Water damage to reception

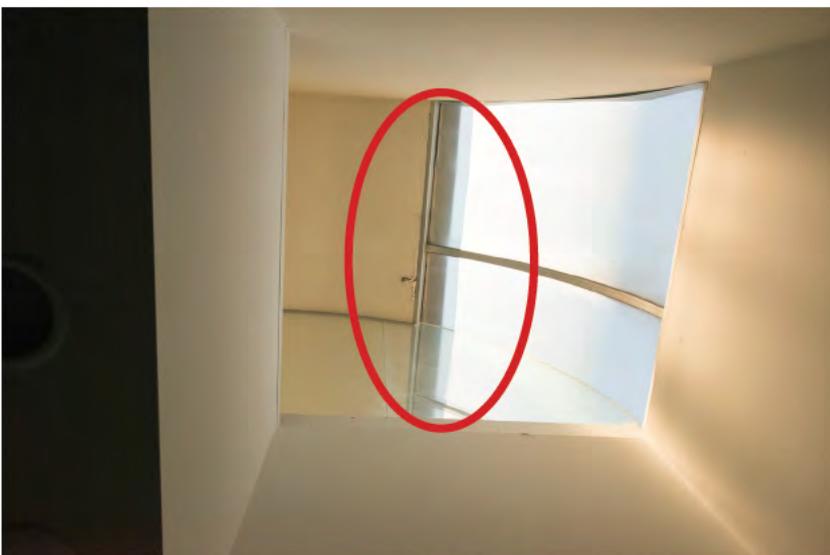
Photo 5. Water damage to meeting room

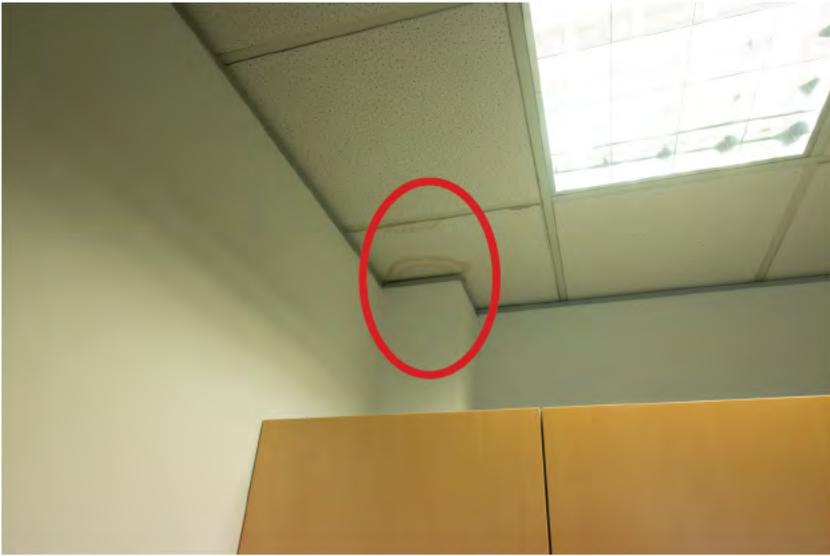
Photo 6. Water damage to office

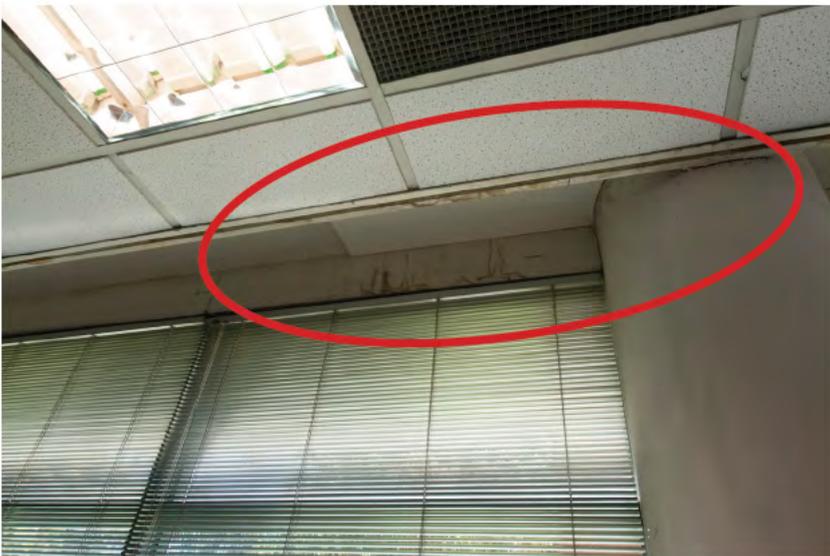
Photo 7. Water damage to office

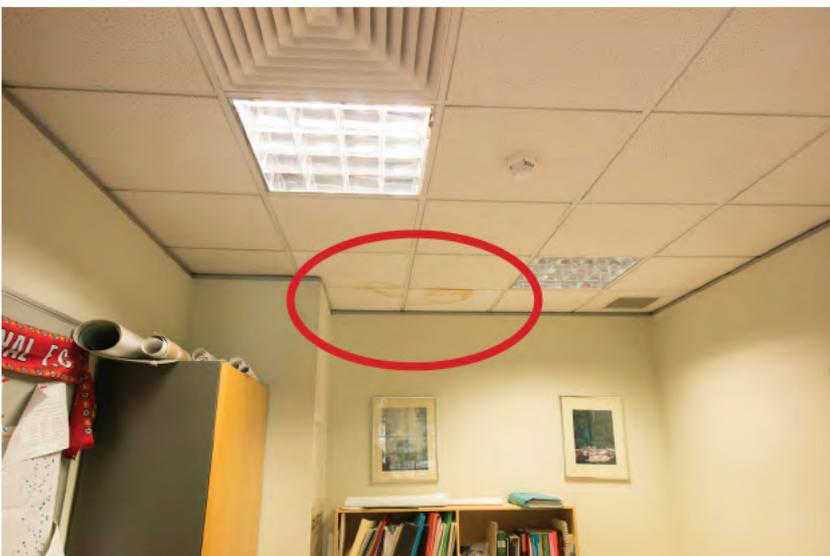
Photo 8. Water damage to office

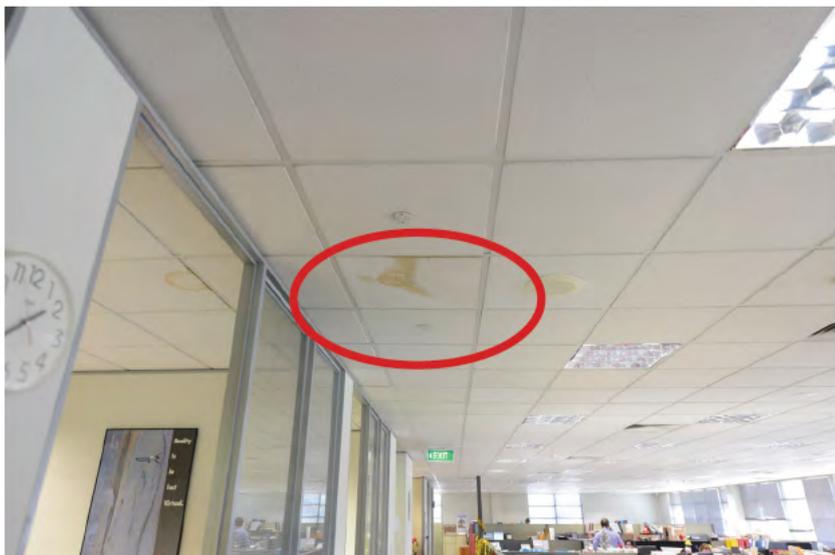
Photo 9. Water damage to office

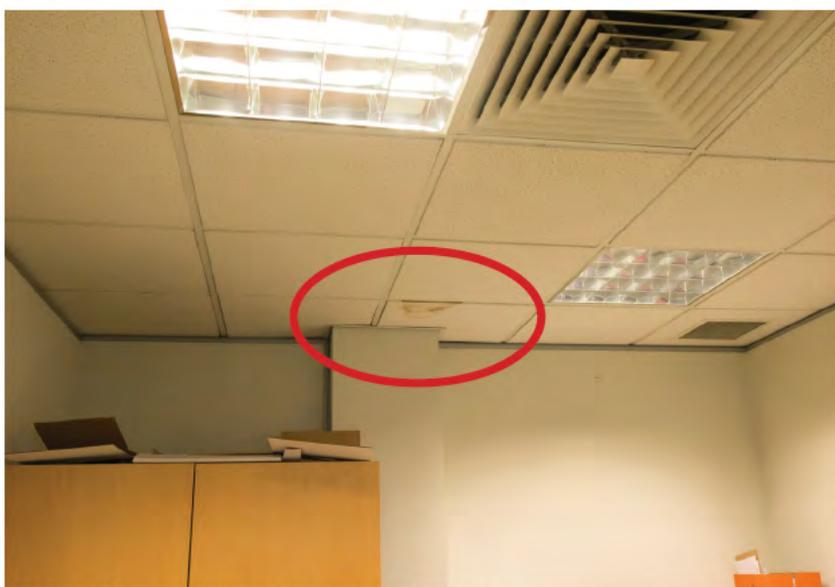
Photo 10. Water damage to office

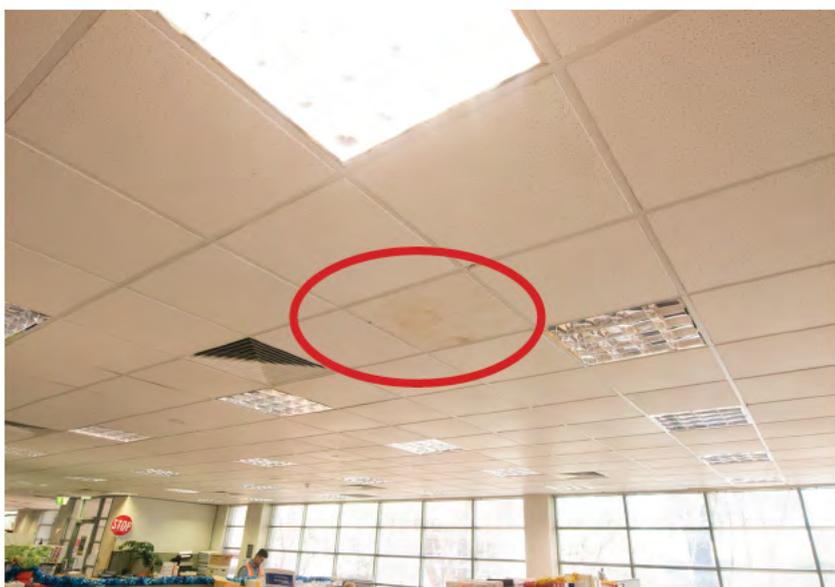
Photo 11. Water damage to office

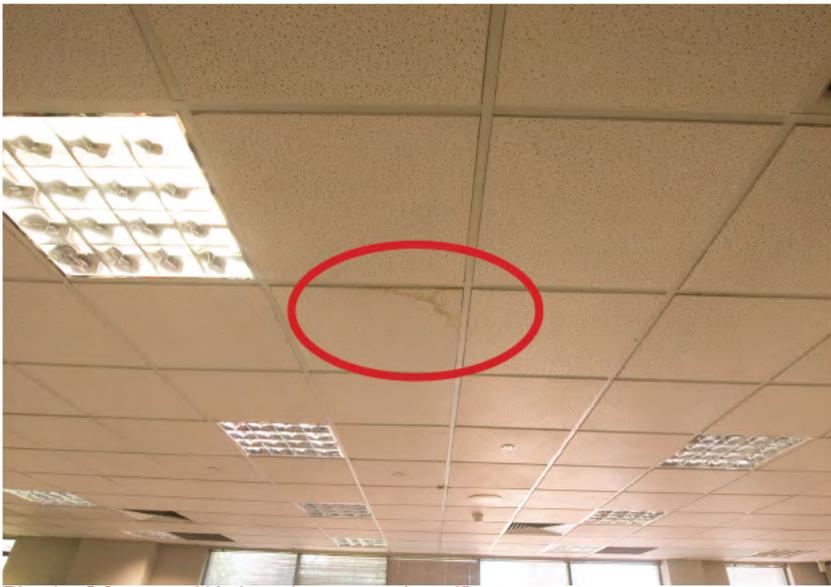
Photo 12. Water damage to office

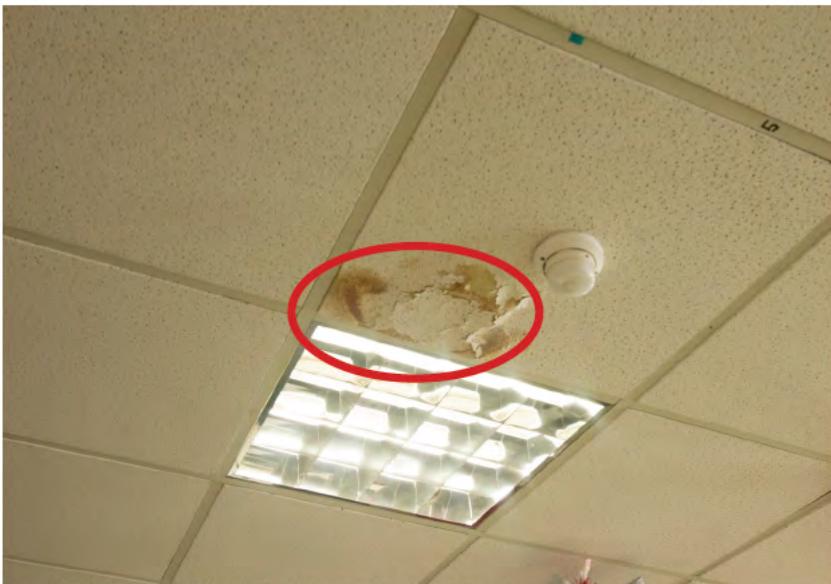
Photo 13. Water damage to office

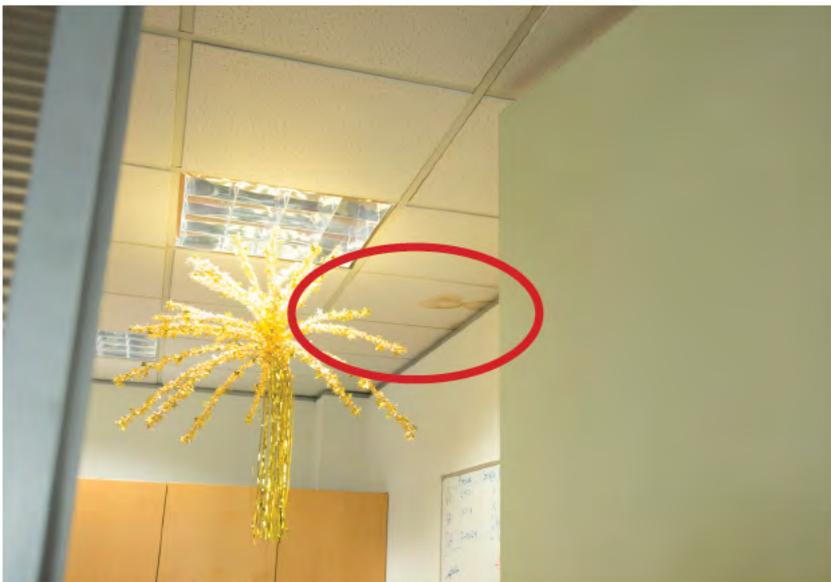
Photo 14. Water damage to office

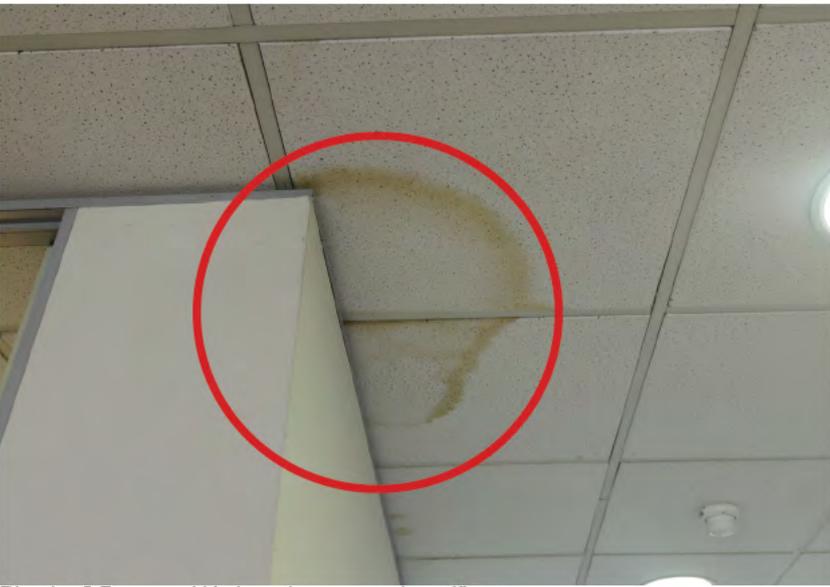
Photo 15. Water damage to office

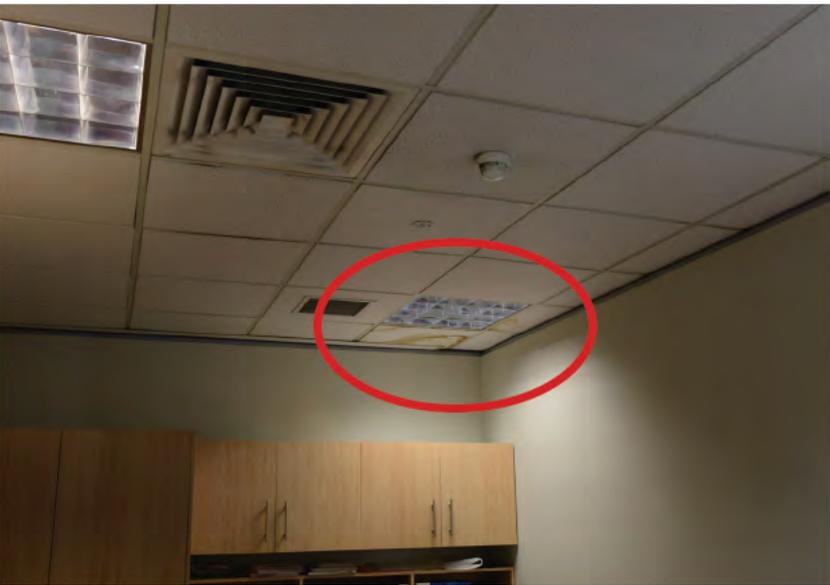
Photo 16. Water damage to office

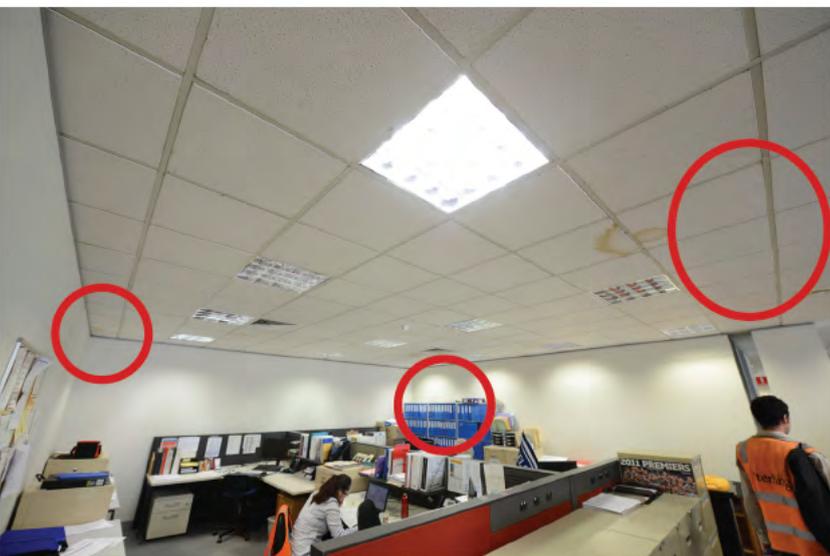
Photo 17. Water damage to office

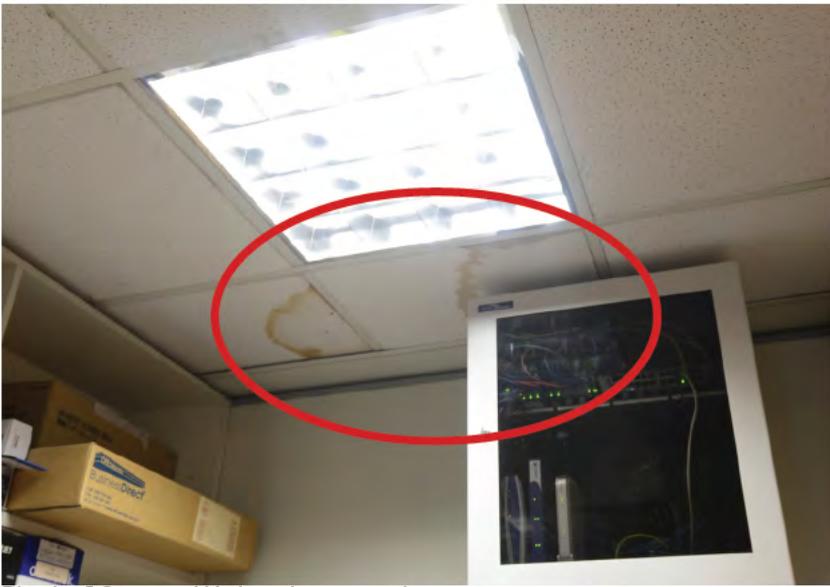
Photo 18. Water damage to comms area

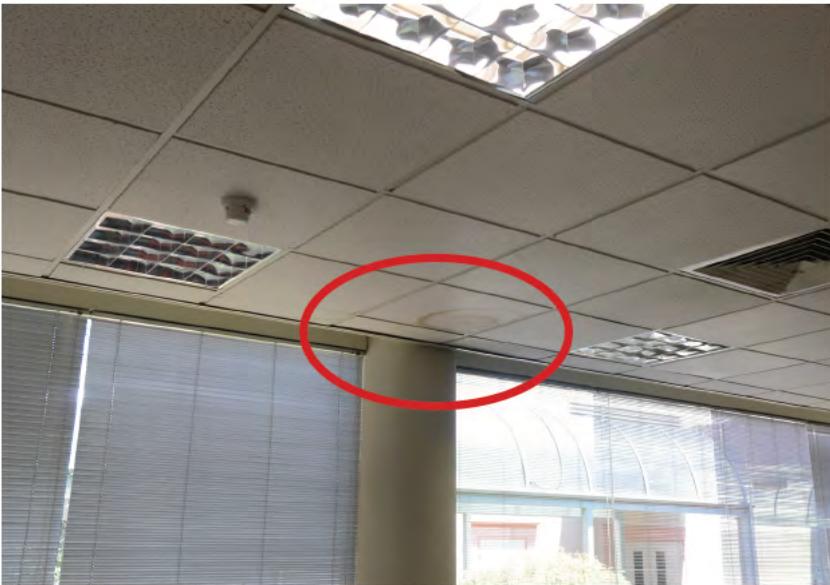
Photo 19. Water damage to office

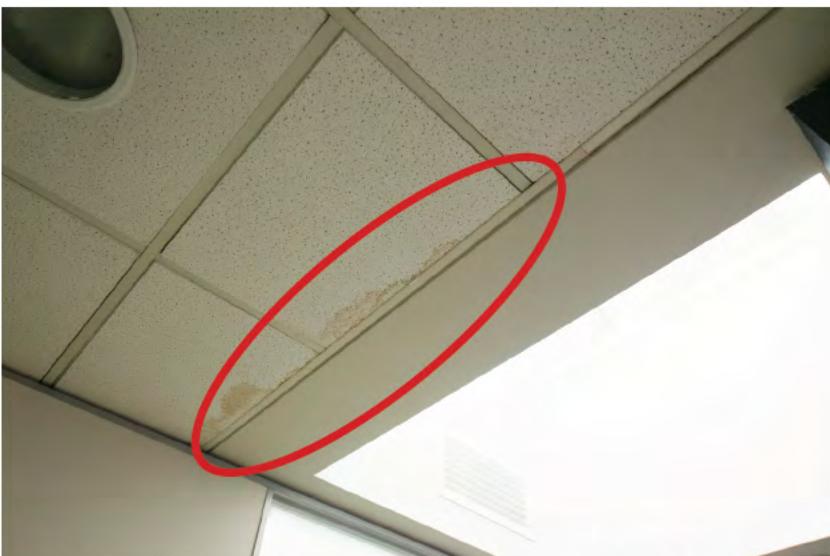
Photo 20. Water damage to meeting room corridor

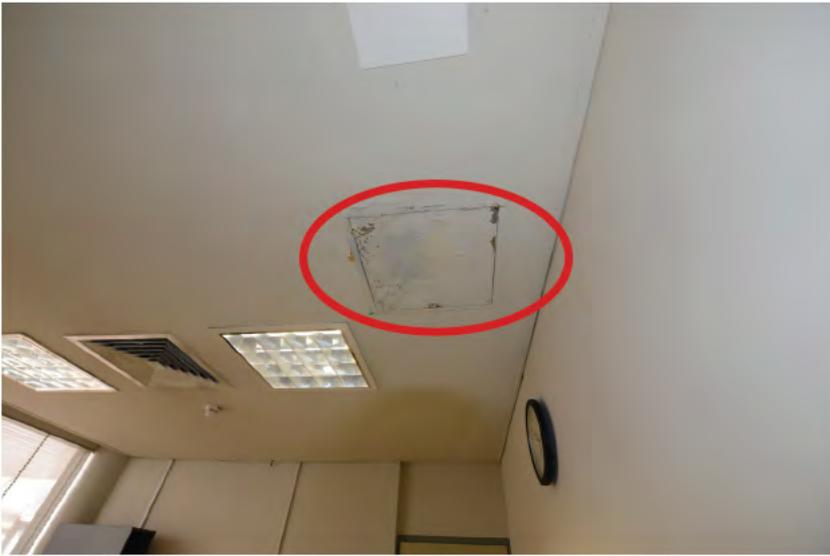
Photo 21. Water damage to first aid room

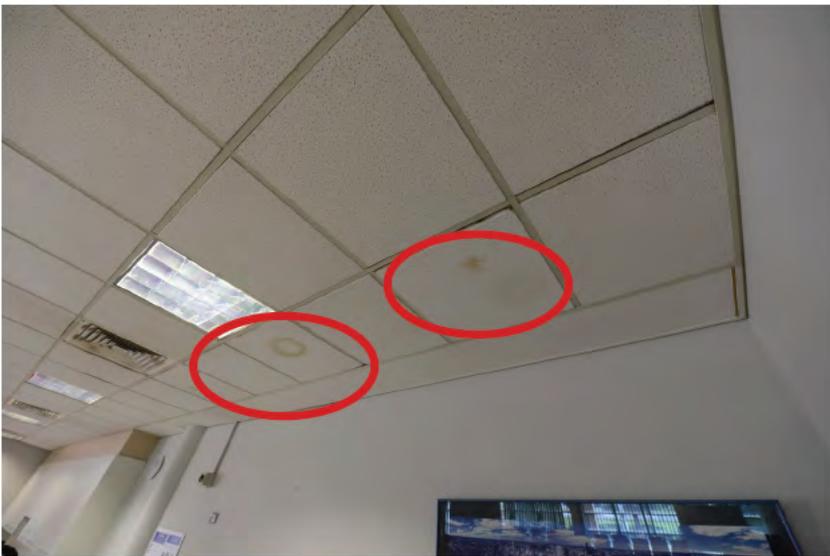
Photo 22. Water damage to lunch room

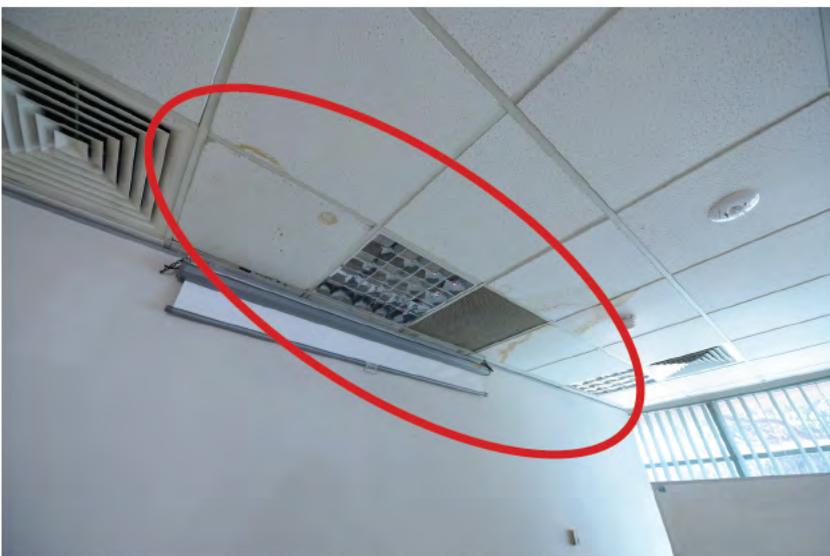
Photo 23. Water damage to lunch room

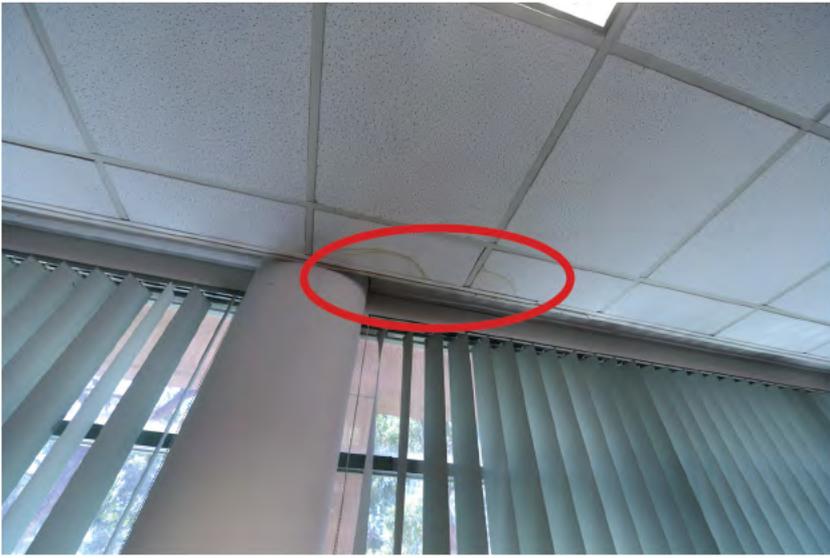
Photo 24. Water damage to lunch room

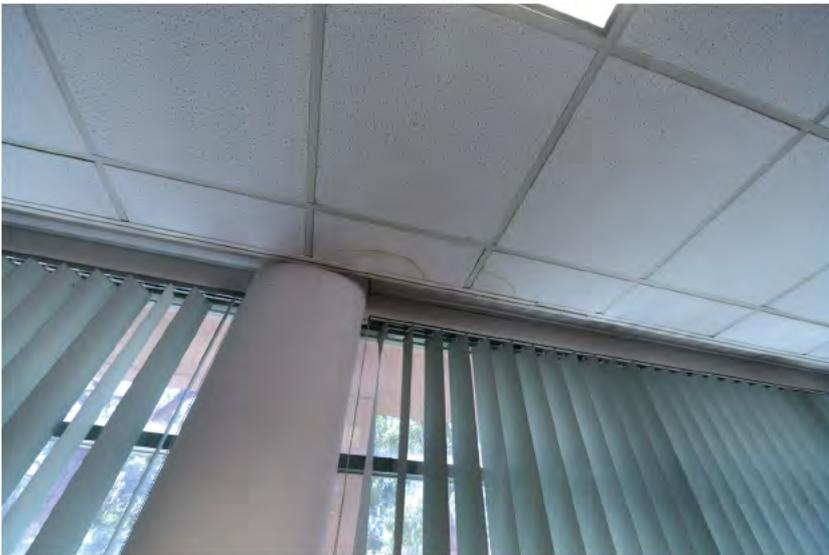
Photo 25. Ceiling tile replacement

Extensive water damage to ceilings coupled with mechanical refurbishment and relocation should coincide with replacement of ceiling tiles. We would recommend replacing all the ceiling tiles with more modern ceiling tiles and perhaps some feature tiles to break up the ceiling.

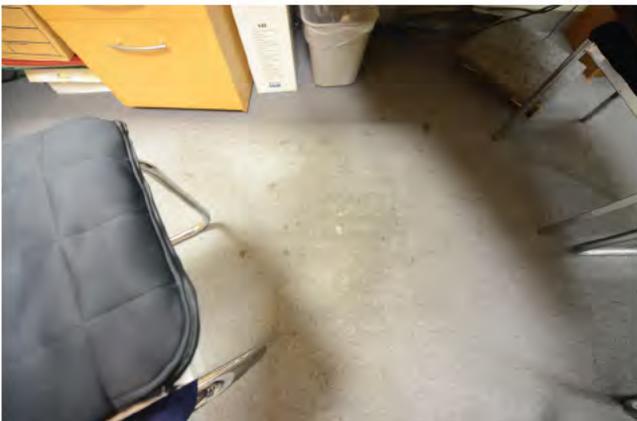
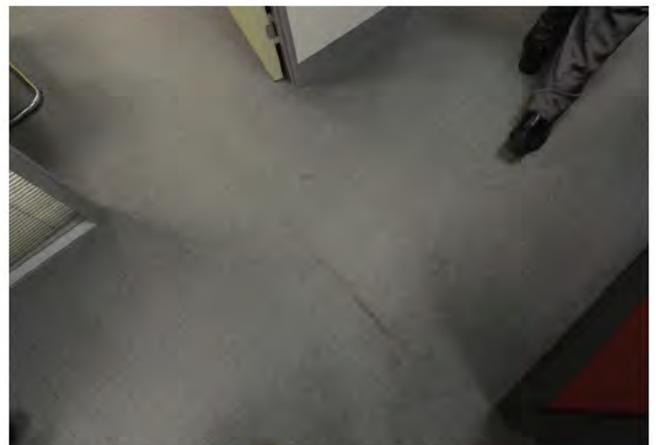
Photo 26. Carpet Replacement

Photo 27. Carpet Replacement

While the carpet is maintained and has been repaired and patched it is at the end of its serviceable life. We recommend full replacement of all carpet as part of any refurbishment.

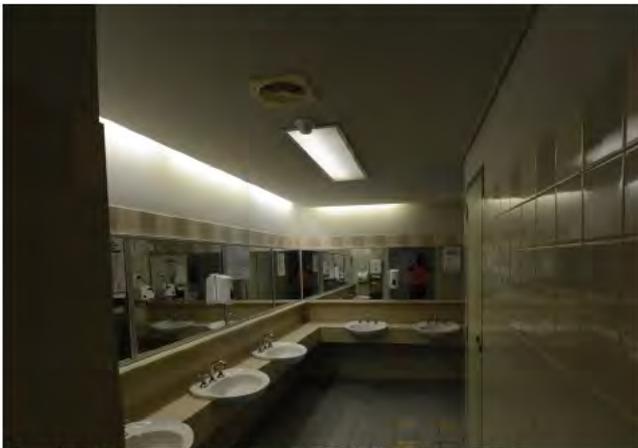
Photo 28. Bathroom Refurbishment

While fittings and fixtures in the amenities are currently serviceable the fittings are getting to the end of their serviceable life. If the office is to be refitted there will be major works needed in the toilets to make them compliant to the latest standards. This would be an ideal time to completely refit all the toilets to modern finishes and fittings.

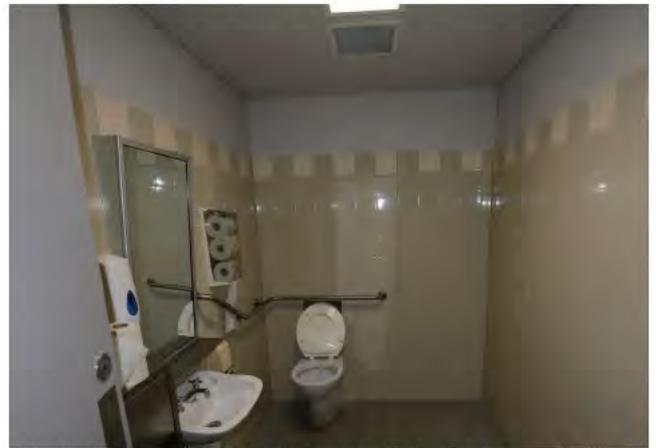
Photo 29. DA Bathroom Refurbishment

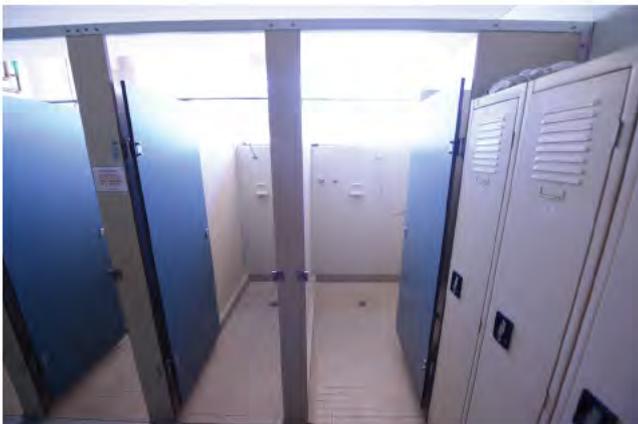
Photo 30. Shower Refurbishment

The fittings and layout of the shower room are serviceable while the fittings are approaching the age of replacement. As part of a whole office refurbishment we would recommend refitting the shower room including new, modern, built in lockers with digital locks.

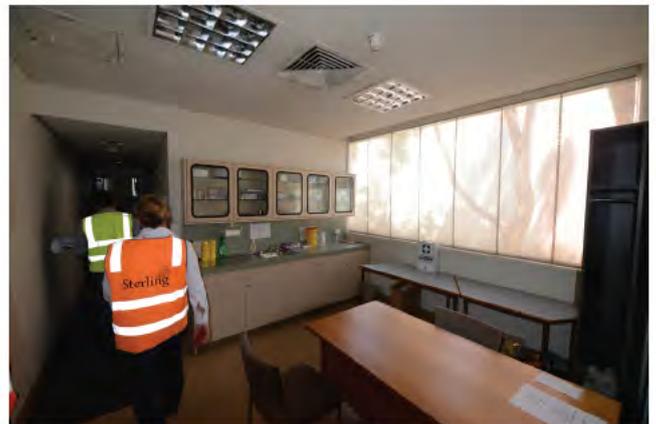
Photo 31. First Aid Refurbishment

The first aid and mothers room is quite grim and shows its age. We would recommend refurbishment of this area including a window or glass doors to the room with beds.

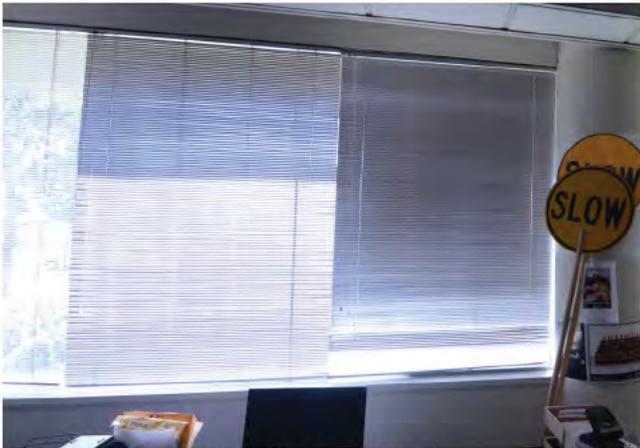
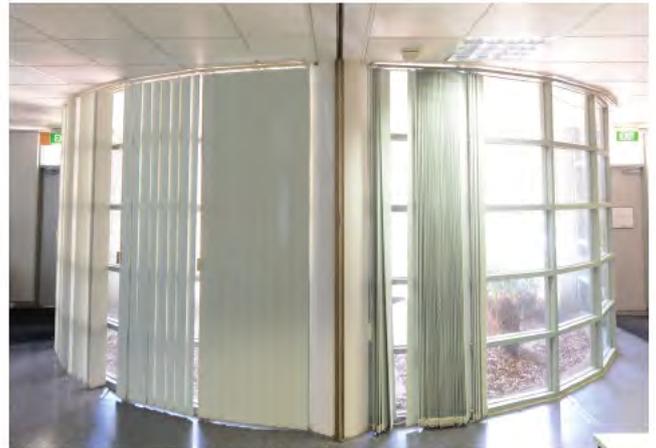
Photo 32. Blind Replacement

Photo 33. Blind Replacement

Of the windows furnishings/blinds are looking very tired and many are damaged through wear. We would recommend in a refurbishment that new double roller blinds be installed.

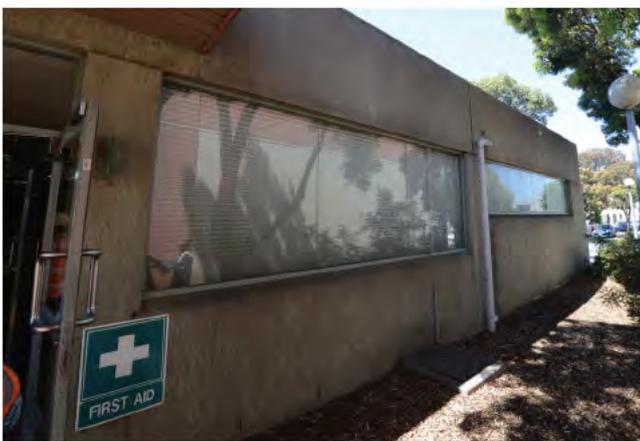
Photo 34. External painting

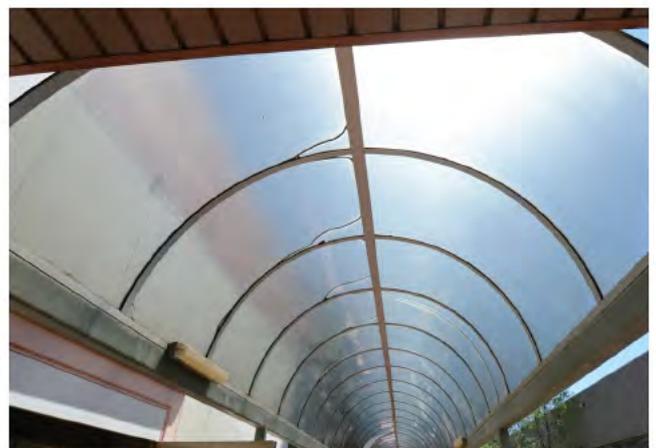
Photo 35. Polycarbonate replacement

78	Site	2	Architectural	Poly carbonate roofing	The polycarbonate roofing to the outdoor walkways at a minimum requires cleaning. However it seems to be getting to the end of its serviceable life and should be considered for replacement as part of an overall refurbishment.	Ardent
79	Site	1	Architectural	Canopy steel	The steel structure to the external canopies has extensive rusting. The steel requires sanding, kill rusting and sealing with paint to prevent major works later on.	Ardent
80	A	1	Architectural	Render	Render to the base of building A is breaking away as it seems to have been exposed. As part of a refurbishment and repainting this should be repaired.	Ardent
81	Site	1	Architectural	Gardent beds	The garden beds especially around building A seem to have been neglected, dug down and had substantial planting removed over time. If water tanks are to be installed a watering system should be incorporated. The garden beds need to be rejuvenated with new planting, mulsh and compost. A landscape Architect should be engaged to design the planting and treatment.	Ardent

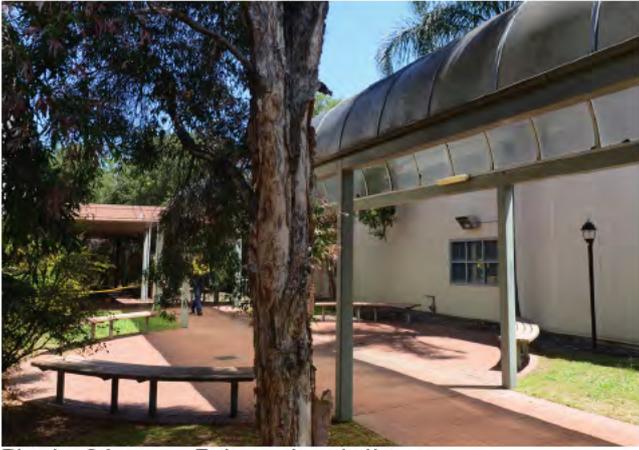
Photo 36. External painting

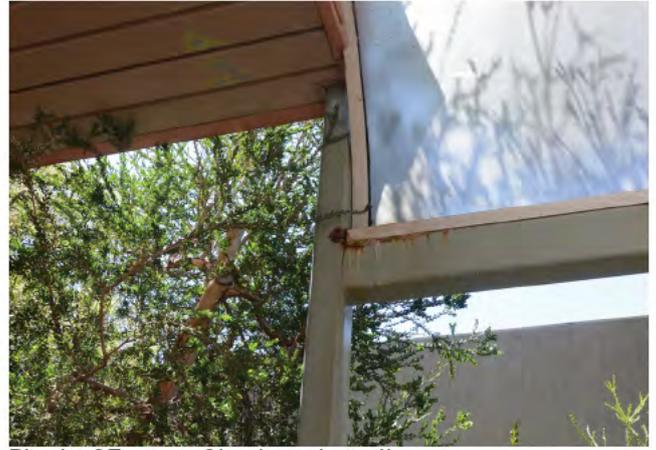
Photo 37. Steel work rusting

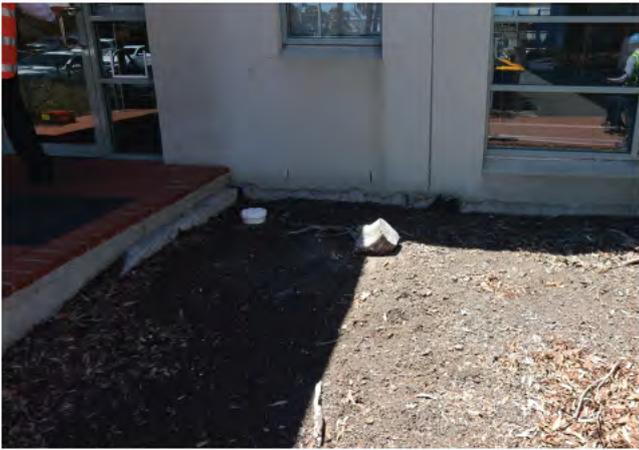
Photo 38. External painting, render repair

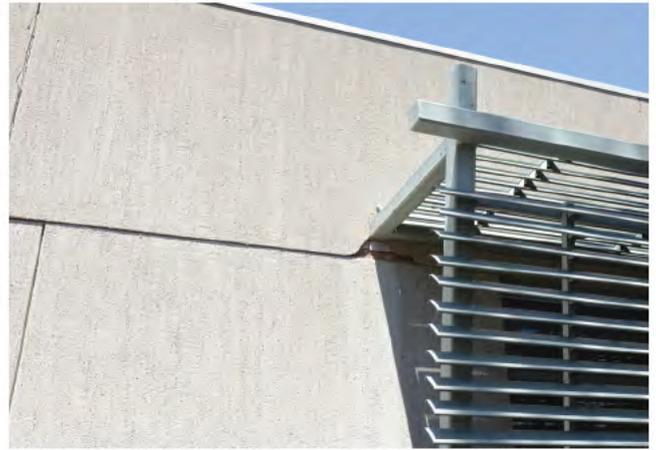
Photo 39. External Cladding repair

82	A	2	Architectural	Western façade	The Western façade that is part of the building extension needs repair work. The cladding panels and reder are cracking and lifting creating the risk of water ingress to the building.	Ardent
83	A	1	Architectural	Plaster sheet repair	The plaster sheet ceilings in the entrance and front meeting rooms need repair and painting	Ardent
84	A	1	Architectural	Workstations	If full refurbishment is to occur workstations will need at least new inserts to update them.	Ardent
85	A	1	Architectural	Windows	If energy efficiency is to be a high priority then replacing all of the offices windows with double glazed and low e glazing should be considered.	Ardent
86	A	1	Architectural	Natual light	If full refurbishment is to occur we would recommend the introduction of natural light to the centre of the building via solartube skylights.	Ardent
87	A	1	Architectural	Furniture and joinery	As part of a full refurbishment, fixed joinery should be considered for replacement as well as furniture in the lunch room.	Ardent

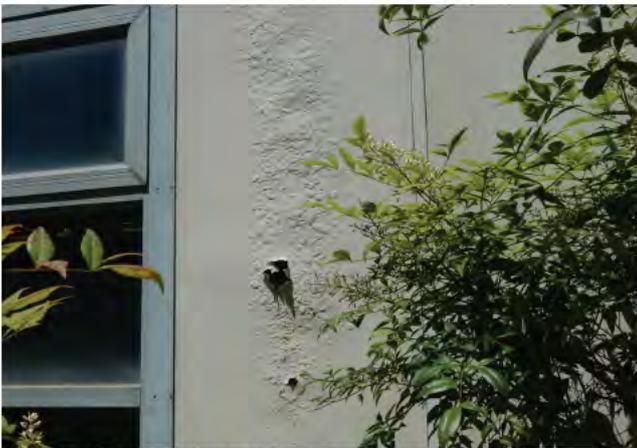
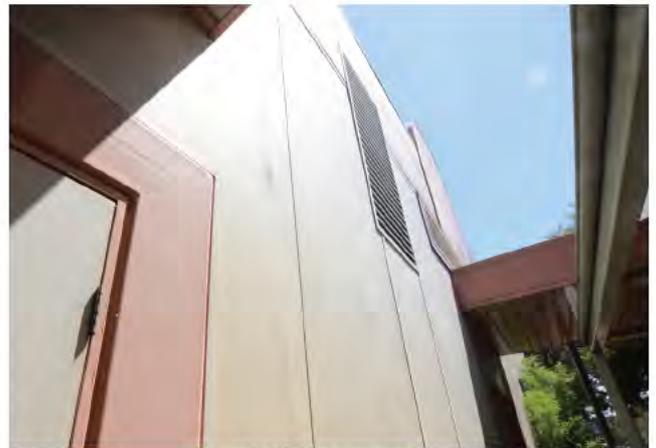
There are some small areas of paneling where the coating has completely failed and the base metal skin has rusted badly. Given the difficulty in replacing panels consultation will need to be made with a the manufacturer as to potential rectification methods that don't require panel replacement.

Photo 40. Insulated panels rusting

Photo 41. Insulated panels rusting

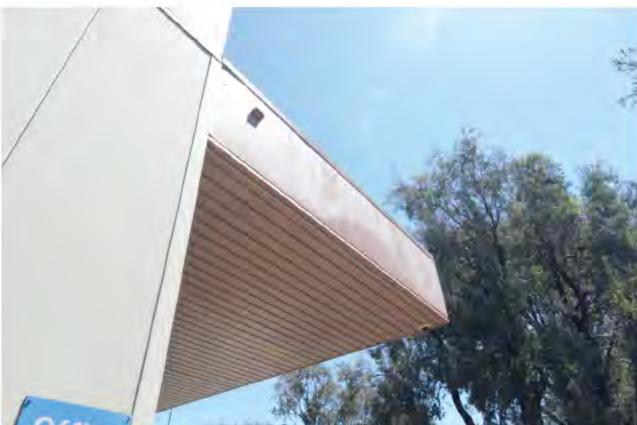
Most all external painted surfaces on buildings BCD are due for repainting. Much of the paint is in very poor condition and will require extensive preparation before new top coat paint is prepared to ensure longevity.

Photo 42. Repaint external surfaces
