# SEYMOUR CITY GATE REGULATOR PIT

## ELECTRICAL SURGE EVENT NOVEMBER 2009

Rev O      5 May 2010

Geoff Cope & Associates Pty Ltd

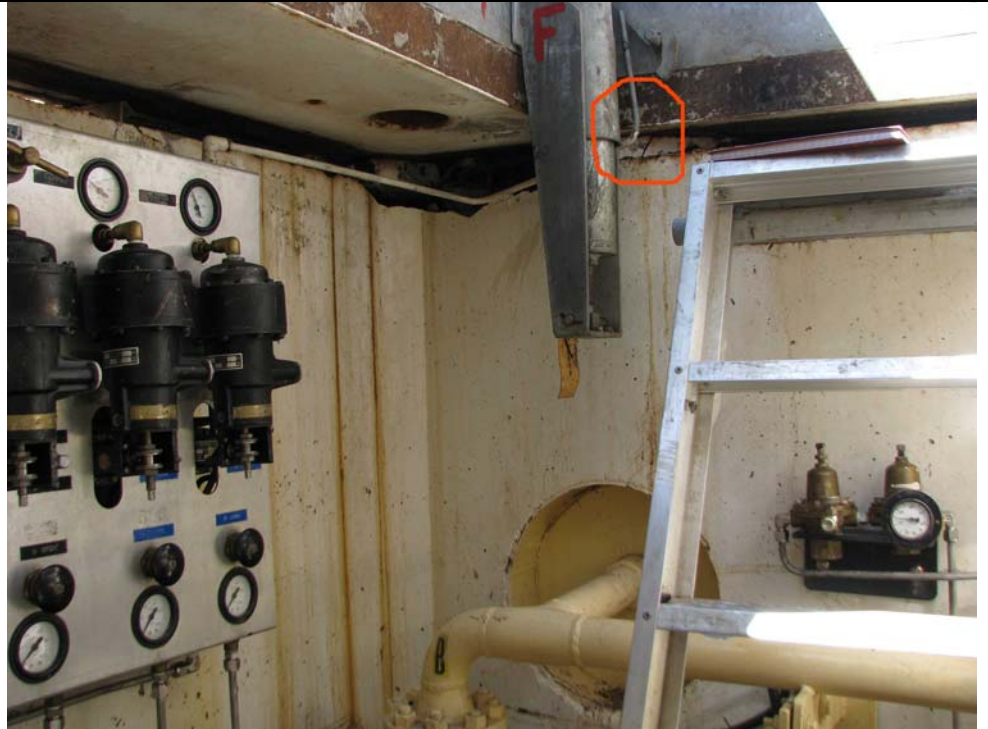
Figure 1:

Comprehensive preliminary inspections were carried out by APA personnel following the incident. These revealed no significant damage caused by the gas ignition apart from that associated with the lid of the regulator pit. Arcing was observed on a section of stainless steel tubing where it ran beneath the pit lid, with corresponding evidence of an arc on the steel frame of the lid. With the lid closed, the tubing would have been lightly in contact with the lid at the point where the arcing occurred. Relevant photographs are shown in Appendix 3.

Pit interior. Tubing where arcing had occurred is circled in red.

It is therefore recommended for regulator pits where telecommunications (or other) facilities are likely to increase the likelihood of lightning strikes, that all metalwork and pipework be electrically bonded. This applies only to pipework and metalwork that is not already in direct electrical contact, such as would be provided by welded or bolted connections or connection via metallic support frames, busbars etc. Pipework and metalwork connected in such a manner should be considered as electrically continuous and not requiring additional bonding. Bonding may be via bonding cables or suitably rated SPDs. Bonding cables should be run as directly as practicable and should avoid unnecessary bends and loops which would add inductance to the path. Bonding conductors should be of size 6 mm<sup>2</sup> minimum (copper) for general bonding of pipes and metalwork, or 35 mm<sup>2</sup> minimum (copper) where they may be subject to a substantial proportion of the lightning stroke current. Where SPDs are required (such as across insulated flanges or couplings where cathodically protected pipe enters a pit) they should be rated to carry both the lightning pulse current and any AC surge current that may be induced from powerlines under fault conditions.

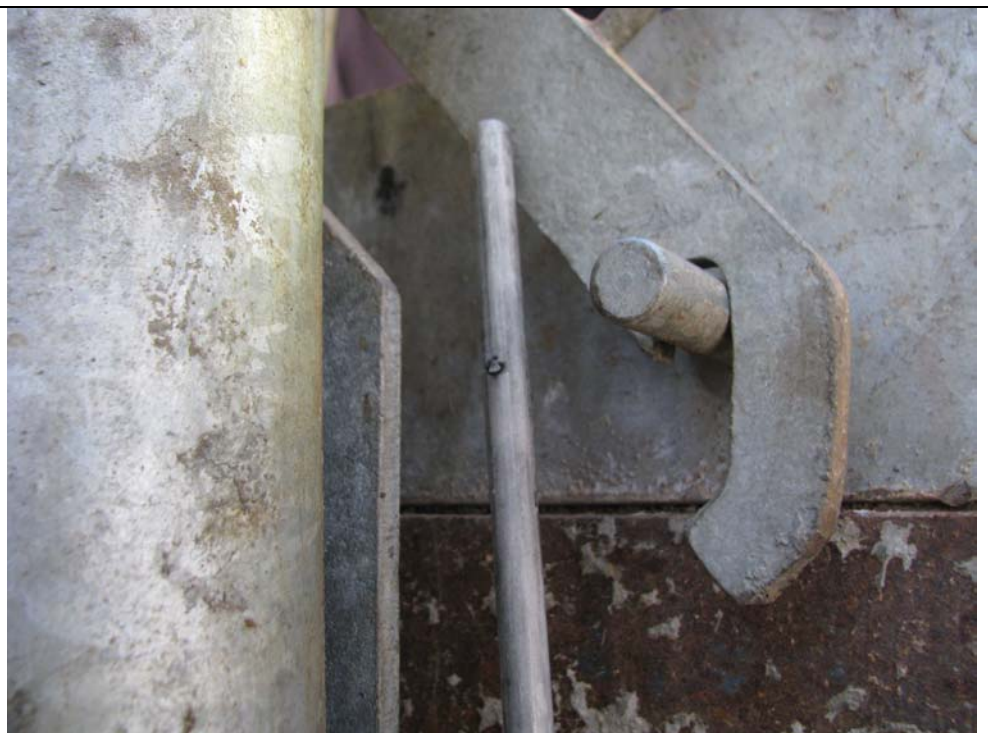
Figure 2:

The exact mechanism that caused the voltage differential and arcing between the regulator pit lid and the tubing directly beneath it is uncertain, although it was almost certainly caused by a lightning stroke. Substantial voltage gradients would have arisen in the ground in the vicinity of the telecommunication pole, and significant currents could have been generated in nearby conductors by the electromagnetic pulse accompanying the stroke. It is possible there may have been a side flash from the telecommunications pole to the metallic pit lid, as this would have presented an attractive nearby ground, augmented by the metallic pipelines beneath. Any of these mechanisms would have been capable of producing sufficient voltage differential to cause arcing between adjacent metallic conductors that were not bonded together. The recommended solution, as discussed in AS/NZS 1768, is to employ equipotential bonding, either by direct connection or via appropriate surge protection devices (SPDs) where direct connection may cause unwanted effects such as loss of cathodic protection.

Closer view of tubing showing arc mark (centre of picture).

Note: Photograph was taken with pit lid open. When lid is closed, the frame of the lid is in light contact with the tubing where the arcing had occurred.
