Final Plan Attachment 8.6 V54 Supporting Information 1

V04 Refurbishment of Dandenong to Crib Point
Pipeline

December 2016

Project Ref/No.	V04		
Project Name	Refurbishment of Dandenong to Crib Point Pipeline	Asset Owner	Envestra
Asset	Transmission Pipeline	Budget Account	Scope Change - CAPEX
Proposed By	Gerald Ramza	Priority Group	Priority 2 - Total Risk Score =76
Reviewed By	Jan Krzys	Step Change Category	
Approved By	Brian Fitzgerald		
Reference Documents

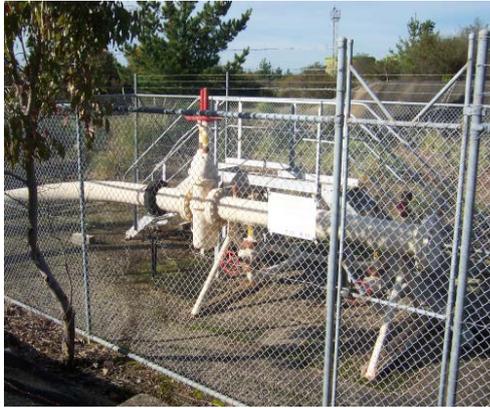
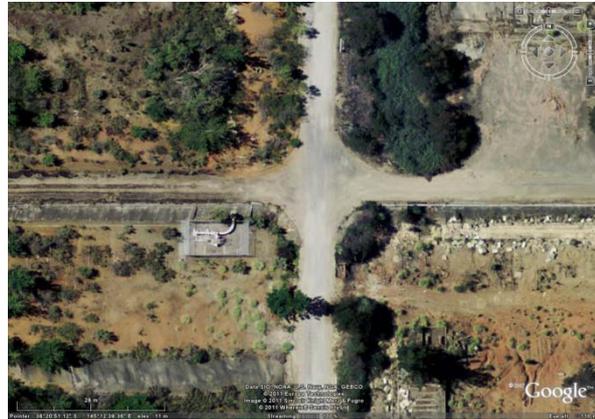
A major industrial installation (BP's Crib Point Refinery) has closed. This refinery took oil from tankers at the Crib Point Jetty. As a result of the Refinery closure, the last section of the DCP is unused, including the pig trap (Fig 1). It is proposed to cut back and abandon 1.4km of the 300mm DCP within the refinery.

Fig 1 Pig trap launch of DCP inside abandoned BP refinery Crib Point.

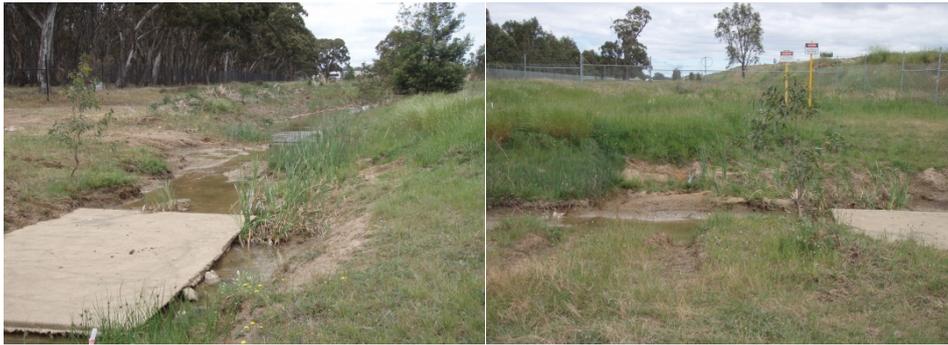
Annual special crossing (e.g. creek and bridge crossings) surveys are also conducted as part of the DCP integrity management program. Several maintenance issues have been identified which require additional operating expenditure to rectify, principally, pipeline cover has been eroded in the vicinity of National Drive, Dandenong South under the Melbourne Water drainage course (Fig 2). The top of the pipeline is protected from water scouring by a concrete slab, which has 100mm clearance from the pipeline.

Fig 2 Undermined scouring protection slab Melbourne Water Course National Drive

Recent heavy rains have undermined the pipeline which is at the edge of the slab and it is physically possible to touch the pipeline in the water from the top of the slab. Top of slab to top of pipe is approximately 300mm. Checks of the coating have shown no coating damage. However the pipeline will require lowering under this water course by approximately 1.5m and will require custom designed concrete channelling to provide protection when flash flooding occurs.

12	Complete all identified alterations required as a result of engineering survey to enable intelligent pigging of the pipeline.	600	
13	Lower Pipeline at National Drive water course	400	
14	Refurbish & upgrade all cathodic protection beds	247	Allow three units to be replaced \$53k each unit, one additional unit for additional protection, and one unit to be partially replaced at \$38k per unit.
15	New concrete scouring protection works (National Drive)	250	Nominal amount cost dependant on design advice and requirements of Melbourne Water
16	Total Capital Expenditure	7266	Note to put the total proposed project cost in perspective current pipeline in 39km long, to replace the pipeline would be approx. \$1540 per metre, total cost \$60 million.

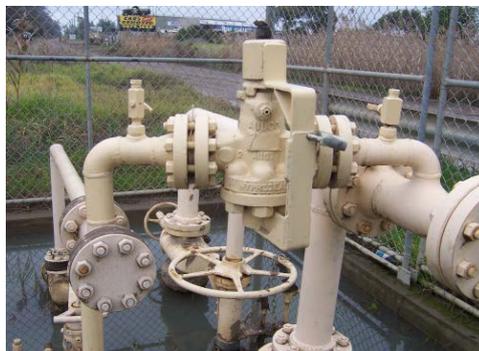
The line valve at Graydens Road, Hastings is located adjacent to the railway easement near Kanowna St which is an unmade road from which the pipeline can be accessed. This road has been graded and reformed a number of times such that its profile has been distorted and this causes flash flooding of the valve pit during heavy rain. Works are required in conjunction with the road authority to reconfigure the valve pit and its drainage protection. Sandblasting of the pipe-work and recoating of the valve installation is also necessary.

Fig 3: Graydens Road line valve installation

Description	Total \$K	Basis of costing
9	Recondition line valve installation at Graydens Rd and install drainage flood protection	100	Allowance depends on requirements of council and final drainage design. Is a nominal amount for design drawings council approvals, excavation and removal of valve concrete enclosure recoating of pipework and recast of new concrete with possibly additional roadworks.
10	Engage Contract Project Manager (Pipeline Engineer) for duration of project. Required for design basis, design life rating, ESV sign-off, and project liaison construction and remediation management for five years.	925	Allow \$185k per annum for five years, cost \$925k
11	Relocate launching and receiving pig traps & modify for IP.	200	Basis of estimate is recent experience in altering the 200mm transmission pipeline at Robinsons Rd for Peninsula Link Road works. Cost of project \$401k, \$600k has been allowed for item 2, it is anticipated that bypass works will be required to provide continuous supply of gas to Esso at Long Island Point, in order to install pigging bars which will allow the pigs to pass the branch line connection point.

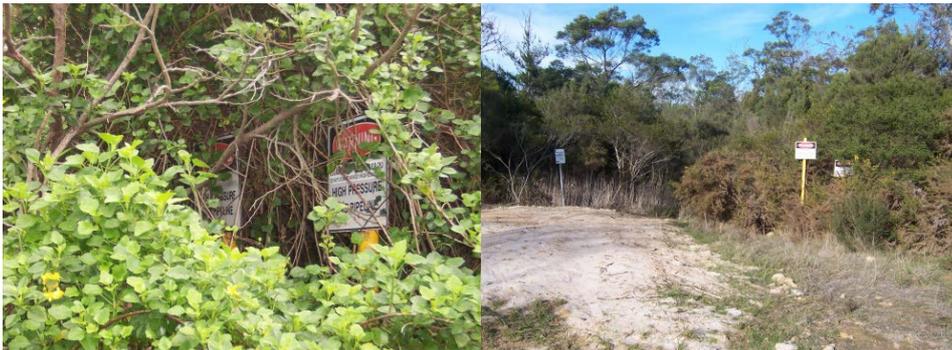
Sections of the DCP are located in environmentally sensitive areas where vegetation clearance over pipeline easements has been problematic, in particular a section of pipeline traversing the Warringine Creek reserves in Hastings and the Bittern Coastal wet lands. Refer to Figure 4 below.

Figure 4: Vegetation growth - Warringine Reserve

The Victorian Government's "Victoria's Native Vegetation Management - A Framework For Action" mandates that any vegetation losses must be balanced by commensurate revegetation elsewhere. This will add significant cost to clearing the DCP easements based on recent estimates of \$1m in net gain offsets for a proposed 7 km duplication of the DCP. Consequently, easement clearance has been severely constrained during the life of the DCP.

3	Clear easement vegetation including provision for vegetation offset costs Warringine Park & Bittern Coastal Wet Lands. Resign pipeline route as required	1200	First 20km of the existing Dandenong to Crib Point pipeline is in the process of being duplicated and will be duplicated to Robinsons Rd. No duplication is planned beyond this point. Within this duplication 7km of pipeline easement required vegetation net gain costs of \$1M, It is assumed that a similar amount has to be allowed for in the balance of 19km not yet cleared. This is a conservative estimate as the pipeline traverses Bittern Coastal Wet lands reserve and the Warringine Creek Reserves.
4	Cut back and abandon 1.4km of 300mm TP pipeline within refinery.	200	Typical cost for small alteration allows for stopple fittings \$75k,excavation labour, lamination testing, x ray welding labour, non-destructive testing of welds and certification prior to hot tap , degassing of abandoned pipe, and some removal costs
