## Business Case – Capital Expenditure less than \$500,000

### Crack Detection

#### Business Case Number 276

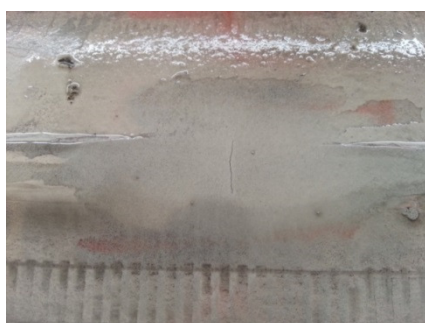
The test results revealed a cluster of cracks in the longitudinal weld directly below the wheel path of the vehicle traffic. All but one anomaly found were removed with a linisher with the larger anomaly determined to be a crack located in the transvers direction (running circumferentially across the longitudinal weld). It appears that the main cause of the crack formation was due to cyclic bending stress due to traffic loads where the pipeline has shallow cover.

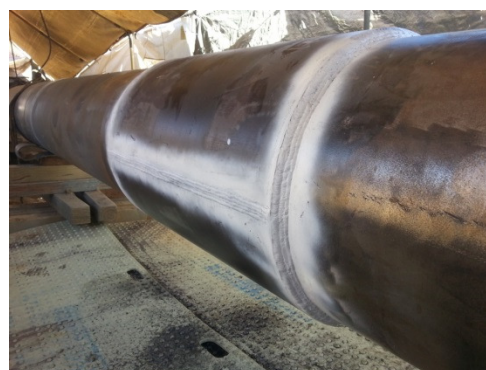
Further investigation was carried out with ultrasonic non-destructive testing to determine the extent of the crack. Results confirmed the crack was 4.5mm deep and approximately 12mm long across the longitudinal seam weld.

Engineering assessment recommended installing a Type B fully welded split sleeve to encase the crack for pressure retainment. This repair sleeve provides strength to fully support the pipeline and reinforce the longitudinal stresses in the axial direction along the pipeline required for a crack found in the circumferential direction.
