# Morphett Creek Main Line Valve Coating Assessment Report

Document No. BGS-RP-A-0006 Rev 0B				
File Path: G:\Major Projects\23.3_BGS_Below Ground Station Pipework Recoating\20. Coating Defect Analysis\Morphett Creek\BGS-RP-A-0006 Morphett Creek MLV coating assessment Rev B 190413.docx				
Author	Adam Nuske <i>Adam Nuske</i>			
Report Checked by				
Report Approved by	<i>STEPHEN DYNES</i> <i>Stephen Dynes 22/4/13</i>			
Changes to be approved by				
Version control	Date	Version	Nature of Change	Approved by (Name)
	19/04/2013	0B	Final

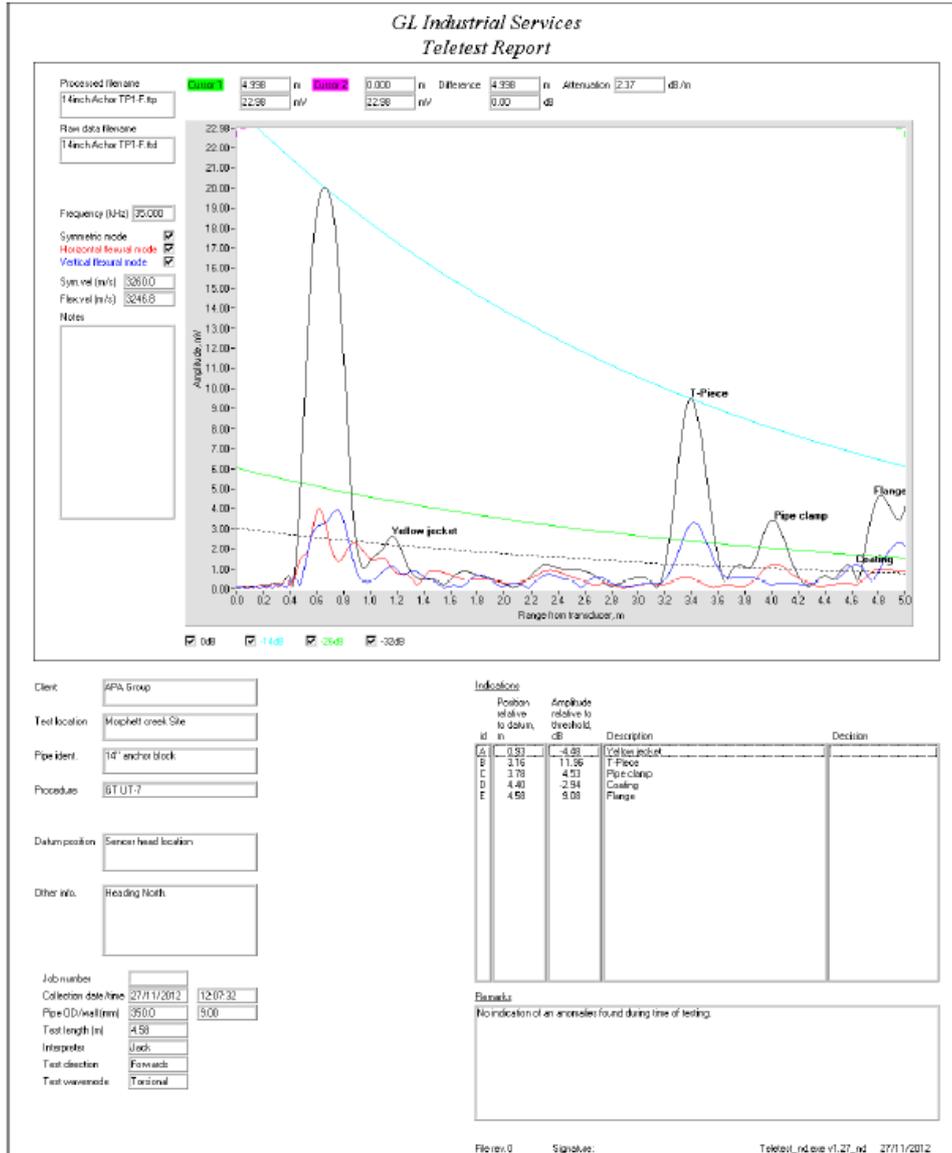
Test Point 1 Line ID: 14" Morphett creek anchor block

#### **Test Point 1**

Test Point 1 is the forward LRUT shot at Morphett Creek MLV. The concrete support block begins 2.45m from the sensor head and as shown in the results of Appendix 4 there are no anomalies detected from this point onwards for this shot. The T-piece was detected at 3.16m, a pipe clamp was detected at 3.78m, some minor coating related result at 4.40m and the MLV at 4.58m.

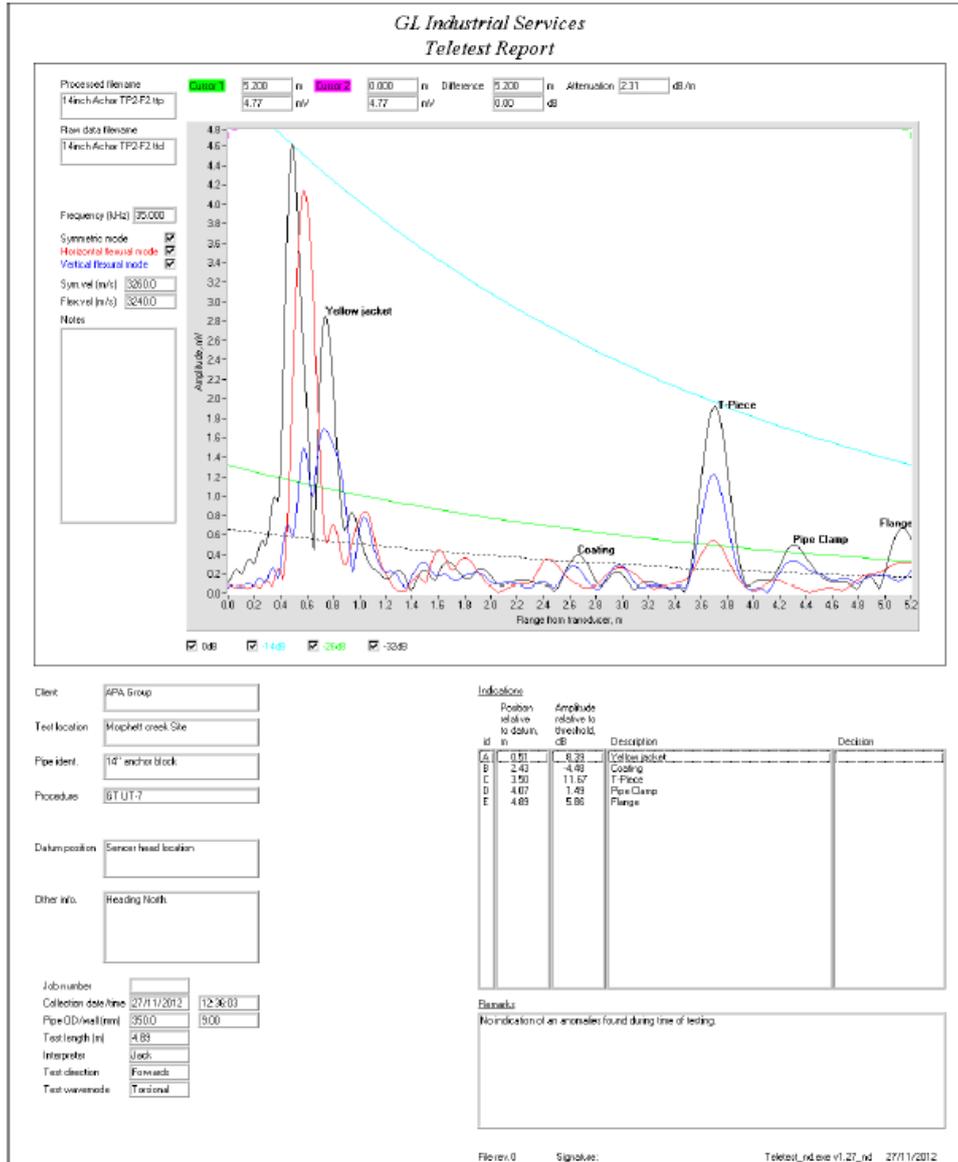
Test Point 2 Line ID: 14" Morphett creek anchor block

## Test Point 2

Test Point 2 is a forward shot at Tindal looking at the north support block. The concrete support block begins 2.7m from the sensor head as shown in the results of Appendix 4, the T-piece was detected at 3.5m and a reading from the pipe clamp is shown at 4.07m. The MLV was correctly detected at a range of 4.9m. There was no reported coating defect or corrosion evident during blasting.
