Warrego Scraper Station

Coating Assessment Report

Document No. BGS-RP-A-0009 Rev 0A				
File Path: \\falcon\exword\2012\12109\Engineering\APA Project Folders - 130513\23.3_BGS_Below Ground Station Pipework Recoating\20. Coating Defect Analysis\Warrego\BGS-RP-A-0009 Warrego coating assessment Rev 0A.docx				
Author	Adam Nuske <i>Adam Nuske</i>			
Report Checked by				
Report Approved by				
Changes to be approved by				
Version control	Date	Version	Nature of Change	Approved (Name) by
	10/07/2013	0A	Final	<i>Stephen [Signature]</i>

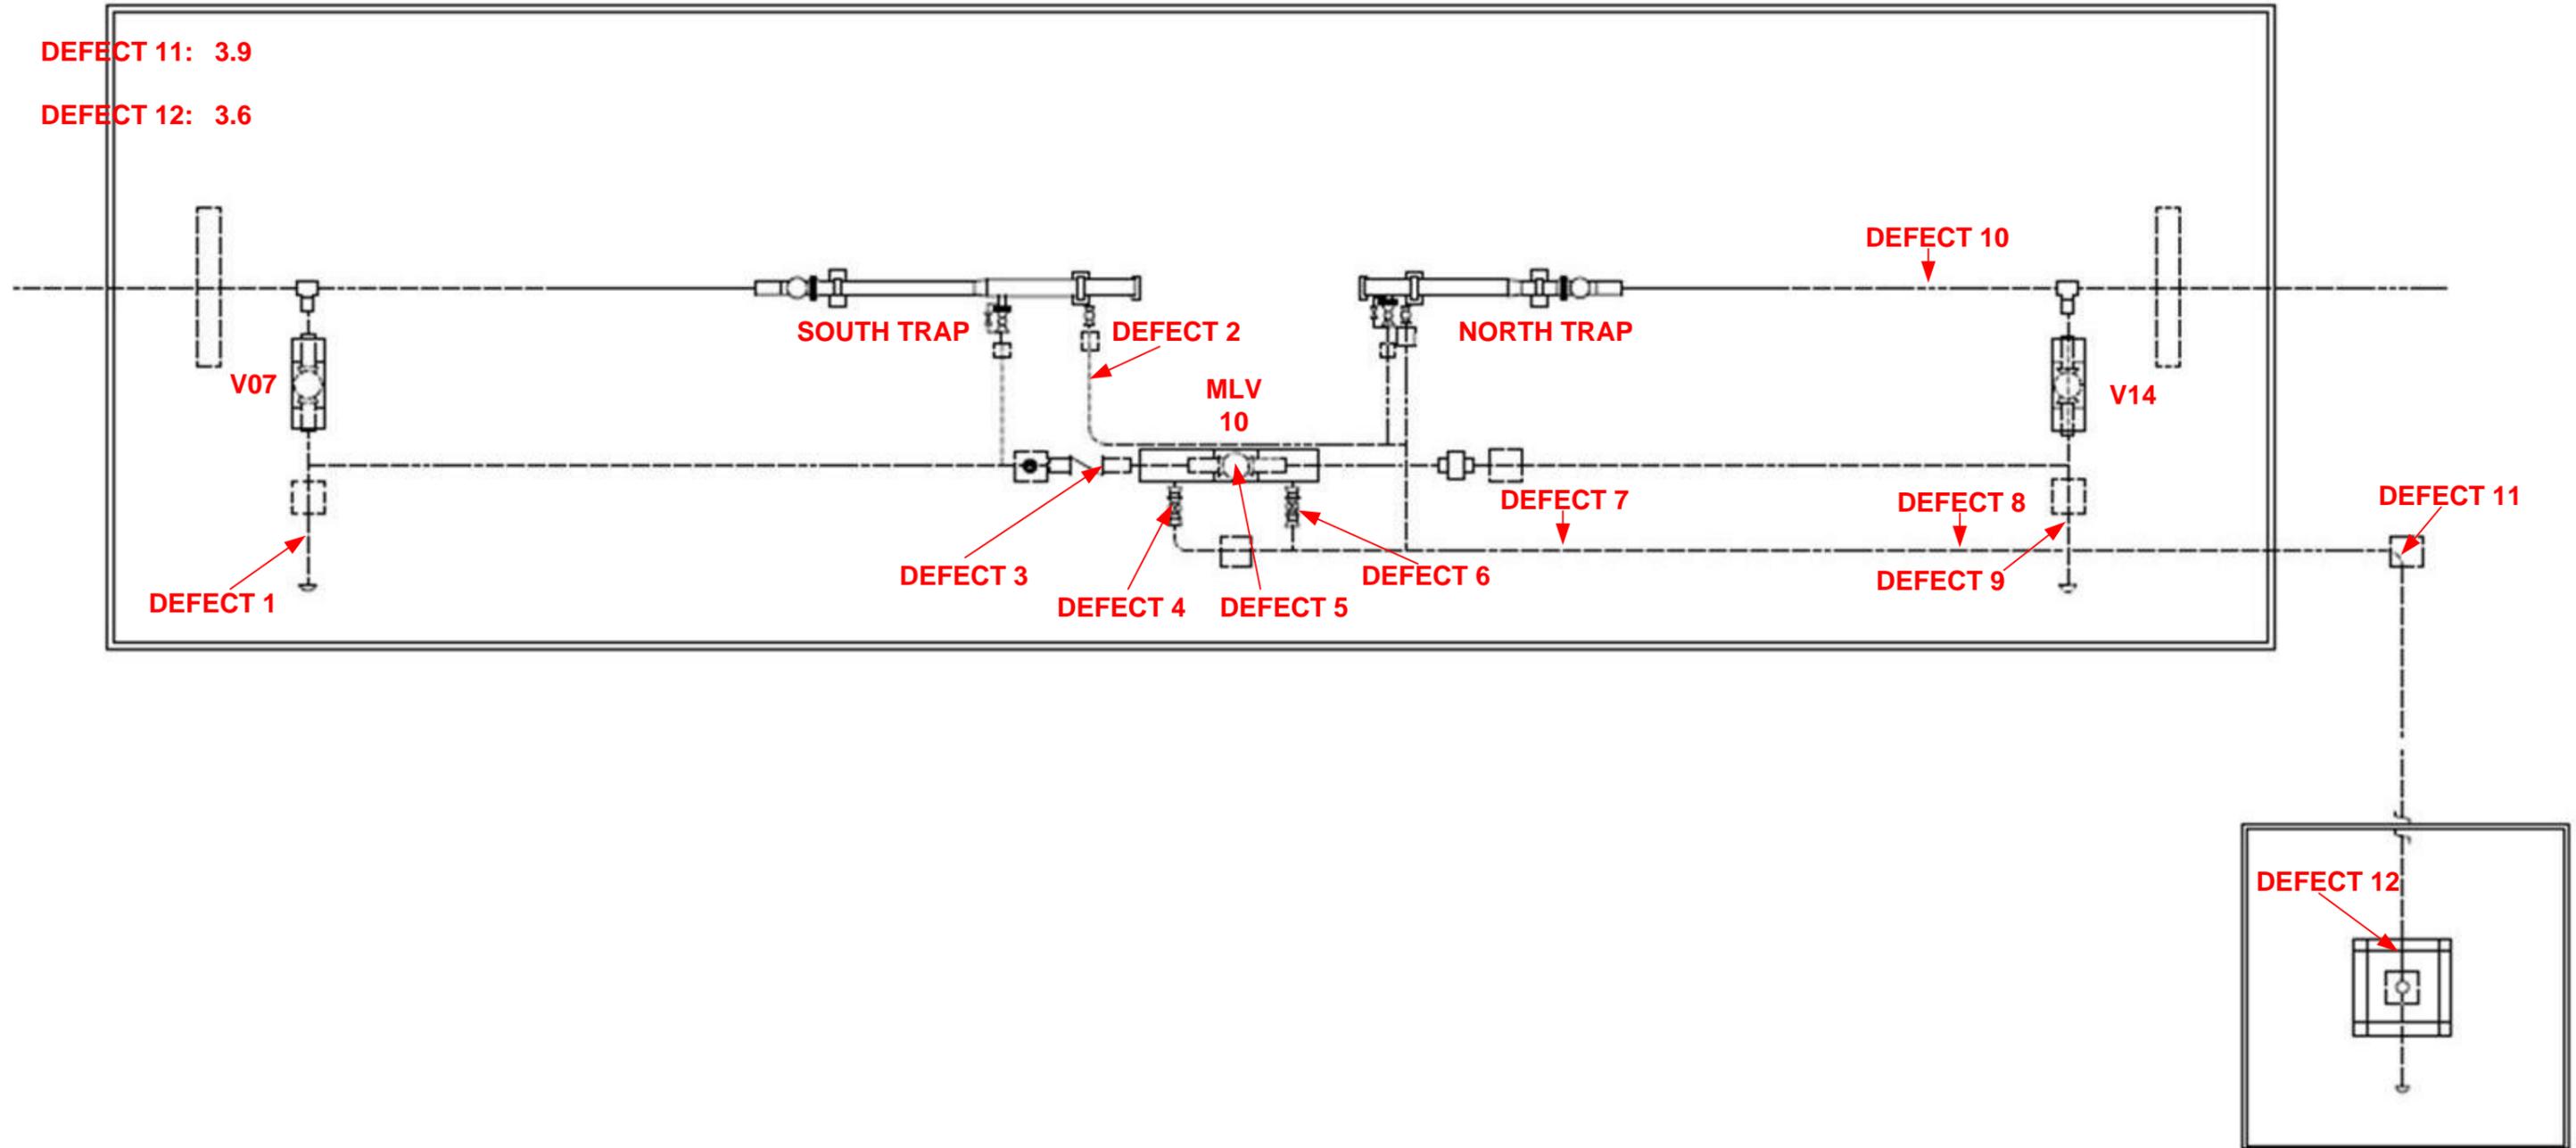
WARREGO DCVG SURVEY

There were 12 areas highlighted as having coating defects by the DCVG survey. These defects are summarised in Table 1 below. Locations of each defect are shown on the drawing in Appendix 1.

DCVG Defect #7, 9 and 12 were not related back to specific defects found in the coating during dig-up, and yet were relatively high %IR readings. DCVG Defect #9 and 12 detections were around concrete support blocks however, therefore there could be a detected defect within the support block. The risk of severe corrosion within these concrete blocks is low, despite making for ideal CP (Cathodic Protection) shielding structures, as the block is securely sealed where the pipe enters and exits the concrete blocks.

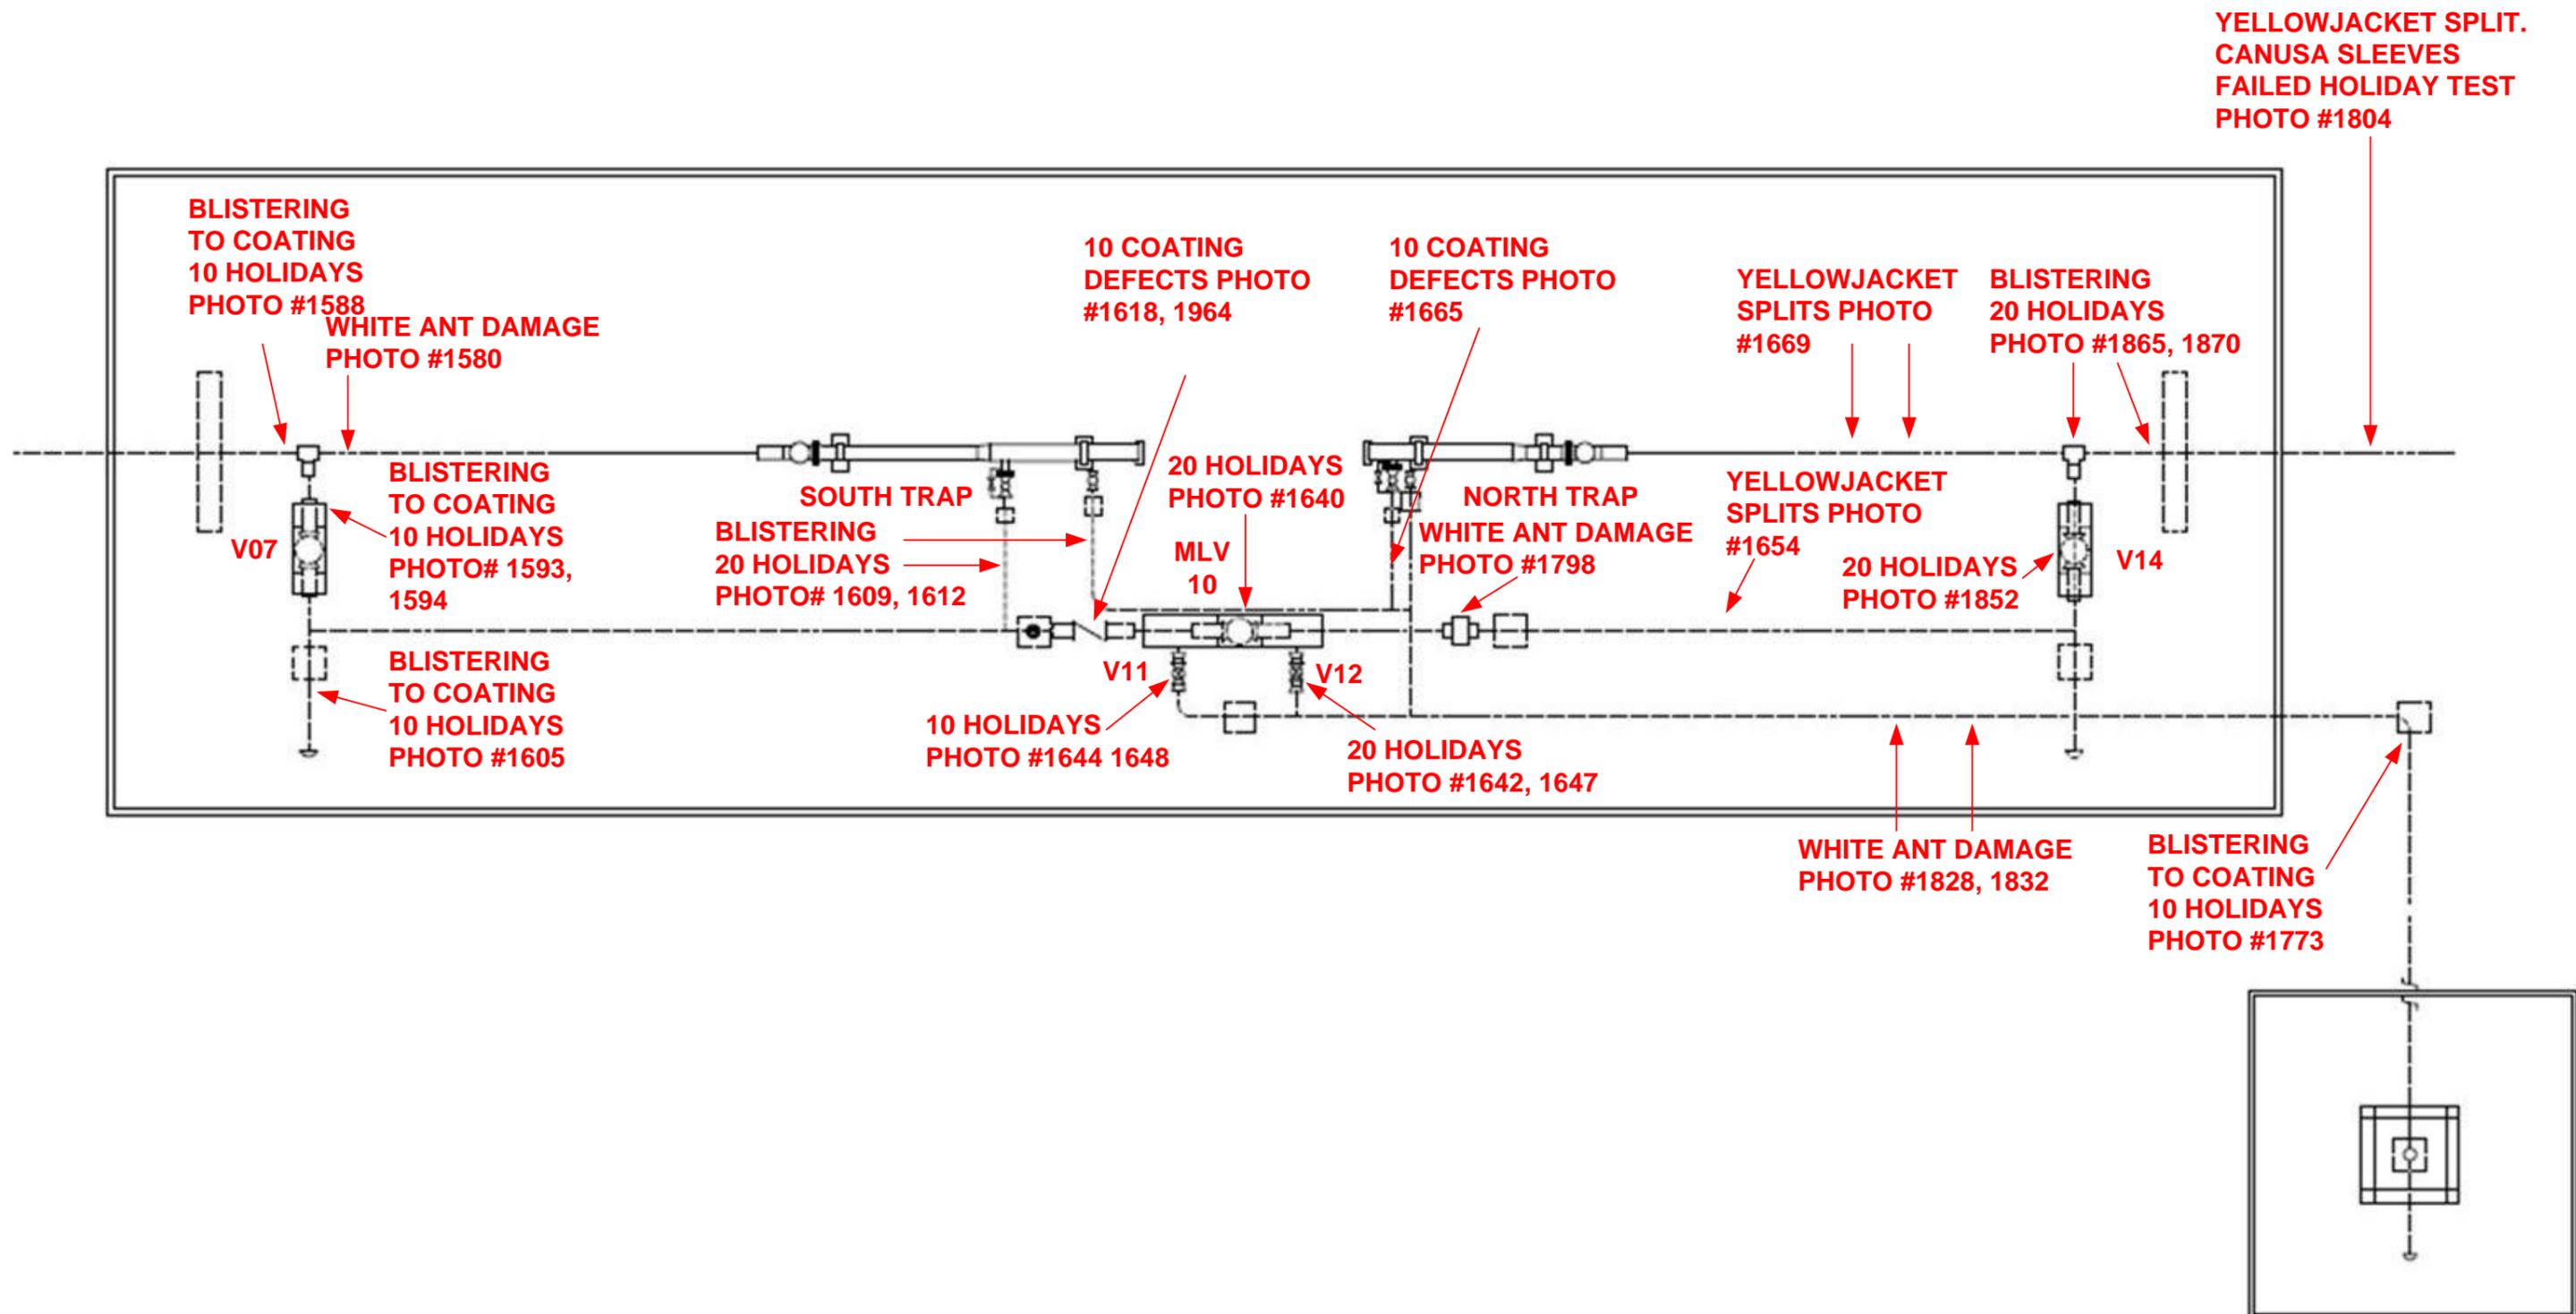
WARREGO COATING DEFECT – VISUAL INSPECTION & HOLIDAY DETECTOR RESULTS

A significant amount of the coating found at Warrego was in poor condition. Many areas of coating were found to be blistering and the coating in places was cracked and pulling away from the pipework. Recorded coating defects have been illustrated on the Warrego Coating Defect layout drawing in Appendix 2. Areas of coating found to fail a holiday test were circled with white paint (refer photos). Some specific examples include:

- Blistering on the southern tee (photo 1588).
- White ant damage to the south tee, MIJ (Monolithic Insulating Joint) and blowdown line (photos 1580, 1798, 1828 and 1832).
- North pig receiver yellowjacket split (photo 1669).
- North side of north anchor block yellowjacket split (photo 1804).
- North side of MLV yellowjacket split (photo 1654).
- Blowdown line 90° elbow concrete support block blistering (photo 1773).

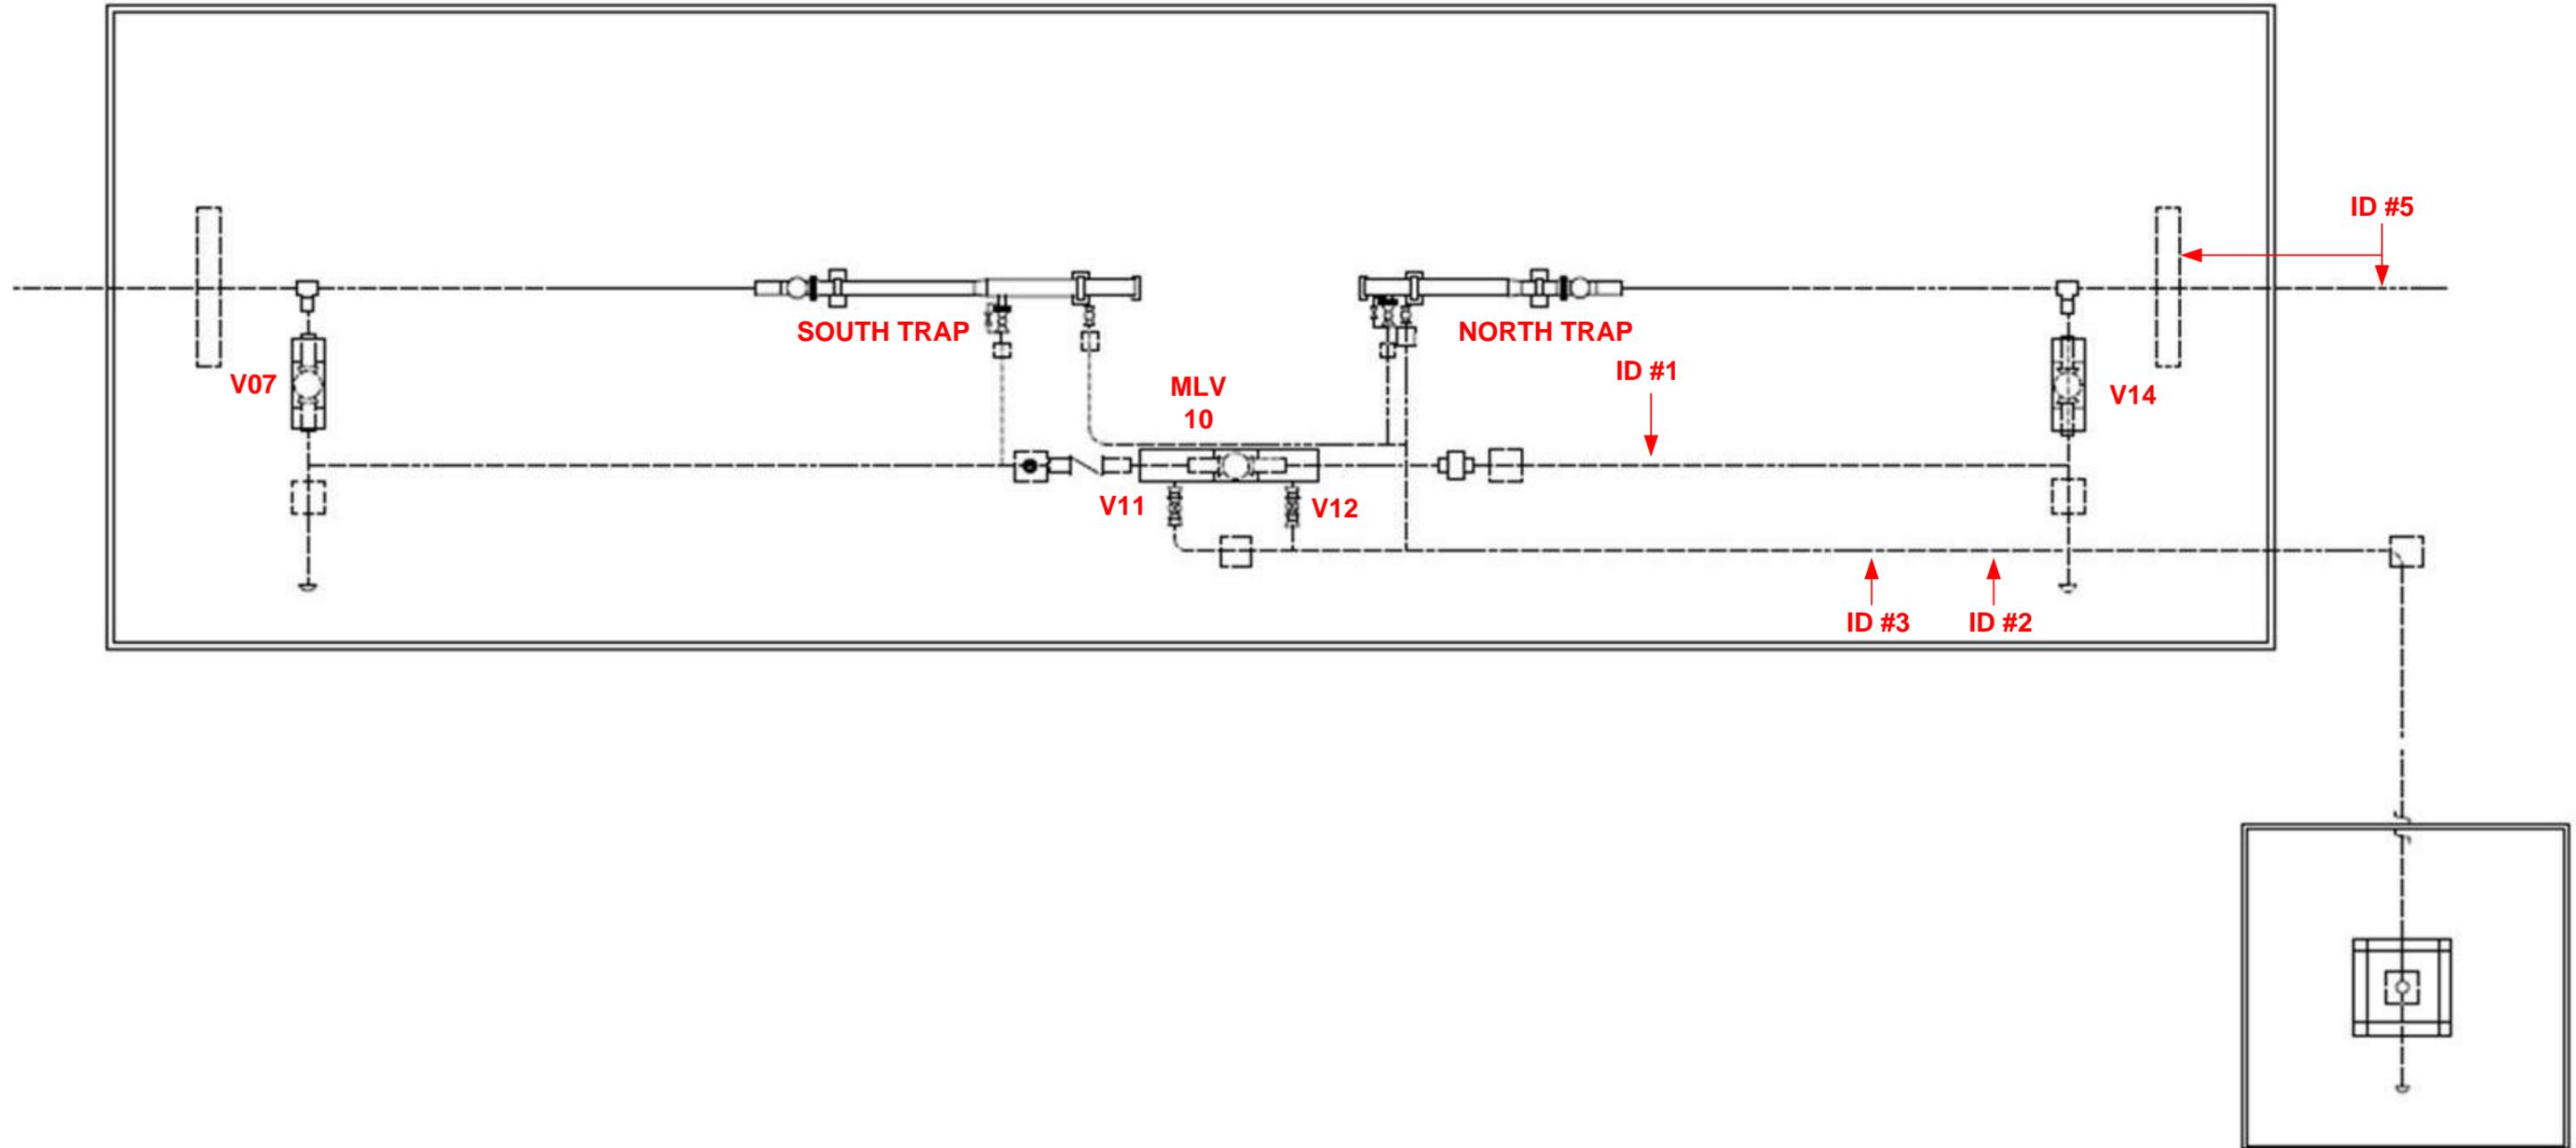
WARREGO METAL LOSS RESULTS

There were 4 areas of metal loss found on the pipework at Warrego. Of these 4 areas containing metal loss, all 4 areas had visible coating defects. The metal loss section of the coating damage assessment form was filled out for each defect – refer to 0.

The corrosion that has occurred at metal loss ID #2 and #3 was in an area where the coating type was tape wrap. Coating defects caused by termite damage were also located nearby which allows for electrolyte migration underneath the coating along the pipe metal surface. The pipe was wrapped circumferentially, and corrosion occurred axially to the pipe for ID #3 and circumferentially for ID #2. This indicates moisture ingress through the tape wrap defect has collected some distance away from where the corrosion subsequently occurred, shielded by the tape wrap from CP.

Metal loss ID #1 occurred underneath a canusa sleeve over a girth weld. The corrosion seen is typical of that seen underneath canusa sleeves; pitting corrosion spanning the circumference of the pipe for the length of the canusa sleeve. The corrosion mechanism is shielding type, with the canusa sleeve acting as the CP shield.

Metal loss ID #5 is most likely to be due to very localised pit corrosion resulting from shielding underneath the canusa sleeve. The coating damage assessment form for ID #5 identifies moisture underneath all of the canusa sleeves in the area including the one with corrosion underneath it. The dis-bondment of the canusa sleeve at the pit site is considered to have resulted in the localised shielding and pit corrosion which has occurred. The appearance of the pit corrosion here is not consistent with pit corrosion evident beneath yellowjacket or tape coating systems generally found elsewhere, it is similar to the pit corrosion found at V14 at Newcastle Waters. Shielding normally results in a very uniform corrosion rate during periods when the local environment is corrosive and cathodic protection currents cannot reach the site to prevent the corrosion.

COATING DAMAGE ASSESSMENT REPORT ID#	DEFECT DIMENSION (mm) LxWxDDEPTH O'CLOCK POSITION ON PIPE	CAUSE OF METAL LOSS
1	220 x AROUND PIPE x 0.55	CORROSION
2	8x12x0.80 3 O'CLOCK	CORROSION
3	30x5x0.61 2:30 O'CLOCK	CORROSION
5	8x5x2.28 6 O'CLOCK	CORROSION

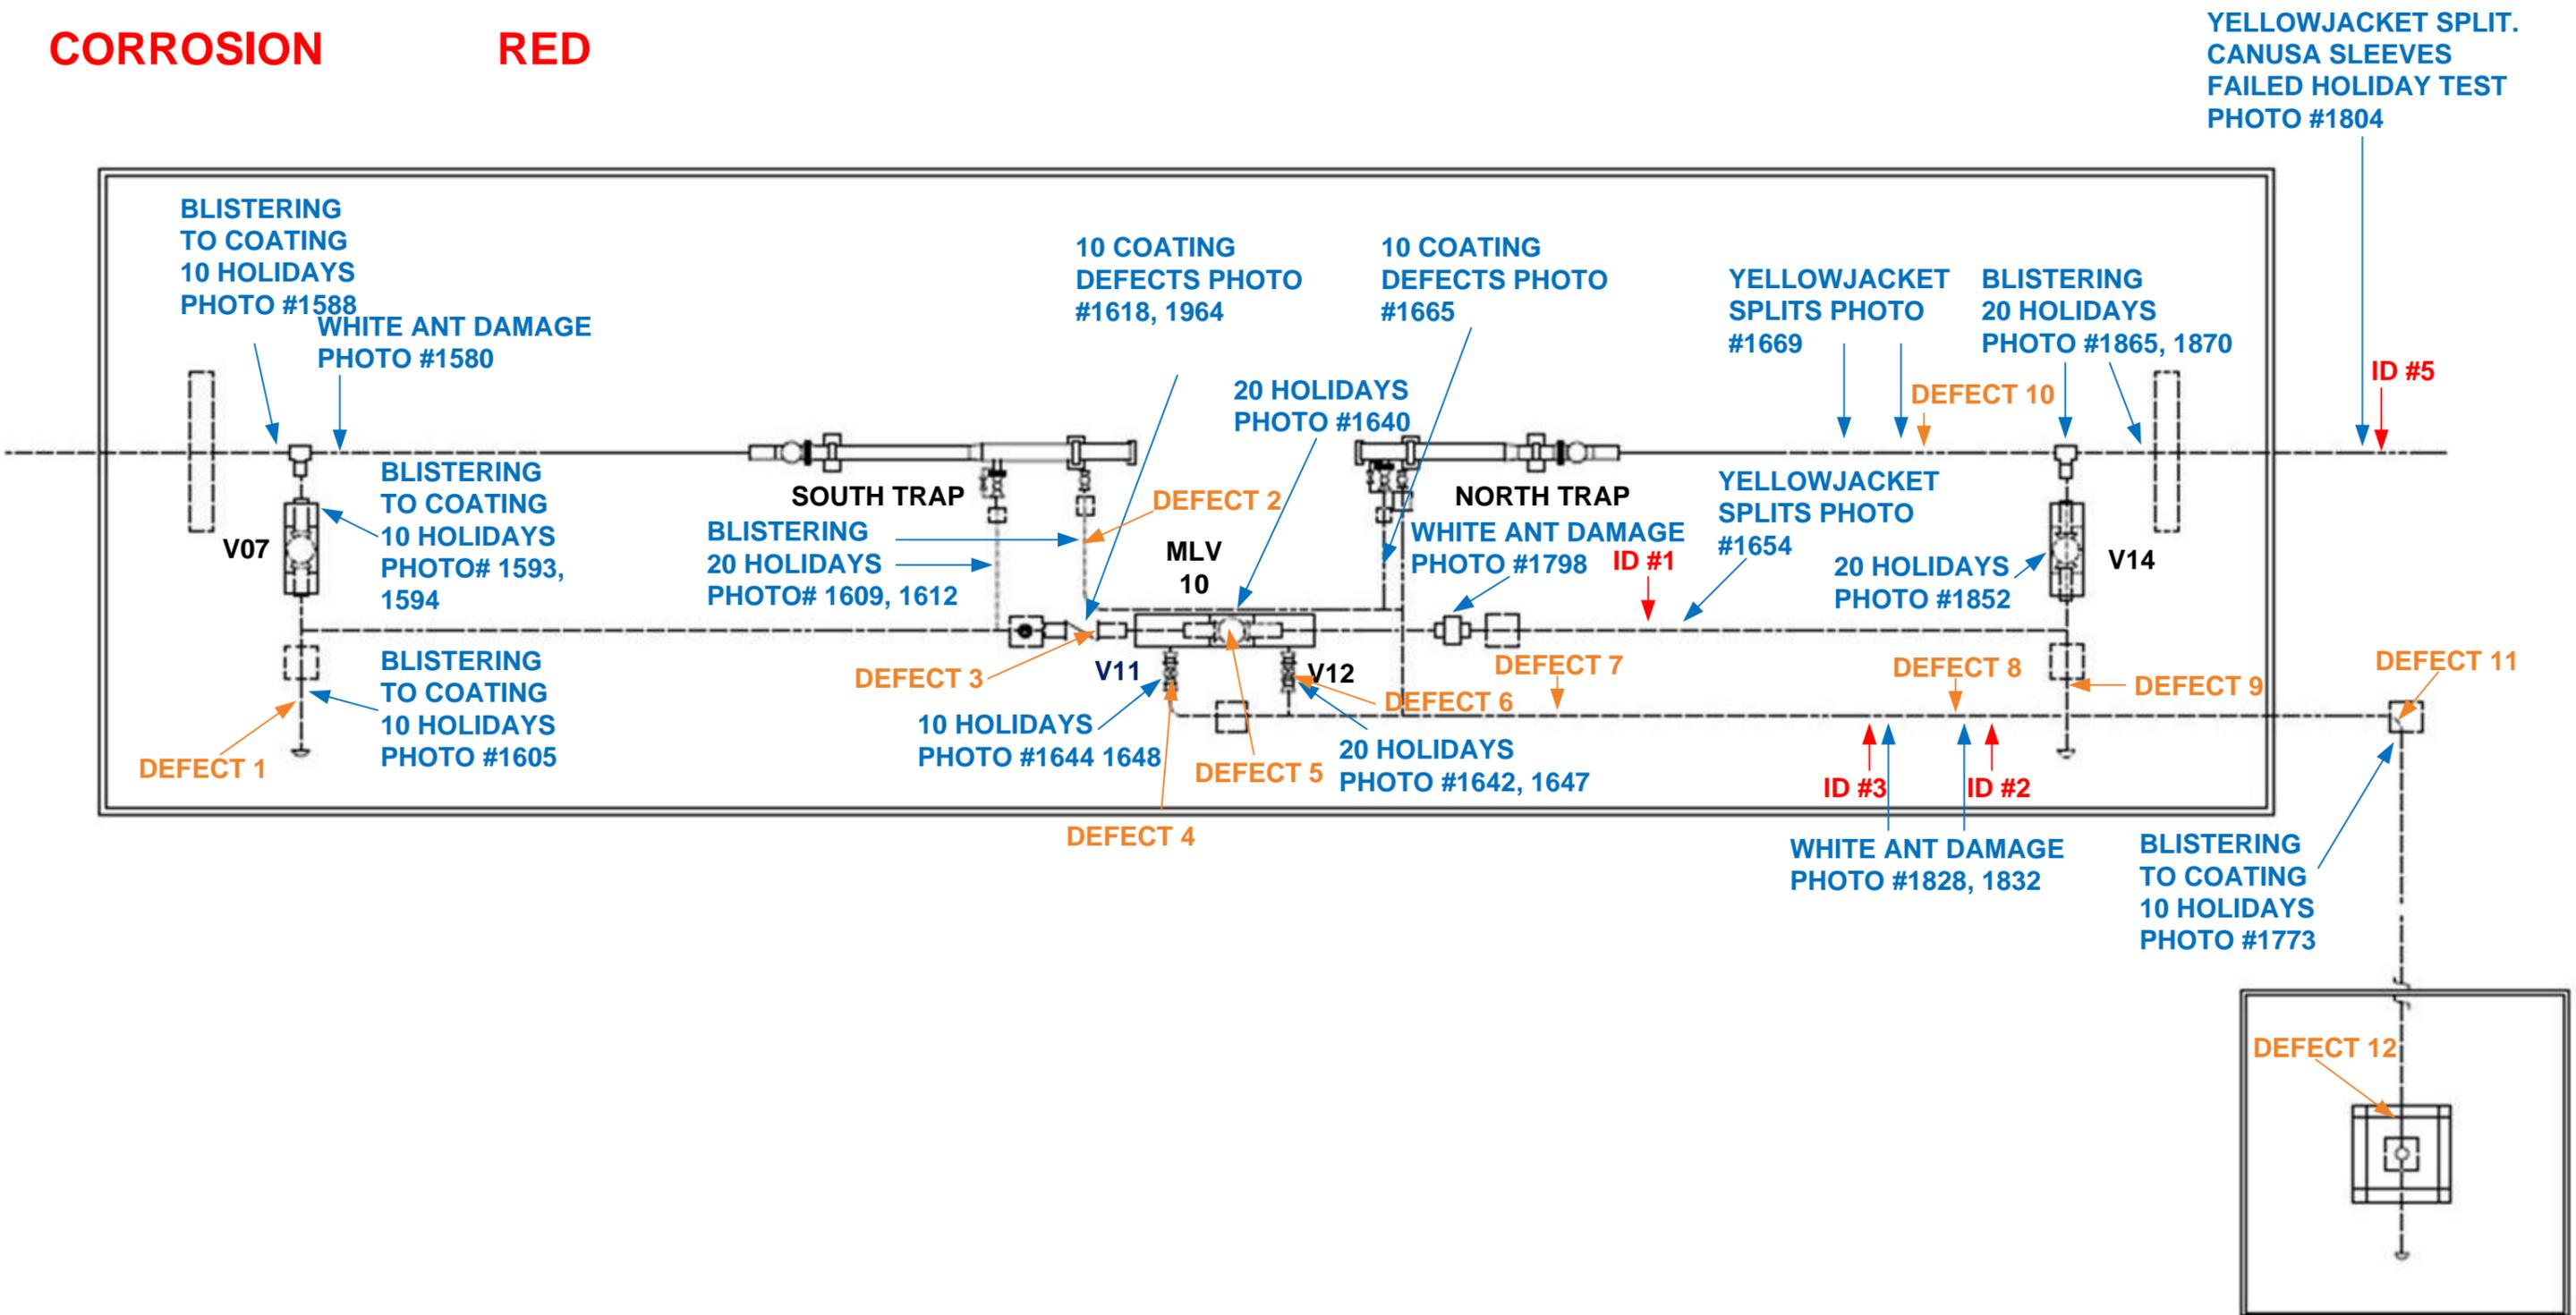
WARREGO DCVG, COATING DEFECTS & METAL LOSS

Compiling the results of DCVG, coating defects noted and corrosion found at Warrego it should be possible to determine and links between the three sets of results. A complete set of results for the DCVG, Coating Defects and Metal loss is included in the Warrego DCVG, Coating Defects and Metal Loss layout drawing of Appendix 1.

The DCVG survey discovered CP leaks which have been referenced back to coating defects found during the dig-up as described in Table 2 and referenced photos of Appendix 1. However, DCVG failed to find blistering on the TEE downstream of V07, blistering around the concrete support downstream of V07, blistering on the south and north trap kicker line, white ant coating damage to the MIJ, the yellowjacket split north of the MIJ, V14 blistering, blistering around the north anchor block and a yellowjacket split north of the northern anchor block.

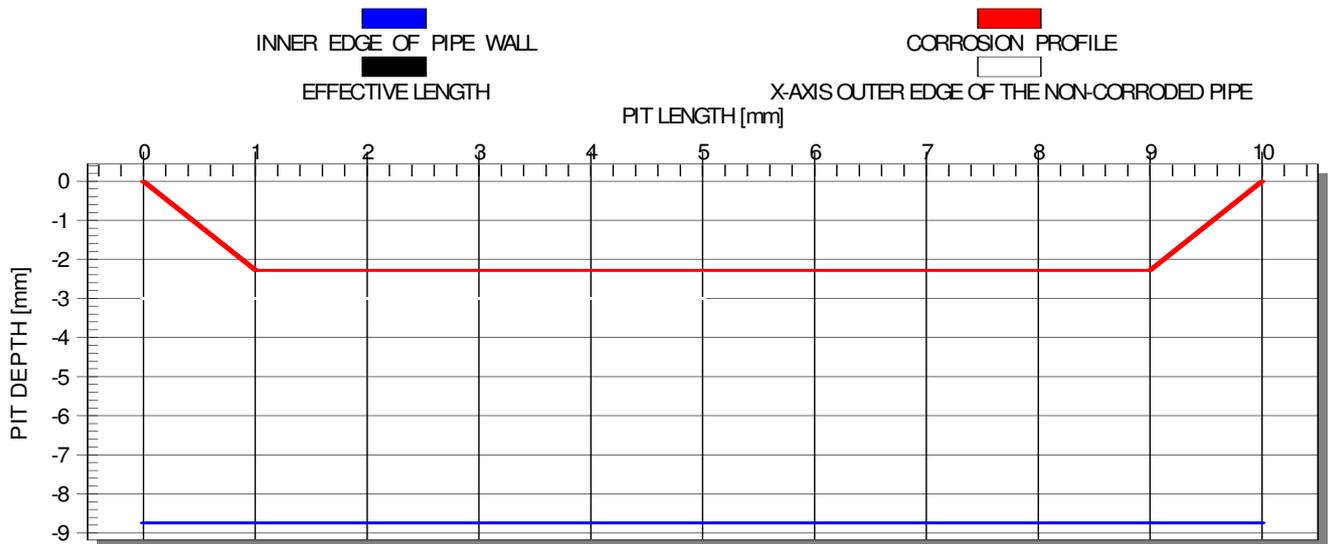
CORROSION PROFILE:

RSTRENG analysis was completed over the more severe area of corrosion to the north anchor block. The pipe wall thickness in the area is 8.74mm (refer to Appendix 1) and the Coating Damage Assessment metal loss form issued from site (Appendix 2) indicates the maximum pit depth of 2.28mm, 8mm axial length and 5mm circumferential length. The results of the RSTRENG analysis indicate that the pipeline passes for the current Maximum Allowable Operating Pressure (MAOP) of 9,650kPag (refer to Appendix 4). The AGP design factor is 0.72 which translates to a required safety factor of 1.39 and the RSTRENG results satisfy this case.

METHOD	Max.Safe Pressure [kPa]	Burst Pressure [kPa]	Safety Factor
RSTRENG - Effective Area	14617	23619	2.45
RSTRENG - 0.85dL	14617	23624	2.45
ASME B31 G	14617	22273	2.31

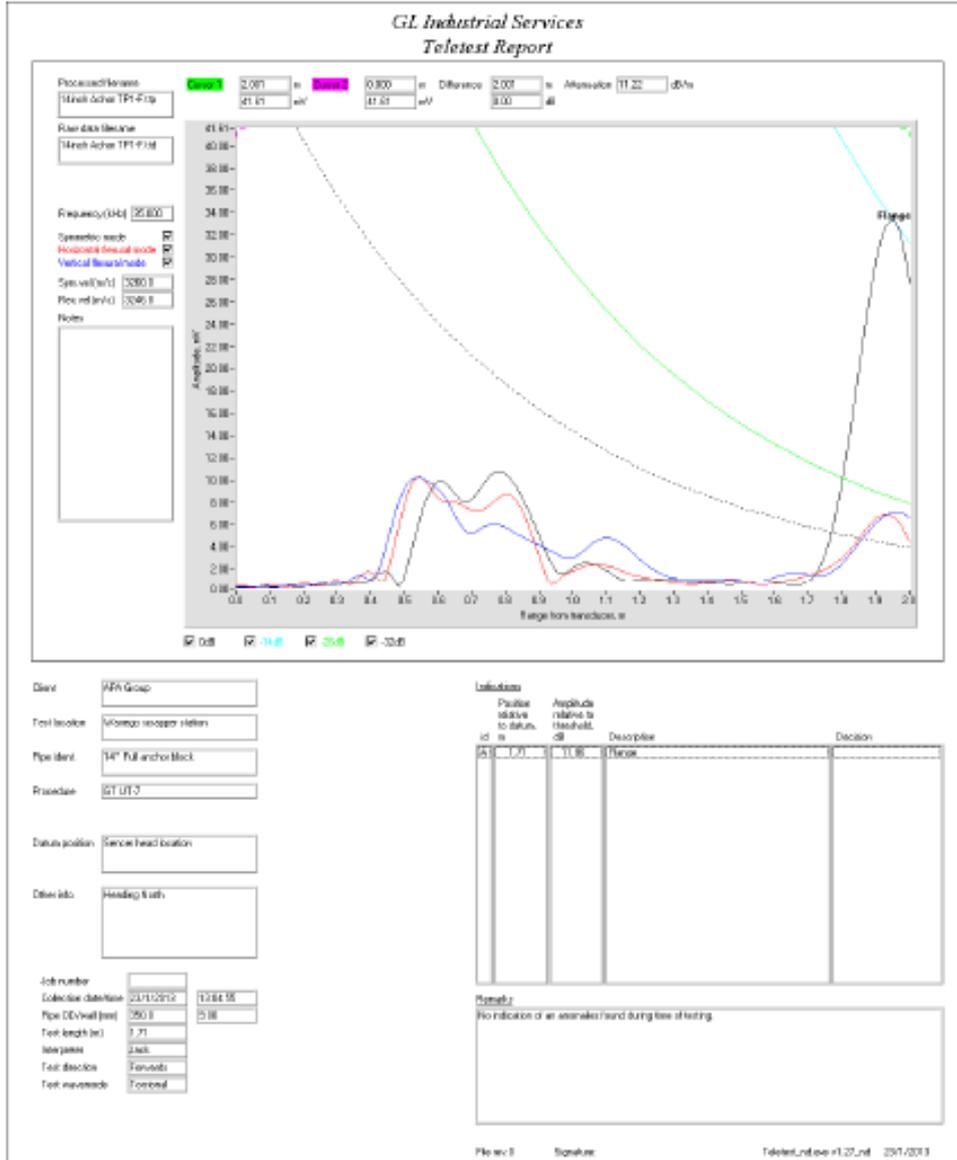
Test Point 1 Line ID: 14" Warrego scapper station

Test Point 1 is the forward LRUT shot at Warrego's south concrete anchor block, looking north. The concrete anchor block begins 1.4m from the sensor head as shown in the results of Appendix 5. There are no anomalies detected from this point onwards for this shot. The flange within the block was detected at a distance of 1.71m, 310mm into the block. Corrosion was not identified within the concrete block.

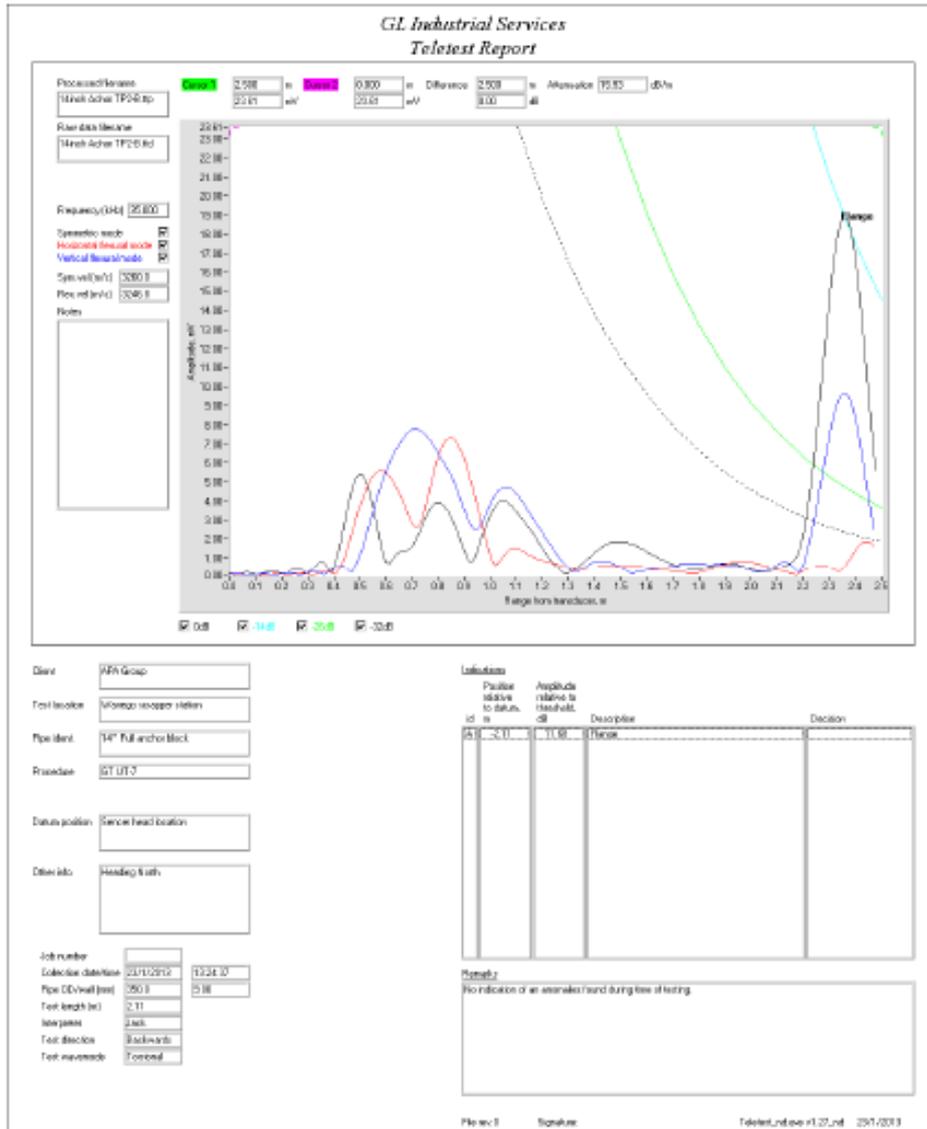
Test Point 2 Line ID: 14" Warrego scrapper station

Test Point 2 is a backward LRUT shot at Warrego's south concrete anchor block, looking south. The concrete anchor block begins 1.8m from the sensor head as shown in the results of Appendix 5. The flange was detected at -2.11m which is 310mm inside of the block. Corrosion was not identified within the concrete block.

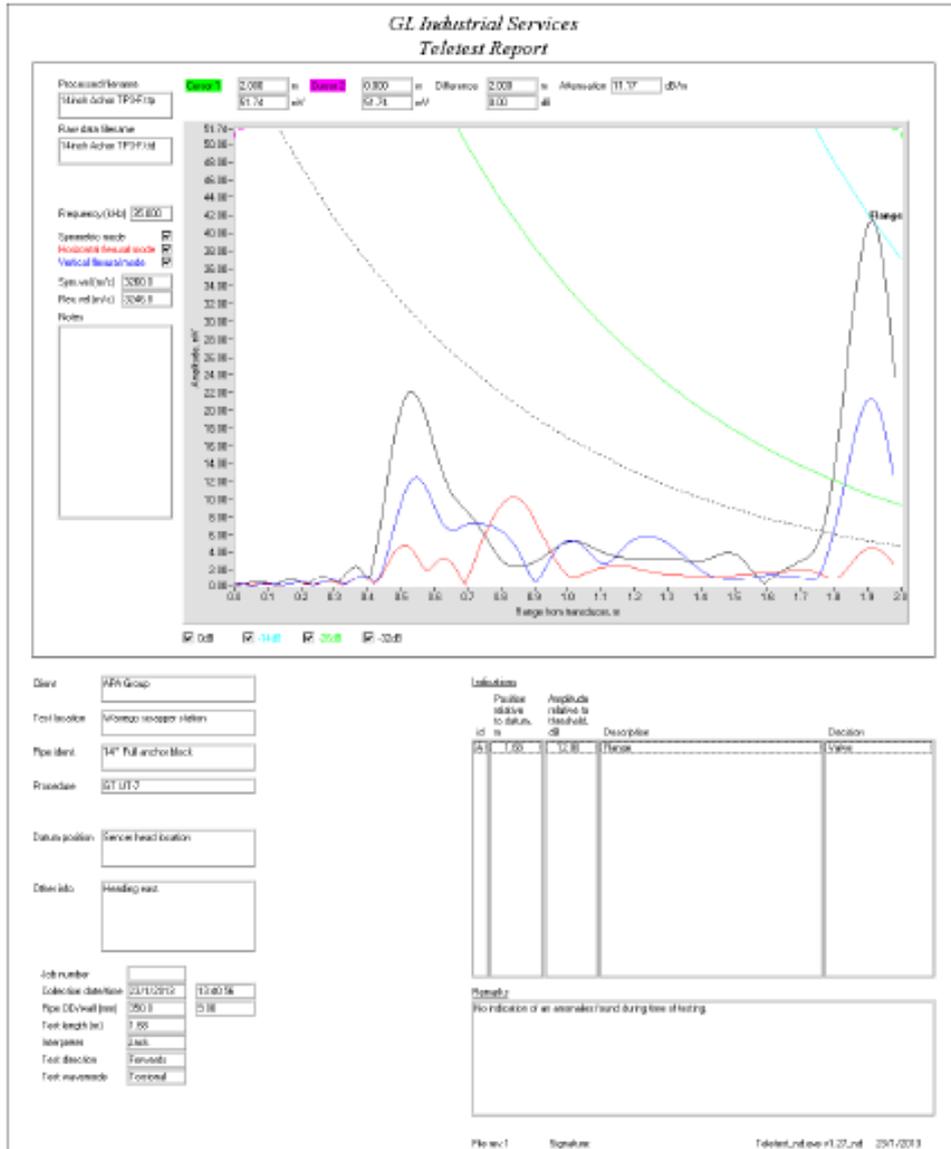
Test Point 3 Line ID: 14" Warrego scrapper station

Test Point 3 is the forward LRUT shot at Warrego's V07 concrete support block, looking east. The body of V07 is 1.7m from the LRUT device with the concrete support block in-between. As shown in Appendix 5 there are no anomalies detected within the concrete support block. The valve body was identified at a distance of 1.68m. Corrosion was not identified within the concrete block.

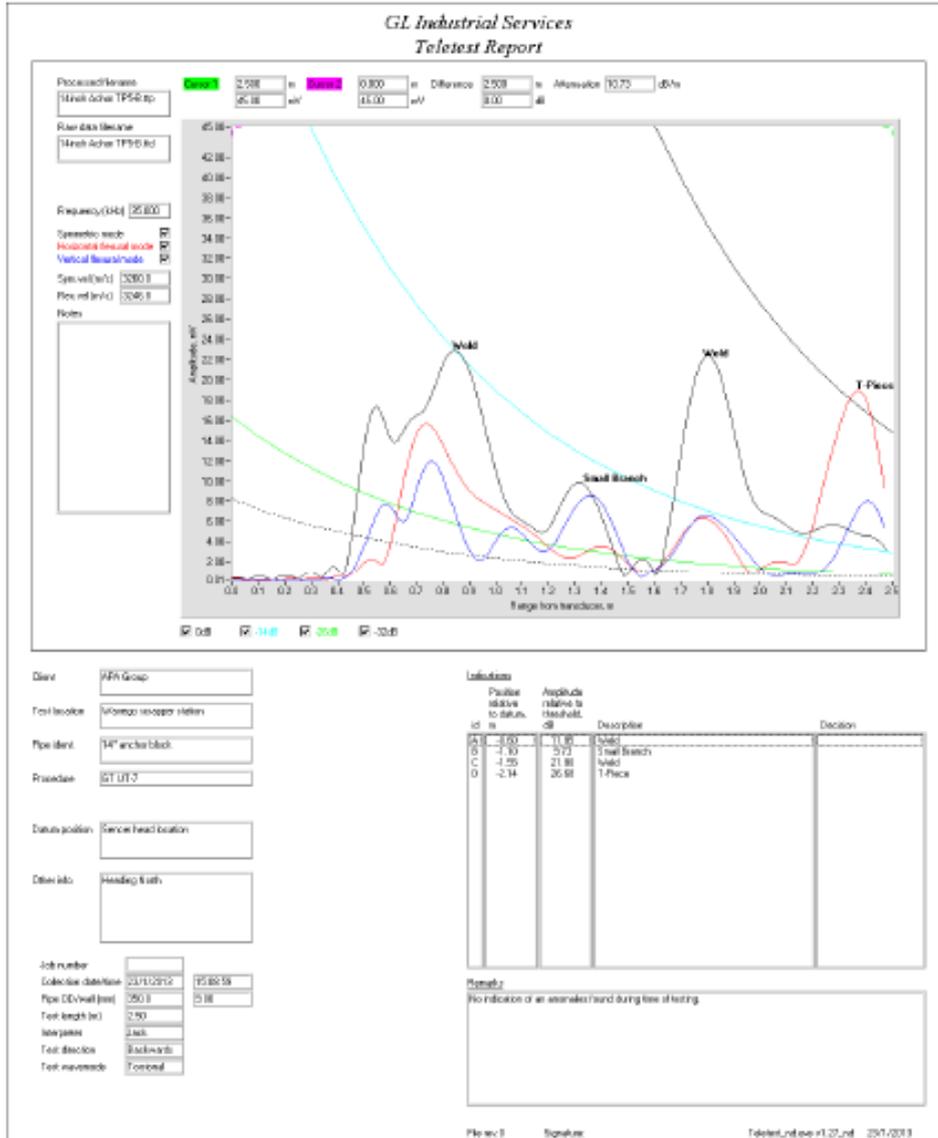
Test Point 5 Line ID: 14" Warrego scapper station.

Test Point 5 is the backward LRUT shot at Warrego's NRV concrete support blocks, looking south. The LRUT has detected 4 significant anomalies identified as a weld at 0.6m, a vertical branched tee at 1.10m, a weld at 1.55m and the horizontal kicker line tee at 2.14m. Photo 1765 of Appendix 3 confirms the position and identification of these fittings and welds. Corrosion was not identified within the concrete block.

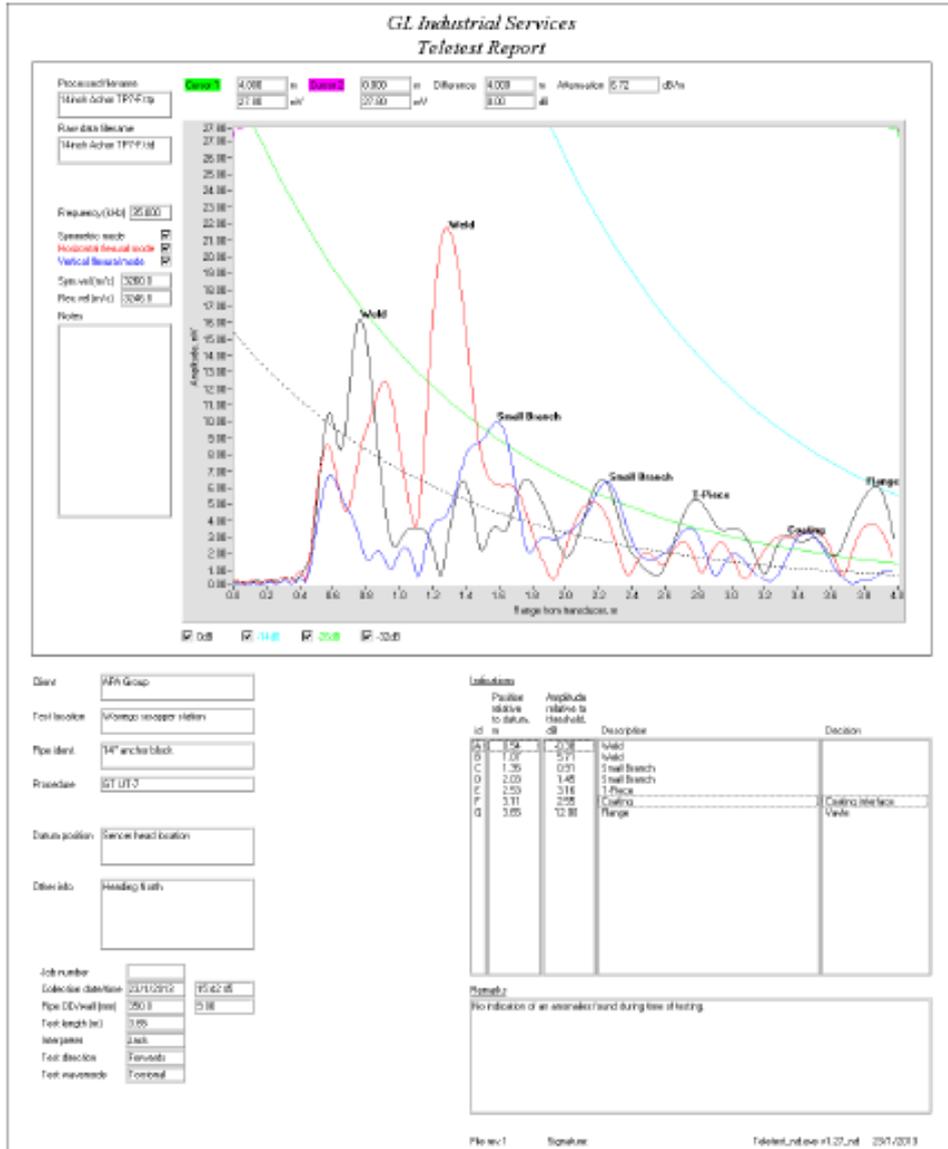
Test Point 7 Line ID: 14" Warrego scrapper station

Test Point 7 is the forward LRUT shot at Warrego's MLV north concrete support block, looking south. The LRUT has detected 7 significant anomalies identified as a weld at 0.54m and 1.07m, two vertical branched tees at 1.35m and 2.03m, a horizontal tee at 2.53m, a coating anomaly at 3.11m and the valve body at 3.65m. Photo 1991 of Appendix 3 confirms the position and identification of these fittings and welds, and the coating anomaly is identified as the interface between the rock guard and the CTE coating – no corrosion was identified. Corrosion was not identified within the concrete block.

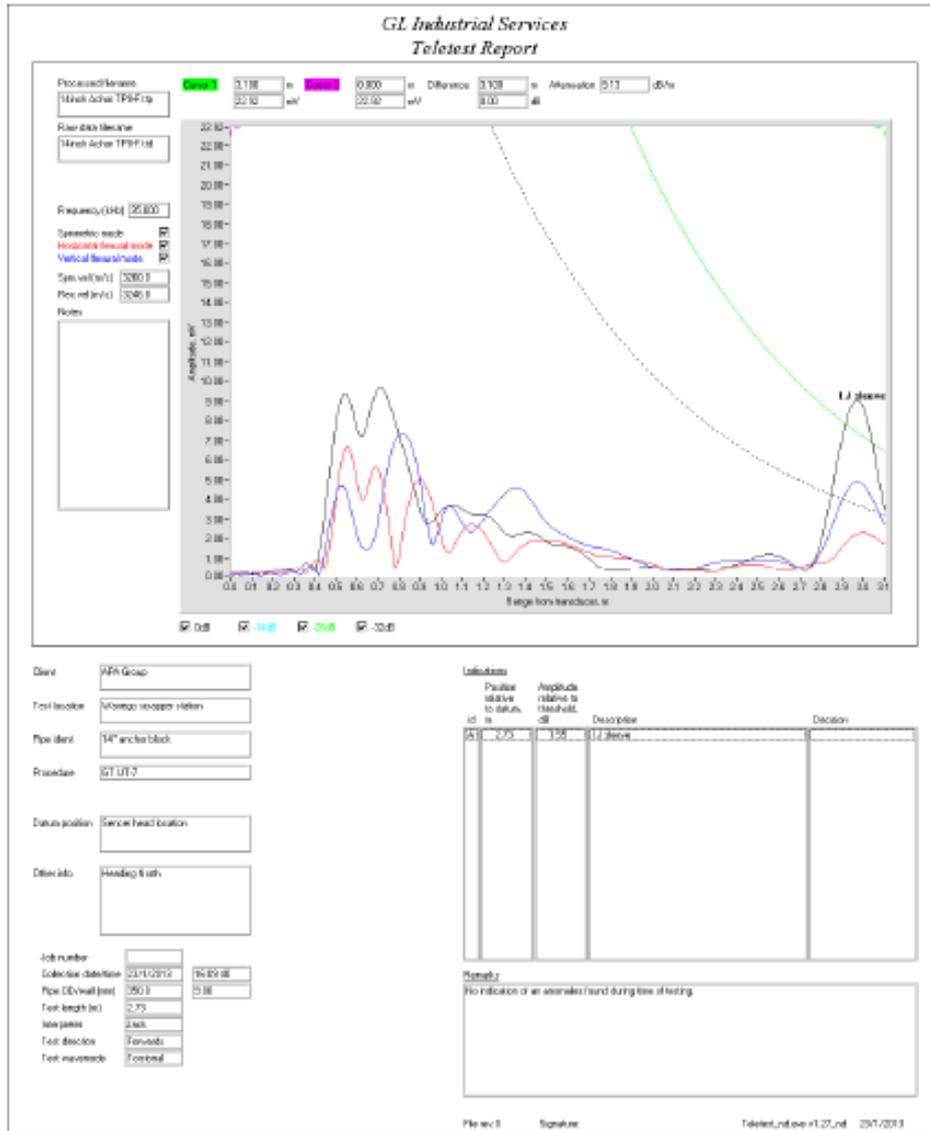
Test Point 8 Line ID: 14" Warrego scapper station

Test Point 8 is the forward LRUT shot at Warrego's MIJ north concrete support block, looking south. The LRUT has detected no significant anomalies between the concrete support block 1.3m from the LRUT device and the MIJ which was detected at 2.73m. Photo 1639 of Appendix 3 and drawing AD0610-6004 Rev. 0 confirms the detected distance between the concrete block and the MIJ. Corrosion was not identified within the concrete block.
