Warrego Scraper Station

Coating Assessment Report

Document No. BGS-RP-A-0009 Rev 0A				
File Path: \\falcon\exword\2012\12109\Engineering\APA Project Folders - 130513\23.3_BGS_Below Ground Station Pipework Recoating\20. Coating Defect Analysis\Warrego\BGS-RP-A-0009 Warrego coating assessment Rev 0A.docx				
Author	Adam Nuske <i>Adam Nuske</i>			
Report Checked by				
Report Approved by				
Changes to be approved by				
Version control	Date	Version	Nature of Change	Approved (Name) by
	10/07/2013	0A	Final	<i>Stephen [Signature]</i>

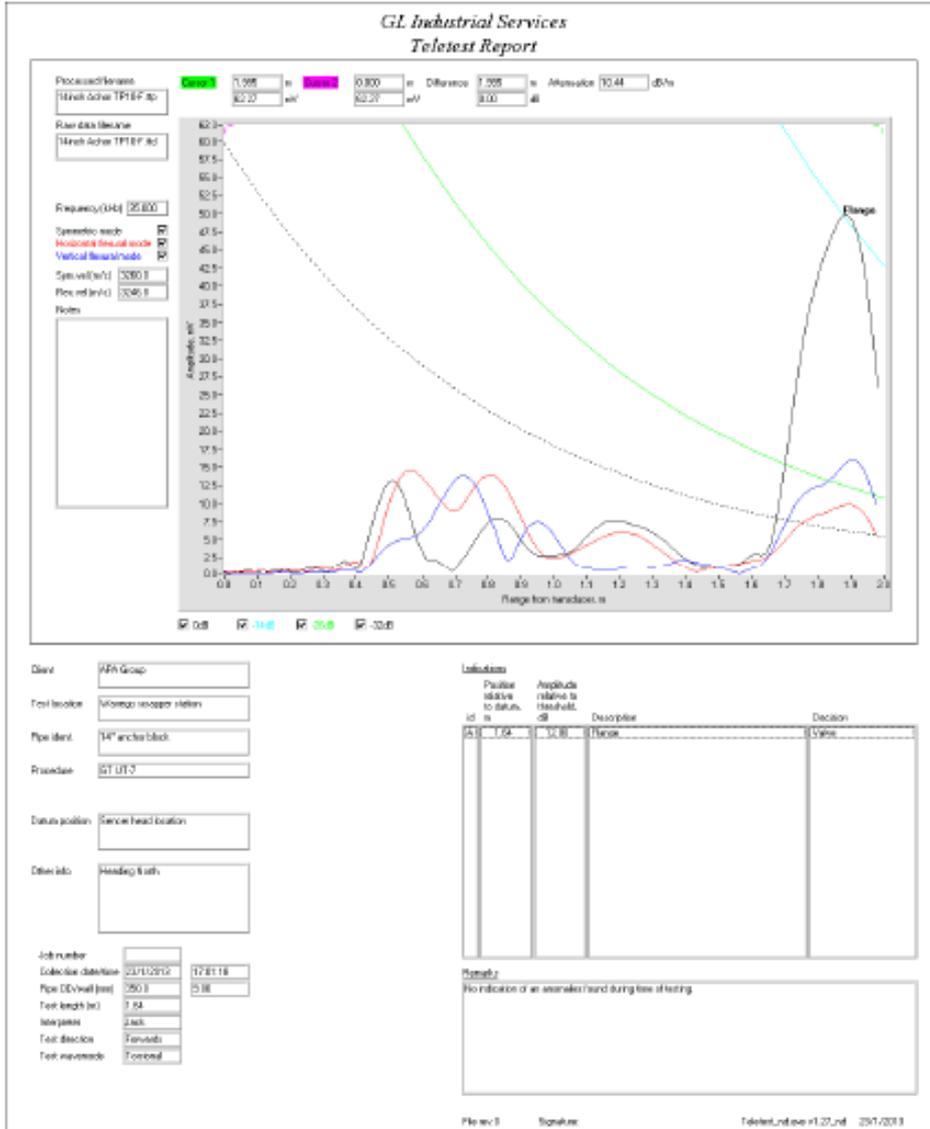
Test Point10 Line ID: 14" Warrego scrapper station

Test Point 10 is the forward LRUT shot at Warrego's V14 concrete support block, looking east. The concrete block begins 0.8m from the LRUT device according to TP10 schematic drawing in Appendix 5. As shown in Appendix 5 there are no anomalies detected within the concrete support block between the start of the concrete block at 0.8m and the valve body identified at a distance of 1.64m. Corrosion was not identified within the concrete block.

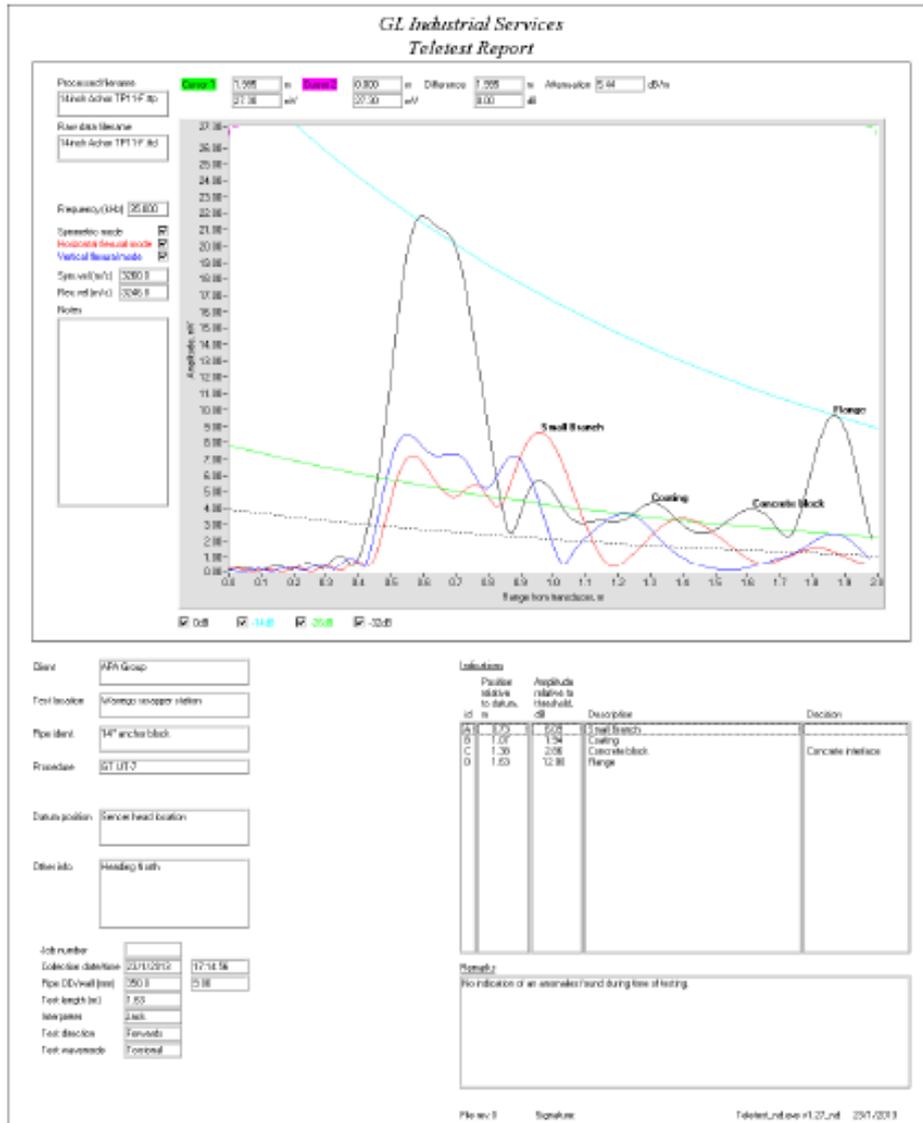
Test Point 11 Line ID: 14" Warrego scraper station

Test Point 11 is the forward LRUT shot at Warrego's north concrete anchor block, looking north. The concrete anchor block begins 1.3m from the sensor head as shown in the results of Appendix 5, and the pig-sig tee is 0.6m from the sensor head. The pig-sig tee is identified by LRUT at a distance of 0.73m, a coating transition (CTE to tape wrap) is identified at 1.07m, the concrete block interface is detected at 1.38m and the flange within the block was detected at a distance of 1.63m, 250mm into the block. Corrosion was not identified within the concrete block.

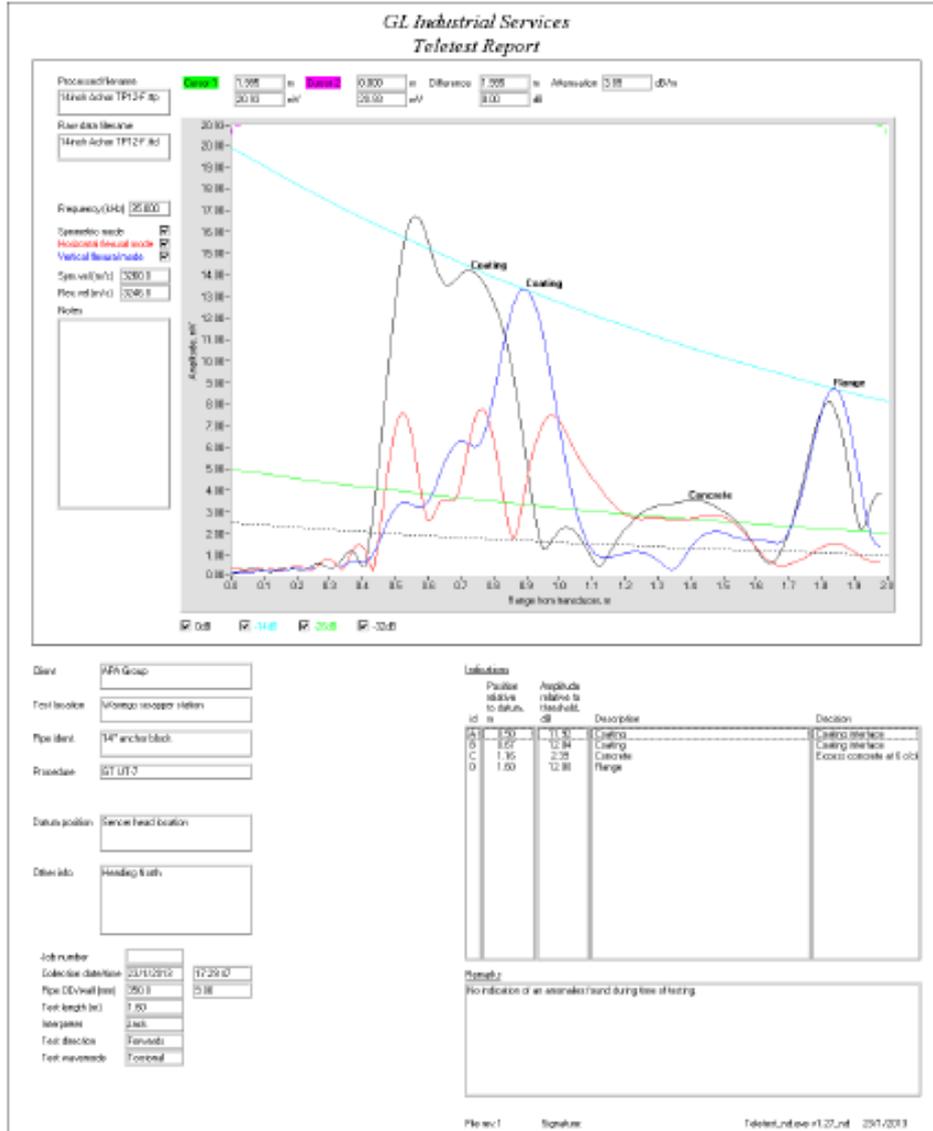
Test Point12 Line ID: 14" Warrego scrapper station

Test Point 12 is the forward LRUT shot at Warrego's north concrete anchor block, looking south. The concrete anchor block begins 1.3m from the sensor head as shown in the results of Appendix 5. Two coating anomalies were identified at 0.50m and 0.67m, the concrete block interface is detected at 1.16m and the flange within the block was detected at a distance of 1.60m, 440mm into the block. Corrosion was not identified within the concrete block.

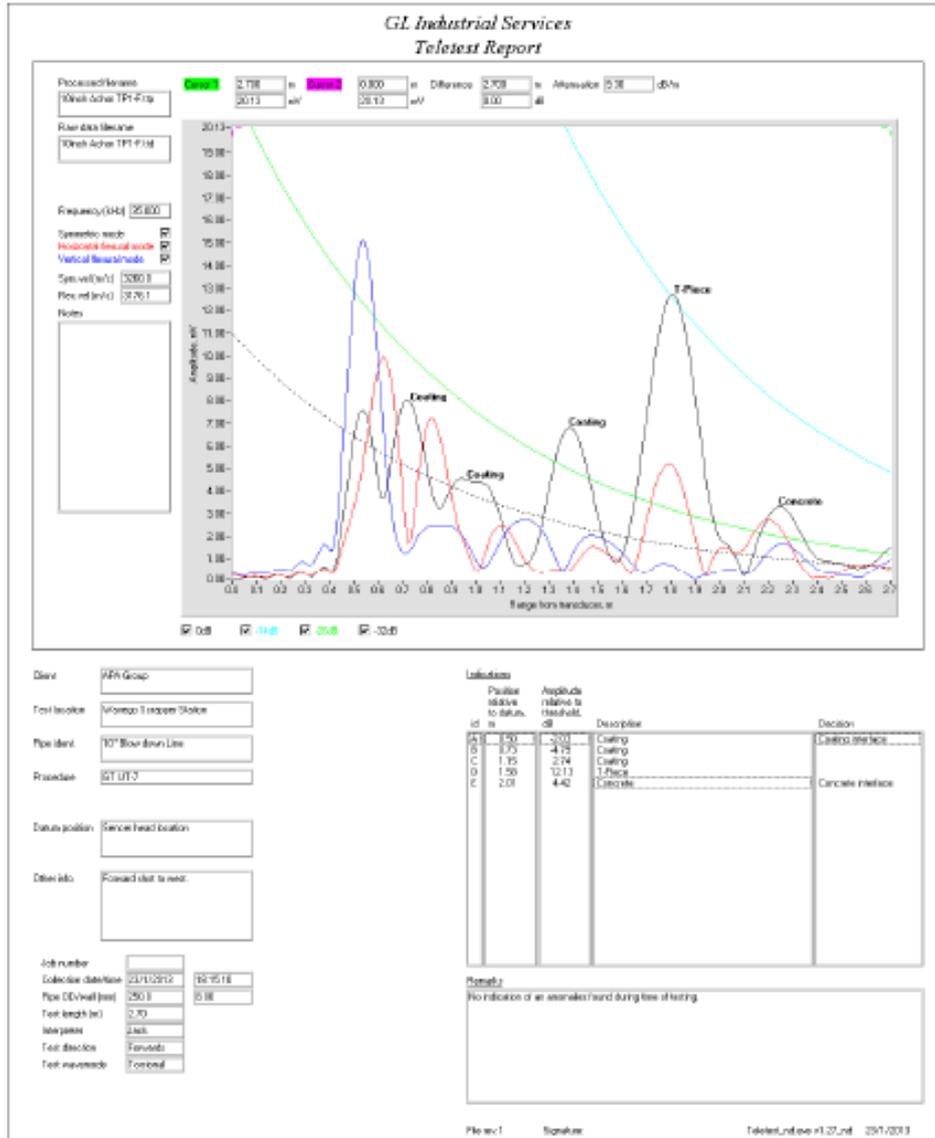
Test Point 1 Line ID: 10" Warrego Scraper station Blow Down line (Forward Shot only)

Test Point 1 is the forward LRUT shot at Warrego's blowdown stack concrete support block, looking west. The concrete interface is 1.3m in front of the sensor head as shown in the results of Appendix 5. 3 coating anomalies were detected at 0.50m, 0.73m and 1.15m from the device, outside of the concrete block. The tee piece was identified within the concrete block at a distance of 1.58m, 280mm inside of the block. The other end of the concrete block was identified by LRUT at a distance of 2.01m. Corrosion was not identified within the concrete block.

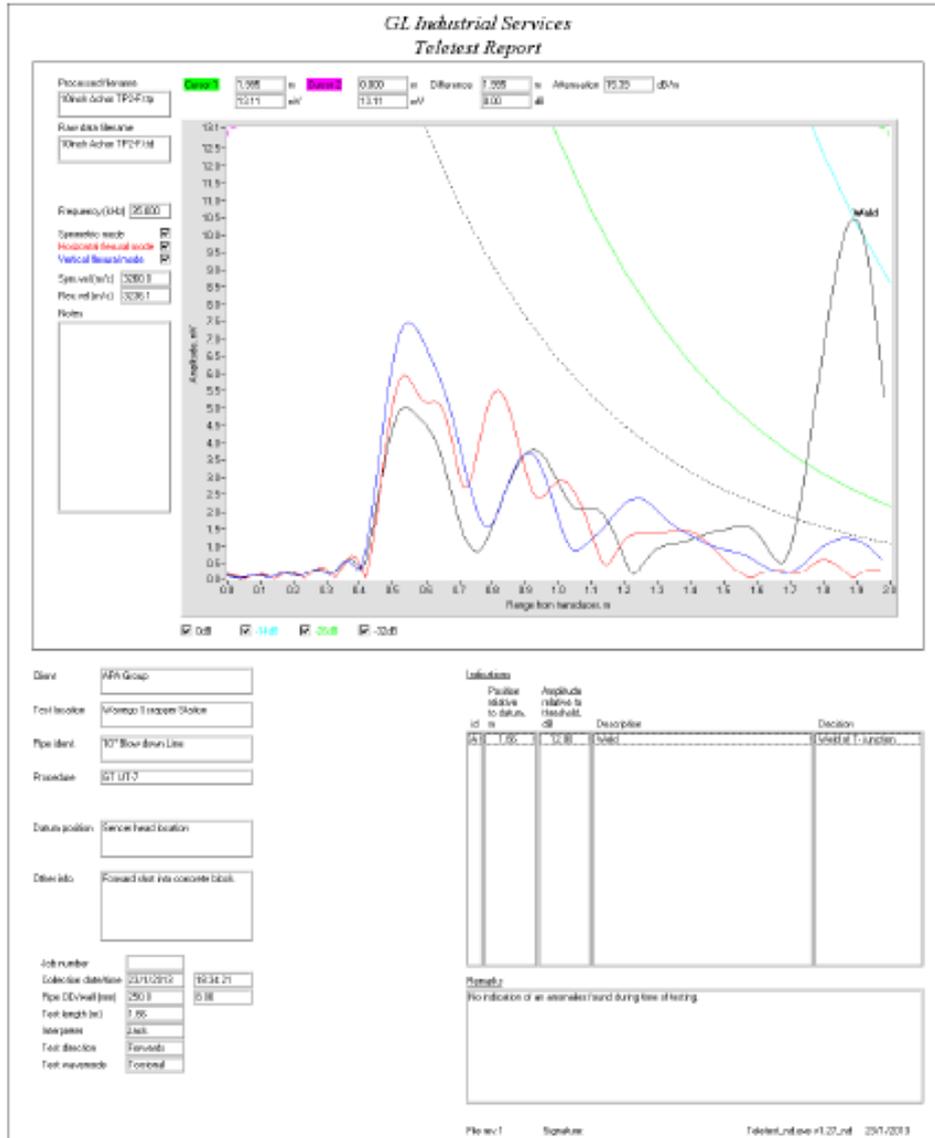
Test Point 2 Line ID: 10" Warrego Scraper station Blow Down line (Forward Shot only)

Test Point 2 is the forward LRUT shot at Warrego's blowdown stack concrete support block, looking vertically down. The concrete interface is 1.4m in front of the sensor head as shown in the results of Appendix 5. No anomalies were detected, only the girth weld into the equal tee at 1.66m; 260mm inside of the concrete block. Corrosion was not identified within the concrete block.

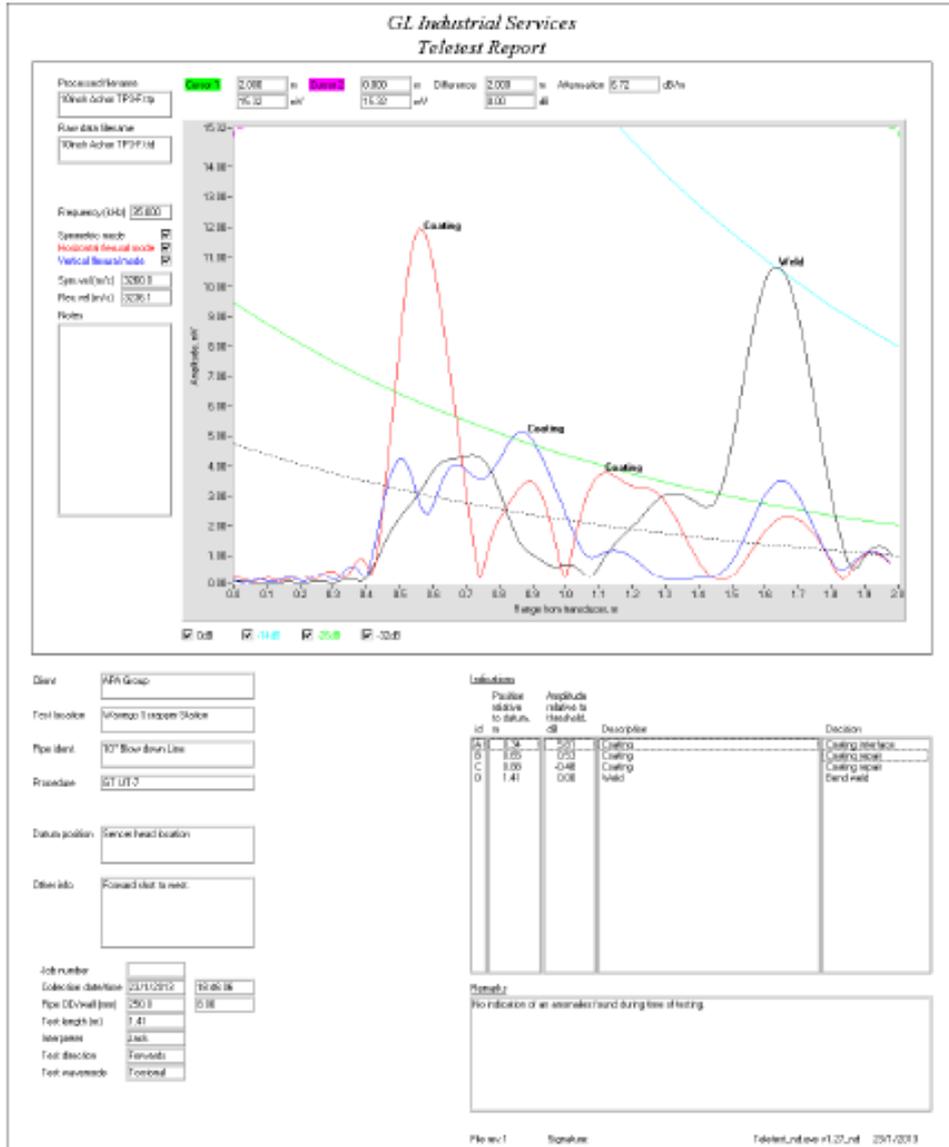
Test Point 3 Line ID: 10" Warrego Scraper station Blow Down line (Forward Shot only)

Test Point 3 is the forward LRUT shot at Warrego's blowdown line 90° elbow concrete support block, looking west. The concrete interface is 1.3m in front of the sensor head as shown in the results of Appendix 5. 3 coating anomalies were detected at 0.34m, 0.65m and 0.88m from the device, outside of the concrete block. The elbow piece girth weld was identified within the concrete block at a distance of 1.41m, 110mm inside of the block. Corrosion was not identified within the concrete block.

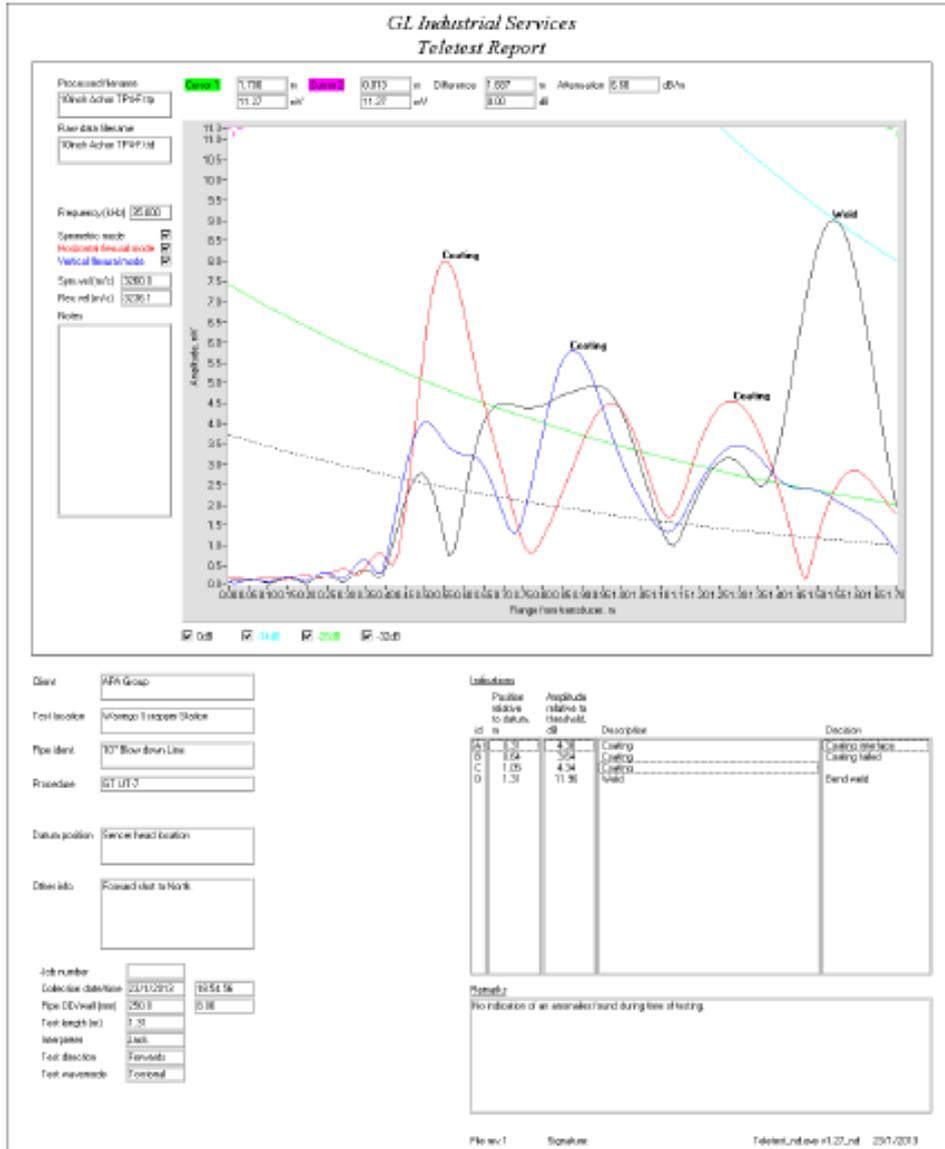
Test Point 4 Line ID: 10" Warrego Scraper station Blow Down line (Forward Shot only)

Test Point 4 is the forward LRUT shot at Warrego's blowdown line concrete support block between V11 and V12, looking south. The concrete interface is 0.75m in front of the sensor head as shown in the results of Appendix 5. No defects or anomalies were detected within the concrete support block. The elbow piece girth weld was identified within the concrete block at a distance of 2.31m on the other side of the block. Corrosion was not identified within the concrete block.
