Darwin City Gate

Coating Assessment Report

Document No. BGS-RP-A-0001 Rev A

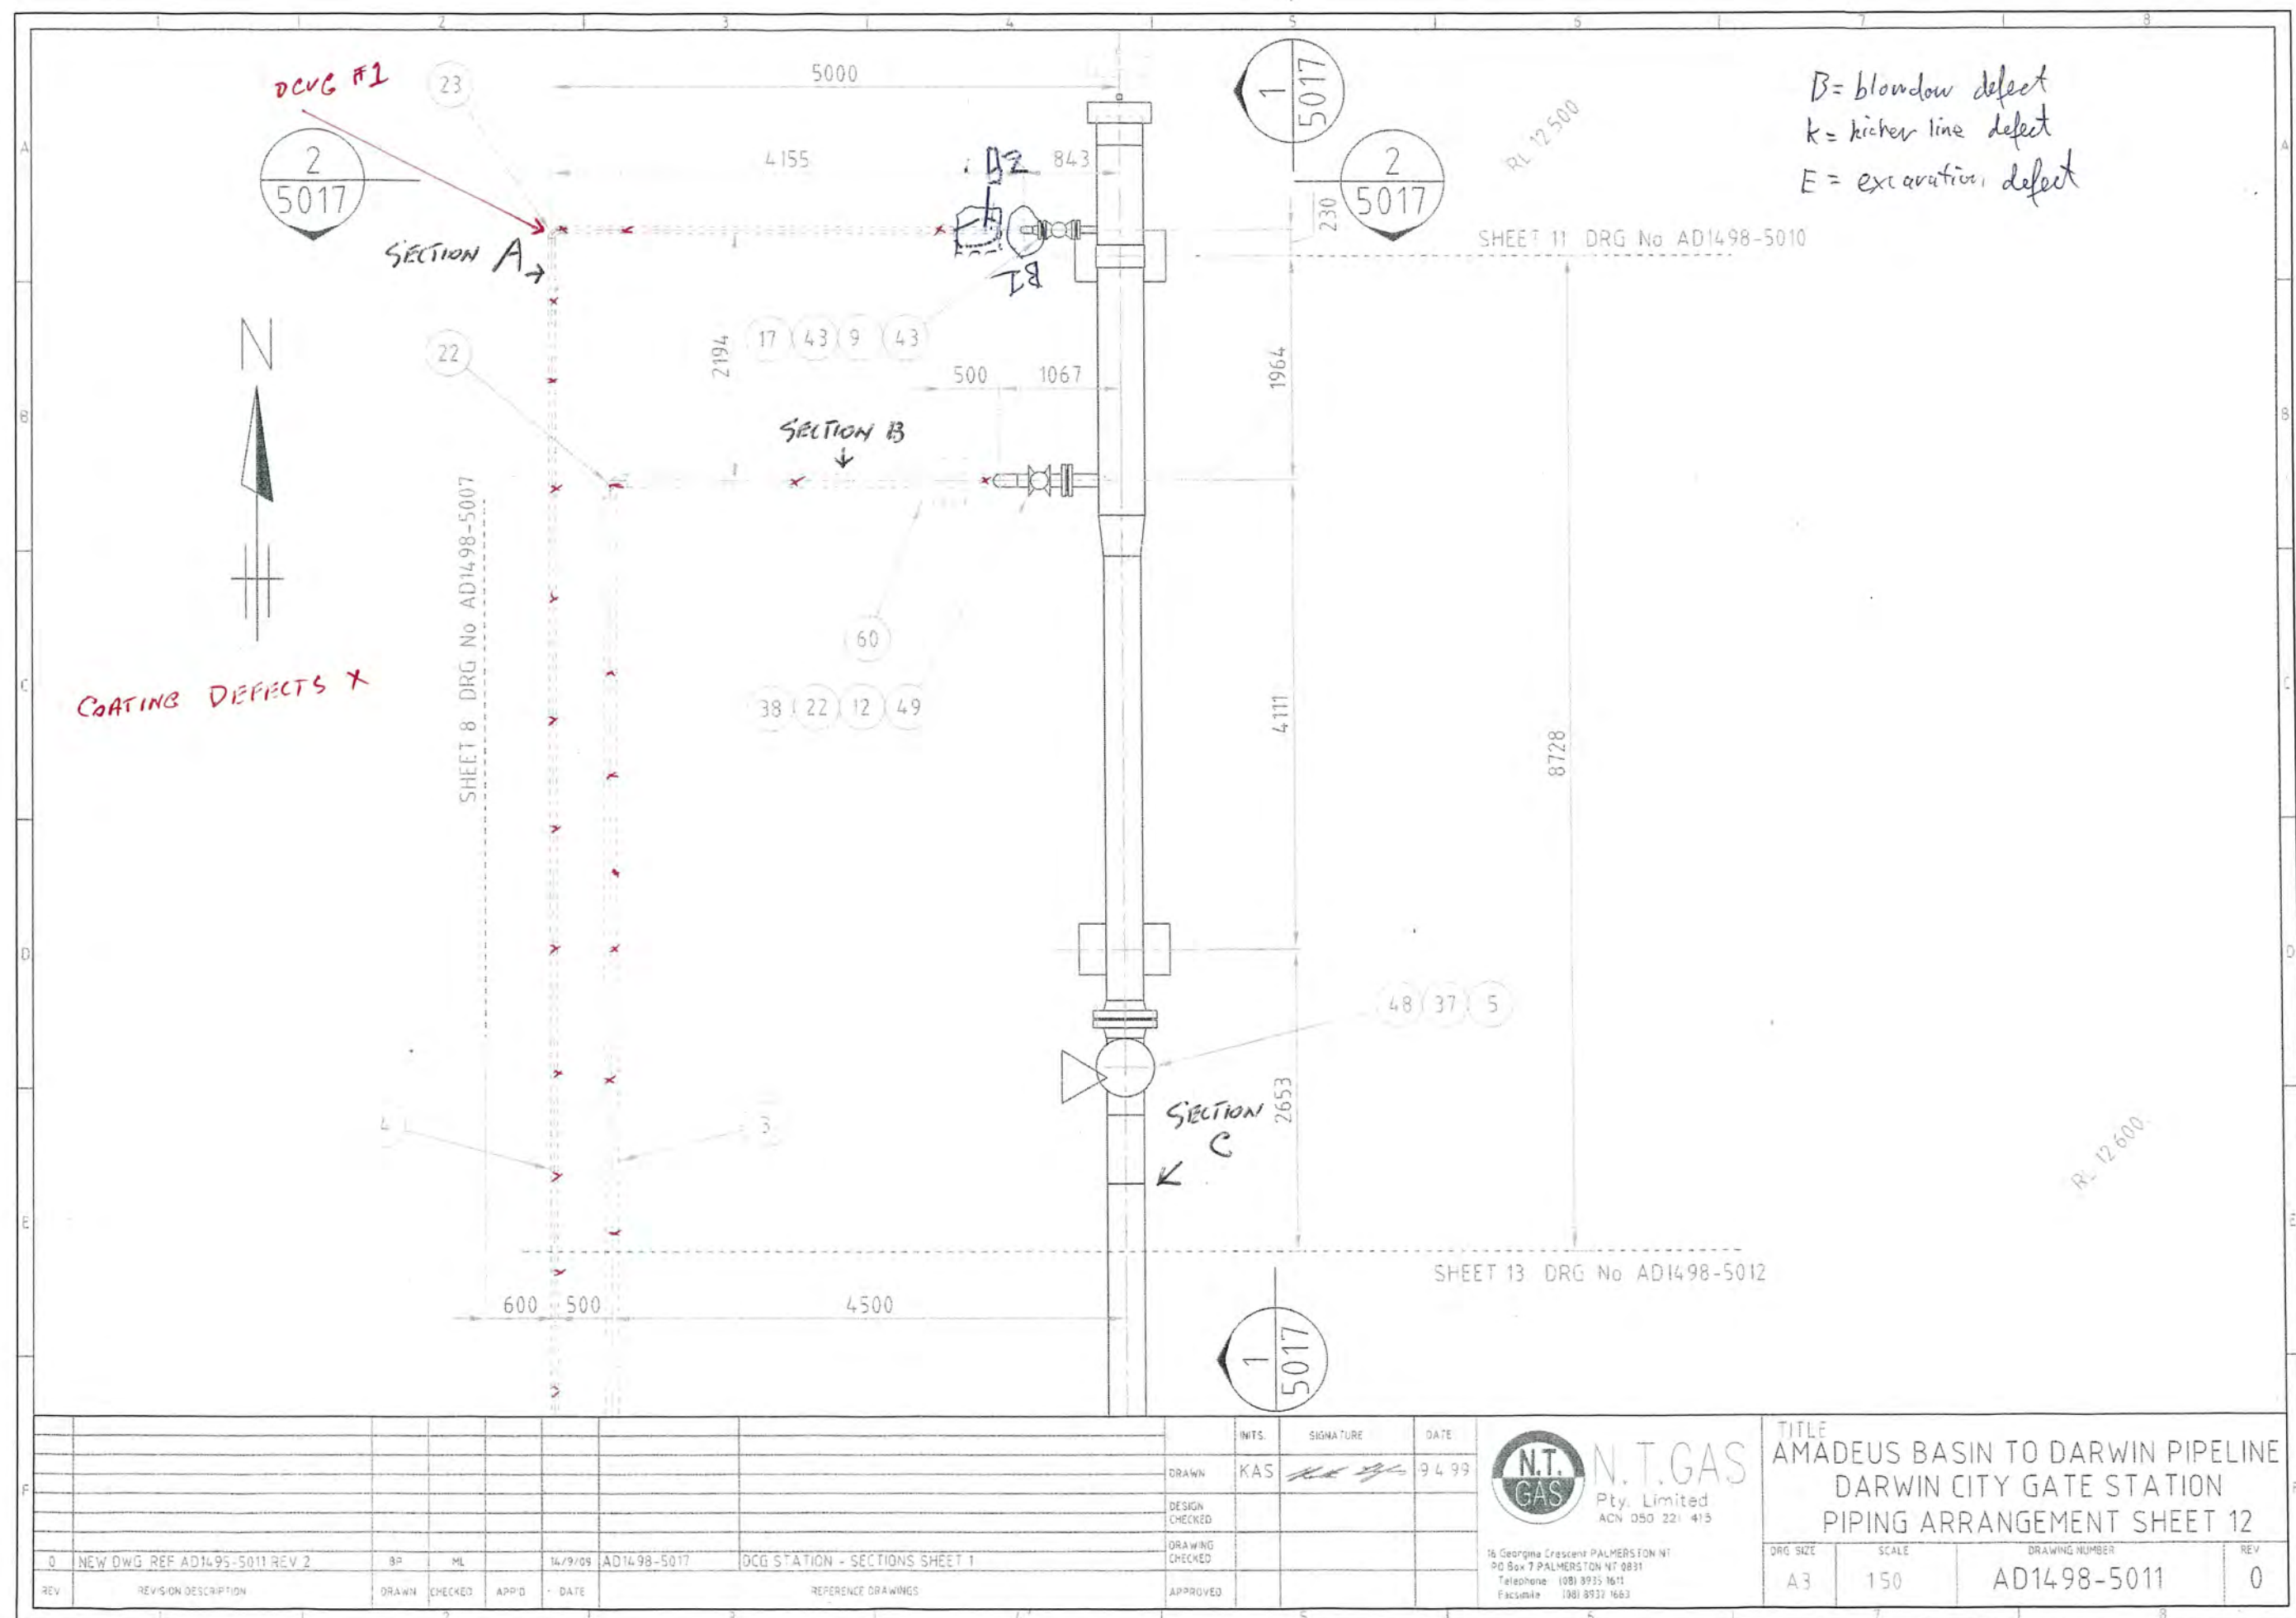
SHEET 12 DRG. No AD1498-5011

DCVG DEFECT #2
SECTION C
COATING DEFECTS

DCVG DEFECT #3

DCVG DEFECT #4

↑ ↑ COATING DEFECT
SECTION H

DCVG DEFECT #6
