Newcastle Waters

Coating Assessment Report

Document No. BGS-RP-A-0001 Rev 0A				
File Path: G:\Major Projects\23.3_BGS_Below Ground Station Pipework Recoating\2. Reports and Approvals\Coating Defect Analysis\Newcastle Waters\BGS-RP-A-0002 DCG coating assessment Rev A.docx				
Author	Adam Nuske <i>Adam Nuske</i>			
Report Checked by	<i>[Signature]</i>			
Report Approved by	<i>S. DYNES 11/3/13</i>			
Changes to be approved by				
Version control	Date	Version	Nature of Change	Approved by (Name)
	5/03/2013	0C	Final

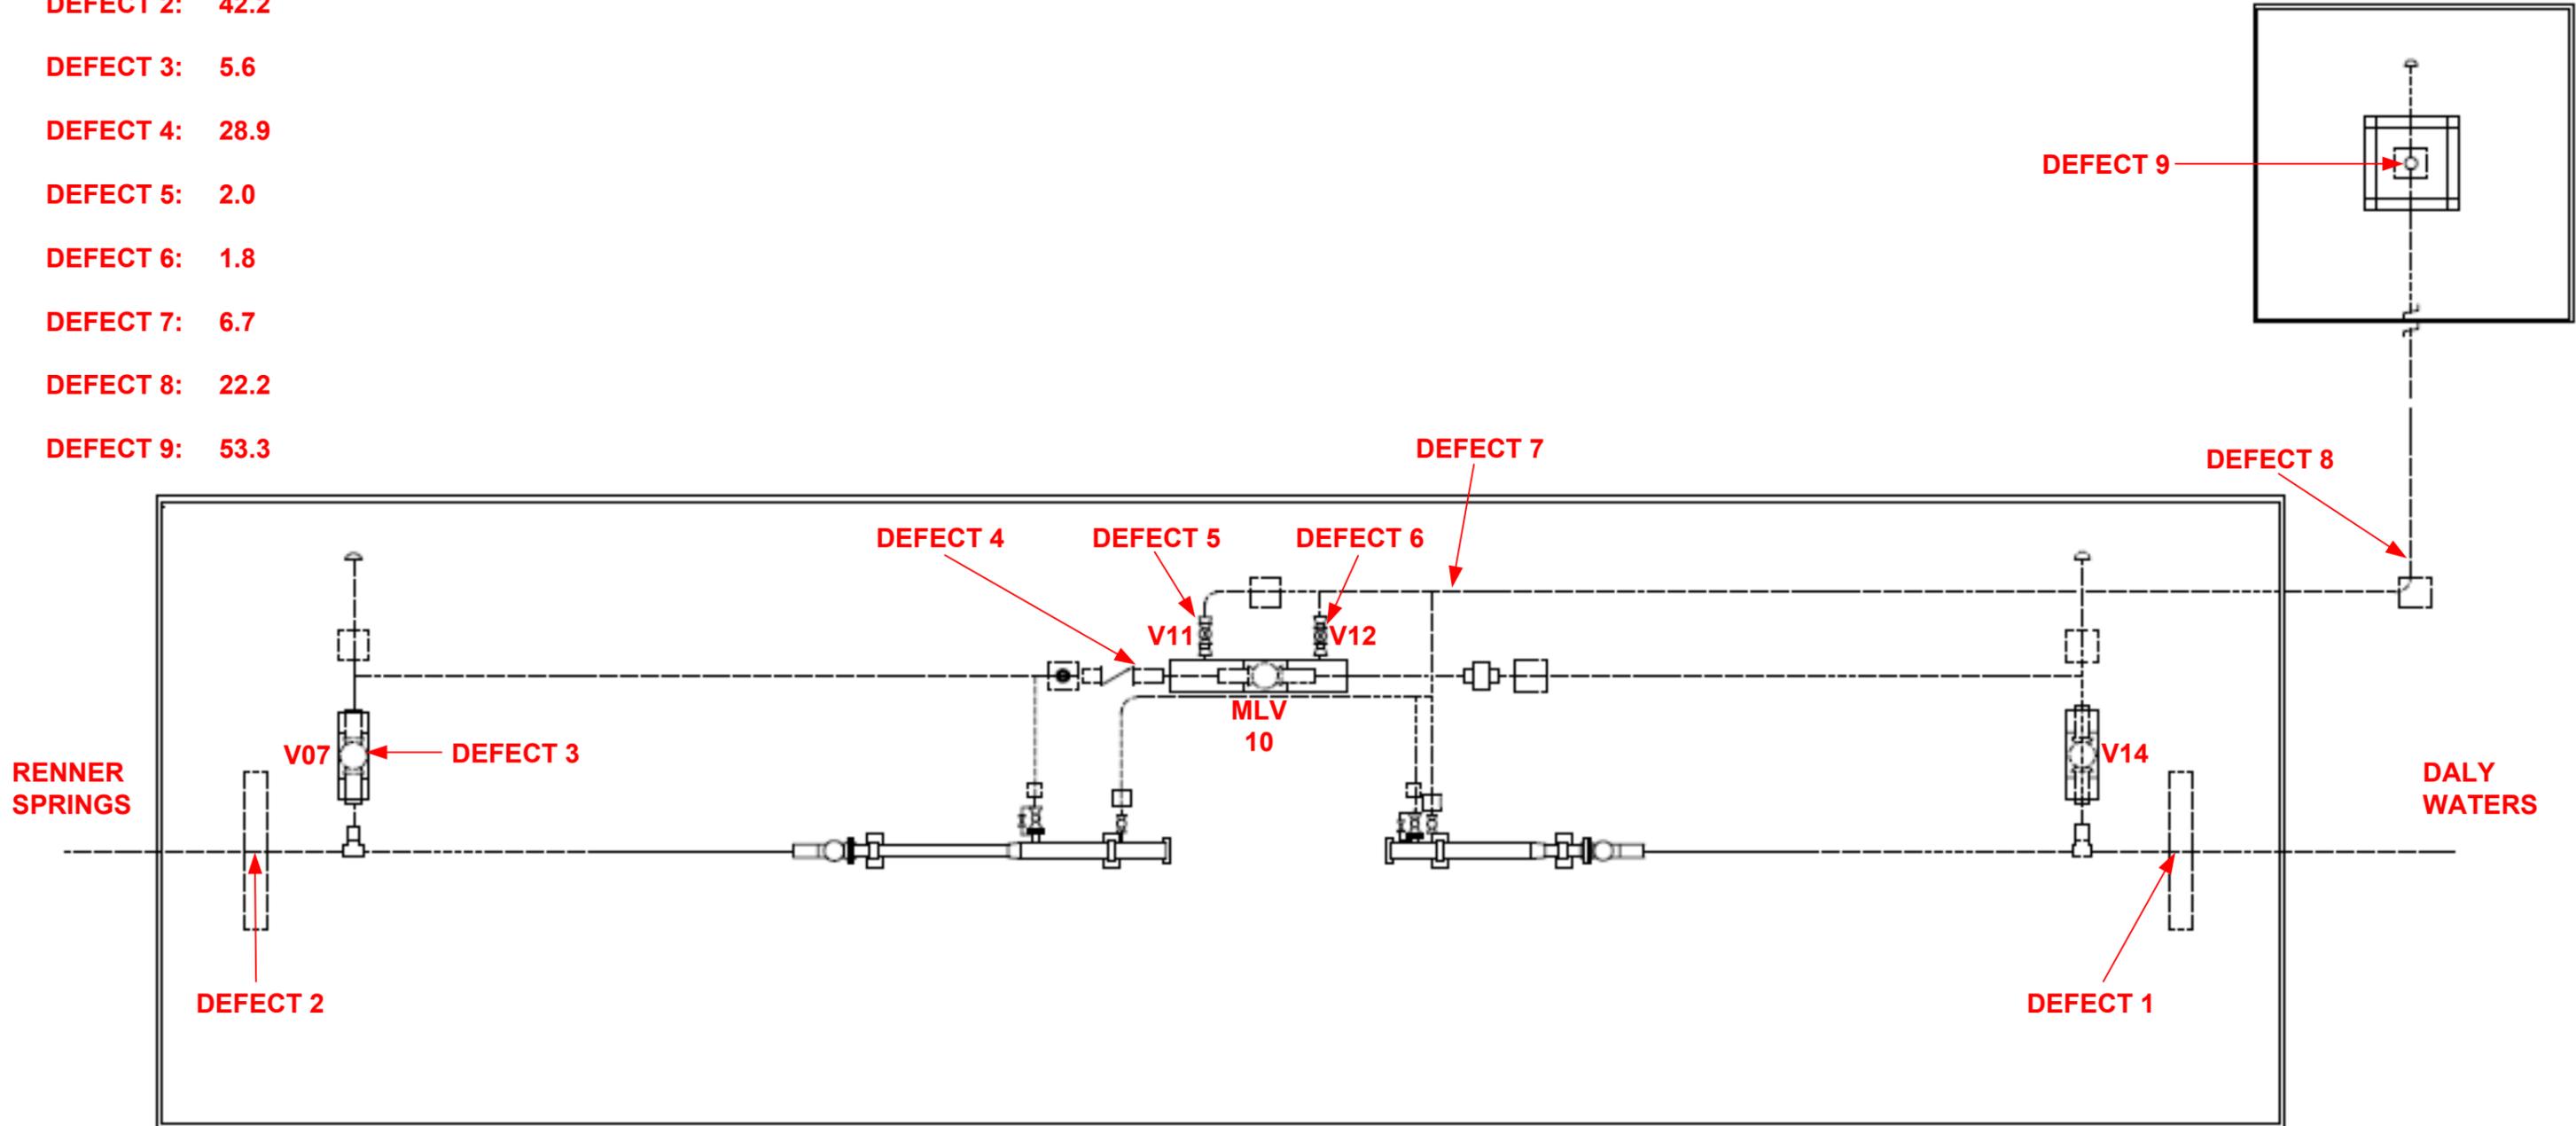
NEWCASTLE WATERS DCVG SURVEY

There were 9 areas highlighted as having coating defects by the DCVG survey. These defects are summarised in Table 1 below. Locations of each defect are shown on the drawing in Appendix 1.

DCVG Defect #1, 2, 8 and 9 were not related back to specific defects found in the coating during dig-up, and yet were most of the highest %IR readings. These detections were all around concrete anchor and support blocks and the assumption is there could be a defect within the concrete anchor/support block. The risk of severe corrosion within these concrete blocks is low, despite making for ideal CP (Cathodic Protection) shielding structures, as the block is securely sealed where the pipe enters and exits the concrete blocks. On this project LRUT surveys were used to determine whether there was a pipe wall defect (metal loss) within these concrete blocks and none were evident at this site.

DCVG	IR (%)
DEFECT 1:	9.0
DEFECT 2:	42.2
DEFECT 3:	5.6
DEFECT 4:	28.9
DEFECT 5:	2.0
DEFECT 6:	1.8
DEFECT 7:	6.7
DEFECT 8:	22.2
DEFECT 9:	53.3

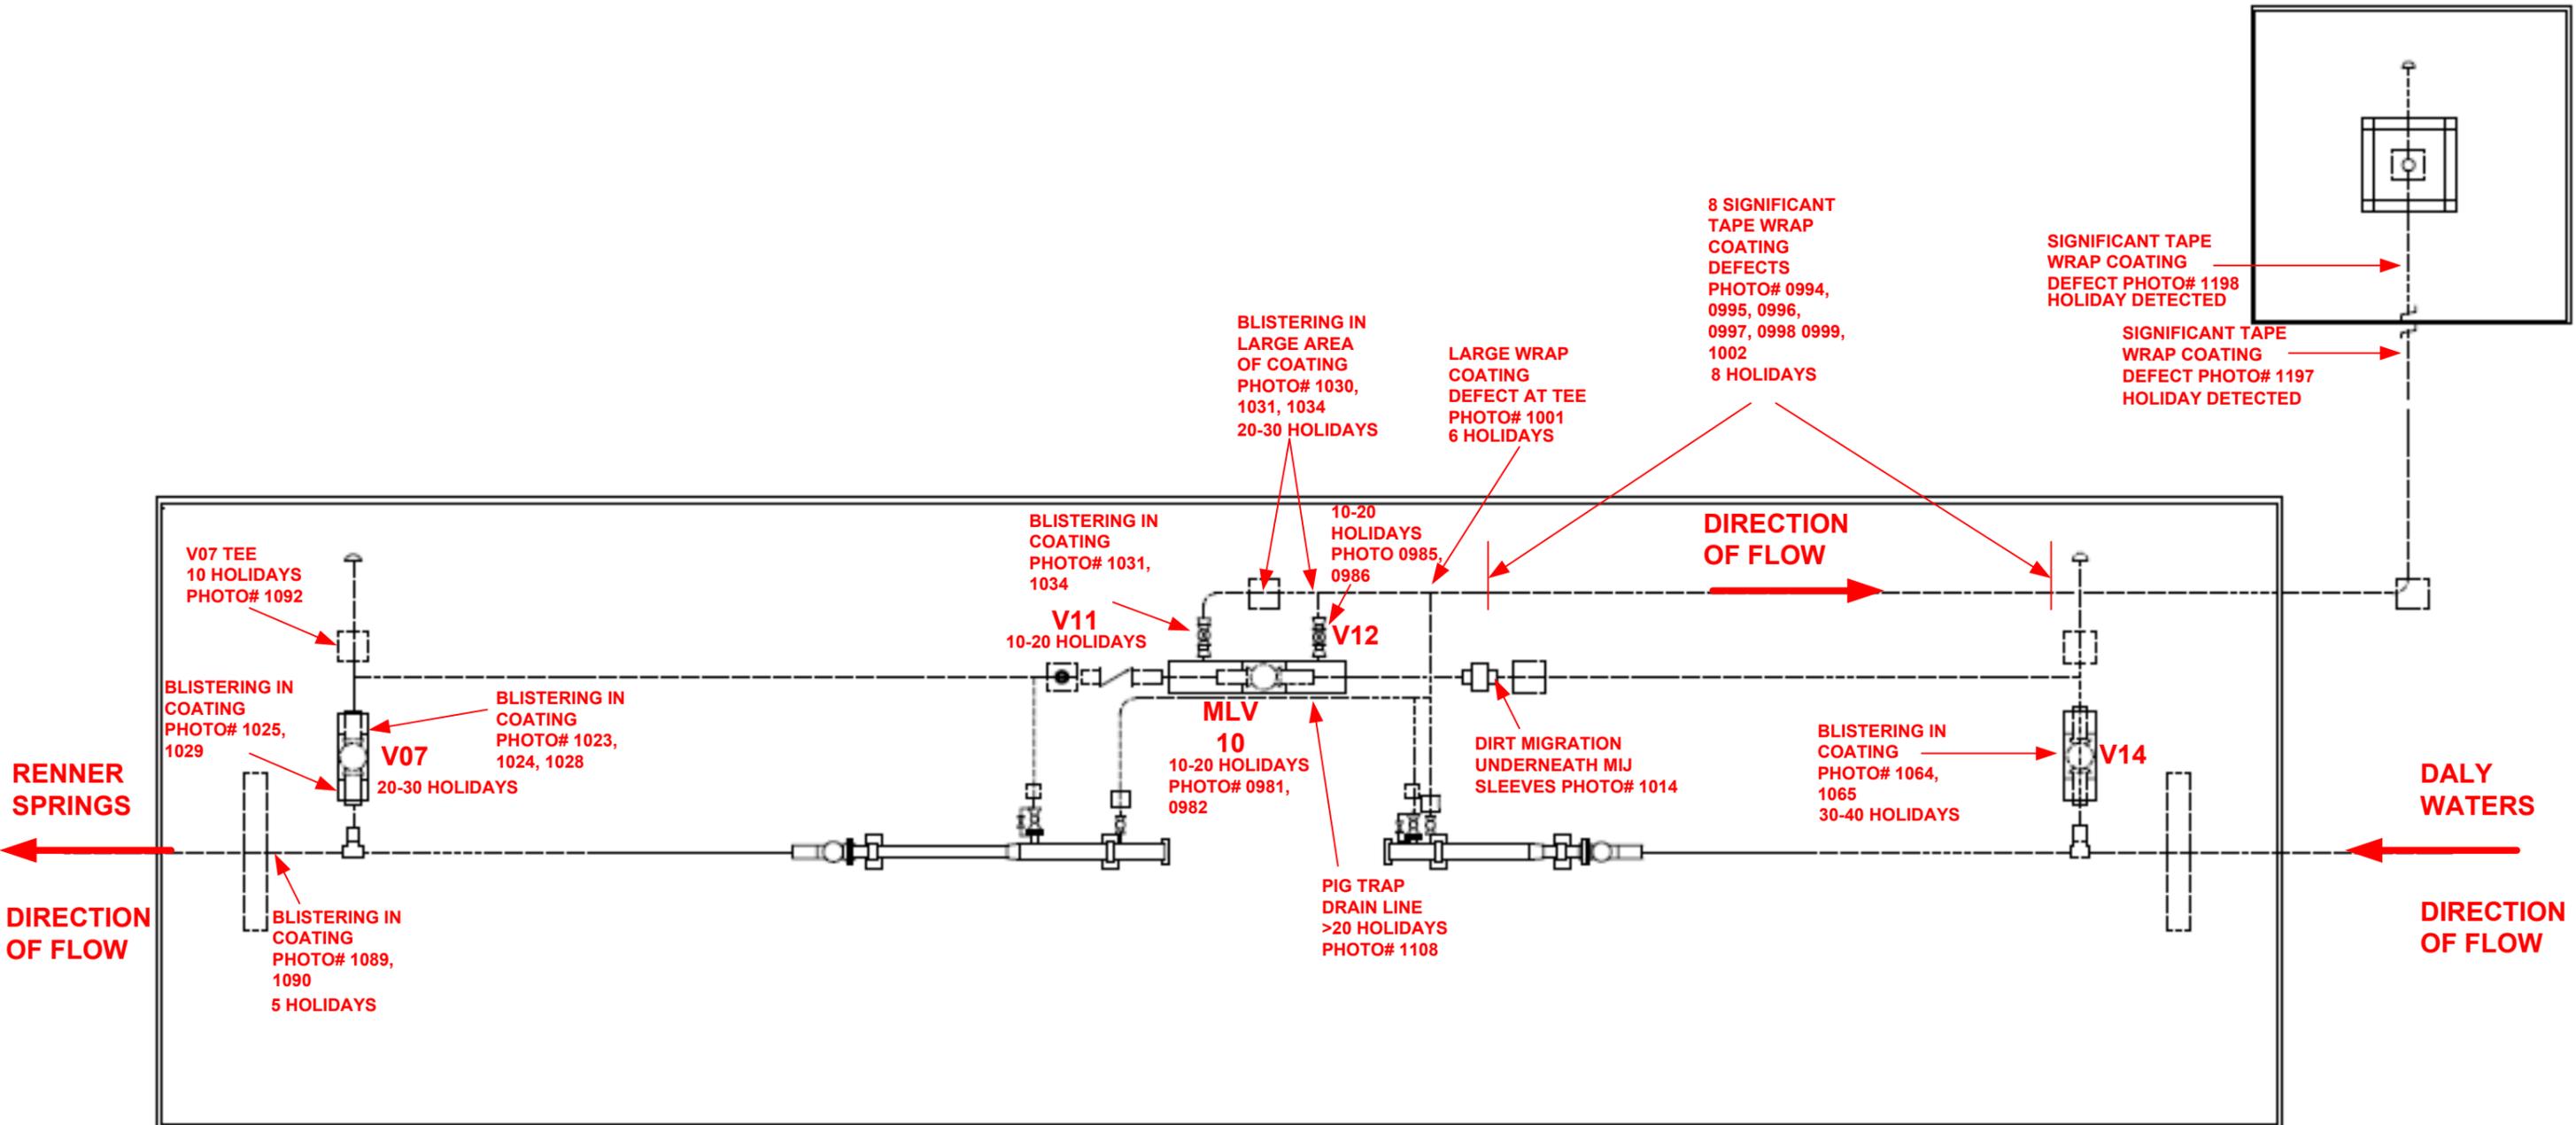
NEWCASTLE WATERS COATING DEFECT – VISUAL INSPECTION & HOLIDAY DETECTOR RESULTS

A significant portion of the coating found at Newcastle Waters was generally in poor condition. Many areas of coating were found to be blistering and the coating exhibited extensive disbondment. Recorded coating defects have been illustrated on the Newcastle Waters Coating Defect layout drawing in Appendix 2. Areas of coating found to fail a holiday test were circled with white paint (refer photos). Some specific examples include:

The DCVG survey reported coating defects which have been referenced back to coating defects found during the dig-up as described in Table 2. However, DCVG failed to find blistering on the TEE downstream of V07, blistering on the concrete support downstream of V11, blistering on V14, and the 8 tape wrap defects located on the blowdown line.

The coating at this station is in poor condition and requires replacement.

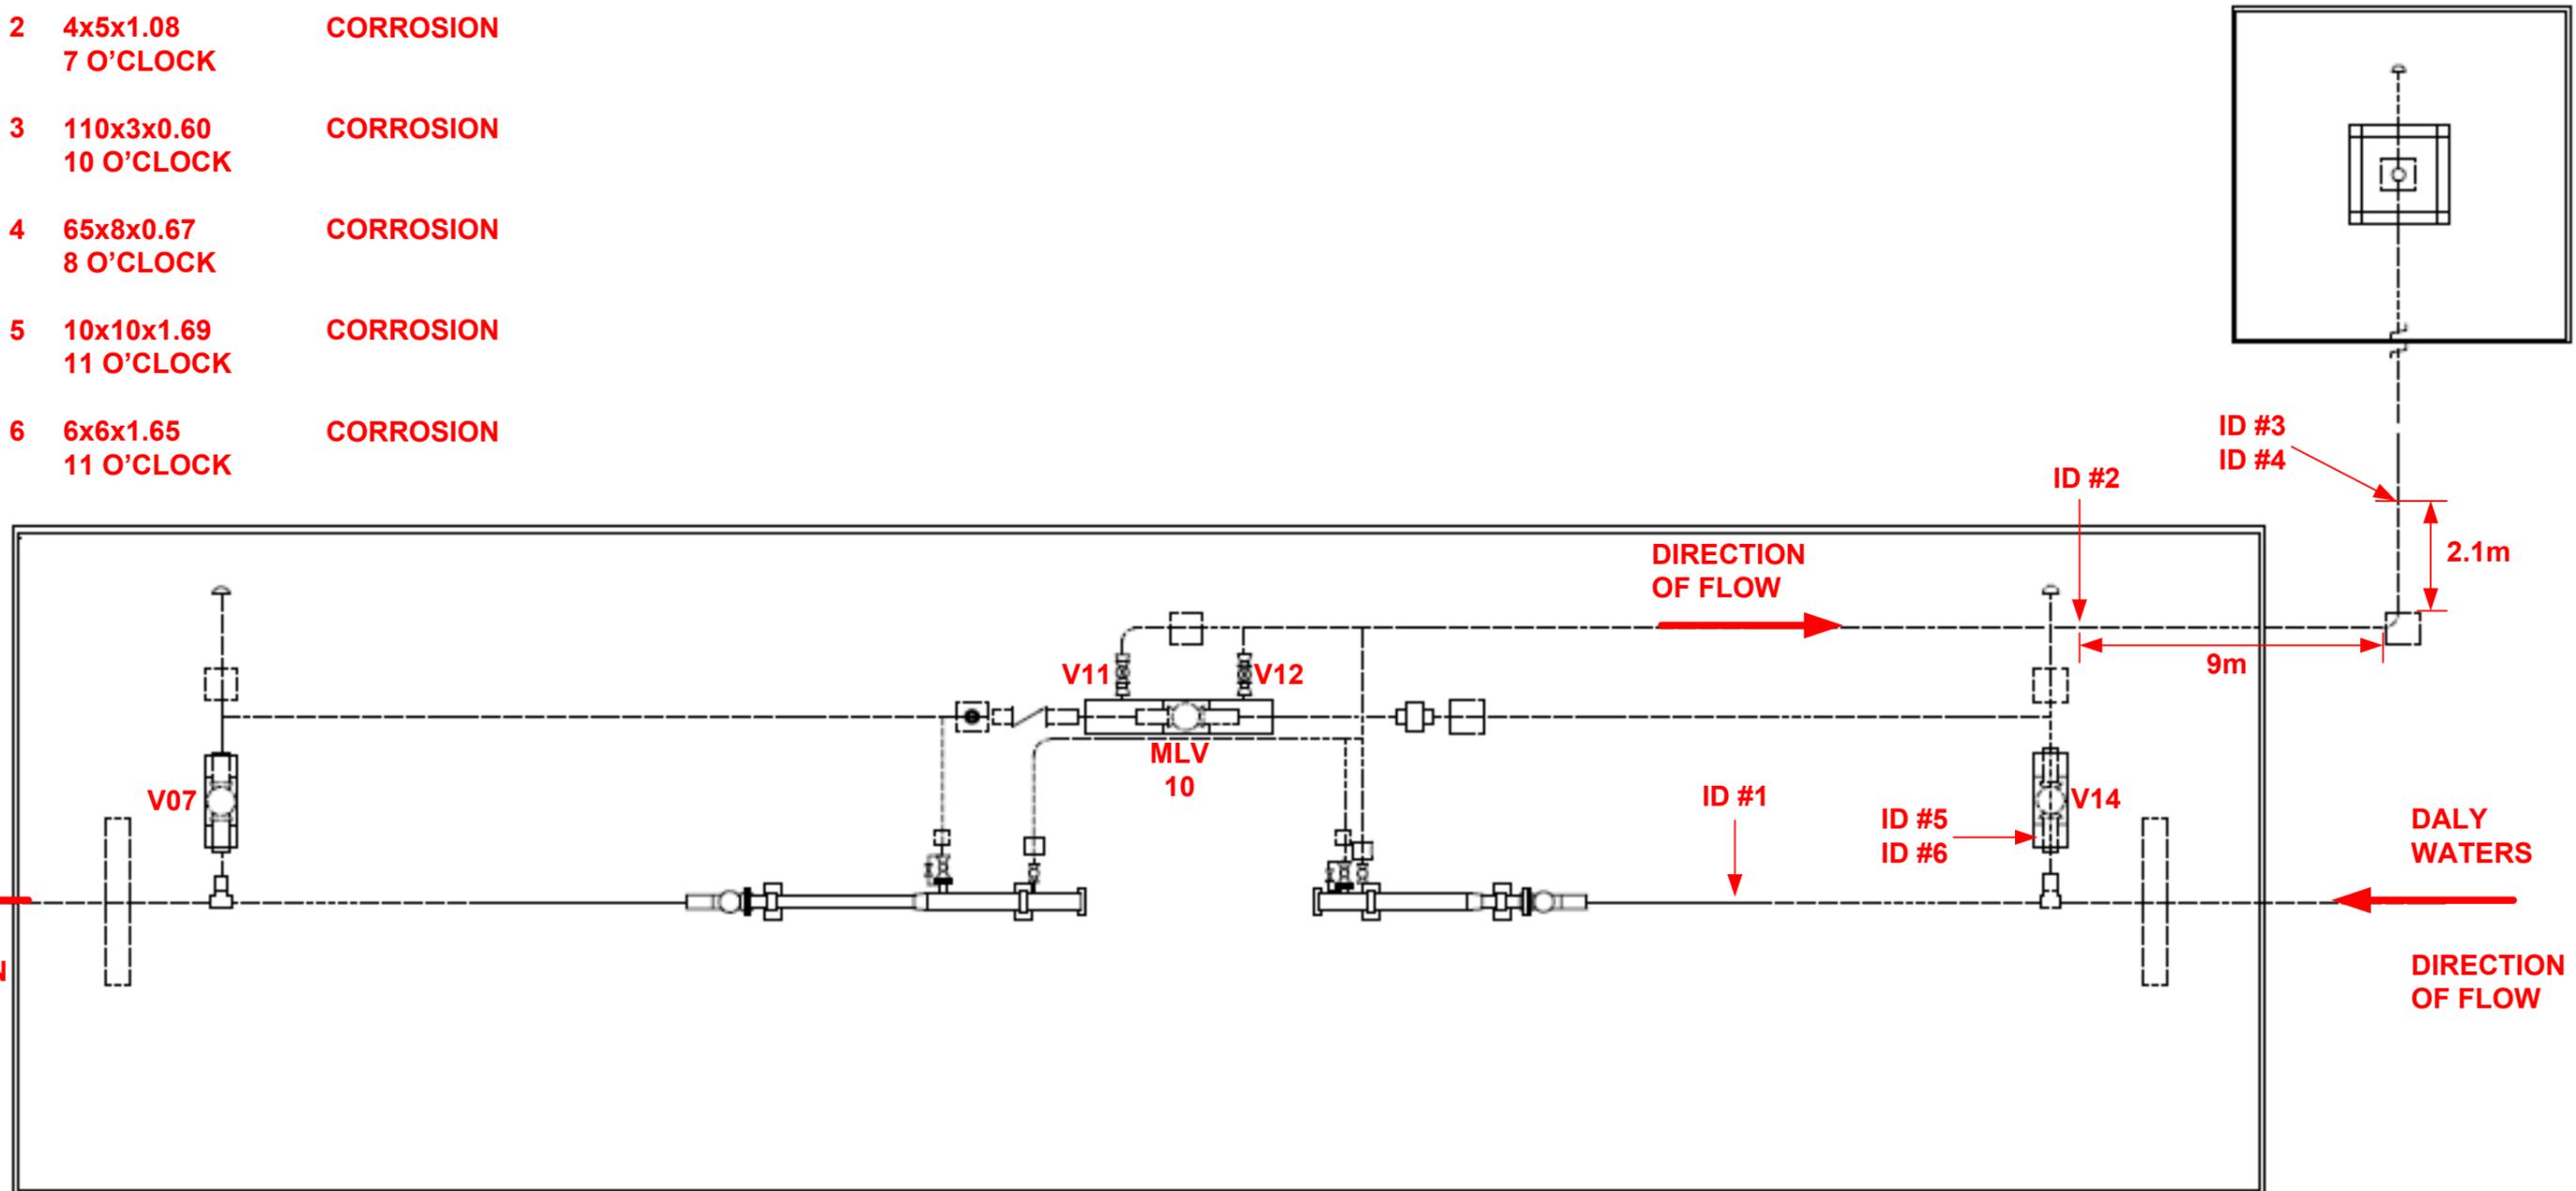
NEWCASTLE WATERS METAL LOSS RESULTS

The location and details of metal loss has been included on the Newcastle Waters Metal Loss Results drawing in Appendix 1.

The DCVG survey missed almost all of the metal loss defects found at Newcastle Waters. Metal loss defects ID# 1, 5 and 6 were identified as resulting from pit corrosion due to shielding. The fact that defects #1, 5 and 6 were not found by DCVG is consistent with the shielding premise. DCVG Defect #8 and #9 may have overlapped to some extent during testing, and DCVG Defect #9 could have been caused partially by the coating defects on the blowdown line. As these are the coating defects suspected for causing the corrosion metal loss ID #3 and #4, DCVG could have detected this coating defect which led to corrosion. However, the coating defect shown in photo 1002 which likely resulted in the more severe corrosion of metal loss ID #2, was not detected by DCVG at all.

COATING DAMAGE ASSESSMENT REPORT ID#	DEFECT DIMENSION (mm) LxWxDDEPTH O'CLOCK POSITION ON PIPE	CAUSE OF METAL LOSS
1	10x6x1.16 5:30 (O'CLOCK)	CORROSION
2	4x5x1.08 7 O'CLOCK	CORROSION
3	110x3x0.60 10 O'CLOCK	CORROSION
4	65x8x0.67 8 O'CLOCK	CORROSION
5	10x10x1.69 11 O'CLOCK	CORROSION
6	6x6x1.65 11 O'CLOCK	CORROSION
