Tanami Road Scraper Station

Coating Assessment Report

Document No. BGS-RP-A-0011 Rev 0A				
File Path: \\falcon\exword\2012\12109\Engineering\APA Project Folders - 130513\23.3_BGS_Below Ground Station Pipework Recoating\20. Coating Defect Analysis\Tanami Rd\BGS-RP-A-0011 Tanami Rd coating assessment Rev 0A.docx				
Author	Adam Nuske <i>Adam Nuske</i>			
Report Checked by				
Report Approved by				
Changes to be approved by				
Version control	Date	Version	Nature of Change	Approved by (Name)
	10/07/2013	0A	Final	<i>Stephen Hughes</i>

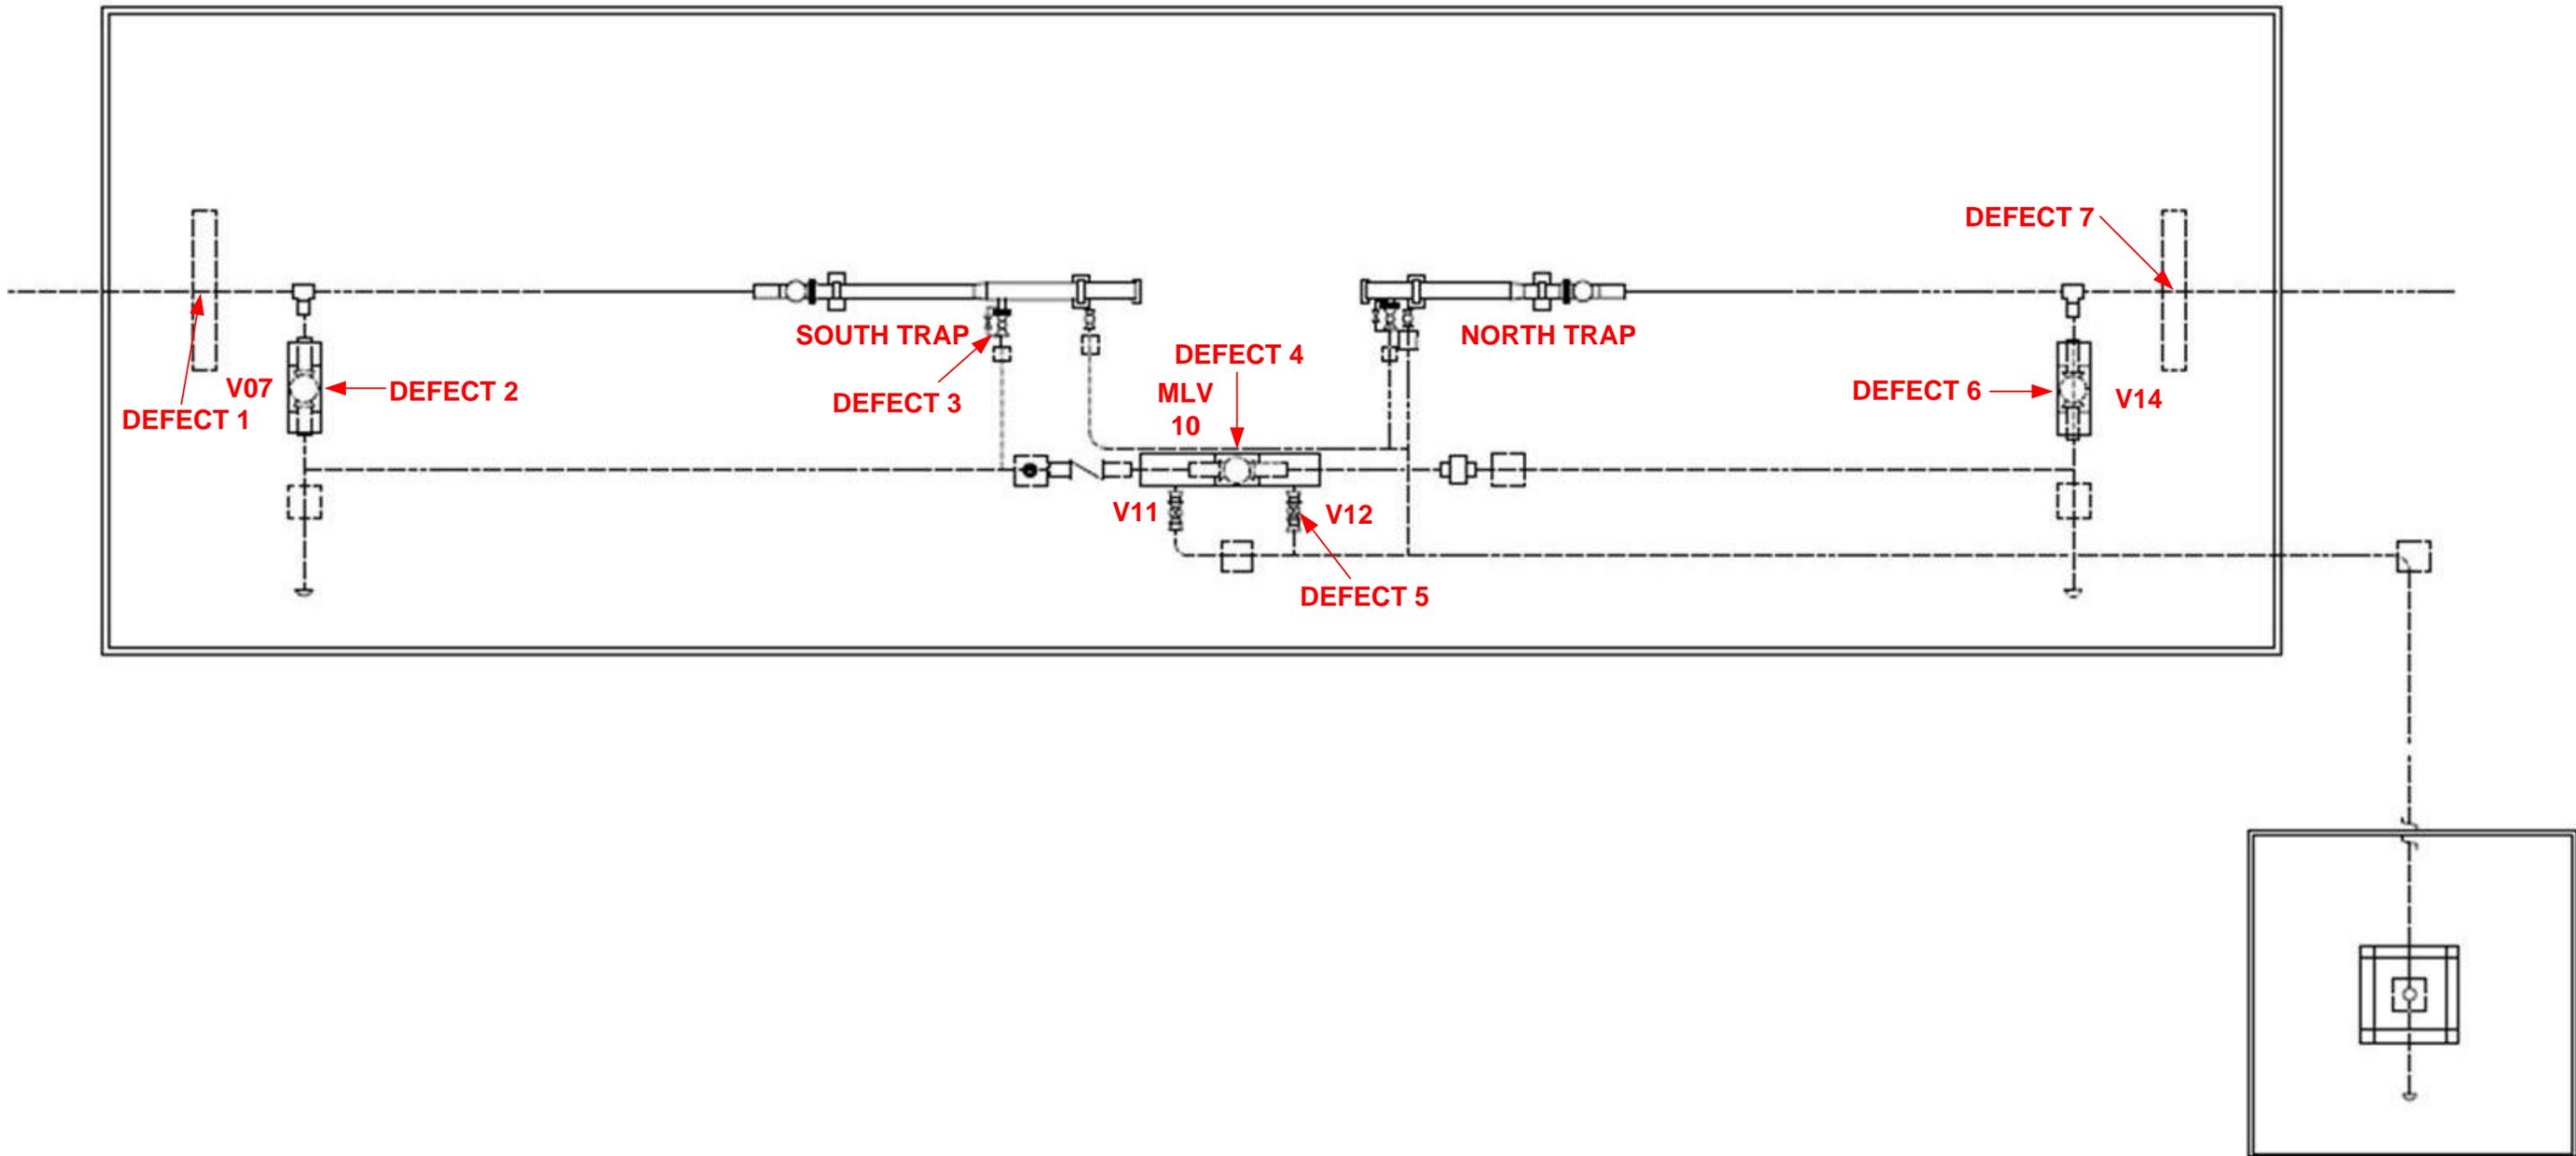
TANAMI RD DCVG SURVEY

There were 7 areas highlighted as having coating defects by the DCVG survey. These defects are summarised in Table 1 below. Locations of each defect are shown on the drawing in Appendix 1.

DCVG	IR (%)
DEFECT 1:	24.0
DEFECT 2:	9.0
DEFECT 3:	4.2
DEFECT 4:	6.8
DEFECT 5:	7.1
DEFECT 6:	2.3
DEFECT 7:	9.4

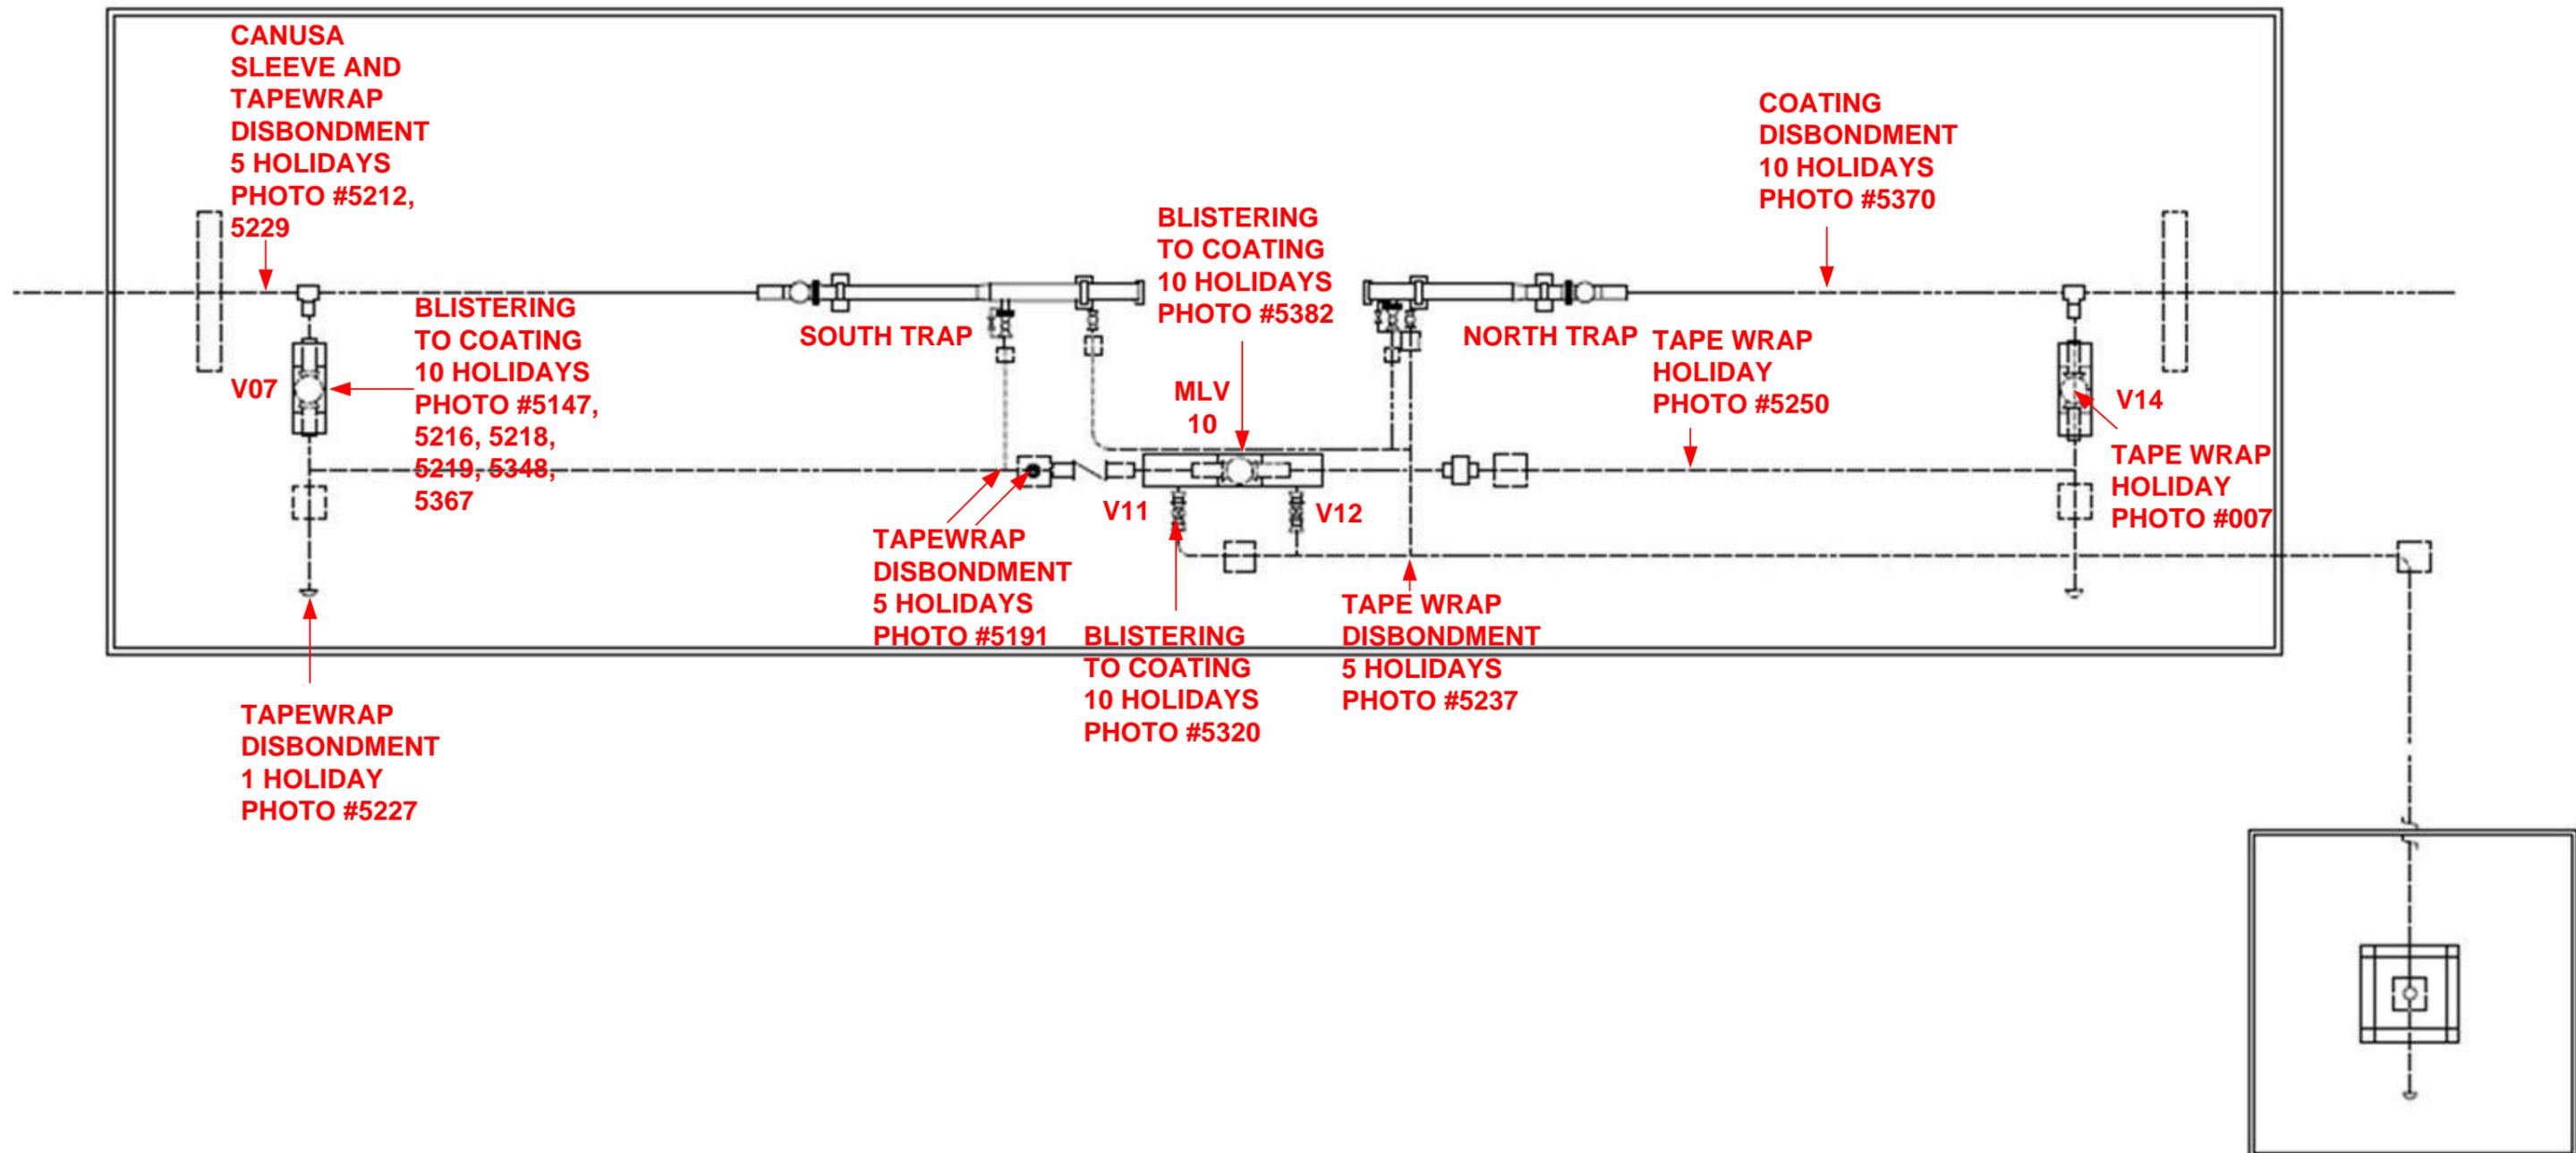
TANAMI RD COATING DEFECT – VISUAL INSPECTION & HOLIDAY DETECTOR RESULTS

Some areas of coating found at Tanami Rd were found in poor condition. CTE coating were found to be blistering and the coating in places was cracked and pulling away from the pipework. Recorded coating defects have been illustrated on the Tanami Rd Coating Defect layout drawing in Appendix 2. Areas of coating found to fail a holiday test were circled with white paint (refer photos). Some specific examples include:

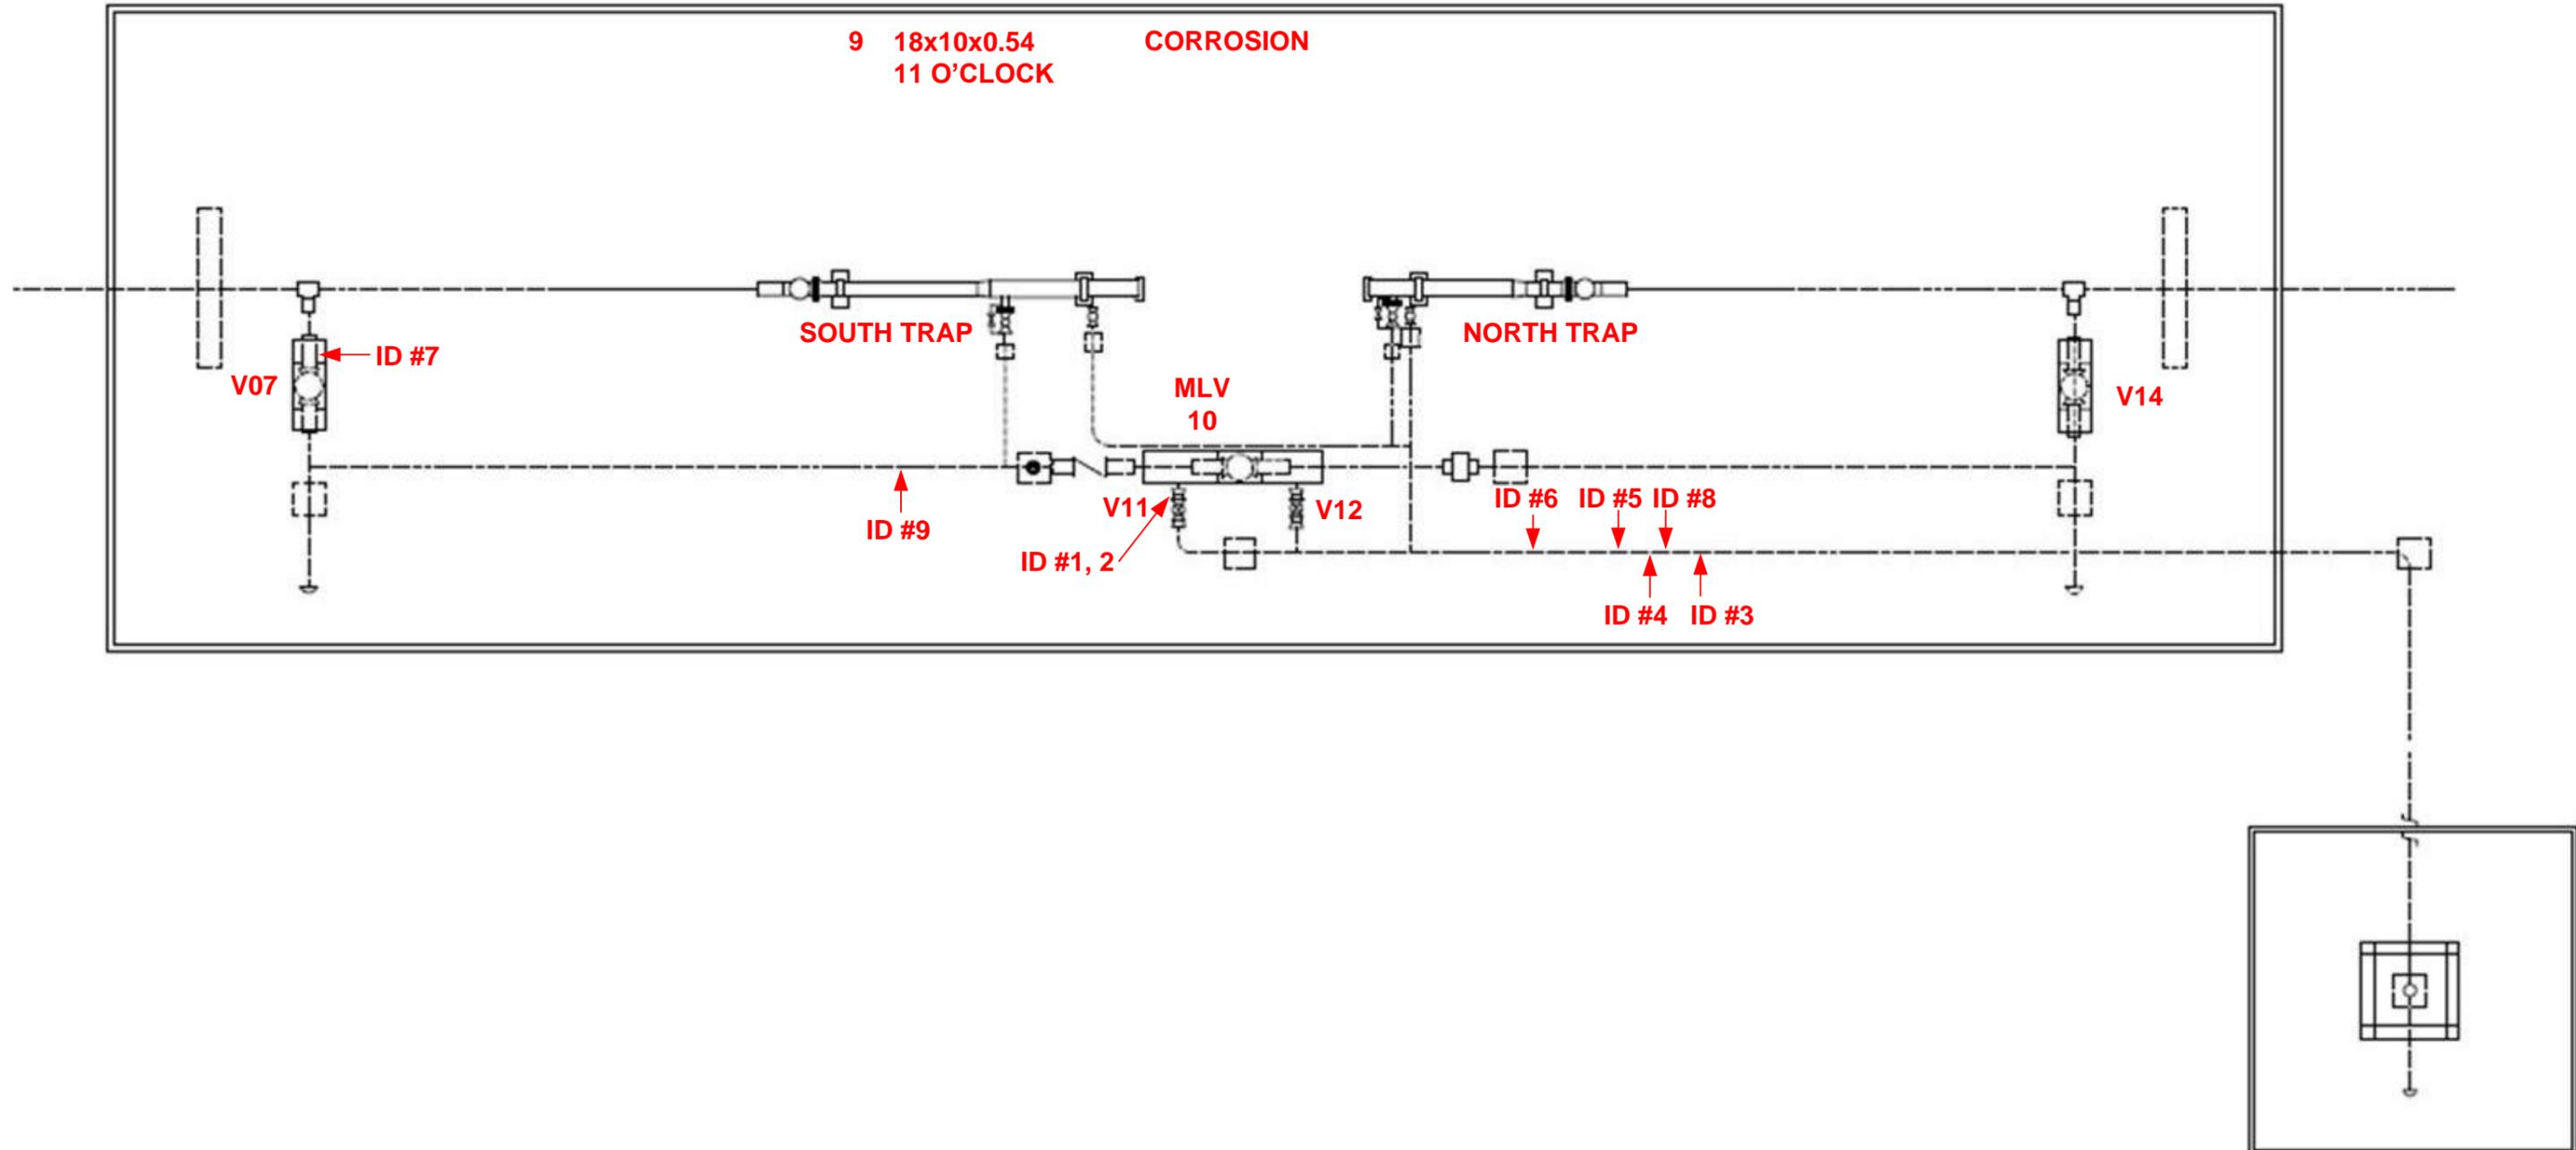
TANAMI RD METAL LOSS RESULTS

There were 9 areas of metal loss found on the pipework at Tanami Rd. Of these 9 areas containing metal loss only all 1 area had a visible coating defect. The metal loss section of the coating damage assessment form was filled out for each defect – refer to 0.

COATING DAMAGE ASSESSMENT REPORT ID#	DEFECT DIMENSION (mm) LxWxDPTH O'CLOCK POSITION ON PIPE	CAUSE OF METAL LOSS	COATING DAMAGE ASSESSMENT REPORT ID#	DEFECT DIMENSION (mm) LxWxDPTH O'CLOCK POSITION ON PIPE	CAUSE OF METAL LOSS
1	7x5x0.72 1:30 O'CLOCK	CORROSION	5	5x6x1.30 9:30 O'CLOCK	CORROSION
2	10x8x1.08 9 O'CLOCK	CORROSION	6	7x9x1.67 9:30 O'CLOCK	CORROSION
3	7x9x1.37 3:30 O'CLOCK	CORROSION	7	26x15x1.70 1:15 O'CLOCK	CORROSION
4	6x6x1.11 10:30 O'CLOCK	CORROSION	8	7x11x1.23 9:10 O'CLOCK	CORROSION
			9	18x10x0.54 11 O'CLOCK	CORROSION

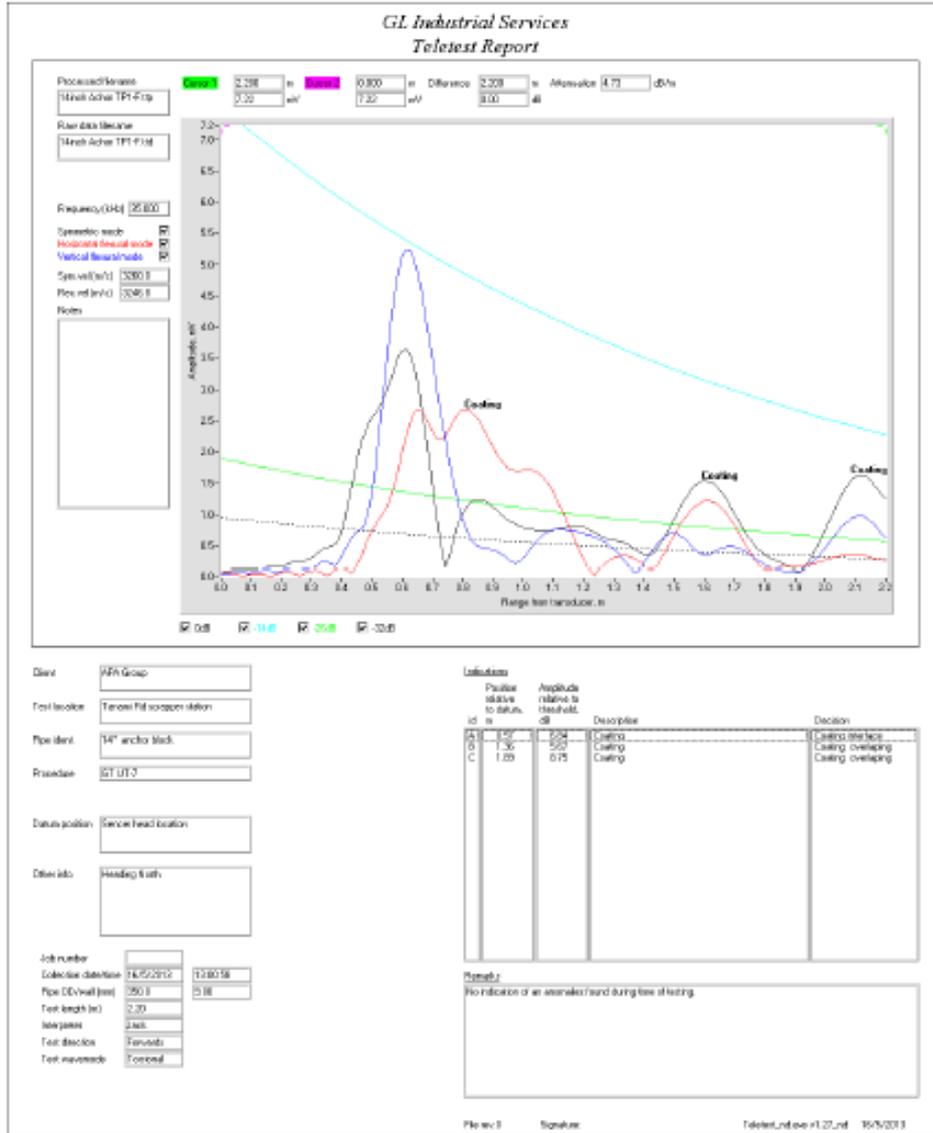
Test Point 1 : 14" Tanami Rd scraper station

Test Point 1 is the forward LRUT shot at Tanami Rd's south concrete anchor block, looking north. Three coating related anomalies were detected by LRUT. There are no results which indicate metal loss on the pipe. Corrosion was not identified within the concrete block.

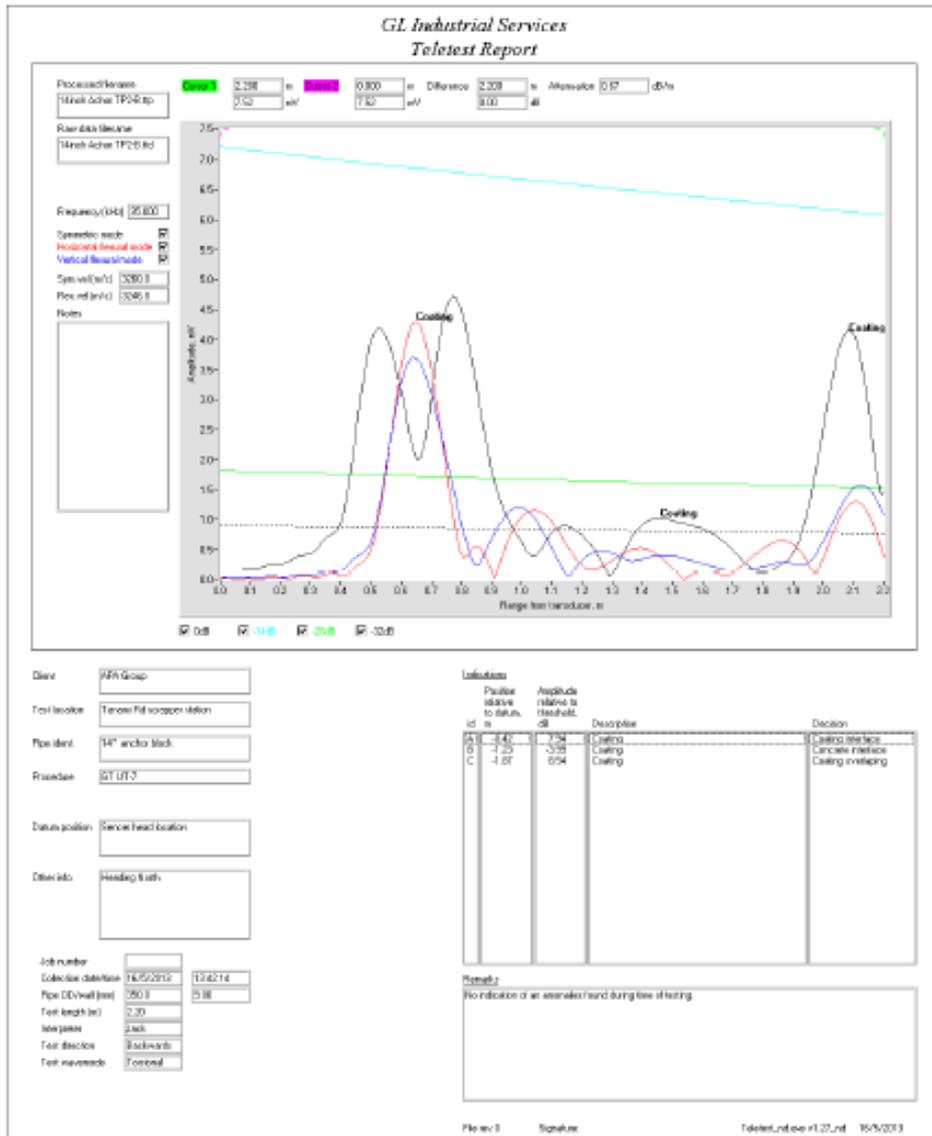
Test Point 2 : 14" Tanami Rd scraper station

Test Point 2 is a backward LRUT shot at Tanami Rd's south concrete anchor block, looking south. Three coating related anomalies were detected by LRUT. There are no results which indicate metal loss on the pipe. Corrosion was not identified within the concrete block.

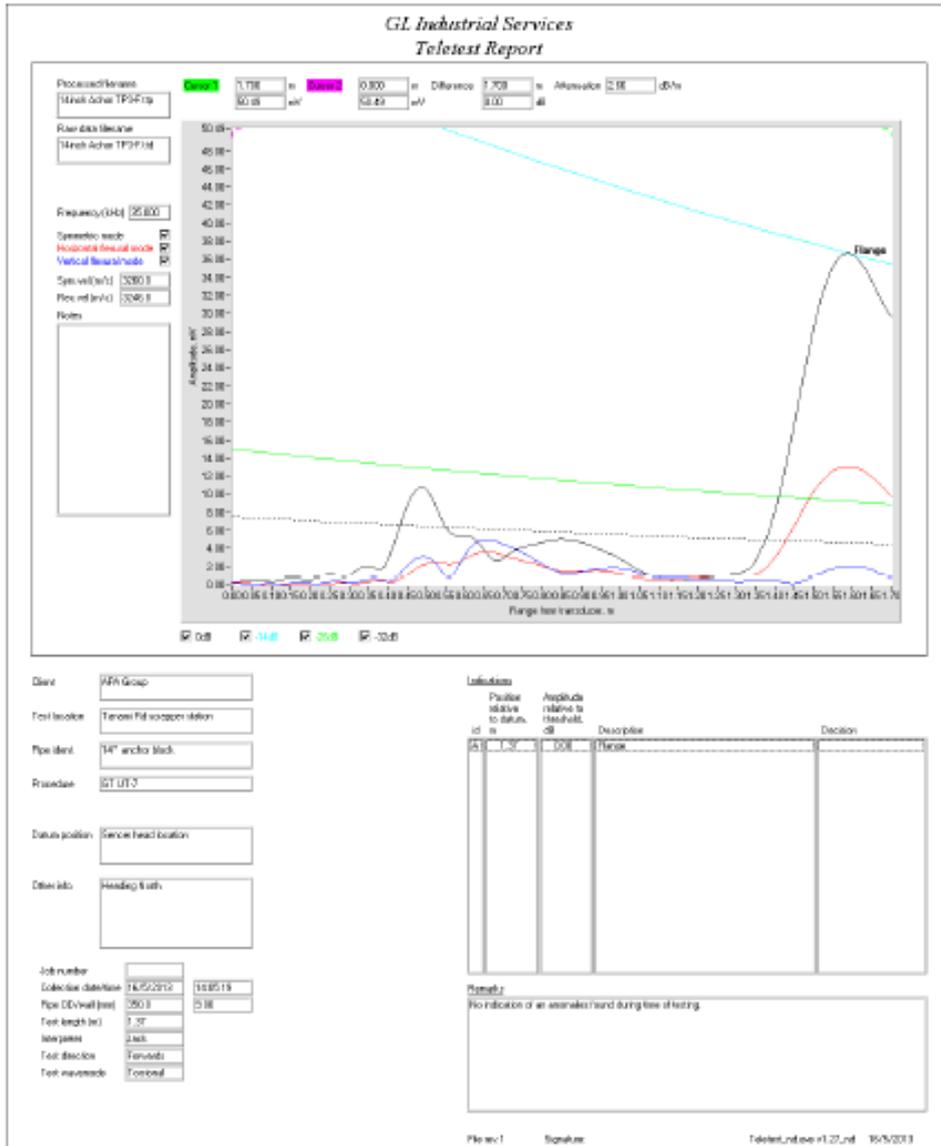
Test Point 3 : 14" Tanami Rd scraper station

Test Point 3 is the forward LRUT shot at Tanami Rd's V07 concrete support block, looking east. The body of V07 is 1.37m from the LRUT device with the concrete support block in-between. As shown in Appendix 5 there are no anomalies detected within the concrete support block. Corrosion was not identified within the concrete block.

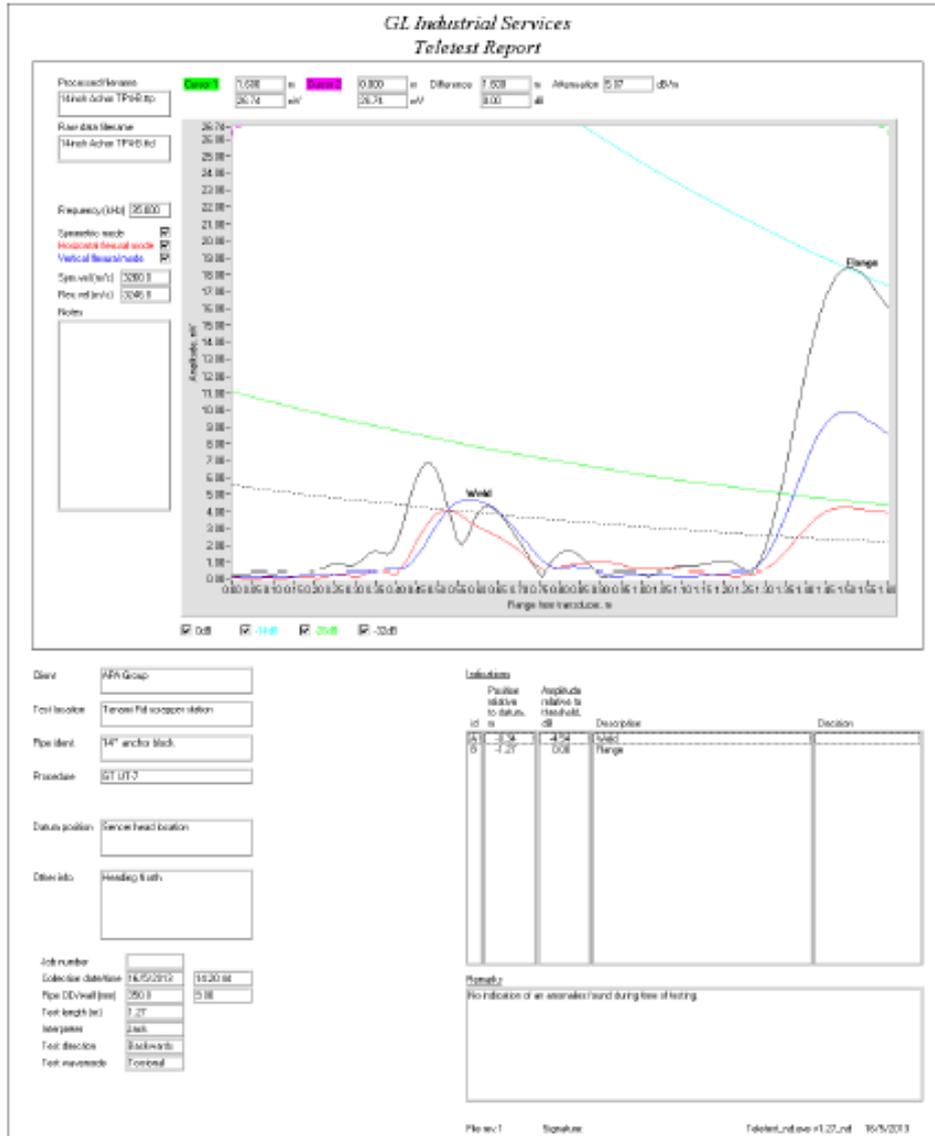
Test Point 4 : 14" Tanami Rd scraper station

Test Point 4 is the backward LRUT shot at Tanami Rd's V07 concrete support blocks, looking west. The LRUT has detected 1 significant anomaly identified as a weld at 0.34m and the valve body at 1.27m. The weld detected at 0.34 is the valve girth weld correctly identified, refer to photo 5652. Corrosion was not identified within the concrete block.

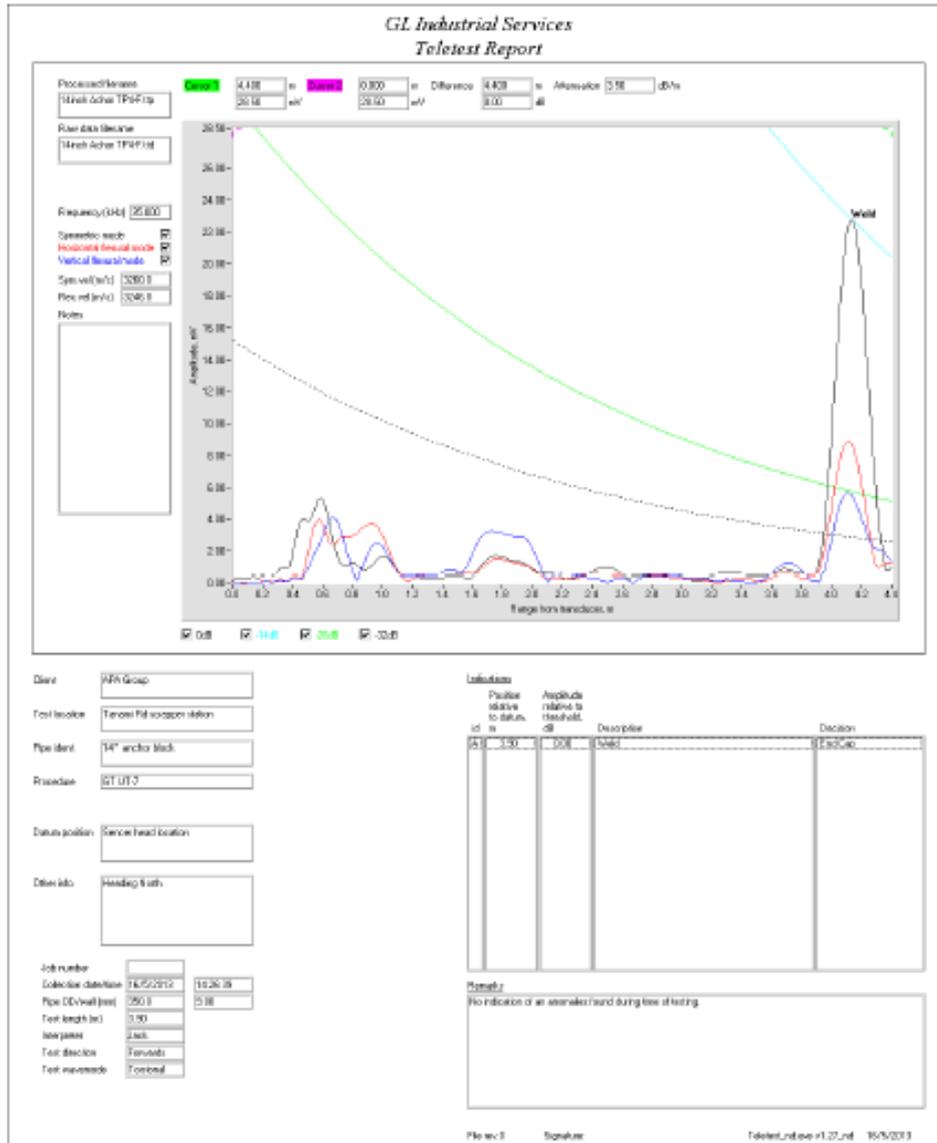
Test Point 4 : 14" Tanami Rd scraper station

Test Point 4 is the forward LRUT shot at Tanami Rd's V07 concrete support blocks, looking east. The LRUT has detected 1 significant anomaly identified as a weld at 3.90m from the end cap weld. Corrosion was not identified within the concrete block.

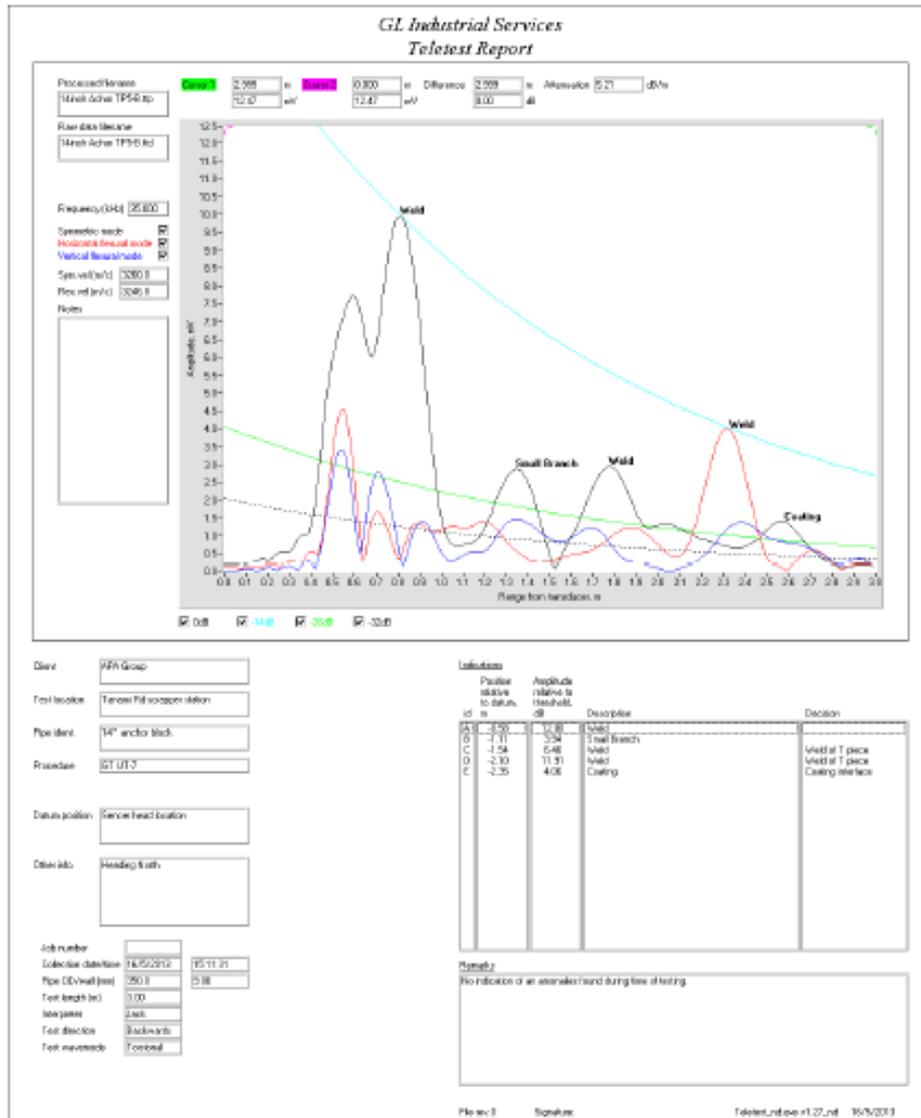
Test Point 5 : 14" Tanami Rd scraper station

Test Point 5 is the backward LRUT shot at Tanami Rd's NRV concrete support blocks, looking south. The LRUT has detected 45 significant anomalies identified as a weld at 0.58m, a vertical branched tee at 1.11m, a weld at 1.54m and the horizontal kicker line tee at 2.10m. Photo 5380 of Appendix 3 confirms the position and identification of these fittings and welds. Corrosion was not identified within the concrete block.

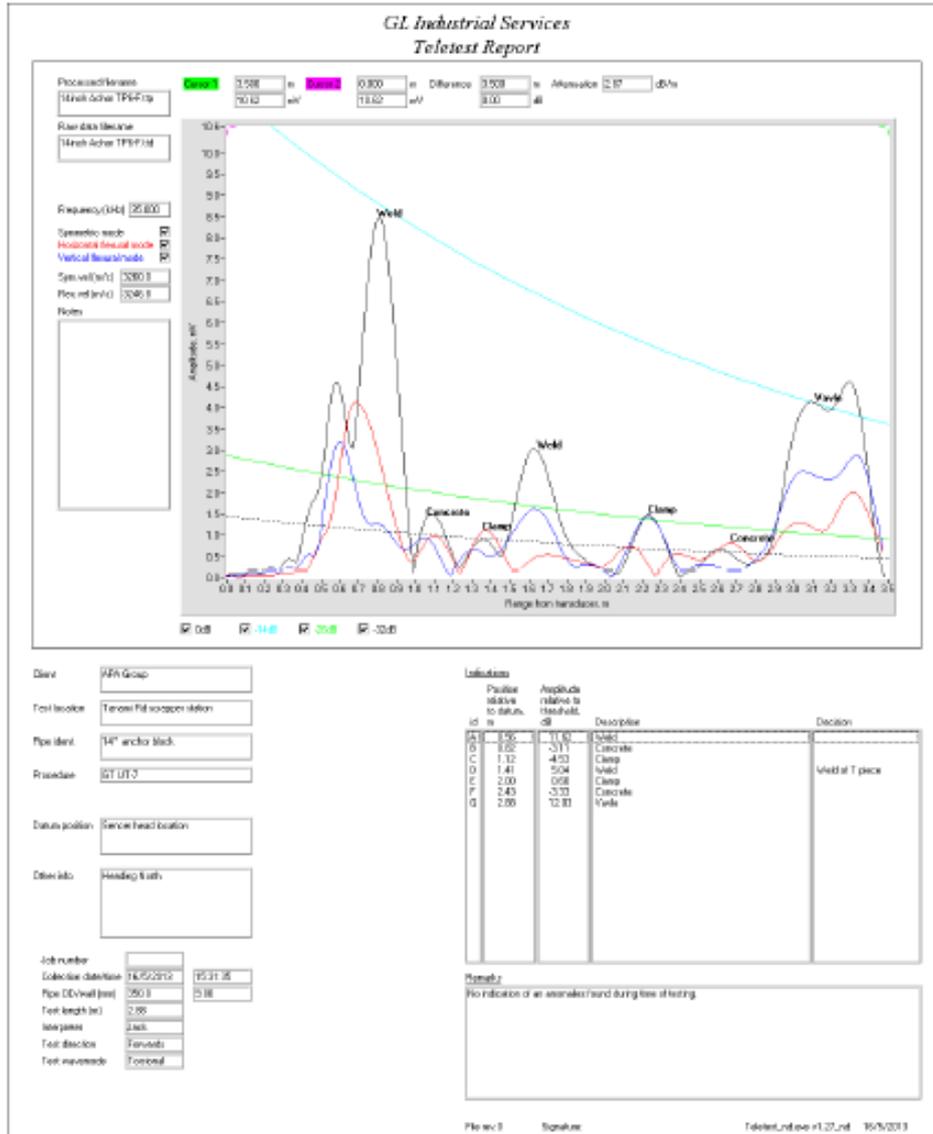
Test Point 6 : 14" Tanami Rd scraper station

Test Point 6 is the forward LRUT shot at Tanami Rd's MLV south concrete support block, looking north. The LRUT has detected 7 significant anomalies identified as a weld at 0.5m, the concrete interface at 0.83m, a pipe clamp at 1.22m, a weld at 1.41m, a clamp at 2.00m, the other edge of the concrete block at 2.43m and the valve body at 2.88m. Photo 5381 of Appendix 3 confirms the position and identification of these clamp fittings and welds. Corrosion was not identified within the concrete block.

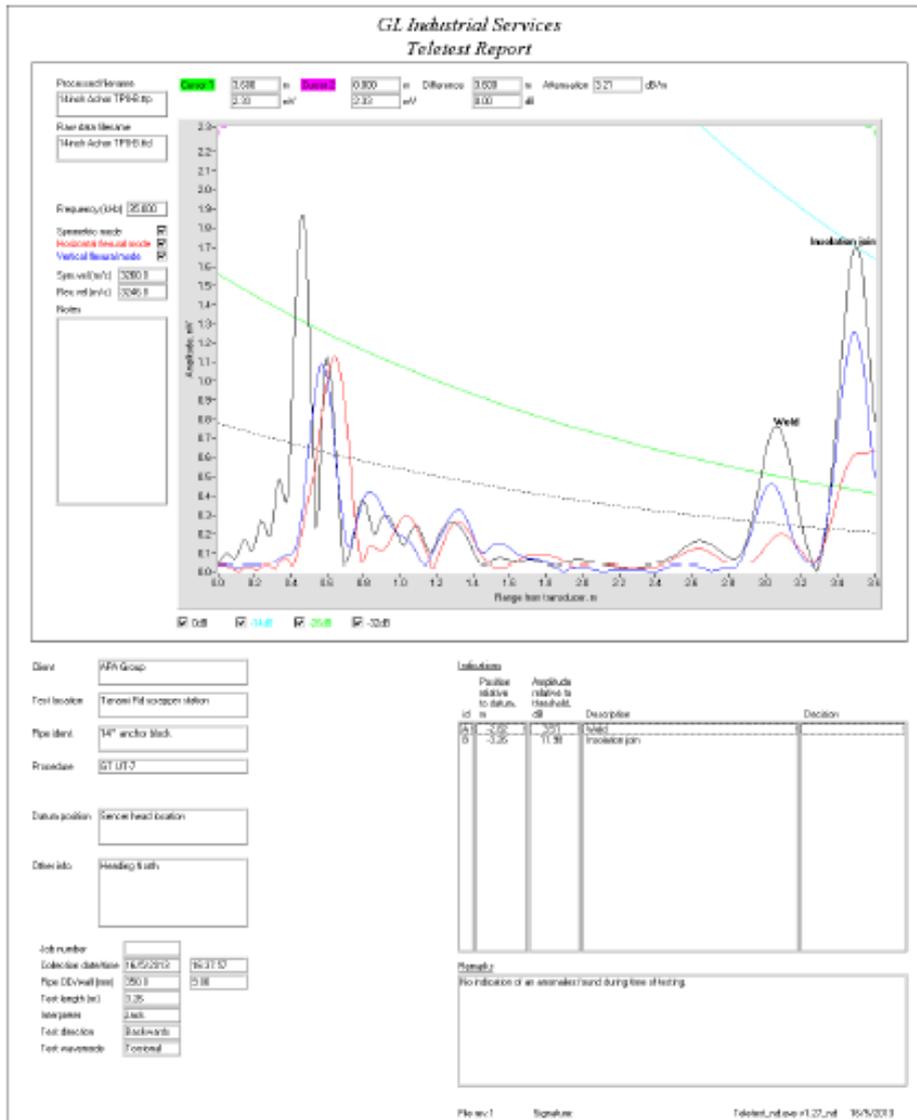
Test Point 8 : 14" Tanami Rd scraper station

Test Point 8 is the backward LRUT shot at Tanami Rd's MIJ north concrete support block, looking south. The LRUT has detected the weld at 2.82m and the MIJ which was detected at 3.26m. Photo 5292 of Appendix 3 confirms the detected distance between the weld and the MIJ. Corrosion was not identified within the concrete block.

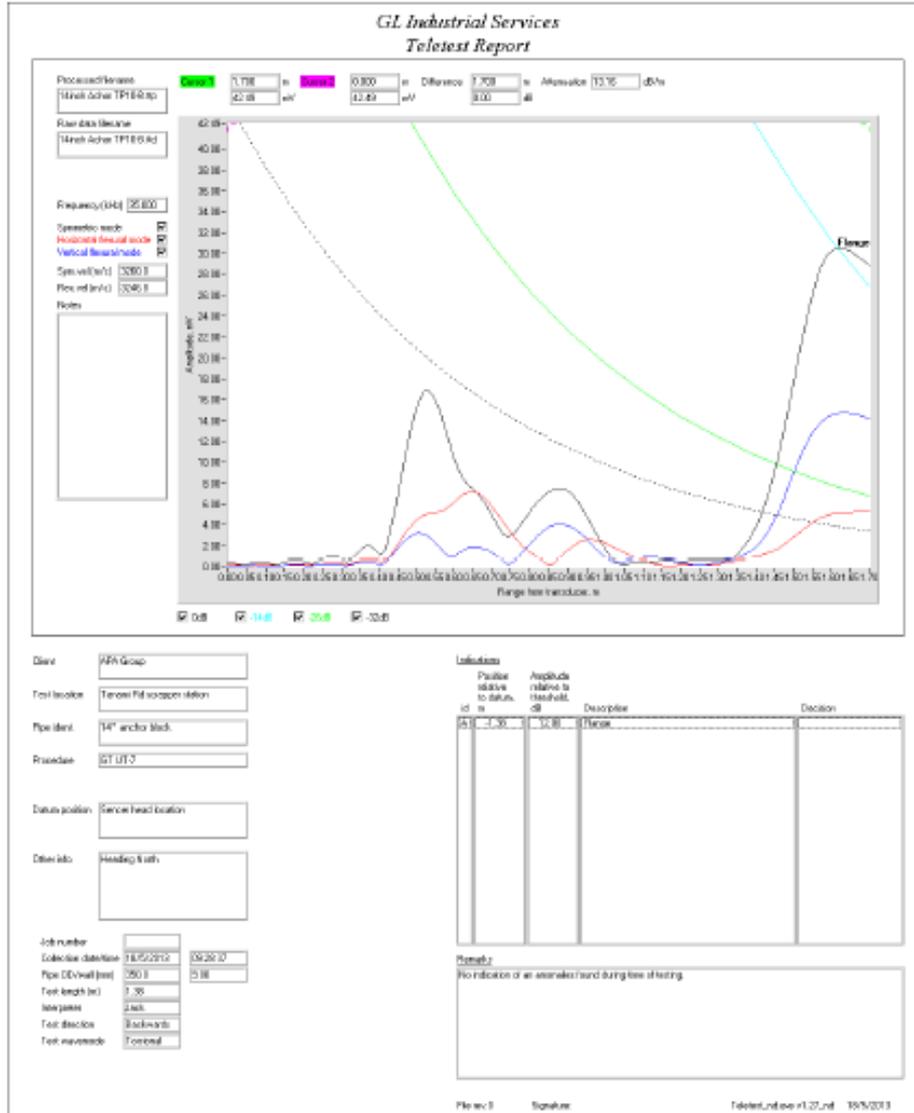
Test Point 10 : 14" Tanami Rd scraper station

Test Point 10 is the forward LRUT shot at Tanami Rd's V14 concrete support block, looking east. As shown in Appendix 5 there are no significant anomalies detected within the concrete support block between the start of the concrete block at 0.8m and the valve body identified at a distance of 1.38m. Corrosion was not identified within the concrete block.

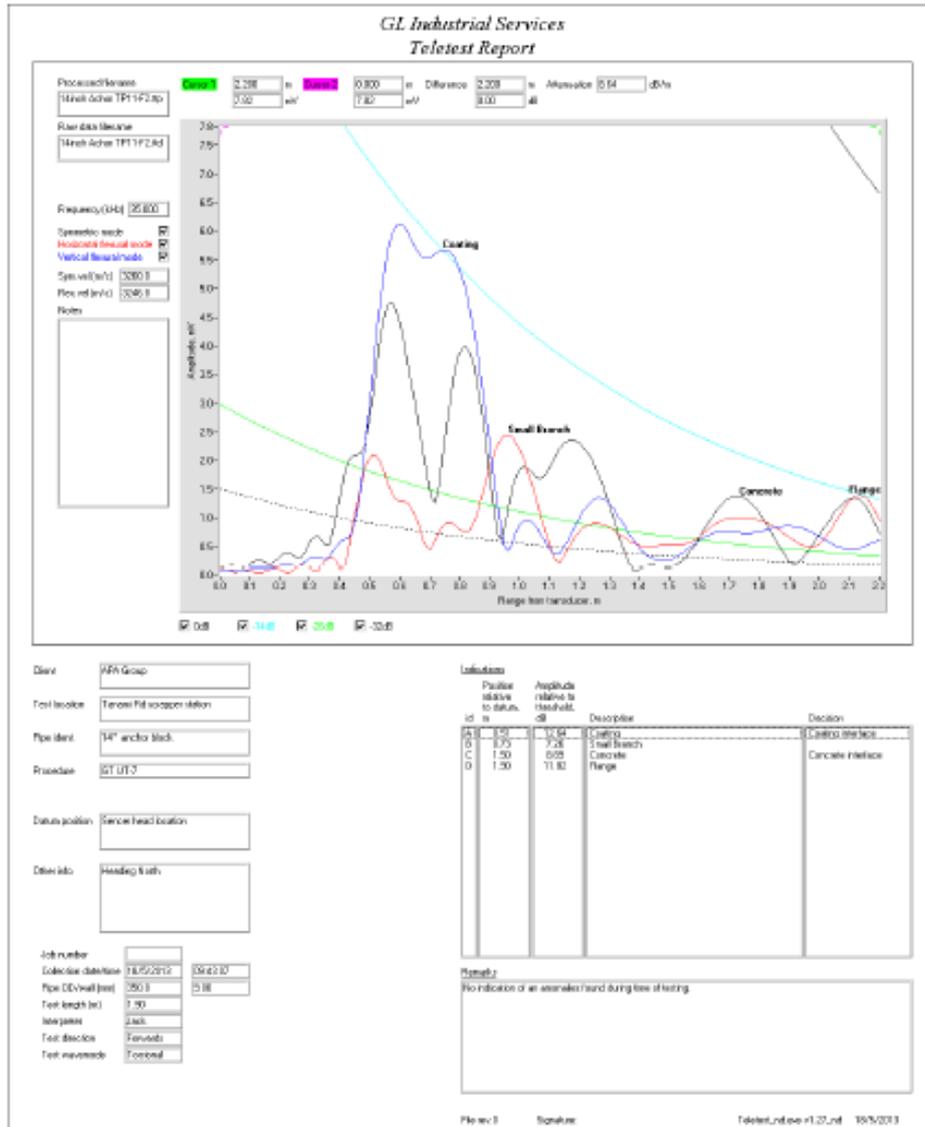
Test Point 11 : 14" Tanami Rd Scraper station Gas line

Test Point 11 is the forward LRUT shot at Tanami Rd's north concrete anchor block, looking north. The concrete anchor block begins 1.50m from the sensor head as shown in the results of Appendix 5, and the pig-sig tee is 0.73m from the sensor head. The pig-sig tee is identified by LRUT at a distance of 0.73m, a coating transition (to yellow jacket, refer photo 007) is identified at 0.51m, the concrete block interface is detected at 1.50m and the flange within the block was detected at a distance of 1.90m, 400mm into the block. Corrosion was not identified within the concrete block.

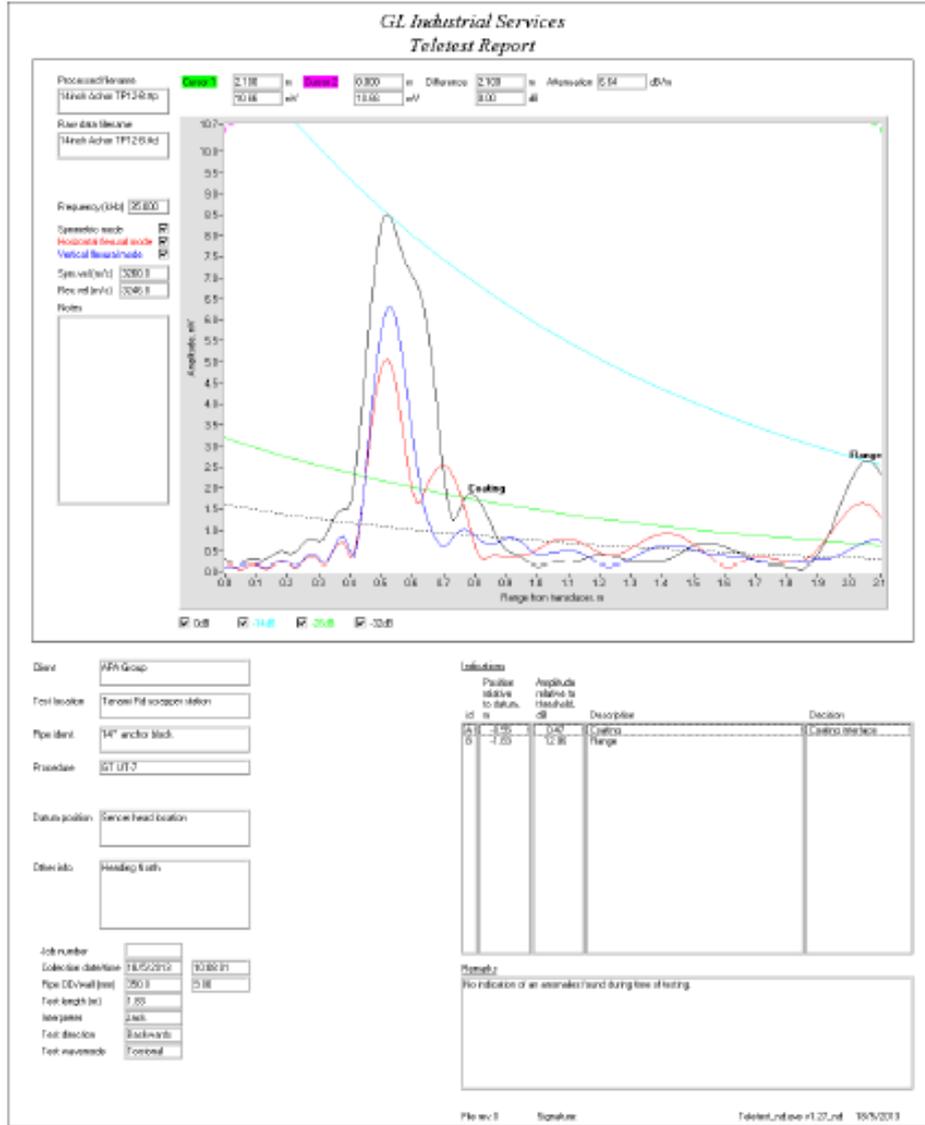
Test Point 12 : 14" Tanami Rd Scraper station Gas line

Test Point 12 is the backward LRUT shot at Tanami Rd's north concrete anchor block, looking south. A coating anomaly was identified at 0.55m, and the flange within the block was detected at a distance of 1.83m. Corrosion was not identified within the concrete block.
