Tanami Road Scraper Station

Coating Assessment Report

Document No. BGS-RP-A-0011 Rev 0A				
File Path: \\falcon\exword\2012\12109\Engineering\APA Project Folders - 130513\23.3_BGS_Below Ground Station Pipework Recoating\20. Coating Defect Analysis\Tanami Rd\BGS-RP-A-0011 Tanami Rd coating assessment Rev 0A.docx				
Author	Adam Nuske <i>Adam Nuske</i>			
Report Checked by				
Report Approved by				
Changes to be approved by				
Version control	Date	Version	Nature of Change	Approved by (Name)
	10/07/2013	0A	Final	<i>Stephen Hughes</i>

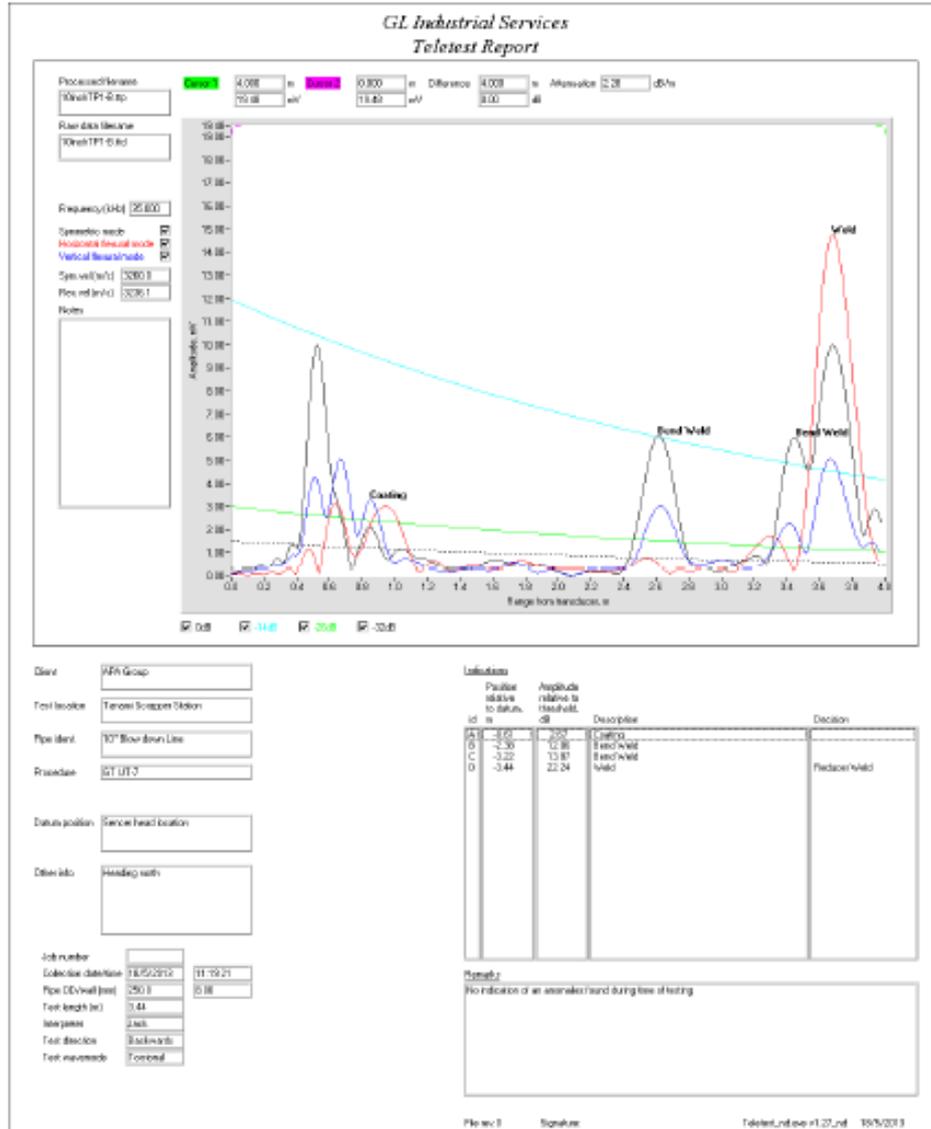
Test Point 1 : 10" Tanami Rd scraper station blow down line

Test Point 1 is the backward LRUT shot at Tanami Rd's blowdown line concrete support block between V11 and V12, looking south. A coating anomaly was detected at 0.61m from the device. The elbow piece weld was identified downstream the concrete block at a distance of 2.38m. Corrosion was not identified within the concrete block.

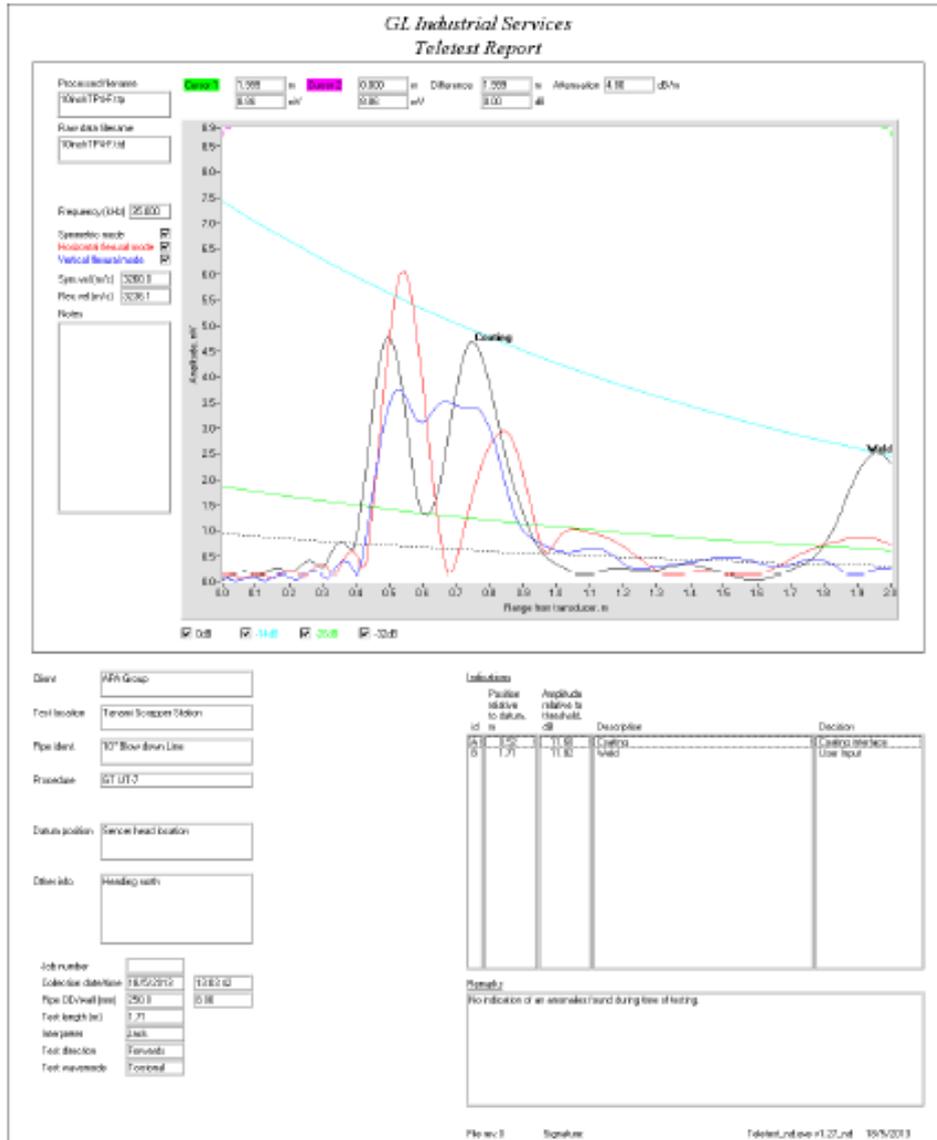
Test Point 4 : 10" Tanami Rd scraper station blow down line

Test Point 4 is the forward LRUT shot at Tanami Rd's blowdown stack concrete support block, looking east. The concrete interface is 0.52m in front of the sensor head as shown in the results of Appendix 5. The tee piece girth weld was identified within the concrete block at a distance of 1.71m, inside of the block. Corrosion was not identified within the concrete block.

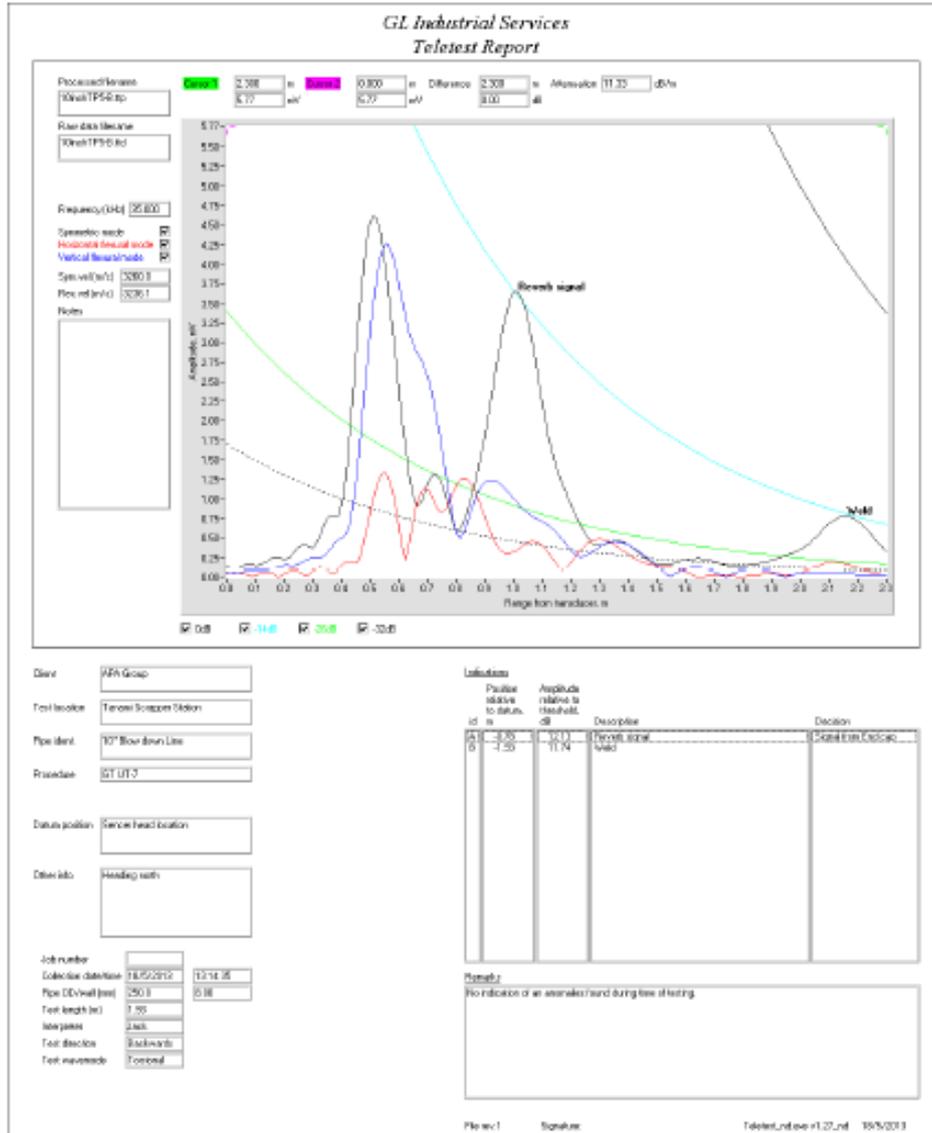
Test Point 5 : 10" Tanami Rd scraper station blow down line

Test Point 5 is the backward LRUT shot at Tanami Rd's blowdown stack concrete support block, looking west. A reverberated signal is detected 0.78m in front of the sensor head as shown in the results of Appendix 5. The tee piece girth weld was identified within the concrete block at a distance of 1.93m, inside of the block. Corrosion was not identified within the concrete block.
