# Tindal MLV Main Line Valve

## Coating Assessment Report

Document No. BGS-RP-A-0005 Rev 0B				
File Path: G:\Major Projects\23.3_BGS_Below Ground Station Pipework Recoating\20. Coating Defect Analysis\Tindal MLV\BGS-RP-A-0005 Tindal MLV coating assessment Rev B 190413.docx				
Author	Adam Nuske <i>Adam Nuske</i>			
Report Checked by				
Report Approved by	STEPHEN DYKES <i>Stephen Dykes 22/4/13</i>			
Changes to be approved by				
Version control	Date	Version	Nature of Change	Approved by (Name)
	19/04/2013	0B	Final

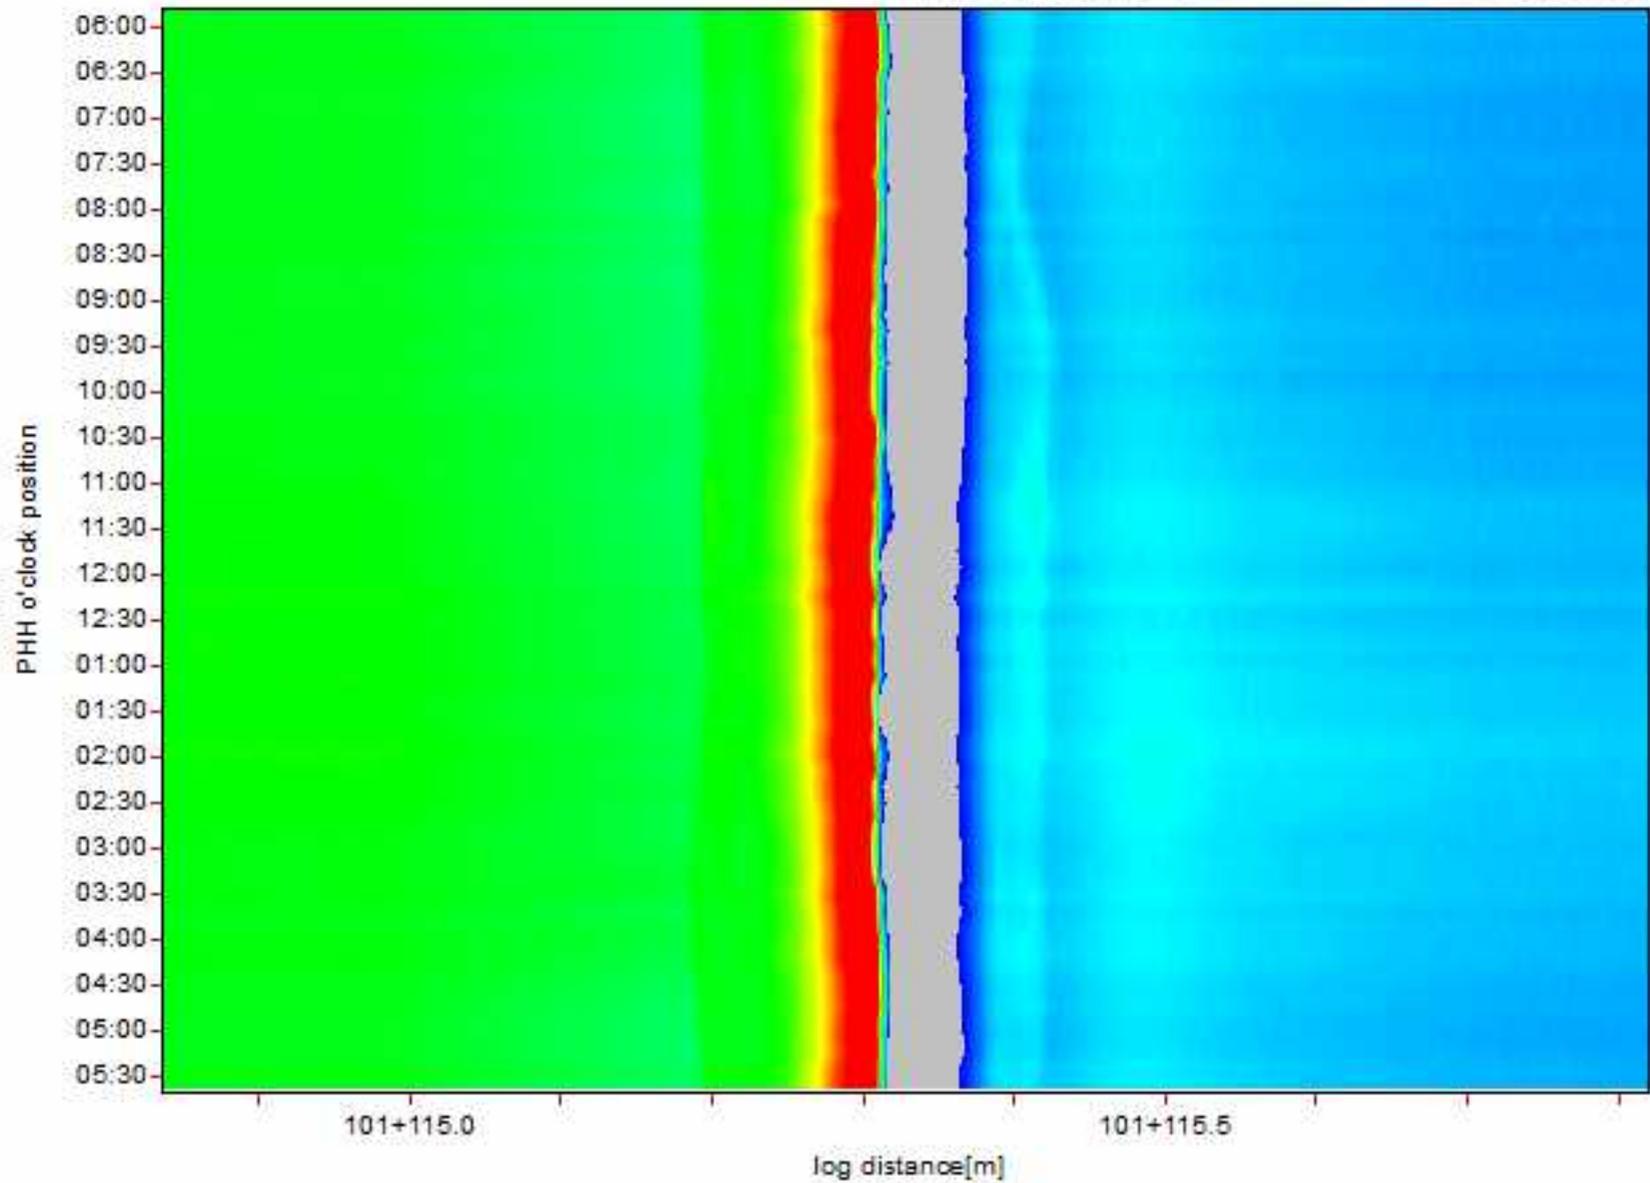
## Appendix 4 Pigging Data

Pigging data is available for these line segments around the area of corrosion. Results of the magnetic field profile in the area around the south canusa sleeve weld are attached, refer to Appendix 4 . Due to the small corrosion pit size the pig was unable to detect a significant disruption to the induced magnetic field strength in the area and metal loss does not appear apparent, note however that the pigging data is dated to 2003.

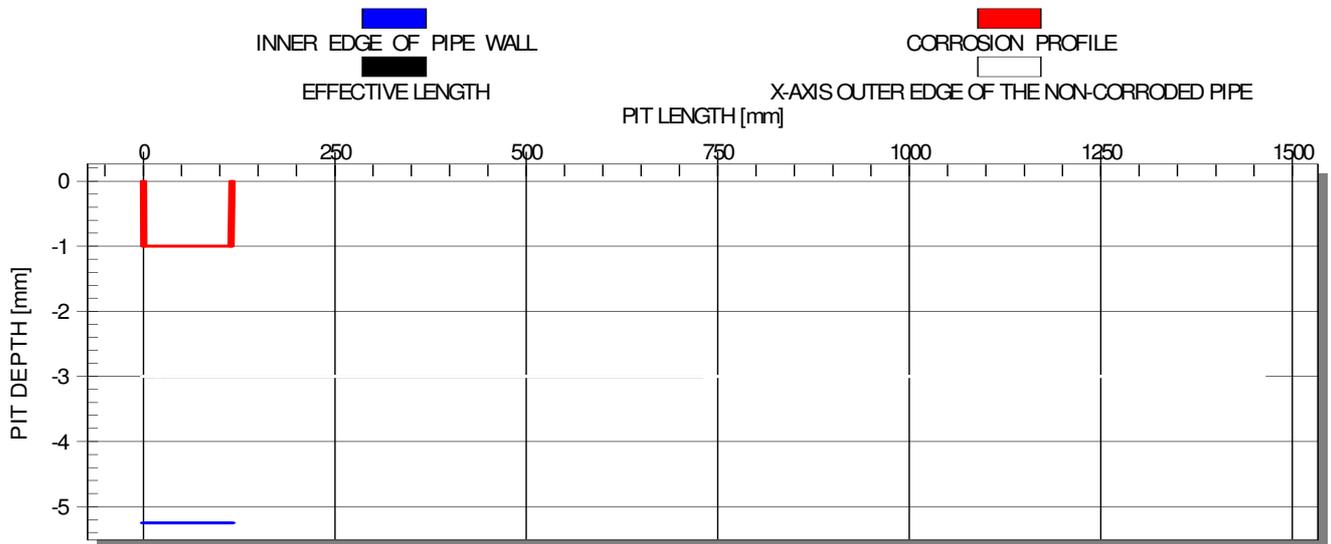
**CORROSION PROFILE:**

RSTRENG analysis was completed over the more severe area of corrosion to the north anchor block. The pipe wall thickness in the area is 7.90mm (refer to Appendix 1) and the Coating Damage Assessment metal loss form issued from site (Appendix 2) indicates the maximum pit depth of 1.0mm. The results of the RSTRENG analysis indicate that the pipeline passes for the current Maximum Operating Pressure (MAOP) of 9,650kPag (refer to Appendix 5). The AGP design factor is 0.72 which translates to a required safety factor of 1.39 and the RSTRENG results satisfy this case.

Pipe Outside Diameter [mm] 323.90 Effective Length [mm] 114.00  
Pipe Wall Thickness [mm] 5.250 Effective Area [mm]<sup>2</sup> 114.01  
SMYS [MPa] 413 Max. Pit Depth [mm] 1.000  
Design Factor 0.72 Max.Depth/Wall Thickness 0.19  
Total Length [mm] 116  
Effective Length: Start 1.00 End [mm] 115.00

METHOD	Max. Safe Pressure [kPa]	Burst Pressure [kPa]	Safety Factor
RSTRENG - Effective Area	9650	13755	1.43
RSTRENG - 0.85dL	9650	14042	1.46
ASME B31 G	9650	13490	1.4

Nr.	Increment [mm]	Pit Depth [mm]
1.	0	0
2.	1	1
3.	115	1
4.	116	0

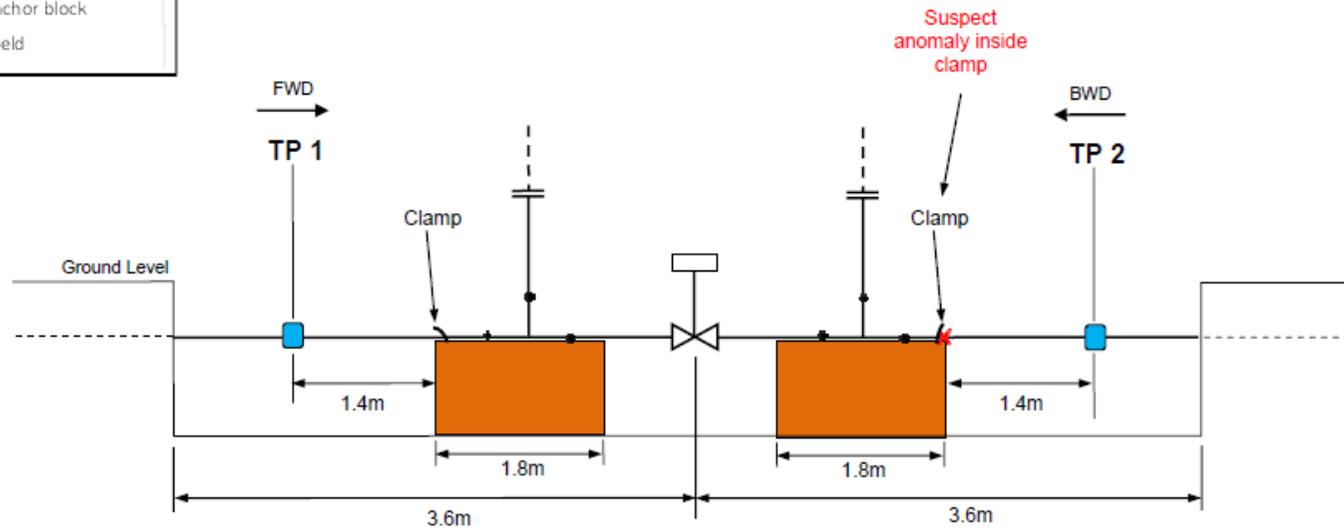
### PIPELINE SCHEMATIC DRAWINGS

LRUT was conducted at Tindal MLV from September 17-18, 2012. Extracts from the LRUT report are presented in Appendix 6. The diagram in Appendix 6 shows the setup and location of the LRUT probe when undertaking the test. Two LRUT 'shots' were conducted from the north (Test Point 1, TP1) and south (Test Point 2, TP2) in order to examine the condition of the pipe wall underneath the support blocks.

Test Point 2 is the backward shot at Tindal. The concrete support block begins 1.4m from the sensor head and as shown in the results of Appendix 6 there is a single anomaly detected at 1.76m in the horizontal plane of the pipe for this shot. There was no reported coating defect or corrosion evident during blasting and the LRUT report suspects that the anomaly is due to the clamp at that location. The T-piece welds were detected at 2.2m and 2.7m, and the MLV was detected at a range of 3.54m.

One anomaly was reported in the area of the south concrete anchor block. The anomaly was detected in the horizontal flexural mode and was a grade 2 anomaly lying in the -32db to -26db range, and classified as a minor anomaly. The anomaly coincides with the point that the steel clamp is bolted over the pipe to secure the pipe to the concrete block, therefore given the location the coating has probably been locally affected and resulted in a localised change to the coating profile and detectable by LRUT.

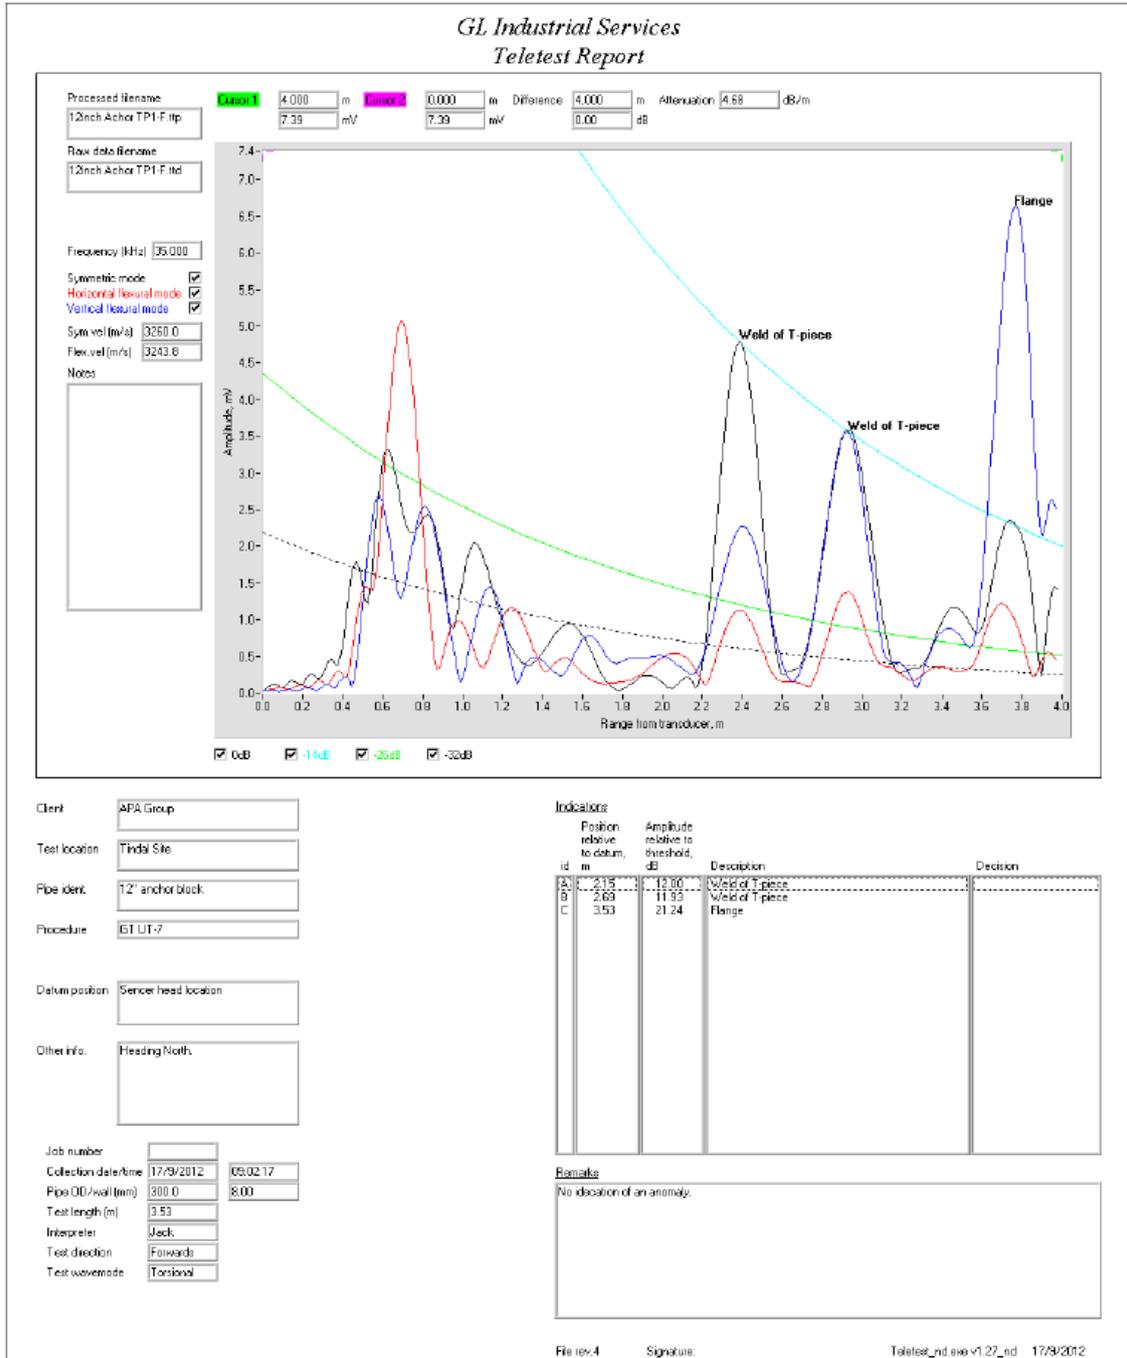
Test Point 1 Line ID: 12" Tindal Heading North

Test Point 1 is the forward LRUT shot at Tindal. The concrete support block begins 1.4m from the sensor head and as shown in the results of Appendix 6 there are no anomalies detected from this point onwards for this shot. The T-piece welds were detected at 2.2m and 2.7m, and the MLV was detected at a range of 3.53m.
