Wauchope Scraper Station

Coating Assessment Report

Document No. BGS-RP-A-0009 Rev 0A

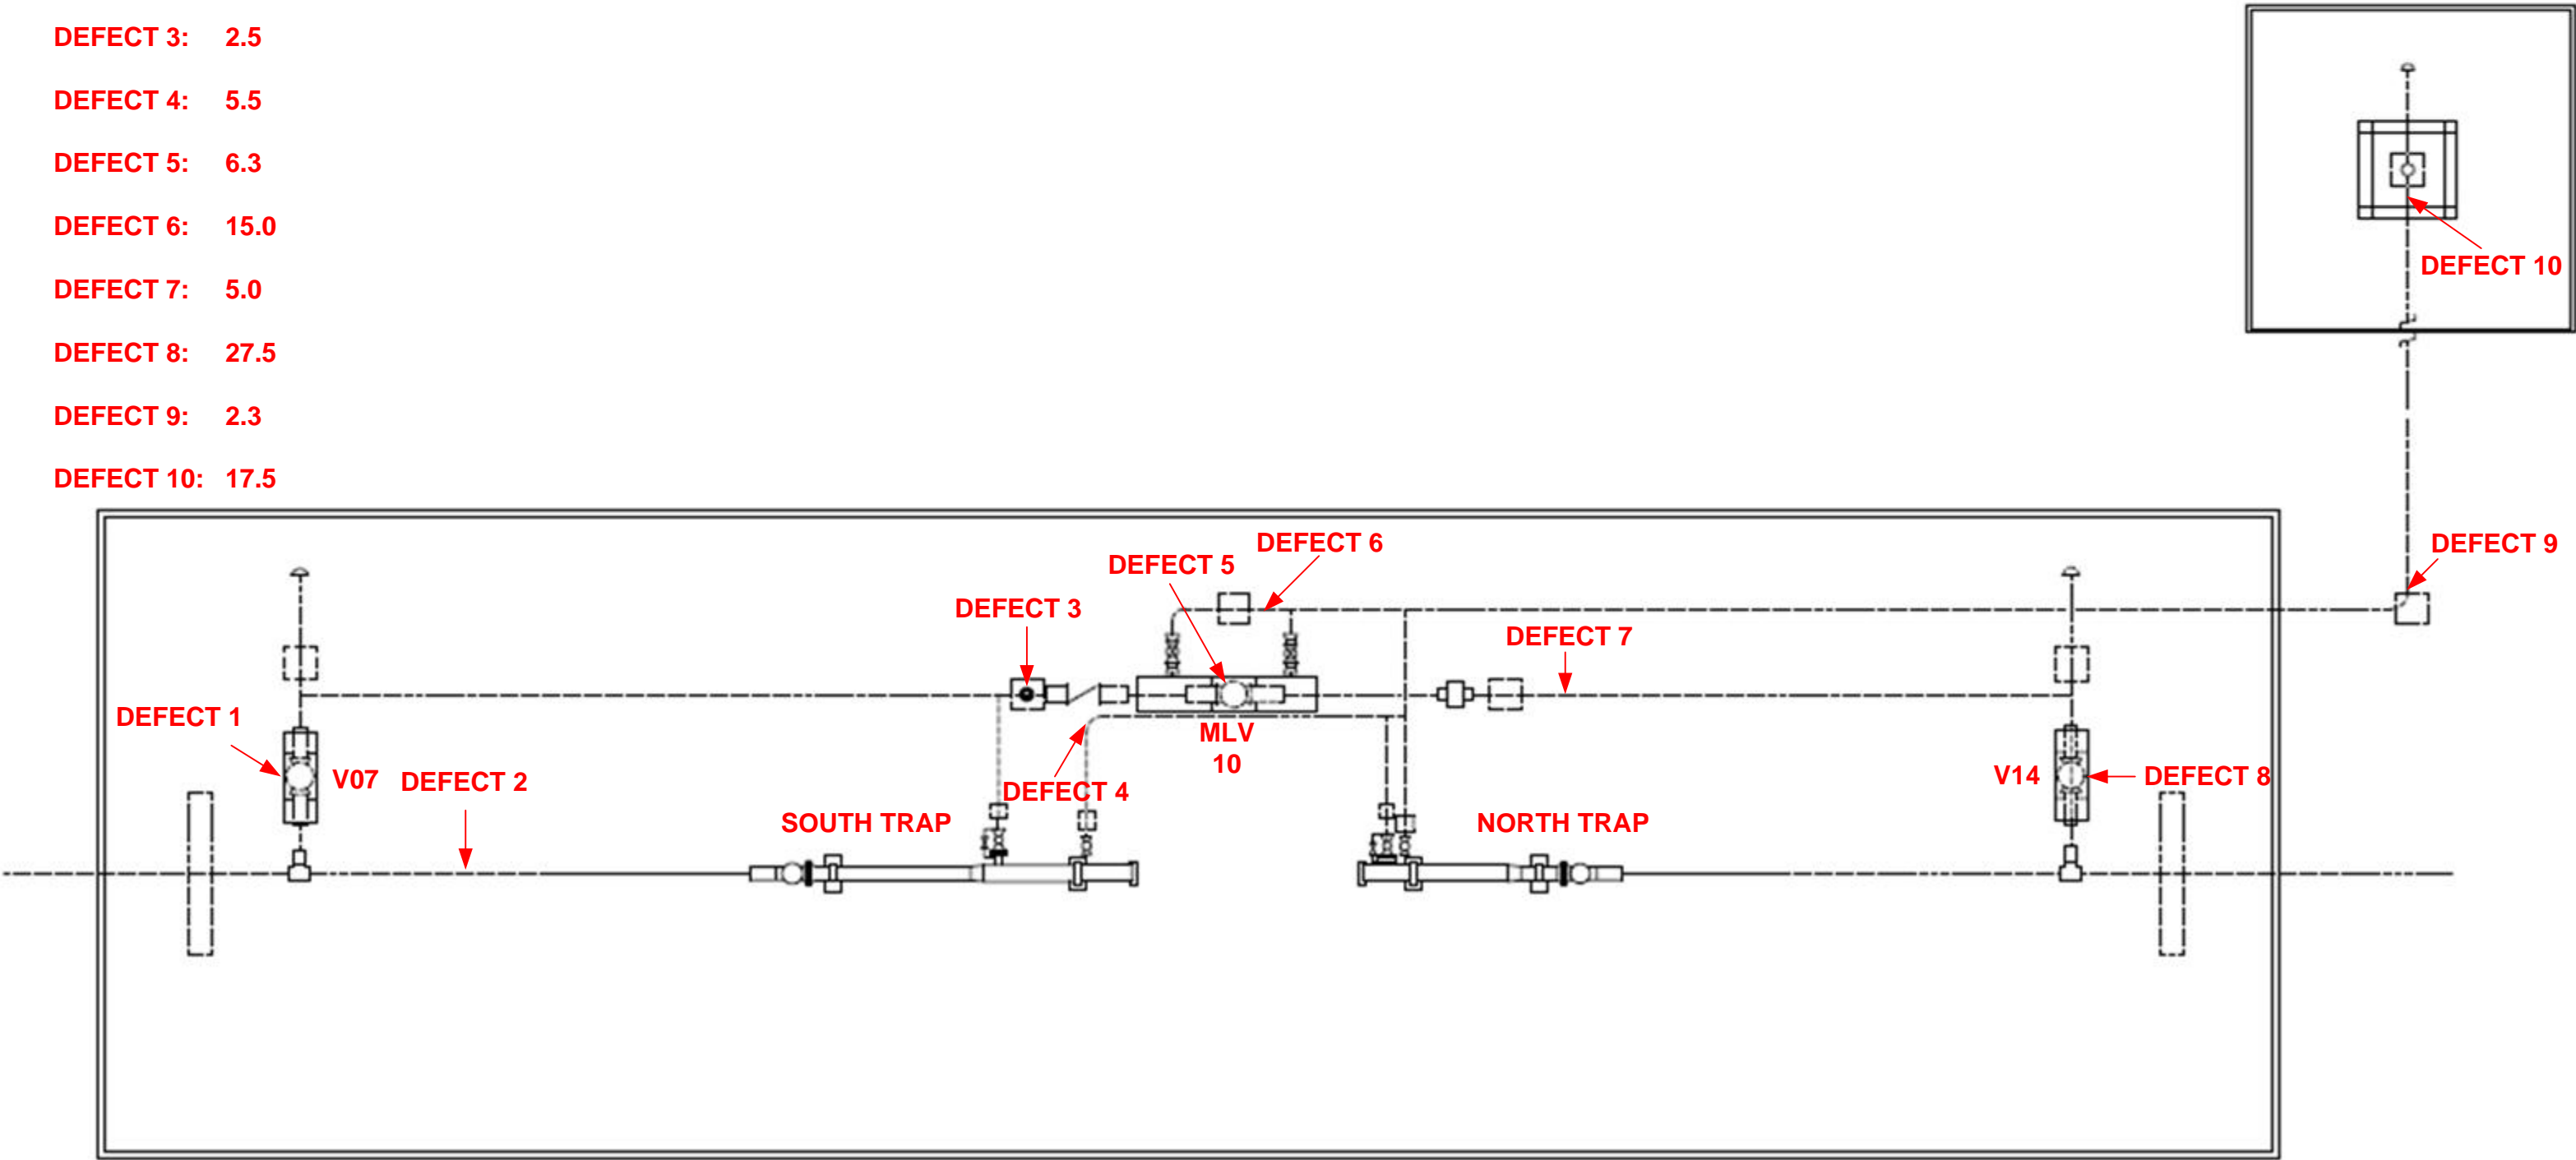
WAUCHOPE DCVG SURVEY

There were 10 areas highlighted as having coating defects by the DCVG survey. These defects are summarised in Table 1 below. Locations of each defect are shown on the drawing in Appendix 1.

DCVG Defect Number	Section	IR
1	V07	2.5 %
2	South pig trap line	15.0 %
3	NRV southern support block	2.5 %
4	South pig trap drain line elbow	5.5 %
5	MLV	6.3 %
6	Concrete support block between V11 and V12	15.0 %
7	North of support block adjacent to MIJ	5.0 %
8	V14	2.3 %
9	Support block with 90° elbow in blowdown line	2.3 %
10	Blowdown stack	17.5 %

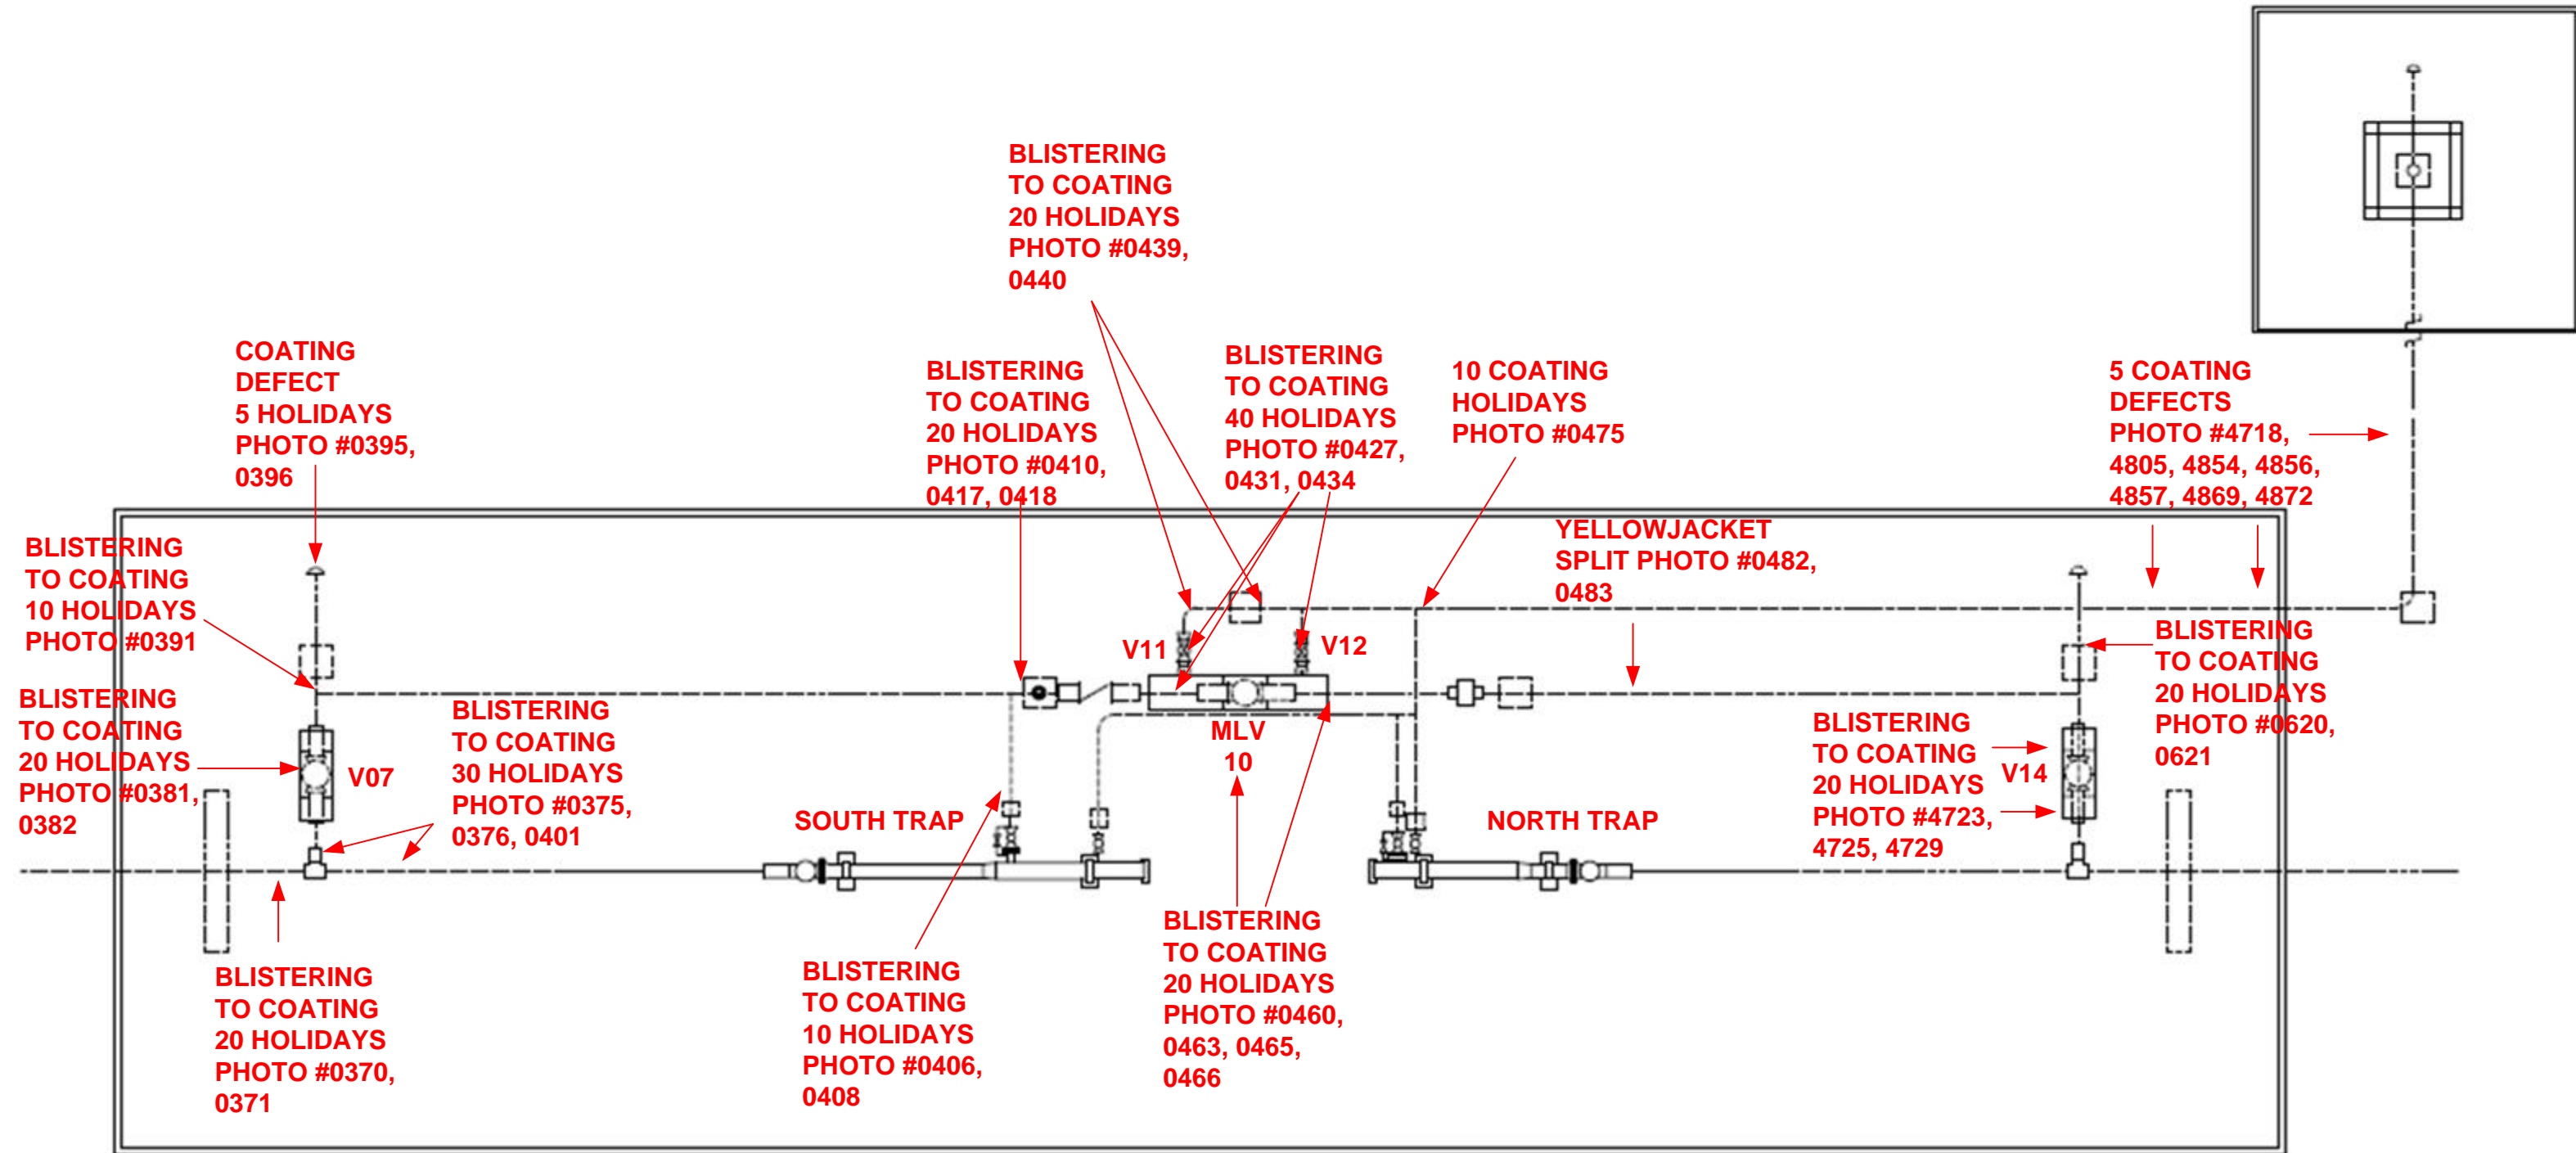
WAUCHOPE COATING DEFECT – VISUAL INSPECTION & HOLIDAY DETECTOR RESULTS

A significant amount of the coating found at Wauchope was in poor condition. Many areas of CTE coating were found to be blistering and the coating in places was cracked and pulling away from the pipework. Recorded coating defects have been illustrated on the Wauchope Coating Defect layout drawing in Appendix 2. Areas of coating found to fail a holiday test were circled with white paint (refer photos). Some specific examples include:

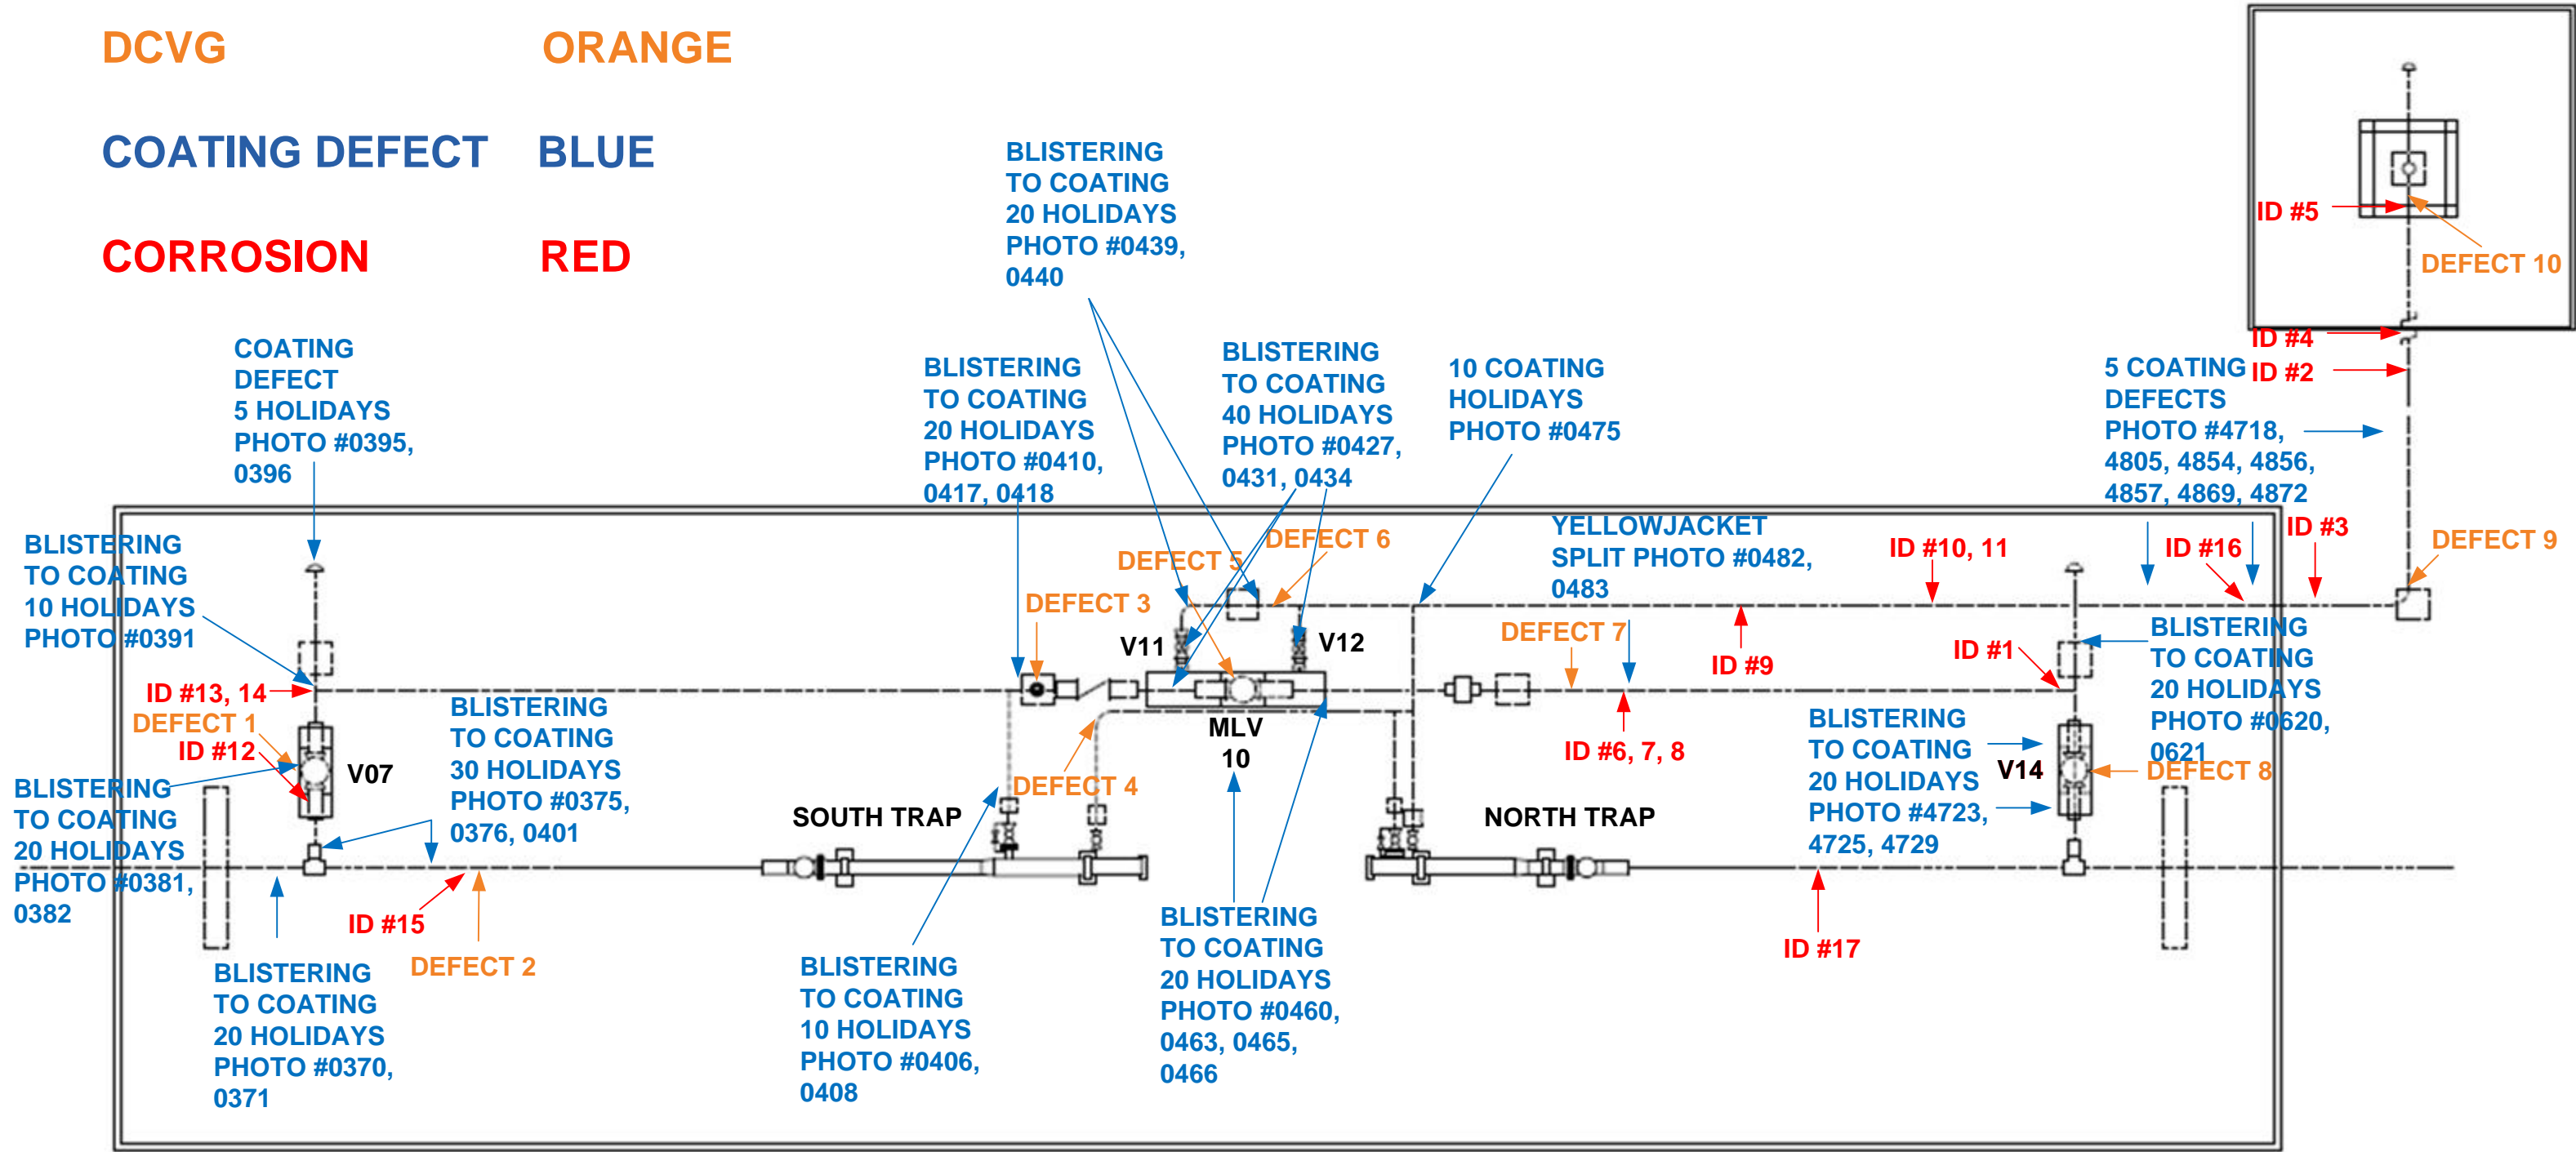
WAUCHOPE DCVG, COATING DEFECTS & METAL LOSS RESULTS

Compiling the results of DCVG, coating defects noted and corrosion found at Wauchope it should be possible to determine any links between the three sets of results. A complete set of results for the DCVG, Coating Defects and Metal loss is included in the Wauchope DCVG, Coating Defects and Metal Loss layout drawing of Appendix 1.

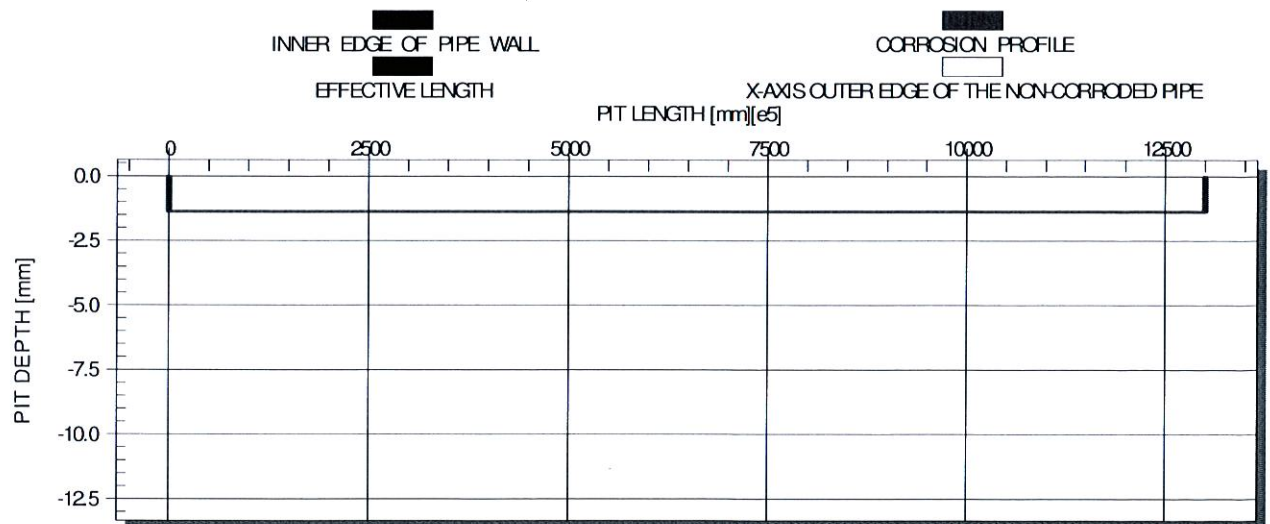
CORROSION PROFILE:

RSTRENG analysis was completed over the more severe area of corrosion to the blowdown line. The pipe wall thickness in the area is 8.74mm (refer to Appendix 1) and the Coating Damage Assessment metal loss form issued from site (Appendix 2) indicates the maximum pit depth of 1.37mm, 13000mm axial length and 10mm circumferential length. The results of the RSTRENG analysis indicate that the pipeline passes for the current Maximum Allowable Operating Pressure (MAOP) of 9,650kPag (refer to Appendix 4). The AGP design factor is 0.72 which translates to a required safety factor of 1.39 and the RSTRENG results satisfy this case.

METHOD	Max. Safe Pressure [kPa]	Burst Pressure [kPa]	Safety Factor
RSTRENG - Effective Area	16138	25719	2.67
RSTRENG - 0.85dL	16138	26185	2.71
ASME B31 G	15837	21996	2.28

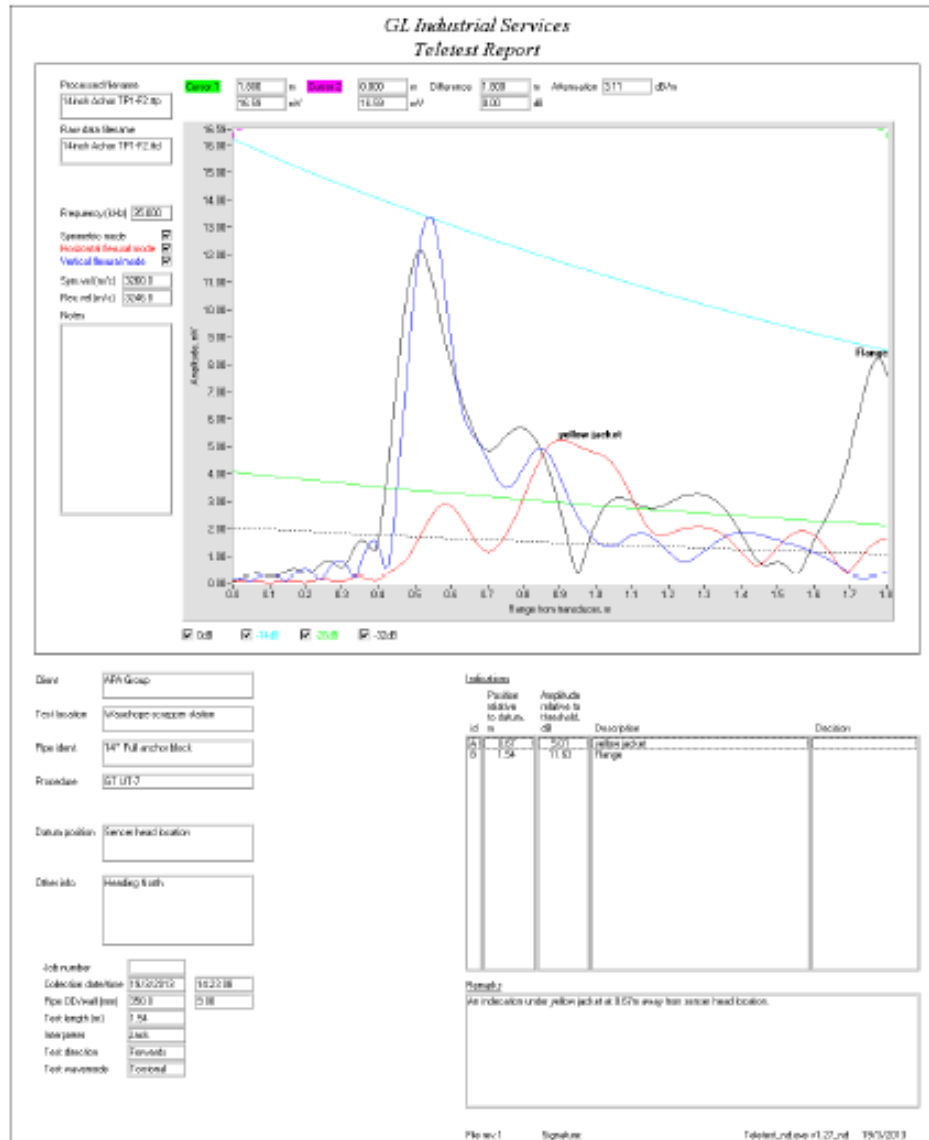
Test Point 1 : 14" Wauchope scraper station gas line

Test Point 1 is the forward LRUT shot at Wauchope's south concrete anchor block, looking north. An anomaly was detected within the yellowjacket region upstream of the anchorblock however no defect was discovered. The flange within the block was detected at a distance of 1.54m. Corrosion was not identified within the concrete block.

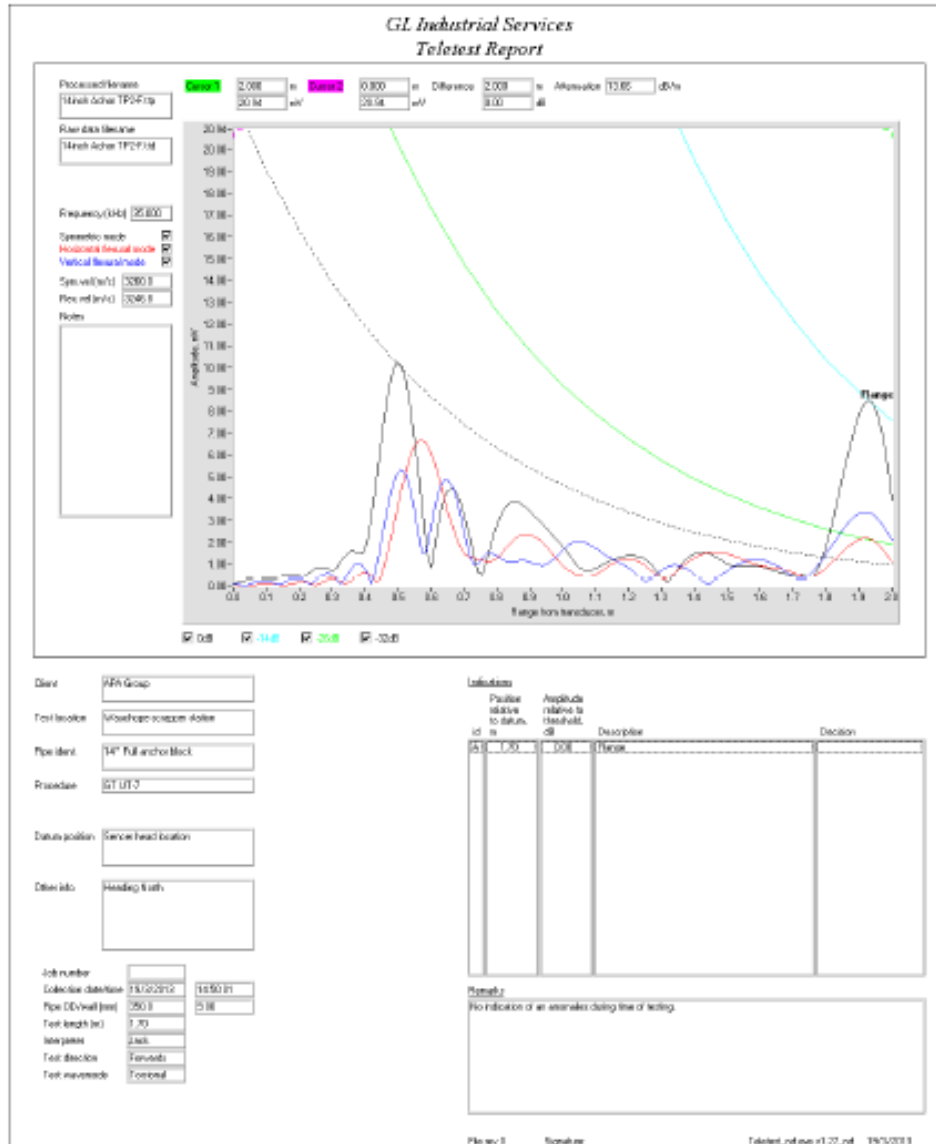
Test Point 2 : 14" Wanchope scrapper station gas line

Test Point 2 is a backward LRUT shot at Wauchope's south concrete anchor block, looking south. The flange within the block was detected at 1.70m. No anomalies were identified. Corrosion was not identified within the concrete block.

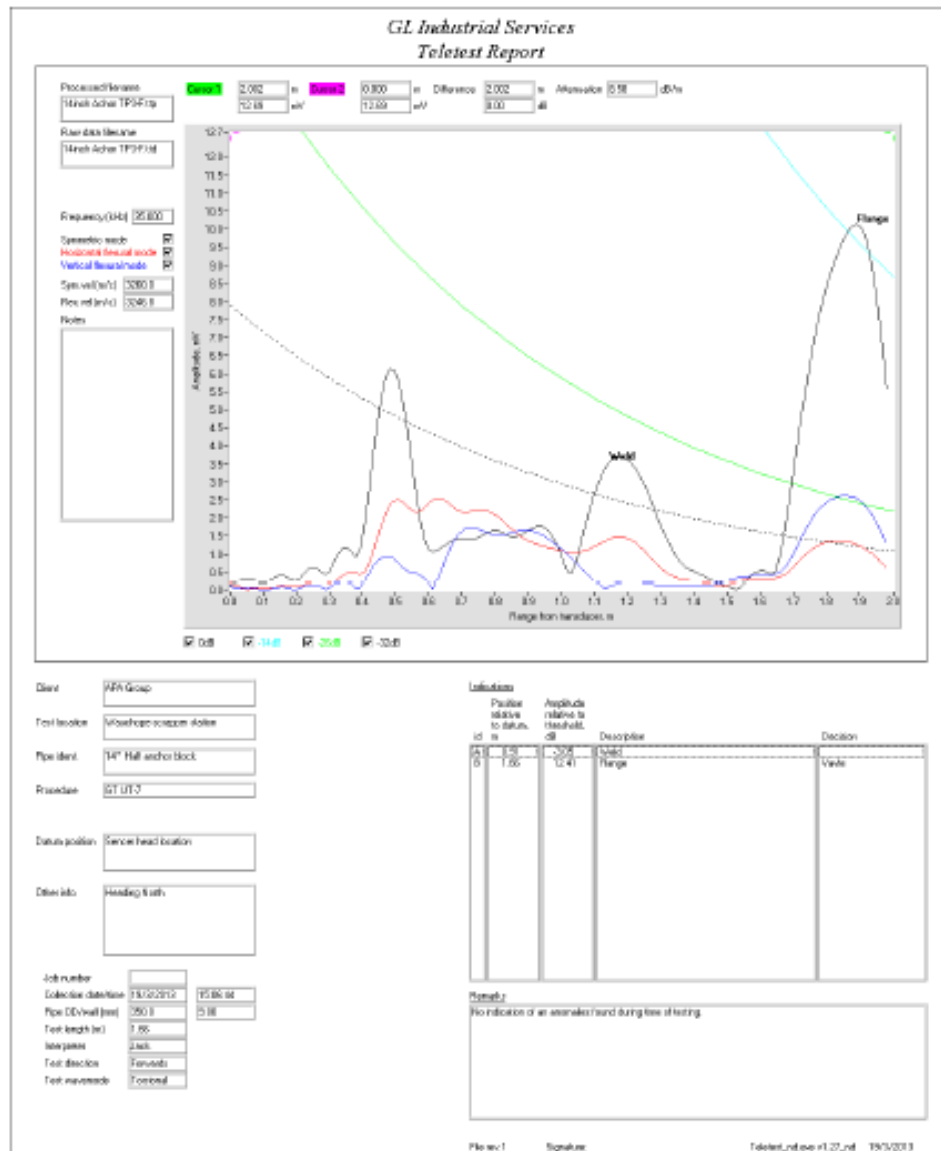
Test Point 3 : 14" Wauchope scraper station gas line

Test Point 3 is the forward LRUT shot at Wauchope's V07 concrete support block, looking west. The body of V07 is detected at a distance of 1.66m from the LRUT device with the concrete support block in-between. As shown in Appendix 5 there are no anomalies detected within the concrete support block, a weld was correctly identified at a distance of 0.91m. Corrosion was not identified within the concrete block.

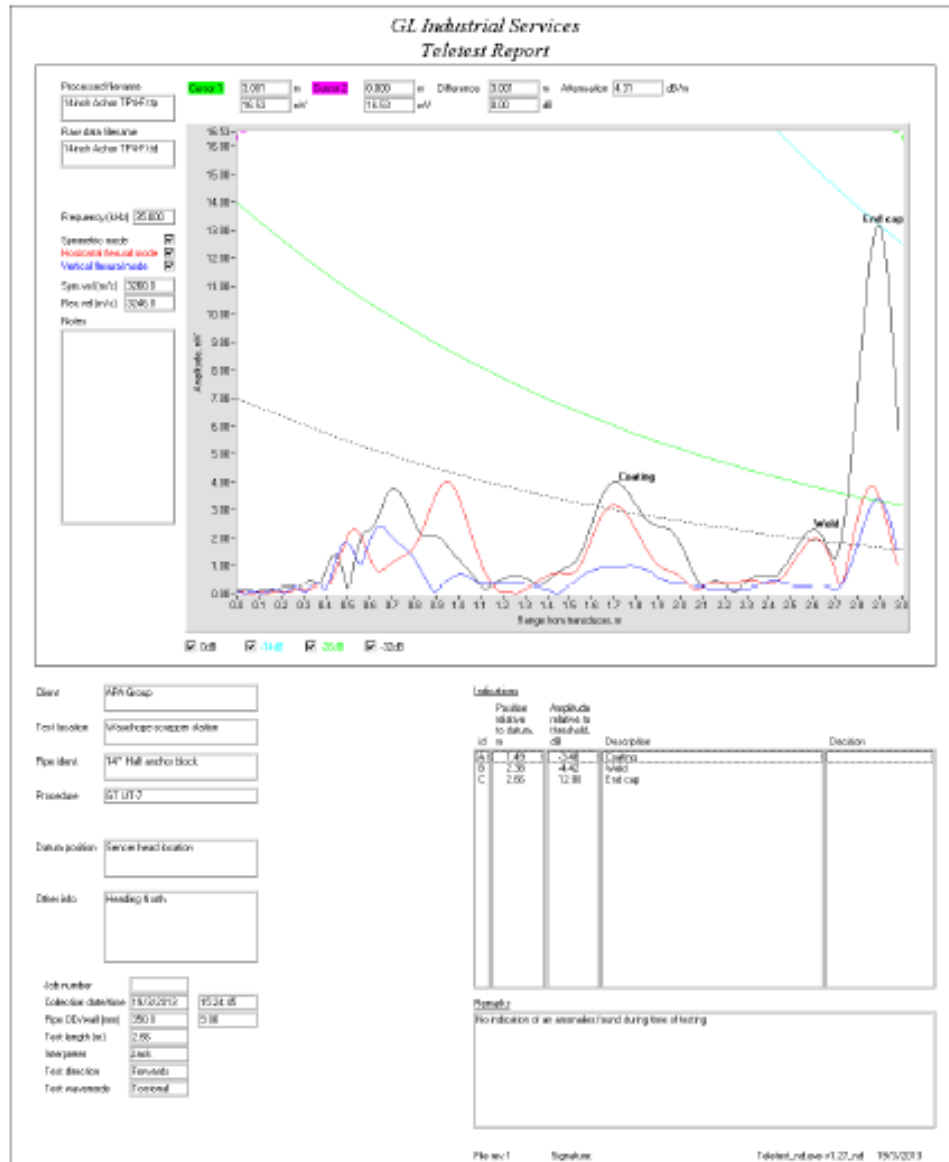
Test Point 4 : 14" Wanchope scrapper station gas line

Test Point 4 is a forward and backward LRUT shot at Wauchope's V07 concrete support blocks, looking east (backward shot) and west (forward shot). The forward LRUT shot has detected a coating change into the concrete block at 1.49m, a weld at 2.38m on the other side of the concrete block, and the end cap at 2.66m. The location of these detected LRUT measurements is consistent with photo 0392. Corrosion was not identified within the concrete block.

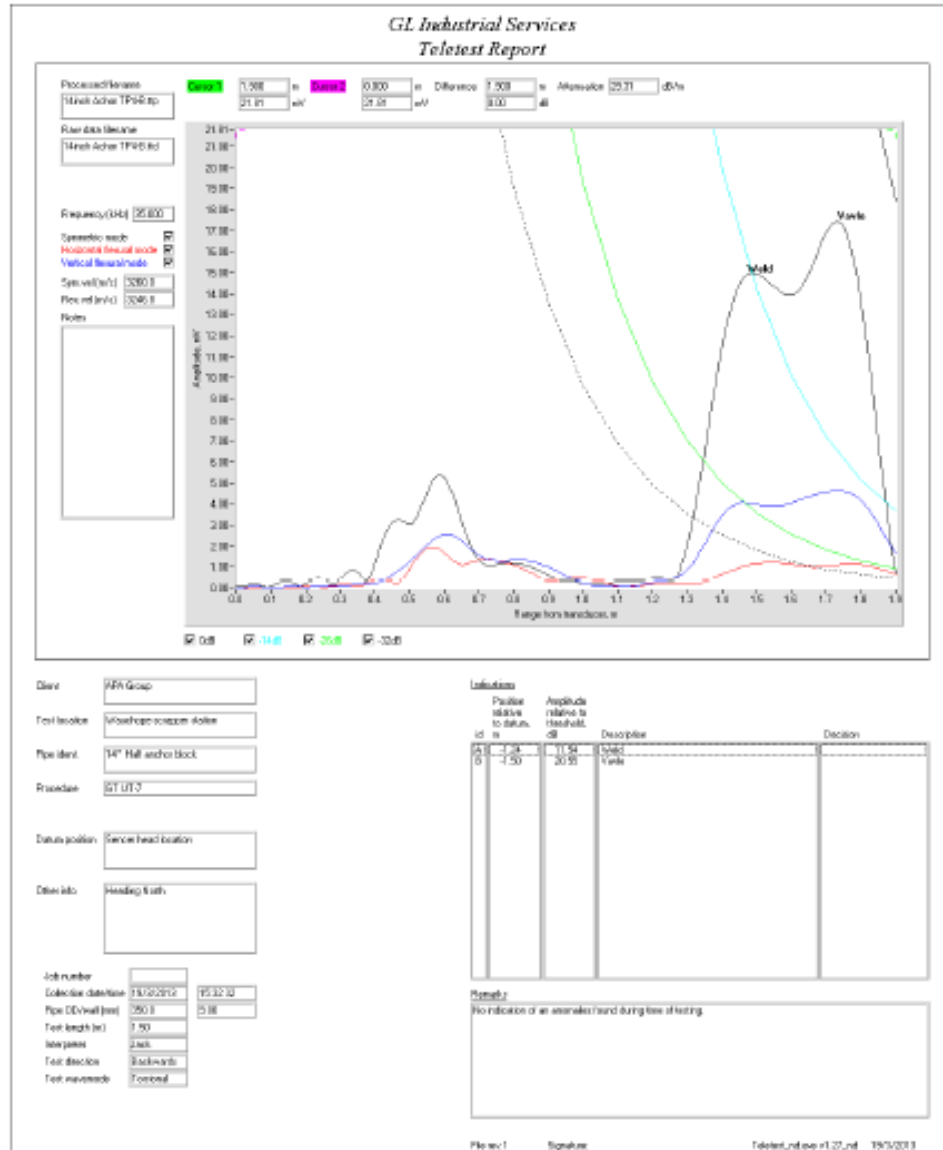
Test Point 4 : 14" Wauchope scraper station gas line

Test Point 4 is a forward and backward LRUT shot at Wauchope's V07 concrete support blocks, looking east (backward shot) and west (forward shot). The LRUT has detected 2 significant readings identified as a valve weld at 1.24m and the valve body at 1.50m. Corrosion was not identified within the concrete block.

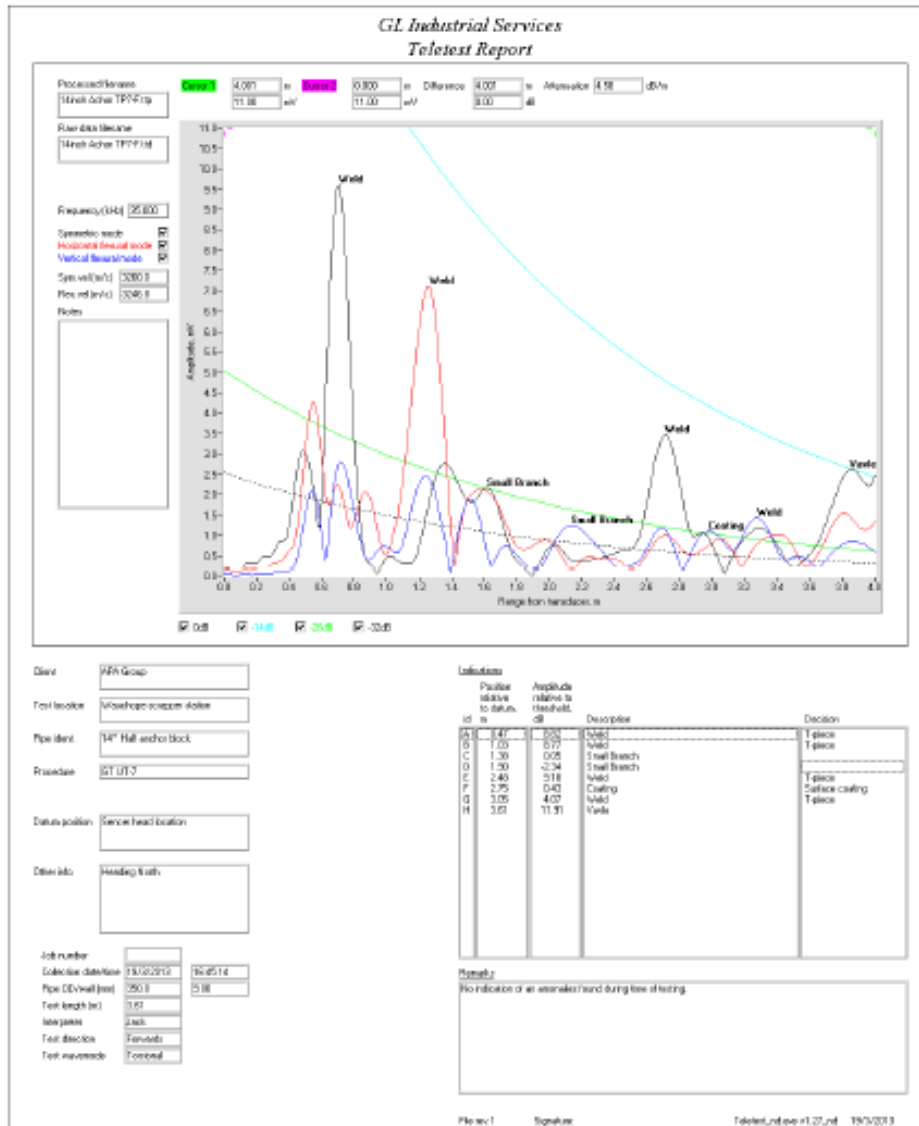
Test Point 7 : 14" Wauchope scraper station gas line

Test Point 7 is the forward LRUT shot at Wauchope's MLV north concrete support block, looking south. The LRUT has detected 8 significant anomalies identified as a weld at 0.47m and 1.03m, two vertical branched tees at 1.38m and 1.90m, a weld at 2.48m, a coating anomaly at 2.75m a weld at 3.05m and the valve at 3.61m. Photo 0450 and 0451 of Appendix 3 confirms the position and identification of these fittings and welds, and the coating anomaly could also be due to the tee into V12. Corrosion was not identified within the concrete block.

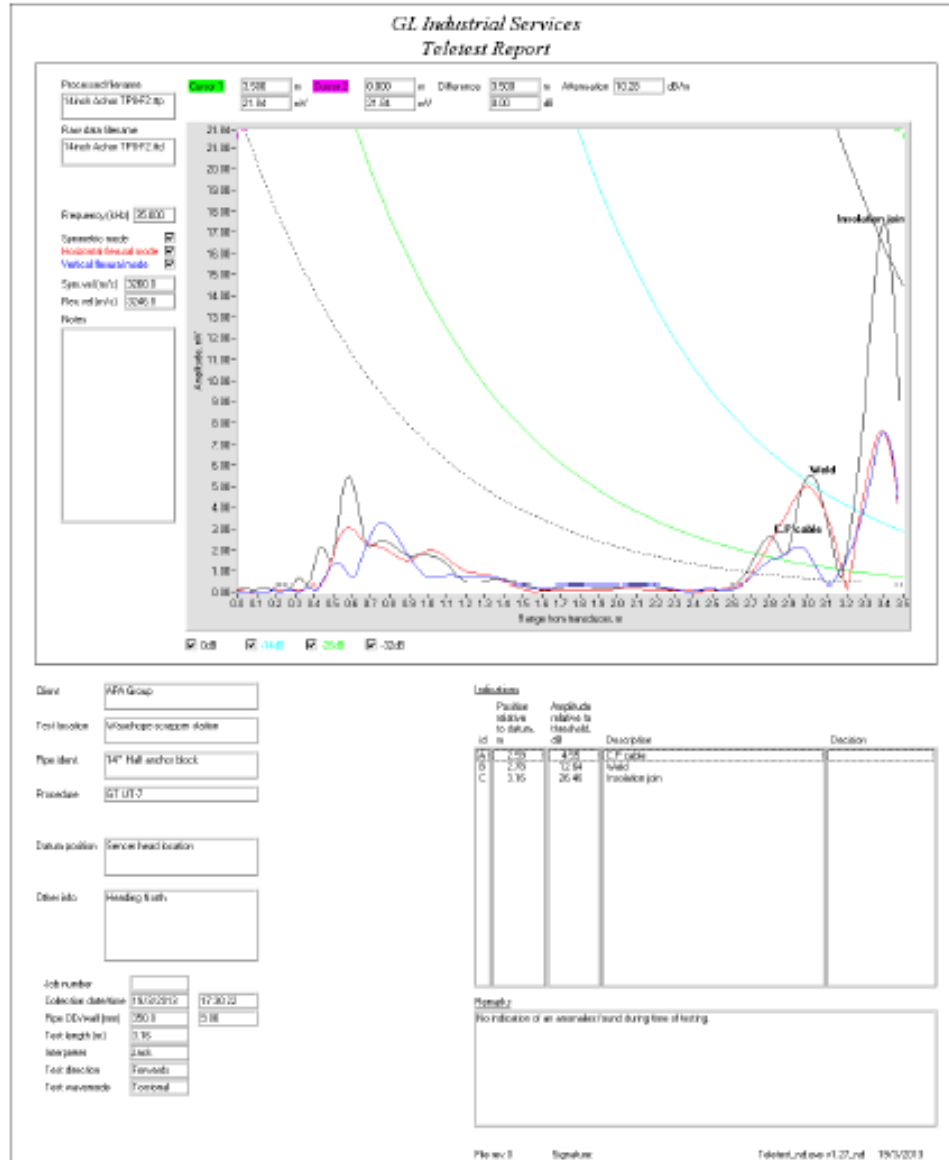
Test Point 8 : 14" Wauchope scraper station gas line

Test Point 8 is the forward LRUT shot at Wauchope's MIJ north concrete support block, looking south. The LRUT has detected no significant anomalies between the concrete support block. The C.P cable welds and the pipe girth weld was detected at 2.59m and 2.78m respectively, and the MIJ was detected a distance of 3.16m. Photo 4700 of Appendix 3 confirms the results of the LRUT. Corrosion was not identified within the concrete block.

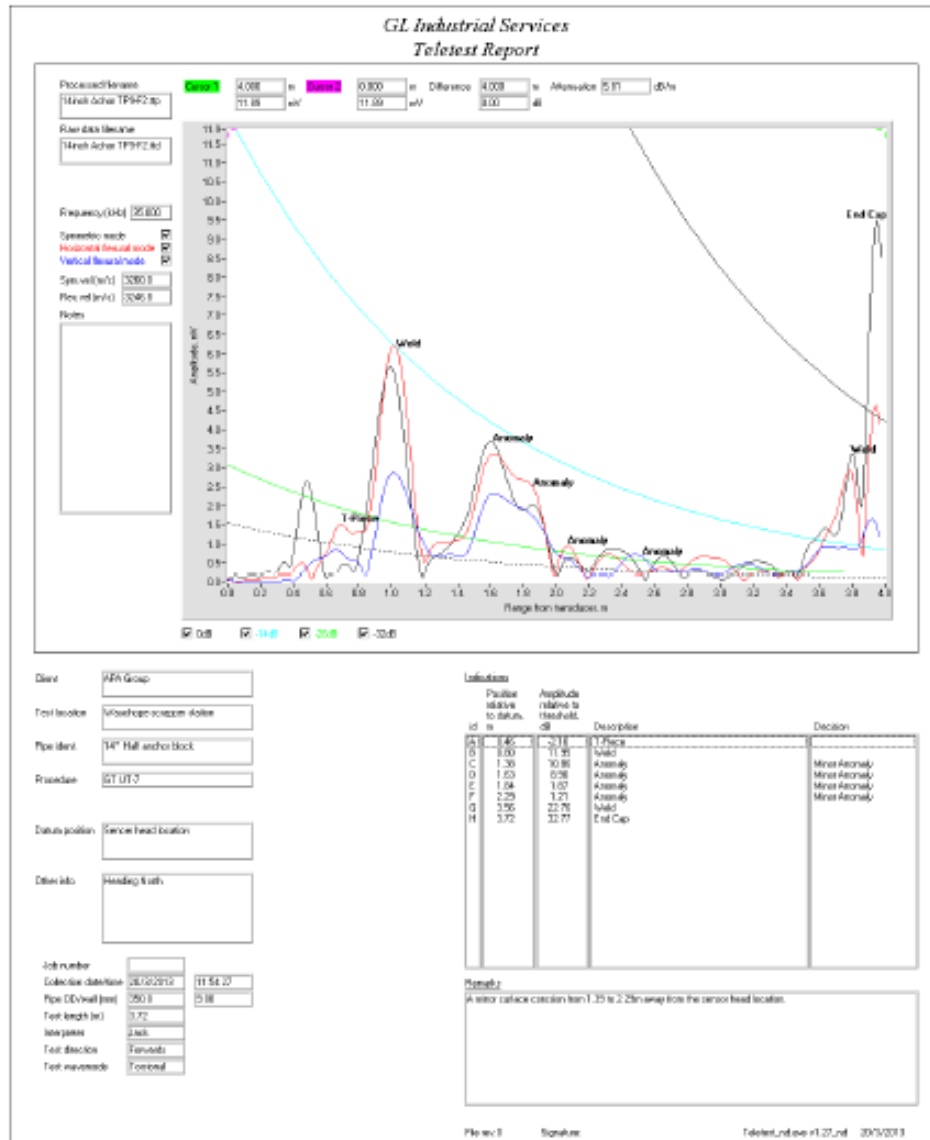
Test Point 9 : 14" Wauchope scraper station gas line

Test Point 9 forward is the forward LRUT shot at Wauchope's V14 concrete support blocks, looking west. The LRUT has detected 8 anomalies identified as the tee piece at 0.46m, girth weld at 0.80m, 4 anomalies; half which lie within the concrete block (1.38m, 1.63m, 1.84m and 2.29m), a girth weld at 3.56m and the end cap at 3.72m. The anomalies are identified as coating anomalies due to identified blistering and CP product build up in the area and the high symmetric LRUT readings. Corrosion was not identified within the concrete block.

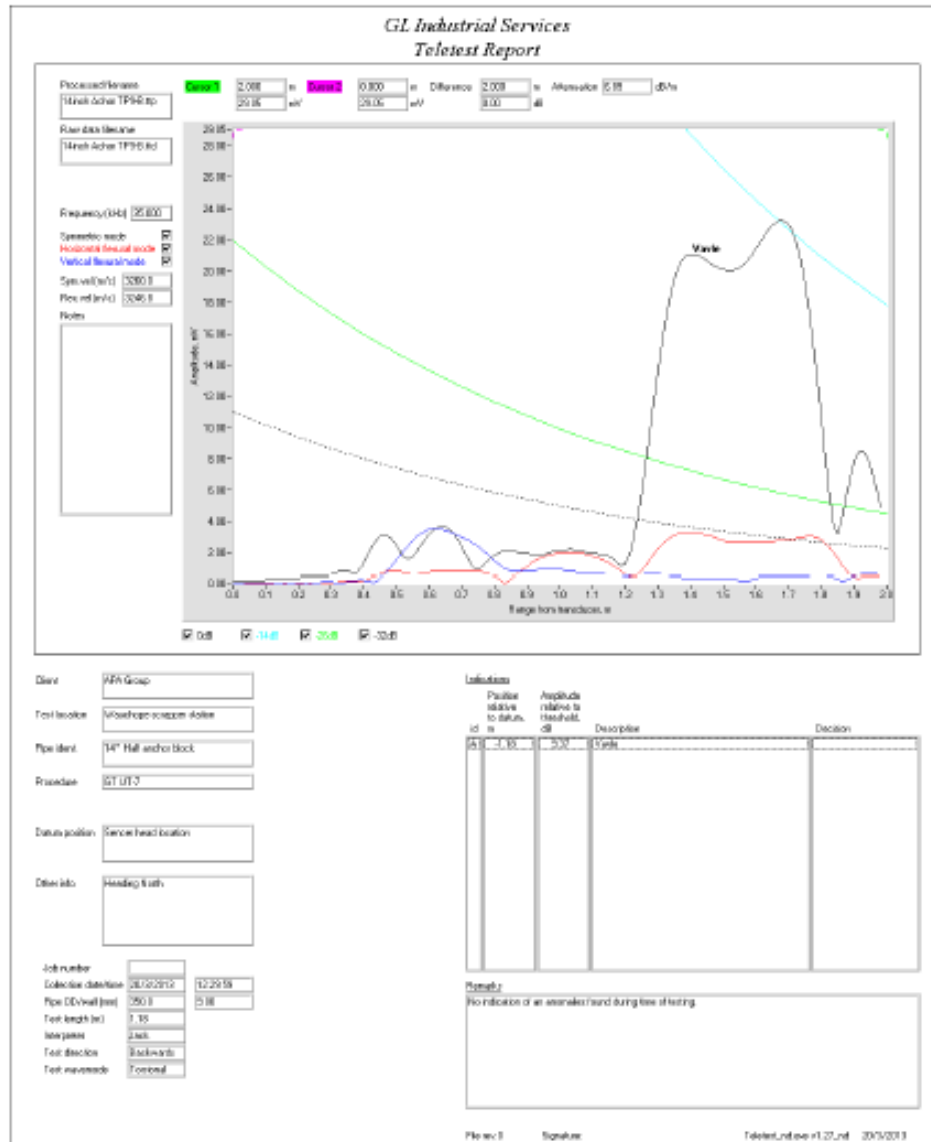
Test Point 9 : 14" Wauchope scraper station gas line

Test Point 9 backward is the backward LRUT shot at Wauchope's V14 concrete support blocks, looking east. The LRUT has detected no anomalies, the valve V14 was detected at a distance of 1.18m from the LRUT device. The concrete block lies before the 1.18m range to the valve and no significant LRUT readings were identified. Corrosion was not identified within the concrete block.

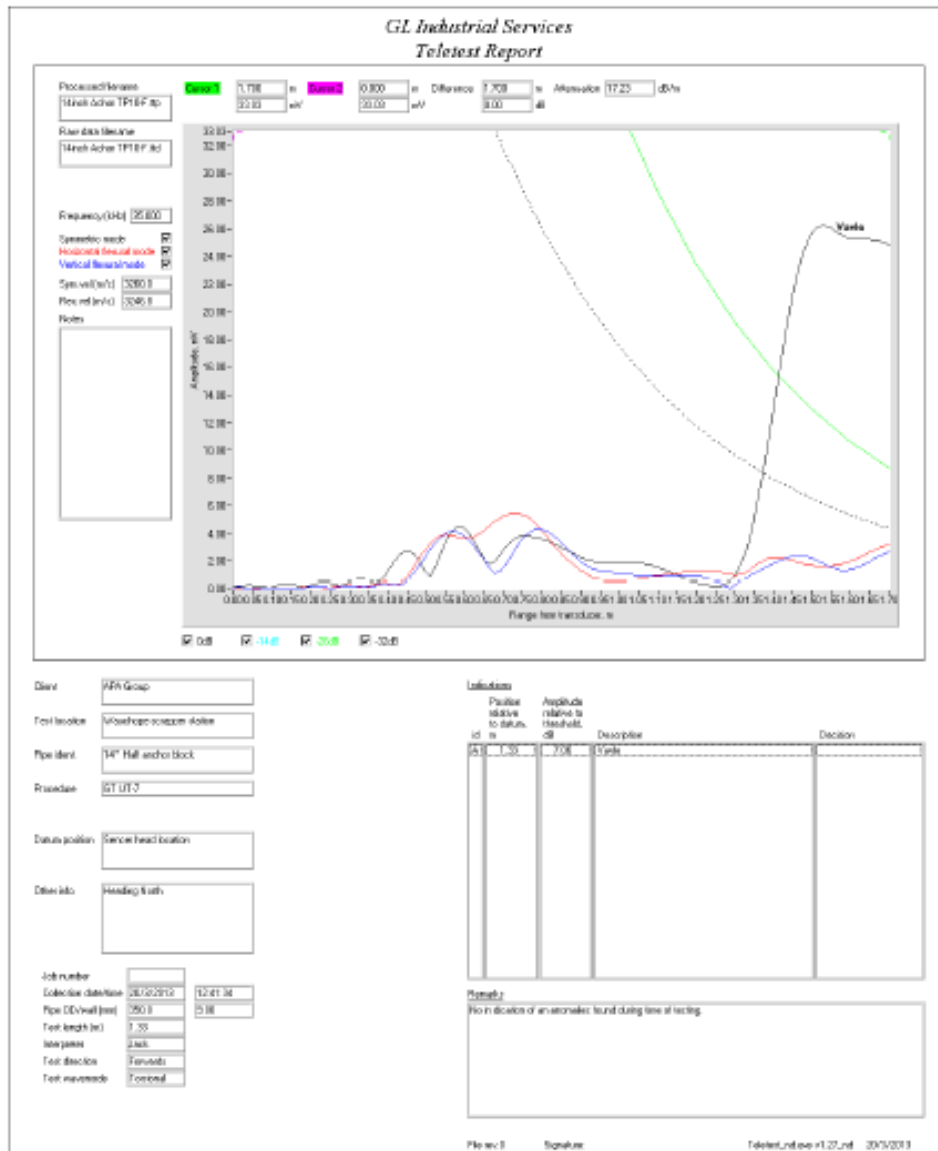
Test Point 10 : 14" Wanchope scrapper station gas line

Test Point 10 is the forward LRUT shot at Wauchope's V14 concrete support block, looking west. The LRUT has detected no anomalies, the valve V14 was detected at a distance of 1.33m from the LRUT device. The concrete block lies before the 1.33m range to the valve and no significant LRUT readings were identified. Corrosion was not identified within the concrete block.
