Wauchope Scraper Station

Coating Assessment Report

Document No. BGS-RP-A-0009 Rev 0A

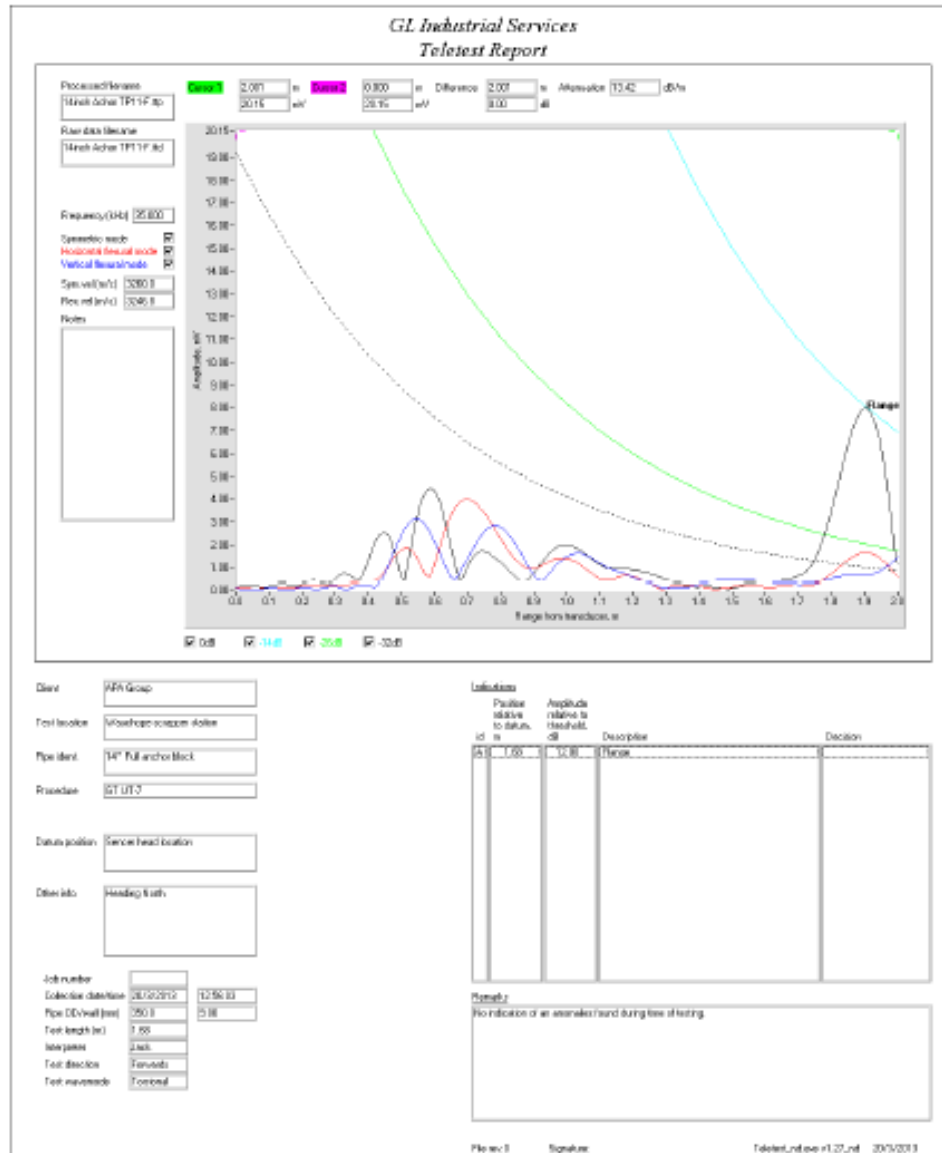
Test Point 11 : 14" Wauchope scraper station gas line

Test Point 11 is the forward LRUT shot at Wauchope's north concrete anchor block, looking south (Note that the schematic drawing in Appendix 5 has incorrectly labelled TP11 and TP12). The anchor flange within the concrete anchor block begins is detected 1.68m from the sensor head as shown in the results of Appendix 5. No anomalies were detected within the range of the concrete block. Corrosion was not identified within the concrete block.

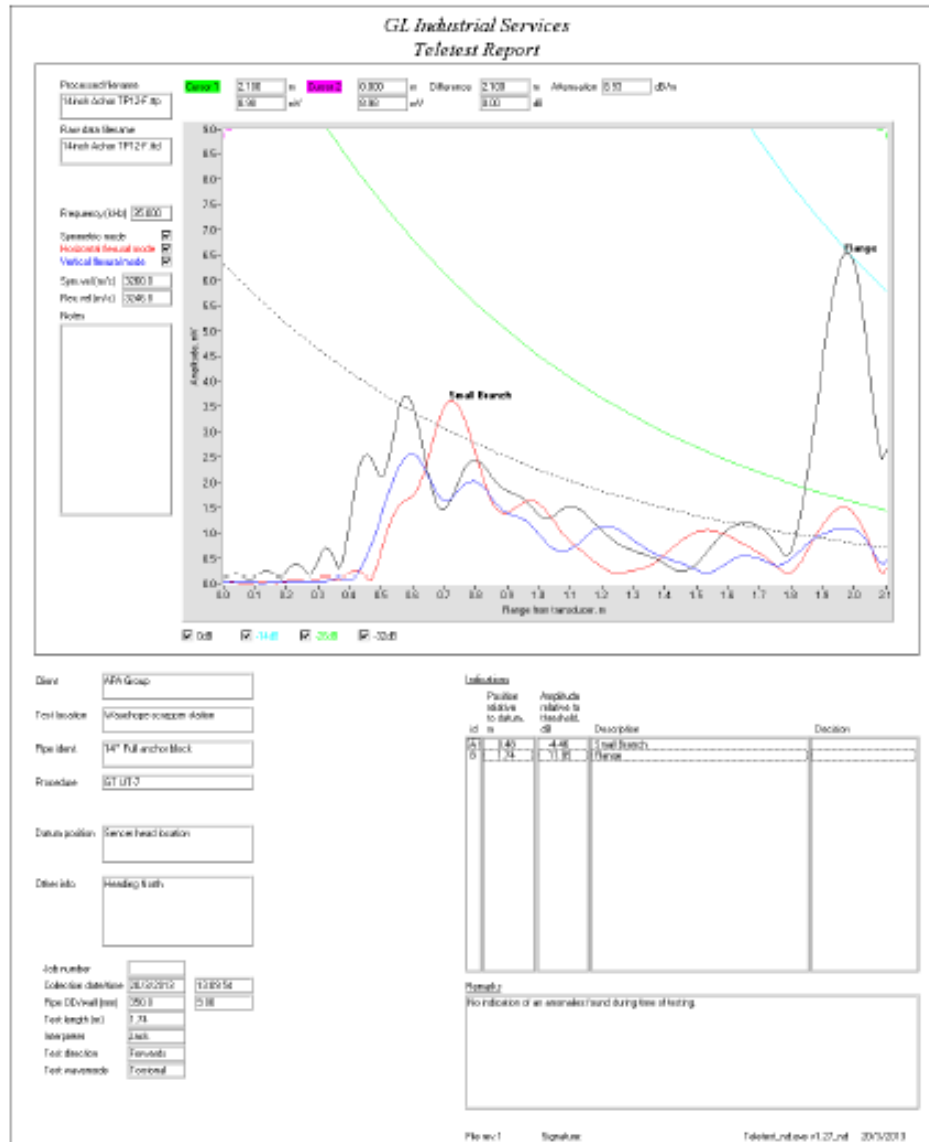
Test Point 12 : 14" Wauchope scraper station gas line

Test Point 12 is the forward LRUT shot at Wauchope's north concrete anchor block, looking north (Note that the schematic drawing in Appendix 5 has incorrectly labelled TP11 and TP12). The concrete anchor block begins 1.3m from the sensor head as shown in the results of Appendix 5. Two coating anomalies were identified at 0.50m and 0.67m, the concrete block interface is detected at 1.16m and the flange within the block was detected at a distance of 1.60m, 440mm into the block. Corrosion was not identified within the concrete block.

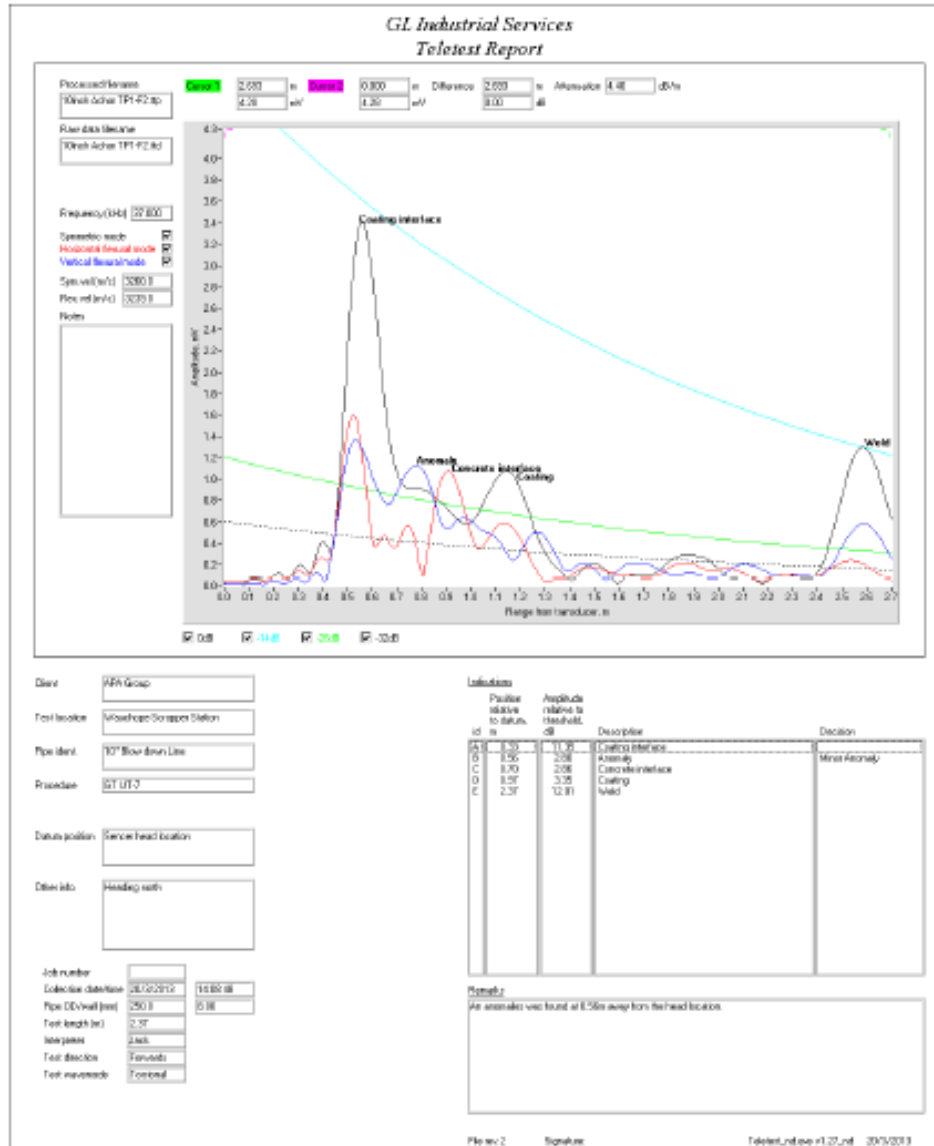
Test Point 1 : 10" Wauchope scraper station blow down line

Test Point 1 is the forward LRUT shot at Wauchope's blowdown line concrete support block between V11 and V12, looking south. The concrete interface is 0.70m in front of the sensor head as shown in the results of Appendix 5. A coating anomaly was detected within the concrete support block at a distance 0.97m, 0.27m into the concrete, this was identified as a coating related anomaly by the LRUT technician. The elbow girth weld was identified by LRUT at a distance of 2.37m. Refer to photo 0448. Corrosion was not identified within the concrete block.

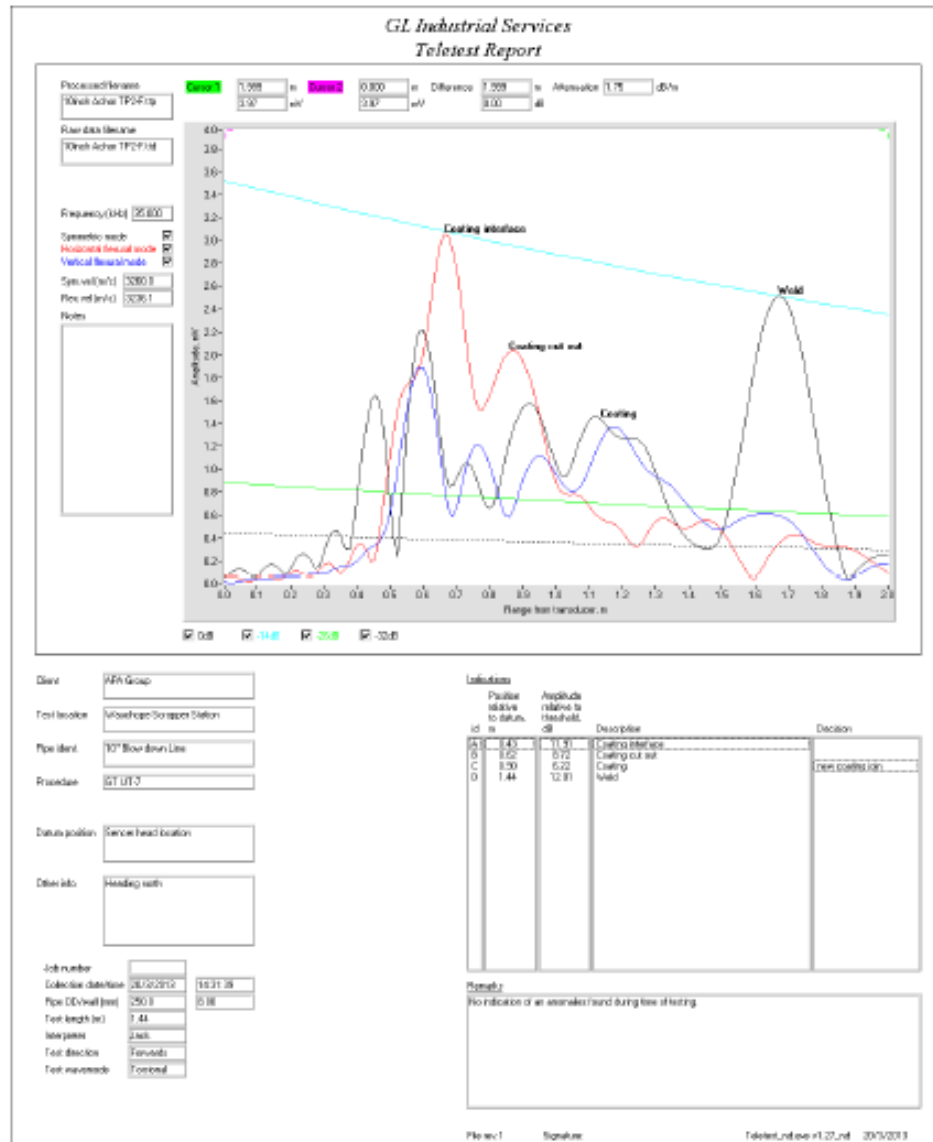
Test Point 2 : 10" Wauchope scrapper station blow down line

Test Point 2 is the forward LRUT shot at Wauchope's blowdown line 90° elbow concrete support block, looking north. The coating interface is 0.43m, 0.62m and 0.90m in front of the sensor head where the tape wrap coating has been removed. The elbow girth weld was detected at a distance of 1.44m from the LRUT device, inside of the concrete block. No anomalies were detected within the concrete block. Corrosion was not identified within the concrete block.

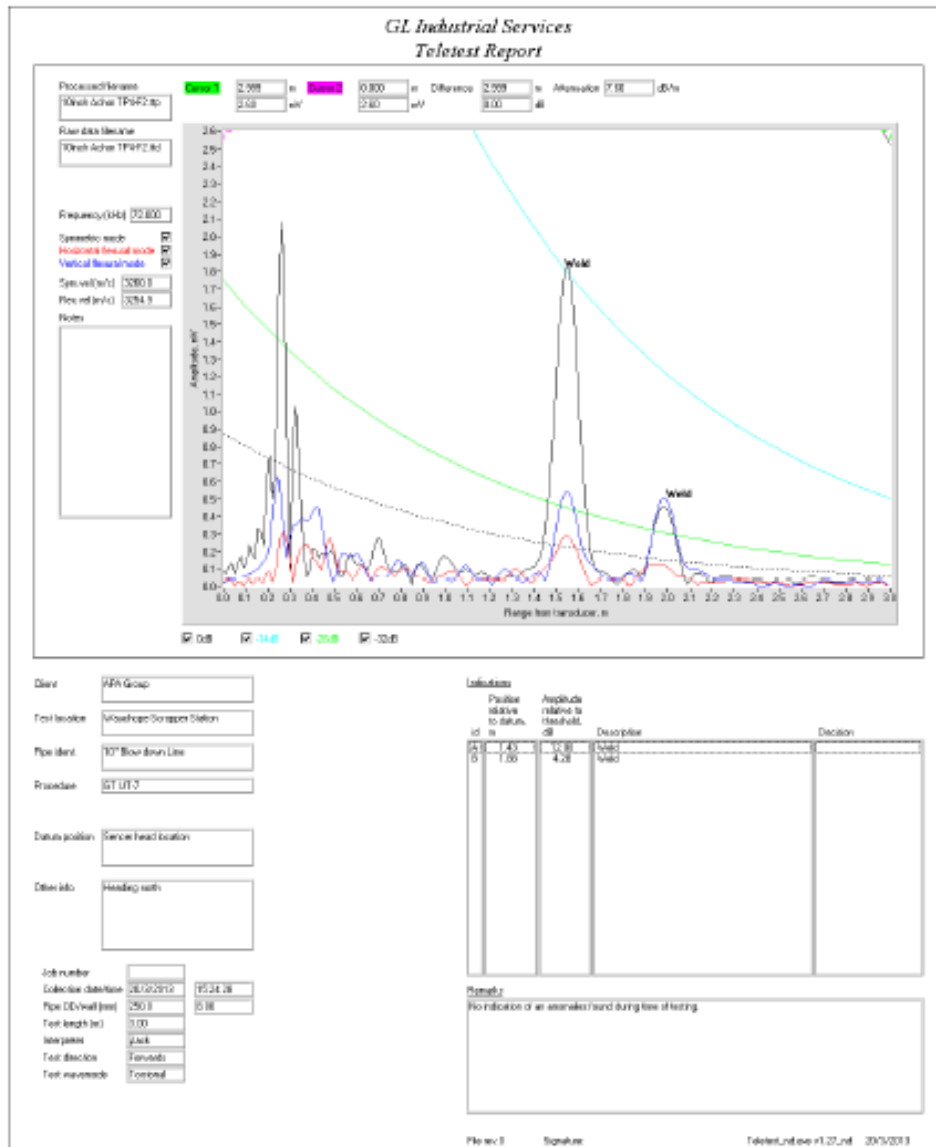
Test Point 4 : 10" Wauchope scrapper station blow down line

Test Point 4 is the forward LRUT shot at Wauchope's blowdown stack concrete support block looking west, refer to photo 0589. 2 welds were detected at 1.43m and 1.88m inside of the concrete block, these are associated with the tee internal to the concrete support block. Corrosion was not identified within the concrete block.

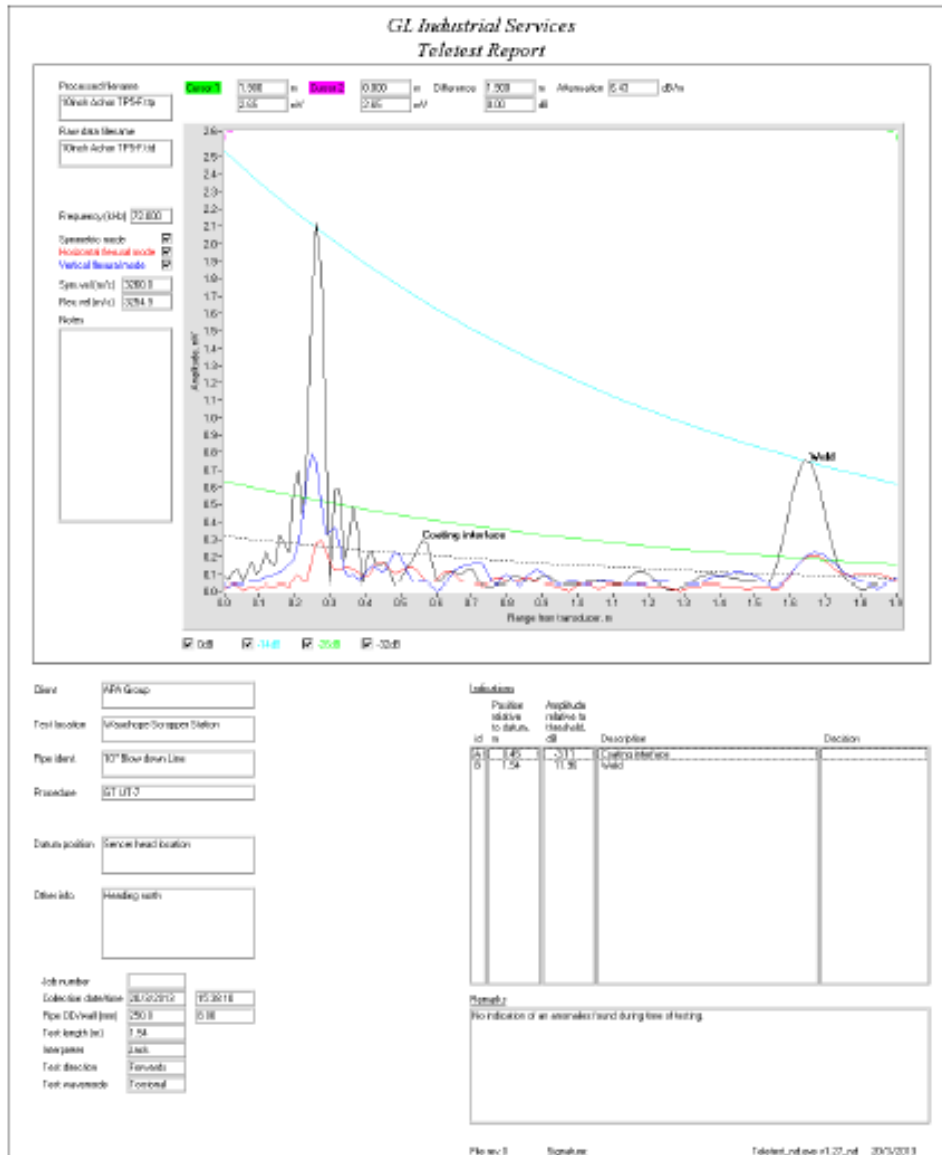
Test Point 5 : 10" Wauchope scraper station blow down line

Test Point 5 is the forward LRUT shot at Wauchope's blowdown stack concrete support block looking vertically down, refer to photo 0589. The coating interface was detected at 0.45m from the device, and the weld to the tee was detected at a distance of 1.54m, inside of the concrete block. Corrosion was not identified within the concrete block.
