# Aileron Main Line Valve Coating Assessment Report

**Document No. BGS-RP-A-0013 Rev 0A**

Aileron is the fourth of the MLV sites to be excavated and assessed. This report compares the DCVG results for Aileron to the results of the coating assessment following excavation including Long Range Ultrasonic Testing (LRUT).

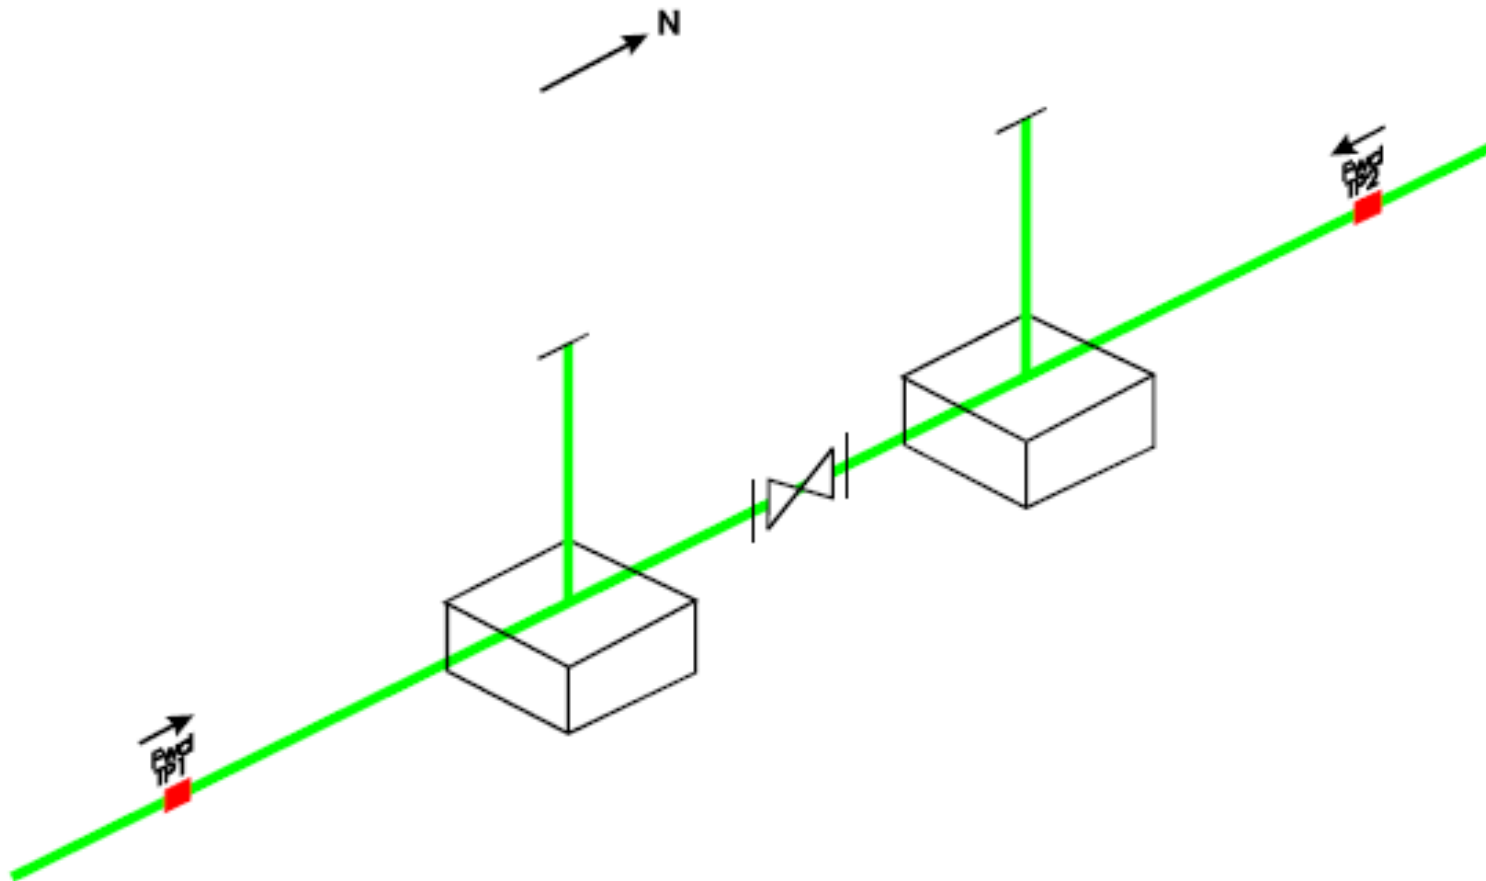
**Line Identification: 14" Aileron gas line**

LRUT was conducted at Aileron MLV from March 21, 2013. Extracts from the LRUT report are presented in Appendix 4. The diagram in Appendix 4 shows the setup and location of the LRUT probe when undertaking the test. Two LRUT 'shots' were conducted from the south (Test Point 1, TP1) and north (Test Point 2, TP2) in order to examine the condition of the pipe wall underneath the MLV support blocks.

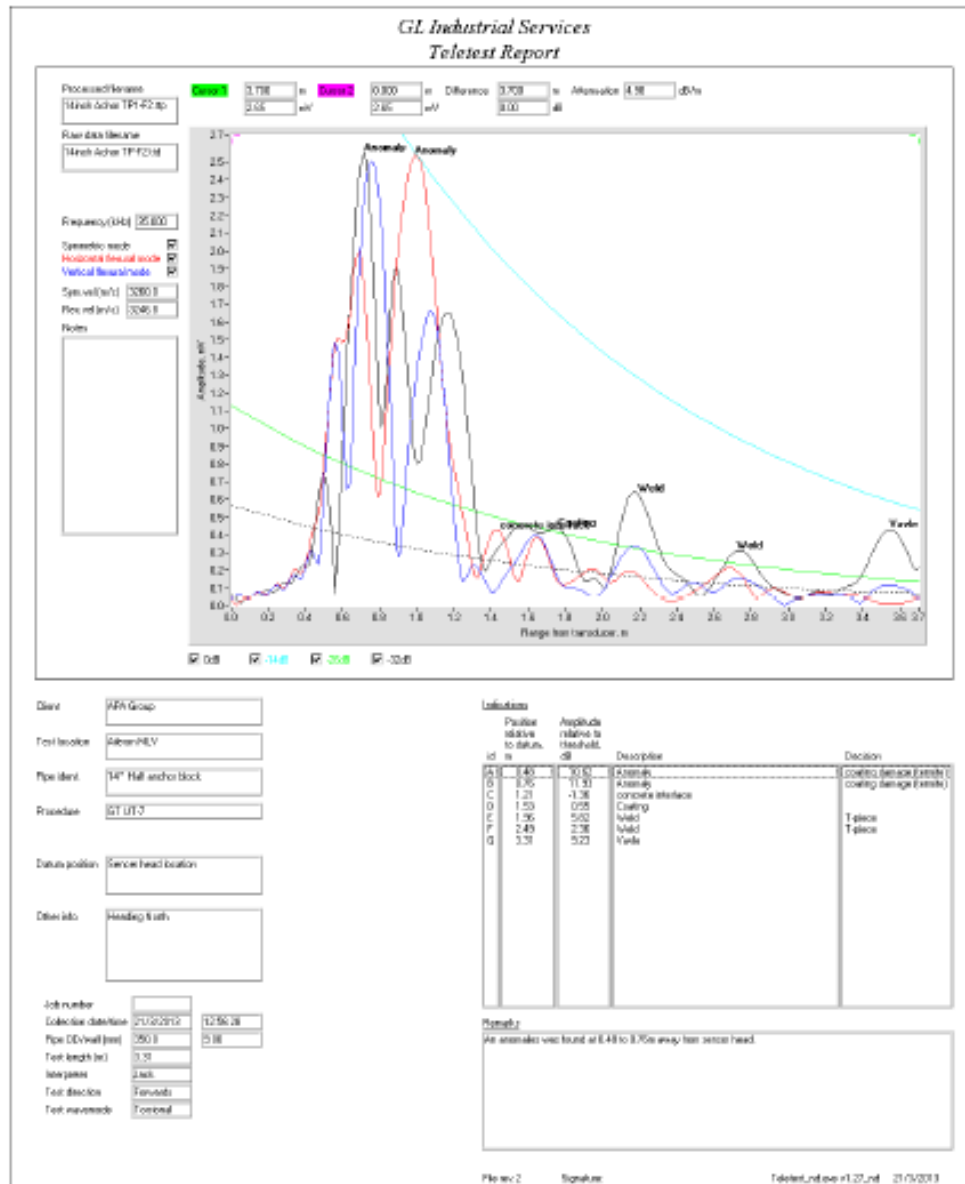
**Test Point 1 : 14" Aileron MLV gas line**

Test Point 1 is the forward LRUT shot at Aileron MLV looking north. The concrete support block begins 1.21m from the sensor head as shown in the scan results. As shown in the results of Appendix 4, a minor coating anomaly due to a pipe clamp is detected at 1.7m (refer photo 0667), tee-piece welds are detected at 1.96m and 2.49m and the valve body detected at 3.31m. Refer to photos 0667, and the schematic drawing of TP1 in Appendix 4 for cross references of these LRUT results. No corrosion was detected within the concrete support block.

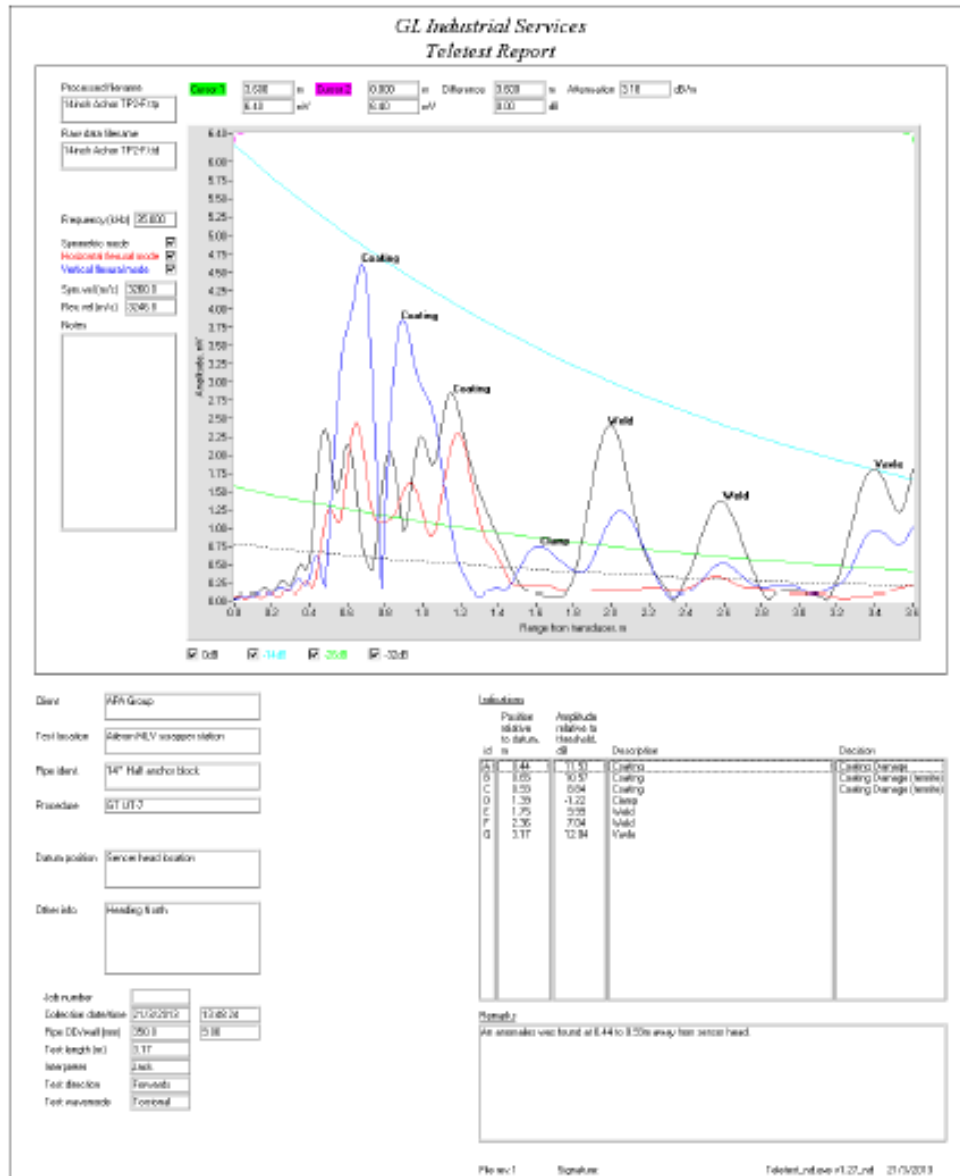
Test Point 2 : 14" Aileron MLV gas line

Test Point 2 is a forward shot at Aileron MLV, looking south, at the MLV north support block, refer to photo 0669. The LRUT detected three coating anomalies related to defects found in the coating due to termite damage at 0.44m, 0.65m and 0.93m. The pipe clamp was detected at a range of 1.39m, the two girth welds of the tee were detected at 1.75m and 2.36m, and the valve body detected at 3.17m. Refer to Appendix 4 for the LRUT result. No corrosion was detected within the concrete support block.
