Kelly Well Main Line Valve Coating Assessment Report

Document No. BGS-RP-A-0012 Rev 0A

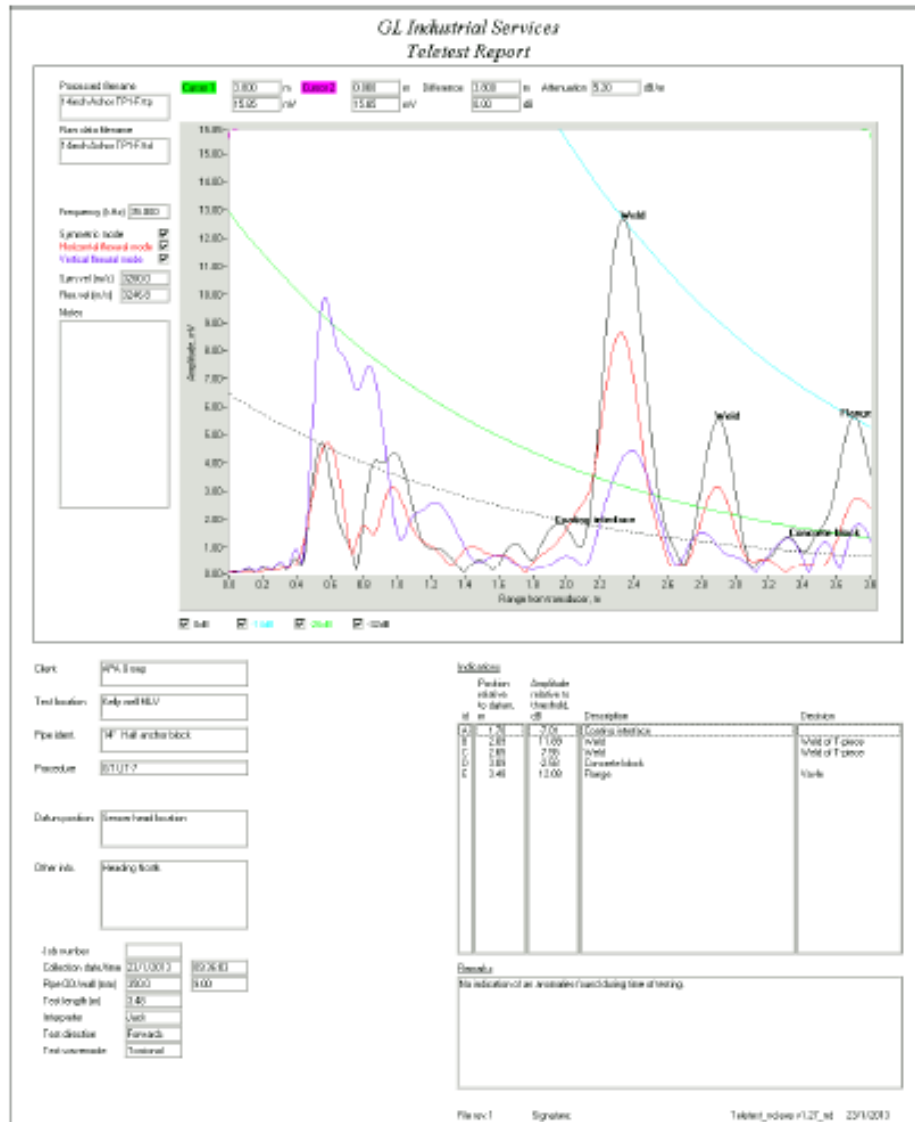
Test Point 1 Line ID: 14" Kelly Well MLV

LRUT was conducted at Kelly Well MLV from January 23, 2013. Extracts from the LRUT report are presented in Appendix 4. The diagram in Appendix 4 shows the setup and location of the LRUT probe when undertaking the test. Two LRUT 'shots' were conducted from the south (Test Point 1, TP1) and north (Test Point 2, TP2) in order to examine the condition of the pipe wall underneath the MLV support blocks.

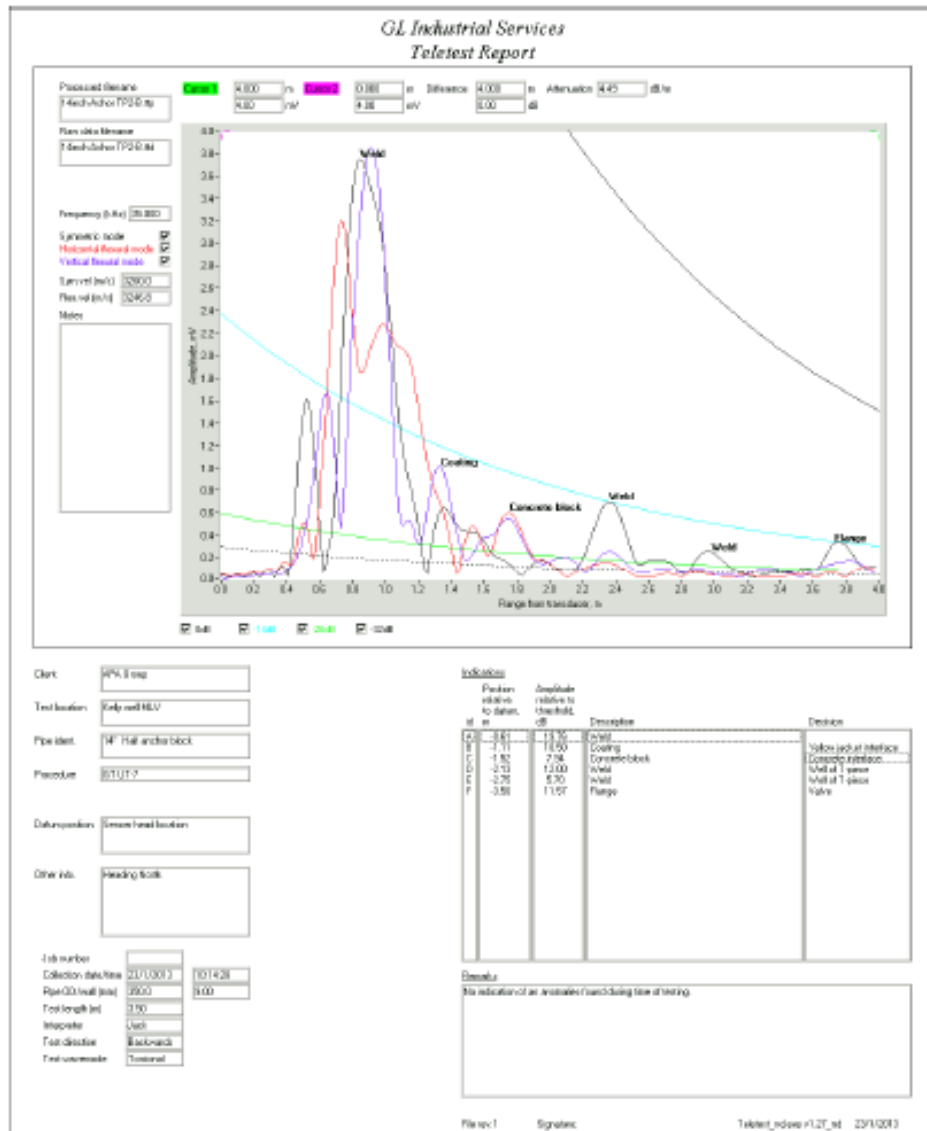
Test Point 2 Line ID: 14" Kelly Well MLV

Test Point 2 is a backward shot at Kelly Well MLV, looking south, at the north support block. The concrete support block begins 1.4m from the sensor head as shown in the results of Appendix 4 at a range of 1.52m, the T-piece welds were detected at 2.13m and 2.75m and the MLV was correctly detected at a range of 3.5m which agrees with the schematic drawing of Appendix 4 for TP2. There was no reported coating defect or corrosion evident during blasting, refer to photo 2102 for cross-reference of the detected welds and valve.
