APA Group Pipeline Management System

Pipeline Integrity Management Plan Northern Territory APA Group Assets

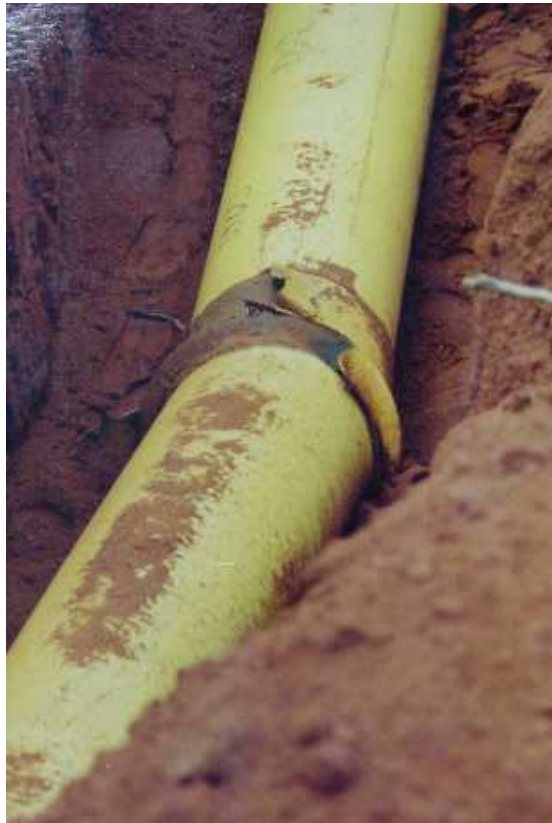
On the 22nd of January 1988, two years after commissioning of the AGP, three large earthquakes occurred at Tennant Creek. These earthquakes were magnitude 6.3, 6.4 and 6.7, and severely buckled the AGP (refer to Figure 1). Since 1988, many minor tremors have been experienced on areas of the AGP, predominantly around Tennant Creek. Refer to Figure 2 for an overview of earthquake activity locations in the Northern Territory in proximity to APA pipelines.

Figure 1. Buckling on the AGP caused by the TCK earthquake

APA Group NT monitor earthquake activity on a monthly basis via the Geoscience Australia website. Any earthquake of a significant magnitude or proximity to the pipeline will be investigated, possibly with a gauge or calliper pig.
