GHD Vegetation Audits 2015-2018

2020-2025
Regulatory Proposal
January 2019

2015 Pre Fire Danger Season Vegetation Clearance Audit Report

2017 Cyclic/Pre-Summer Vegetation Audit

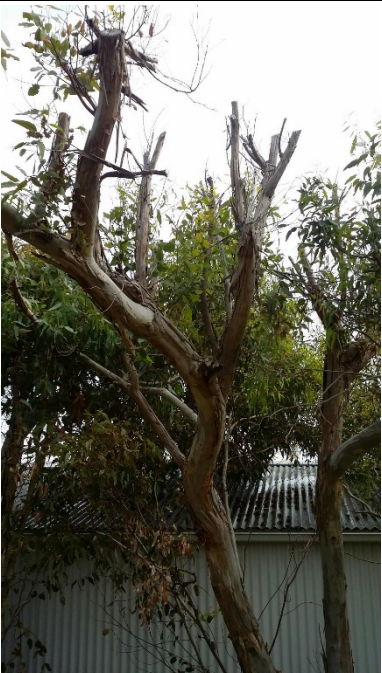
| Outcome of Pruning: | Poor | |
| Value in the landscape: | Medium | |
| Contribution to the future landscape: | Medium | |

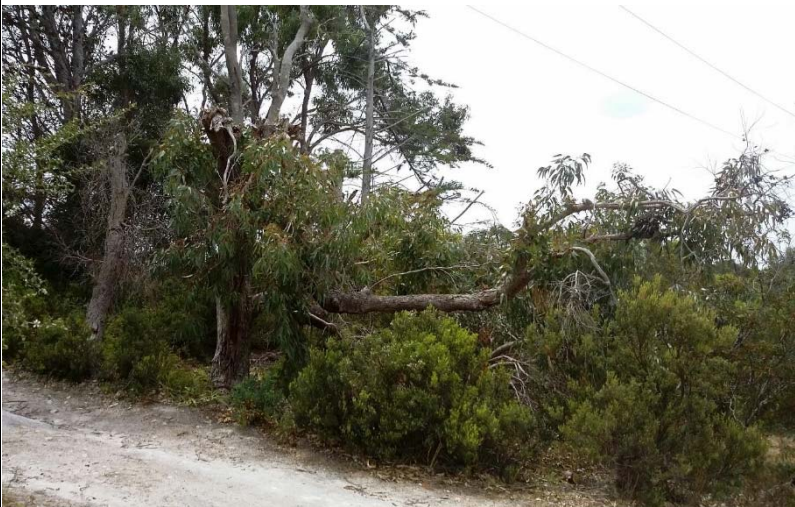
| Outcome of Pruning: | Poor | |
| Value in the landscape: | Medium | |
| Contribution to the future landscape: | Medium | |

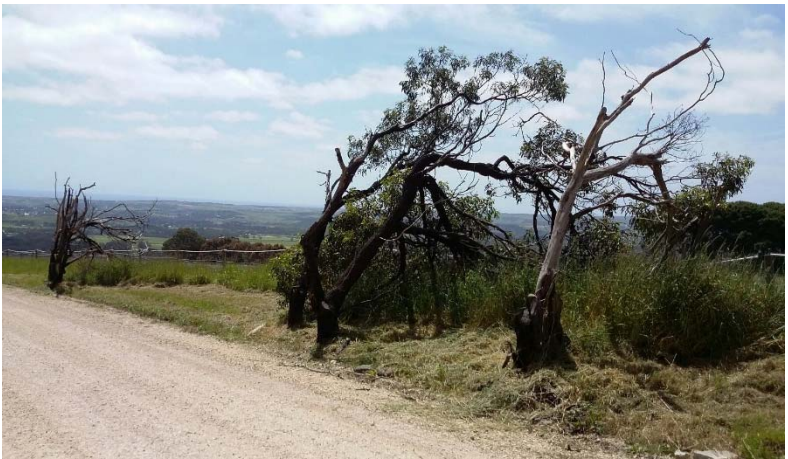
| Outcome of Pruning: | Poor | |
| Value in the landscape: | Low | |
| Contribution to the future landscape: | Nil | |

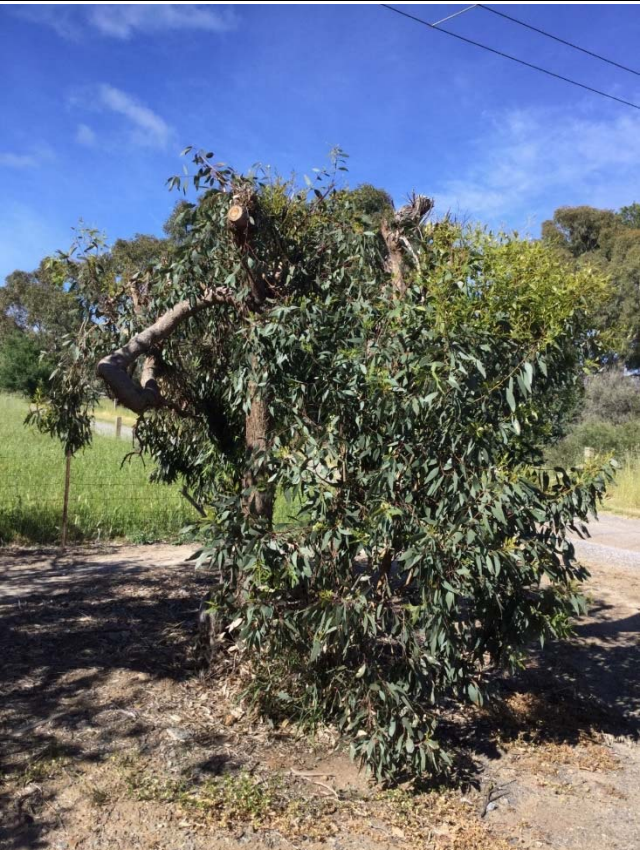
| Outcome of Pruning: | Poor | |
| Value in the landscape: | Medium | |
| Contribution to the future landscape: | Medium | |

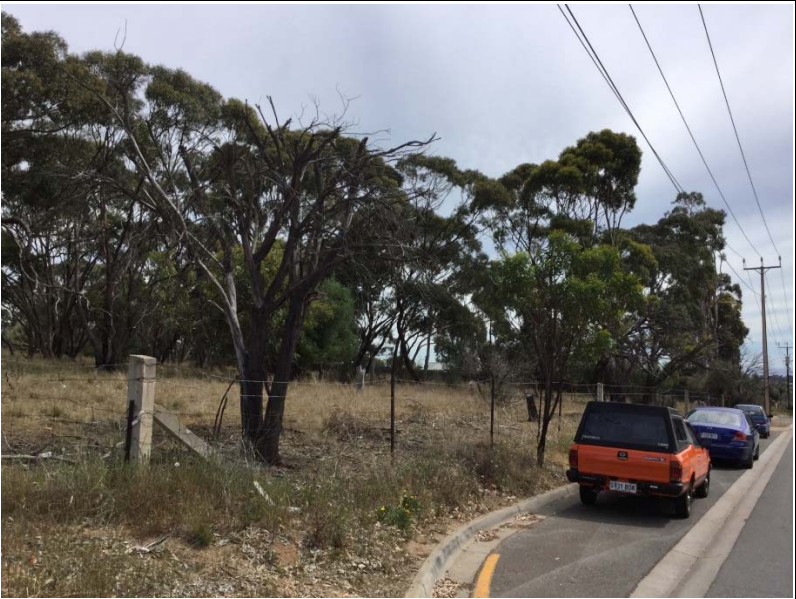
| Outcome of Pruning: | Very poor | |
| Value in the landscape: | Nil | |
| Contribution to the future landscape: | Nil | |

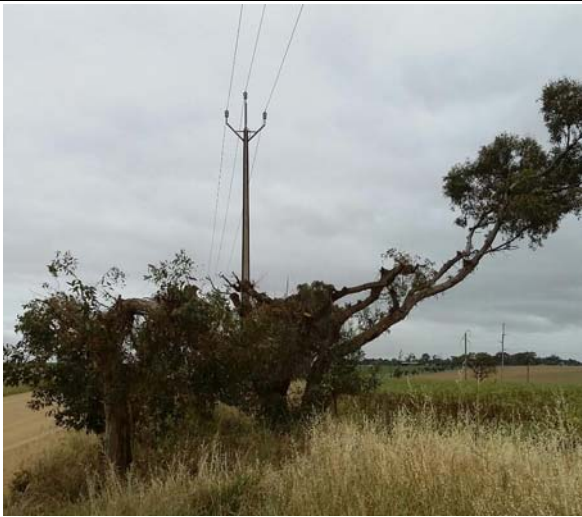
| Outcome of Pruning: | < Optimum | |
| Value in the landscape: | Medium | |
| Contribution to the future landscape: | Medium | |

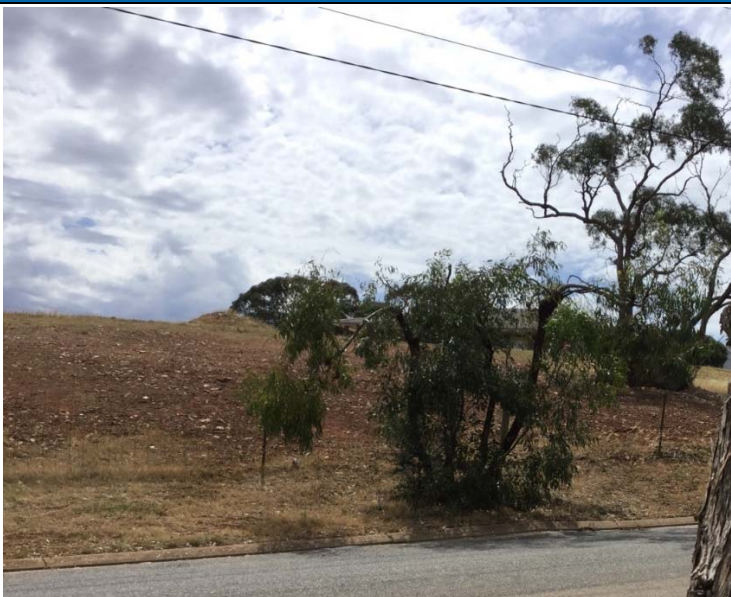
| Outcome of Pruning: | < Optimum | |
| Value in the landscape: | Medium | |
| Contribution to the future landscape: | High | |

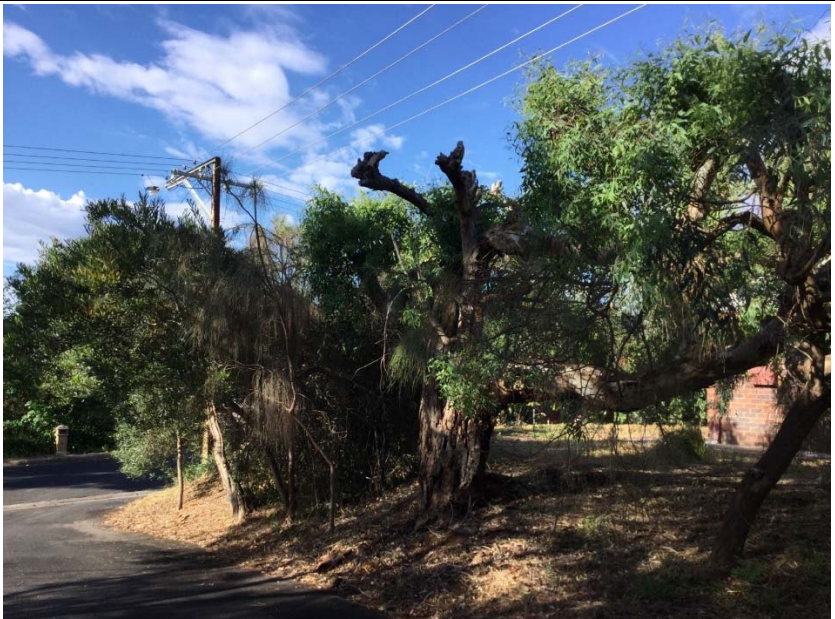
| Outcome of Pruning: | < Optimum | |
| Value in the landscape: | Low | |
| Contribution to the future landscape: | Low | |

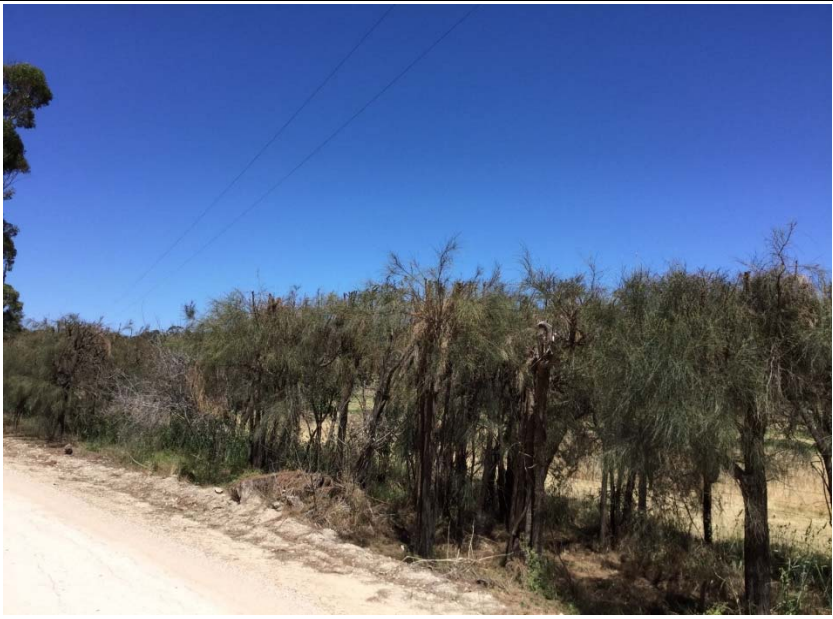
| Outcome of Pruning: | < Optimum | |
| Value in the landscape: | Low | |
| Contribution to the future landscape: | Low | |

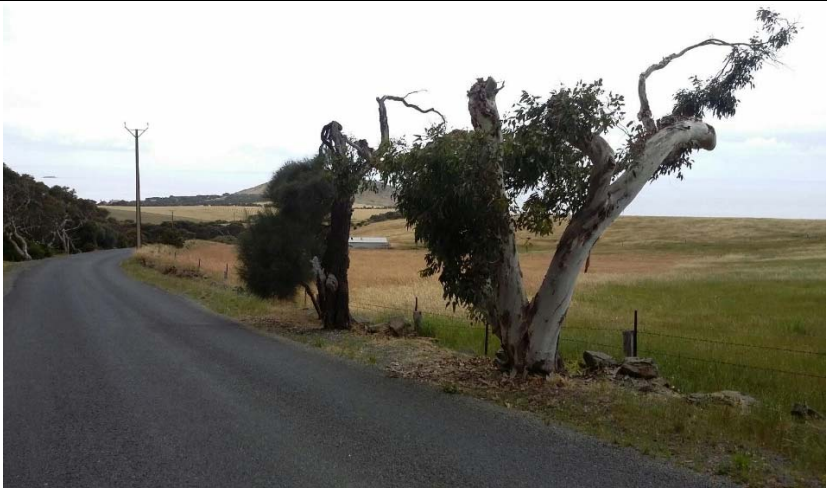
| Outcome of Pruning: | < Optimum | |
| Value in the landscape: | Medium | |
| Contribution to the future landscape: | Medium | |
