roma to brisbane pipeline access arrangement submission.

attachment 5-1 – historic capital expenditure project documents

RBP Emergency Works – Flood Recovery

Business Case Number AA-01 – REVISION 1

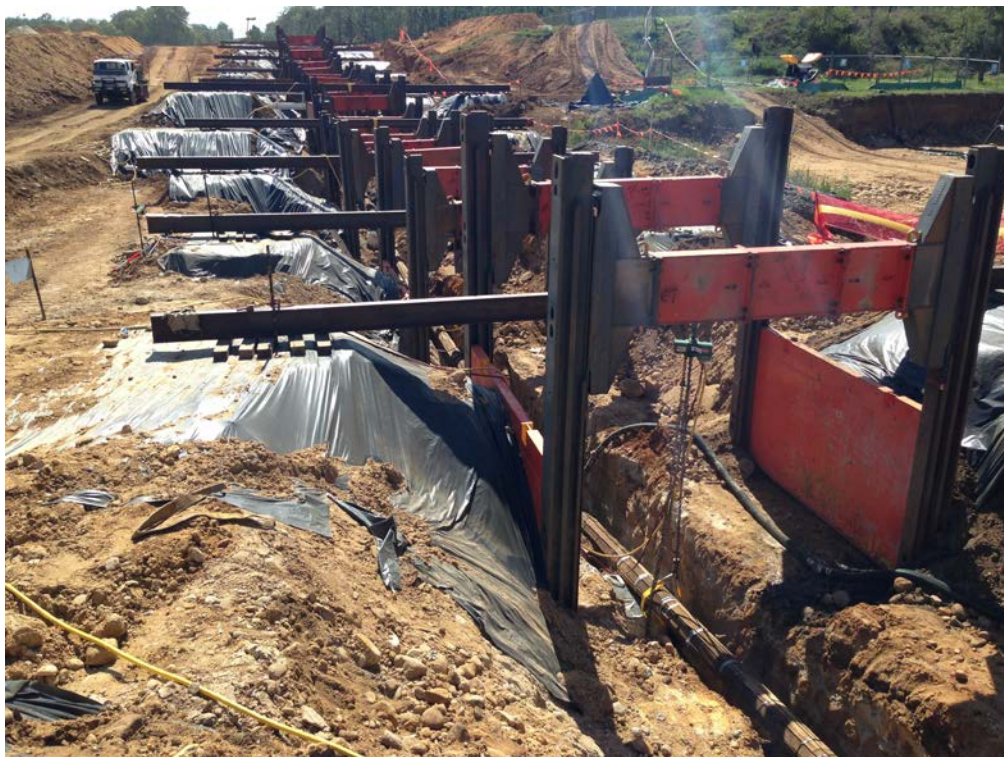
Unfortunately, further flooding at the same location only a few months later washed away the newly repaired creek banks and re-exposed the pipelines. Further studies confirmed that the natural creek bed level had been lowered by the floodwater action and the pipelines no longer had sufficient depth of cover. Target depth was identified as 2 metres below the lowest surveyed point of the creek bed and in-service lowering was selected as the most cost-effective option.

Long and deep trenches were required to implement the lowering, to expose enough pipe to safely lower the creek section without over-stressing the pipe. Significant civil works were therefore carried out through 2013-14 as a major construction project. Each pipeline was separately lowered in a trench using bridging I-beams with chain and winch mechanisms. The photograph below shows the scale of construction required – this was the DN250 pipeline near completion of the lowering process.

Temporary MOP restrictions were enforced on both pipelines while they were exposed during the project. The DN400 was lowered in service, with gas flowing in the pipeline. The DN250 pipeline required blow down, purging and cutting at both ends of the lowering section, due to pipe stress concerns in relation to the vintage girth welds, before lowering and tying-in the lowered pipe section to the existing pipe at either end with new tie-in spools.

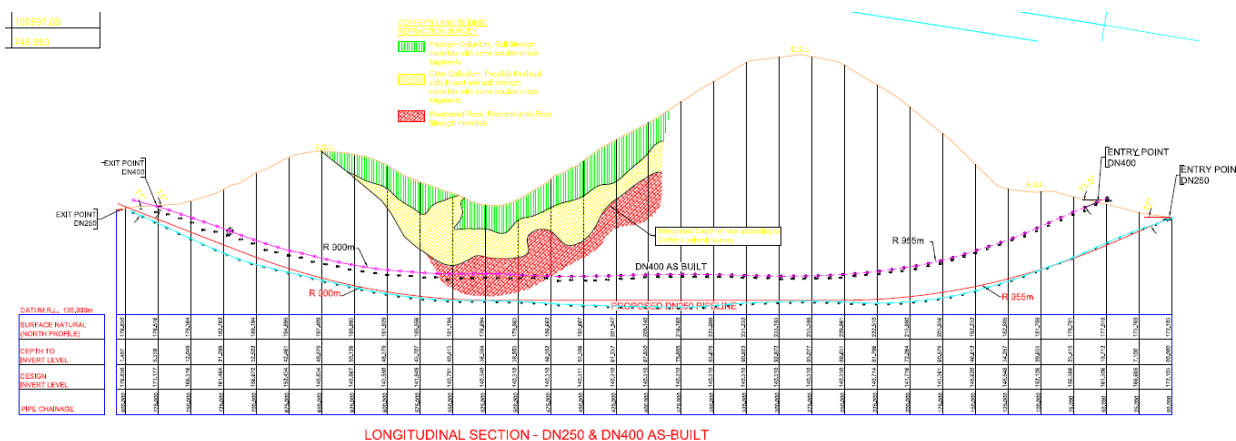
APA discovered a localised landslip in September 2011 in the Marburg Range area at Mile Post 225-226 that had laterally pushed the DN250 pipeline by 1-2 metres. The pipelines are located on a side slope in this area. Emergency works were done to depressurise the damaged section of pipeline and a temporary DN250 above-ground bypass pipeline was constructed through the slip area, using existing DN250 line pipe from APA's spare pipe stocks, and commissioned. Geotechnical and survey monitoring of the slope and of the temporary pipeline was implemented whilst APA developed options for a permanent repair.

Engineering and geotechnical studies determined that in-trench replacement of the pipe was not feasible due to slope instability risks, and that HDD was the preferred option. Due to the high-consequence risk associated with the DN400 pipeline which was located in the same side slope, APA relocated both the DN250 and DN400 pipelines by HDD, beneath the slip area. The total HDD length was approximately 800 metres due to the topography of the area. The image below illustrates the as-constructed pipeline profiles which were selected to avoid the unstable colluvium material in the valley.

The construction project was challenging due to the steep terrain and ground conditions which made HDD difficult. After the replacement sections were installed in the HDD bore holes, they were tied-in to the existing pipelines. Efficiency was gained by using the new DN250 HDD section as a bypass for the DN400 pipeline, by ensuring that it was hydrostatically tested to a pressure suitable for the DN400 operation. Hot tap and stopple operations were used to divert flow into the bypass and then tie-in the permanent DN400 section. Following DN400 commissioning, the DN250 pipeline was blown down, cut and welded in to the new section. The temporary above-ground bypass pipeline was decommissioned and removed from site and the right-of-way was reinstated.
