AMS – Victorian Electricity Transmission Network

Disconnectors and Earth Switches (PUBLIC VERSION)

Document number	AMS 10-59
Issue number	9
Status	Approved
Approver	J. Dyer
Date of approval	27/07/2015

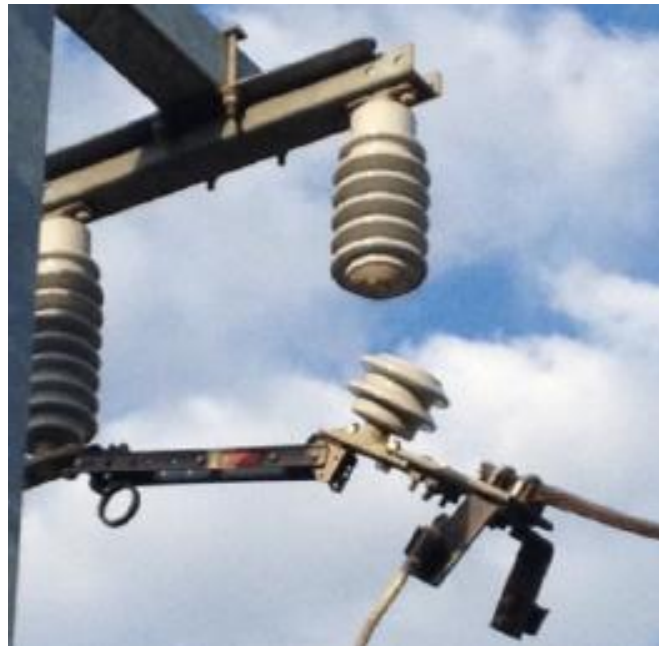
Figure 9 – Insulator Failure of an Underslung Disconnector

On 6th February 2014, while preparing for access permit, the station operator applied flexible earth to a 22 kV capacitor bank circuit breaker bus isolator when, without any warning, the supporting porcelain insulator failed on the hinged point of the single phase isolator (see Figure 9 below). The operator did not receive any injury.

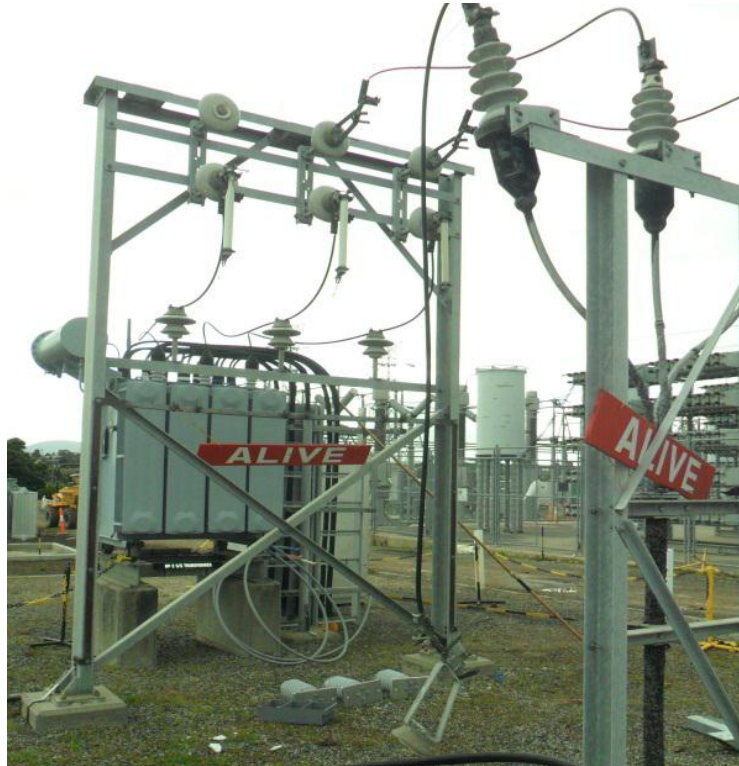
Figure 10 – ROTS 22 kV Station Service Transformer Fused Isolator Incident

On 29th October 2013, an operator suffered an electric shock subsequent to operating a 22 kV station service transformer fused isolator at Rowville Terminal Station (ROTS). The incident was caused due to the failure of the cap and pin type insulator, resulting in the overhead conductor coming in contact with the operator. The failed isolator is shown in Figure 10.
