2017 Safety Performance Report on Victorian Electricity Networks

31 October 2017

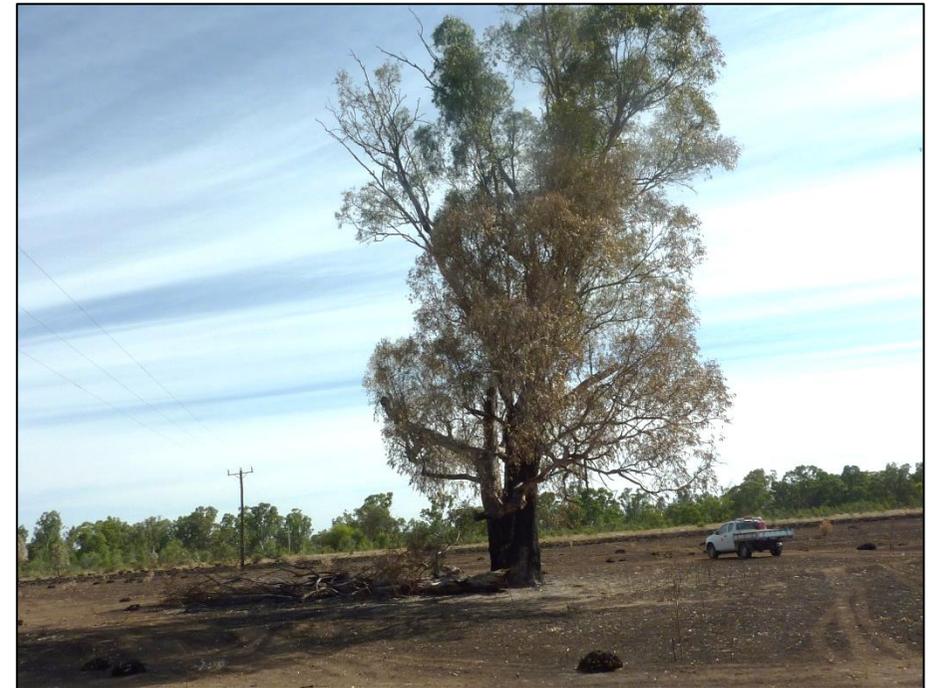
Figure 1 Fire damage at Hendry's Lane, Bridgewater

It was reported that the fire was started due to a tree falling onto high voltage electric lines. ESV conducted an inspection of the site and confirmed this was the most likely cause of the fire ignition.

The Powercor incident report identified that the contributing factors were the prevailing weather on the day of the incident and the tree condition. Observations made by ESV reflected this assertion.

Based on the information available from Powercor and our own inspection data, ESV concluded that it could not be proven that Powercor had failed to comply with its approved electric line clearance management plan in its management of the tree.

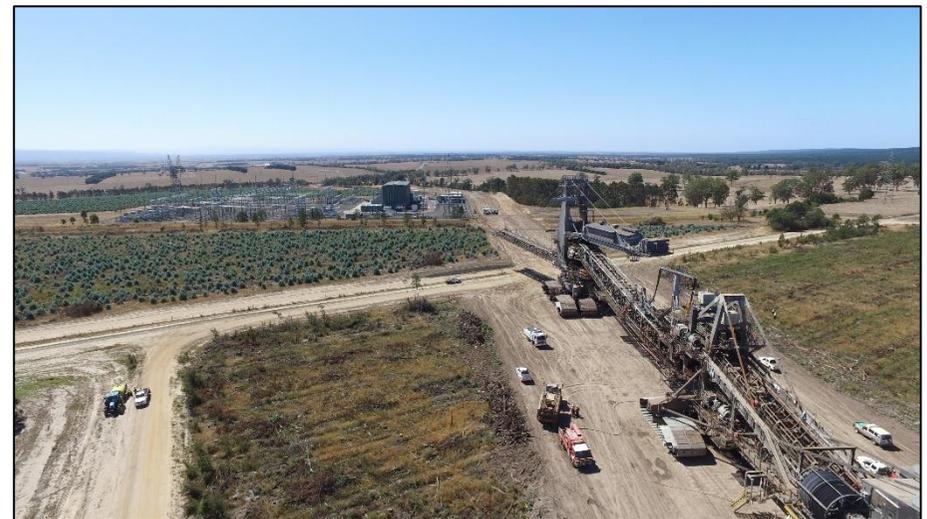
Figure 22 The AGL coal stacker approaching the Loy Yang convertor station

This is the first time that ESV has observed Basslink works practices. The Basslink transmission line is operational most of the time with scheduled maintenance occurring every two years. This observation was the result of a coal stacker being relocated between two of AGL's operations in the Latrobe Valley. The path of the relocation passed under the DC transmission line immediately adjacent to the Loy Yang convertor station (Figure 22).

The relocation of the stacker required the 400 kV DC overhead powerlines between the Loy Yang converter station and the coast to be lowered and reinstated. AusNet Services was engaged to undertake the works on Basslink's behalf.
