Directlink Joint Venture

Directlink
Revised Revenue Proposal

Directlink
Capex business cases

Effective
July 2015 to June 2020

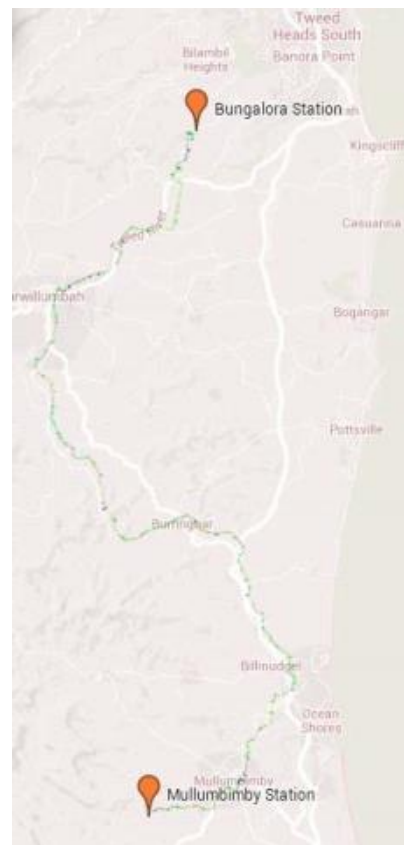
The Directlink DC transmission cables have a high frequency of failure predominantly caused by:

- moisture in the cable, hereafter referred to as moisture; and
- design of the underground to above ground transitions, hereafter referred to as transitions.

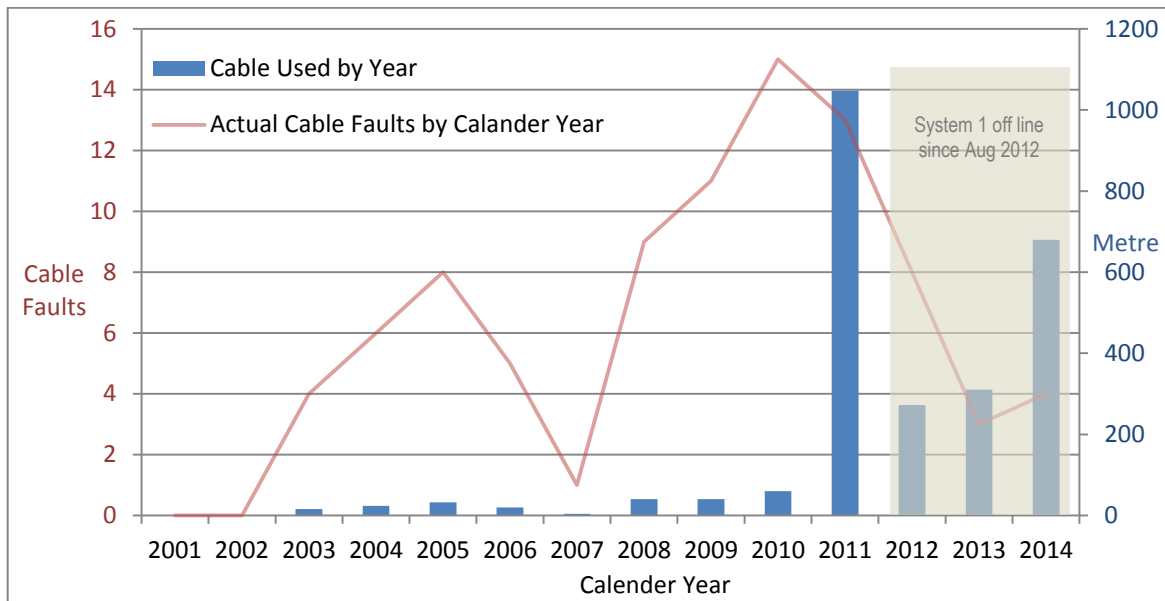
The graph below demonstrates historic usage (replacement) of cable in maintaining Directlink's assets. Since 2011 larger sections of cable have been replaced due to the high number of faults in specific locations. Replacing larger cable sections has delivered positive results and has formed the basis of the expanded cable replacement program for the next regulatory period.

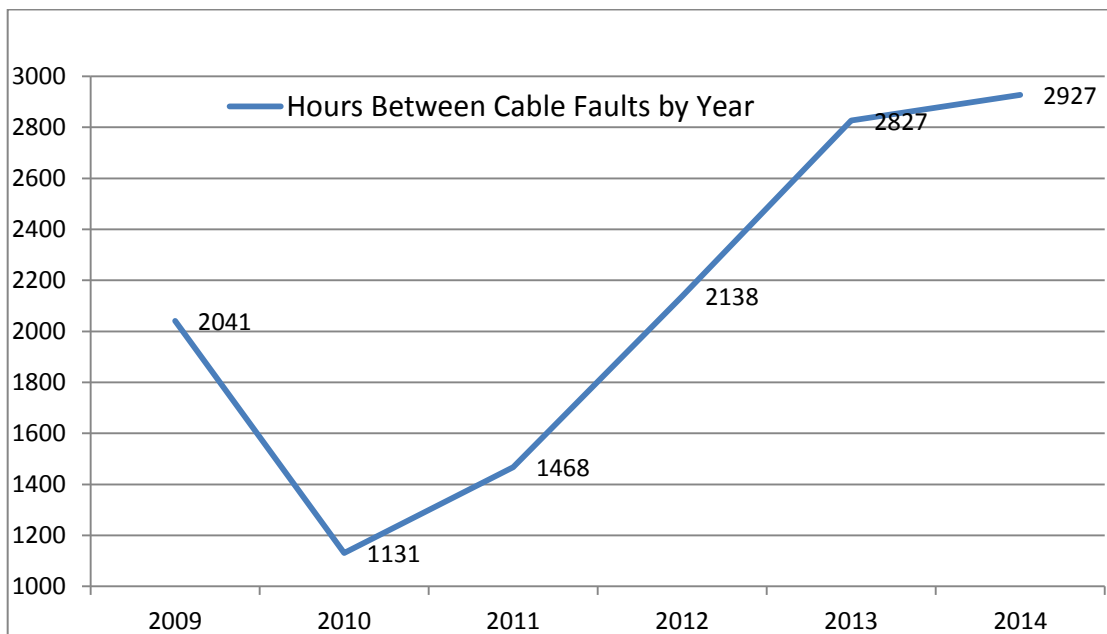
The graph below provides further demonstration of the reliability improvement to be gained from targeted cable replacement. The graph shows that, by 2010, the time between cable faults for that year had dropped to a low of 1131 hours. This has been improved to about 2927 hours, over the last four years. The data indicates that when all three Directlink systems are operational again (Mid 2015) a maximum of 3 cable faults per system per year should be expected at 100% availability. That is 9 cable faults per year.

The trend shown by the graph below indicates that the rate of improvement, made by the large amount of cable replaced in 2011, is declining and more replacement is required to improve the cable reliability to the industry standard.

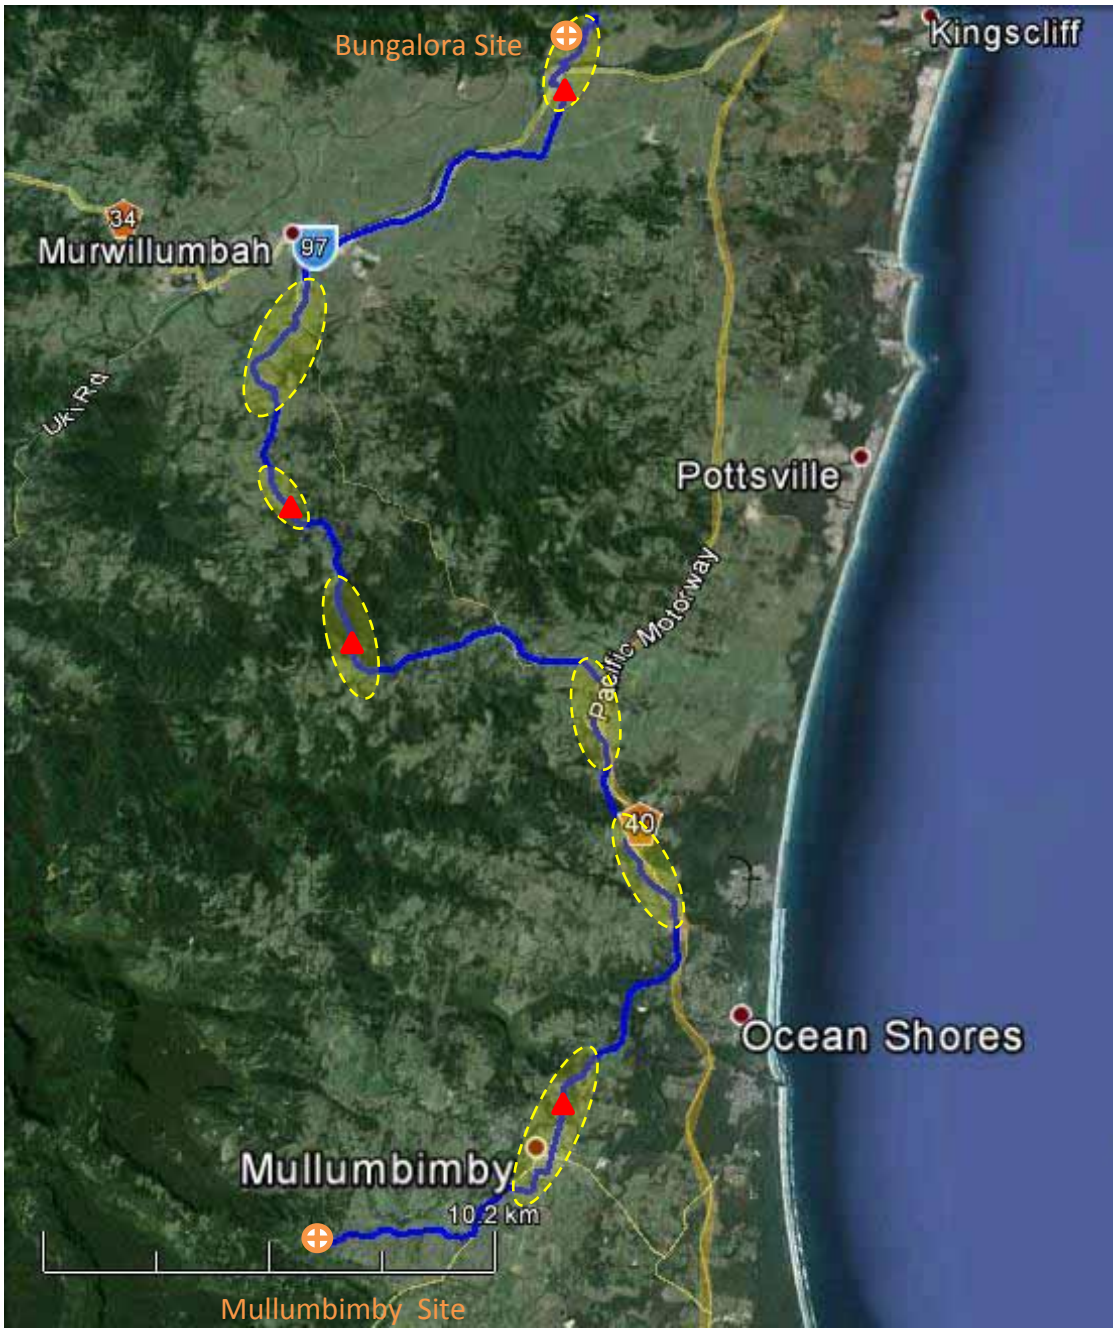
The following map represents some general concentrations of faults over the entire operational life of Directlink. The fault concentration areas are highlighted yellow. The approximate location of past, large cable section replacements are marked with a red triangle. It is proposed that the fault concentration areas will receive specific focus, to mitigate any future faults, with the expanded cable replacement program.

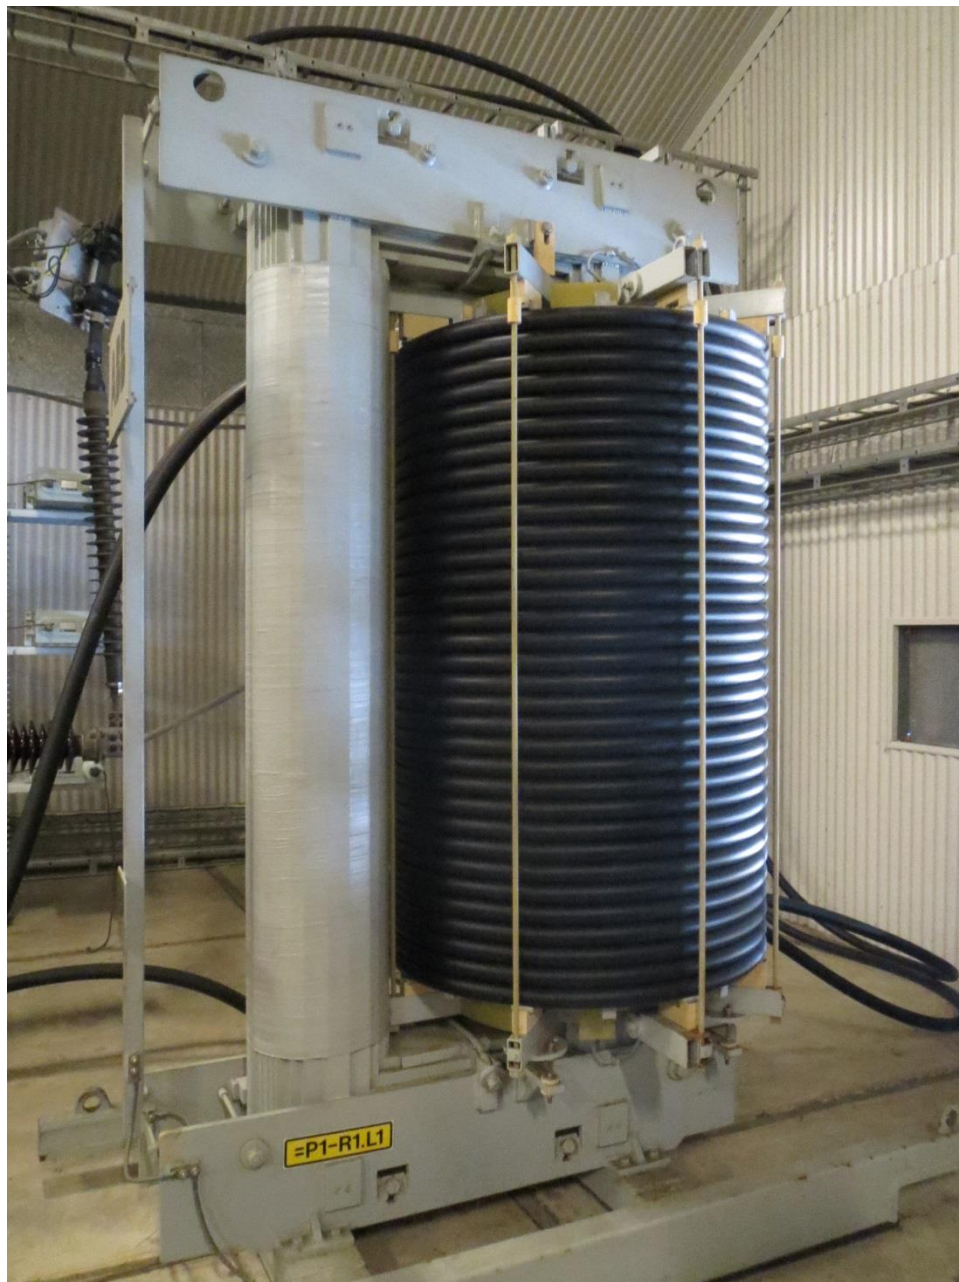
During a site visit 2013 by ABB Power Transformer's Group (Ludvika, Sweden) it was identified that there was corrosion to the core of APA's spare Zero Sequence Reactor which is a critical spare maintained for repairs to the Directlink systems.

ABB subsequently advised that the damage to the core would not be practical to repair via dismantling, cleaning / repair and then reassembly back into the reactor. ABB advised that a new replacement core was the most cost effective treatment to restoring the reactor back into a serviceable unit.

The Zero Sequence Reactor is a specialised item developed by the OEM ABB. The construction is unusual, being made by winding polymeric high voltage DC cable onto a frame which is mounted onto a laminated core.

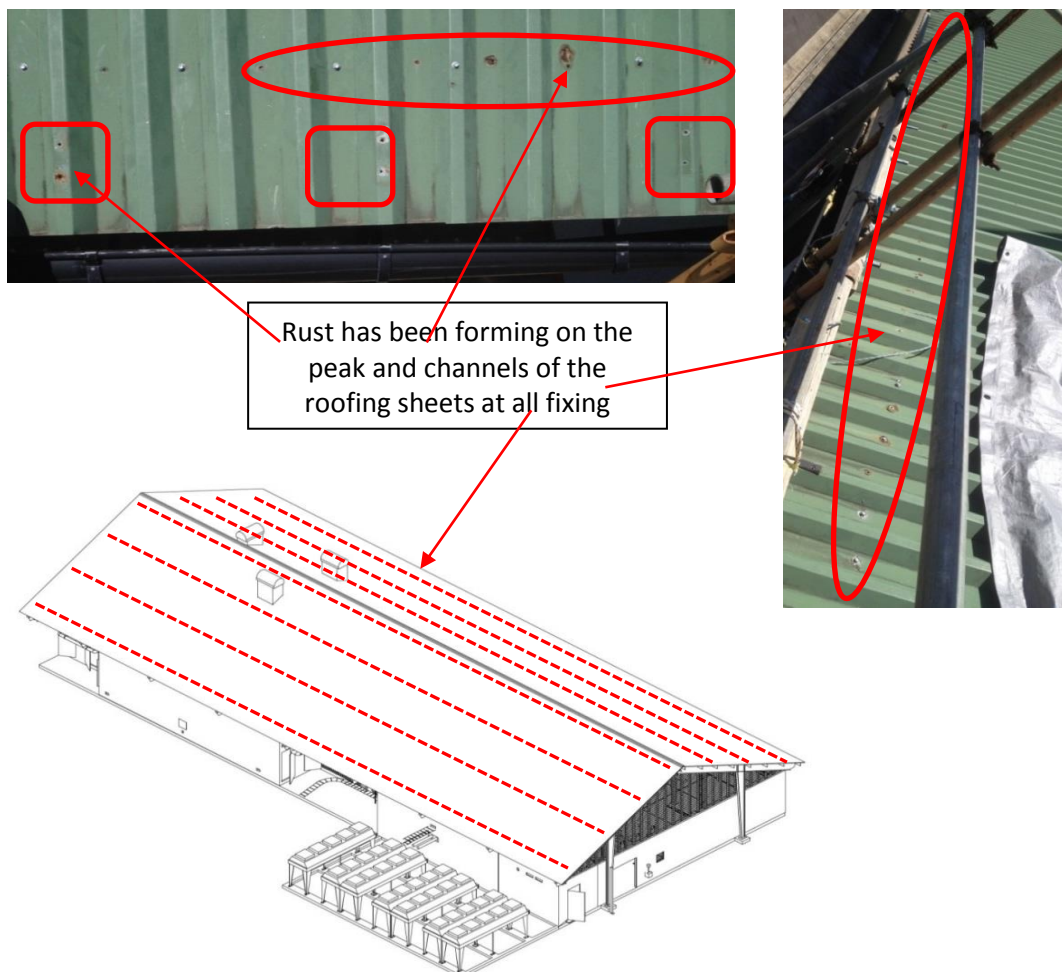
Corrosion is present on the steel roof sheets as hundreds of small rust patches. A small number of the rust patches have corroded completely through the roof sheets. These have been addressed urgently to prevent rain water collecting in the roof insulation and steel substructure, causing further damage to both. The remaining rust patches must be abraided and coated to halt the progression of the corrosion.

Corrosion is present on the heads of the fastening screw protruding above the steel roof sheets. The zinc coating of the screw heads has been consumed, allowing the steel beneath to corrode.

The images below shows the current state of these buildings.

1. scrape back deteriorated paint from roof sheets;
2. remove rust and paint with corrosion inhibitor;
3. strengthen with fiberglass matting and gel coat;
4. coat with polyurethane membrane.
