Directlink Joint Venture

Directlink
Revised Revenue Proposal

*PSC - Directlink DC Cable
Replacement Strategy*

Directlink - Opinion Paper on Directlink DC Cable Replacement Strategy

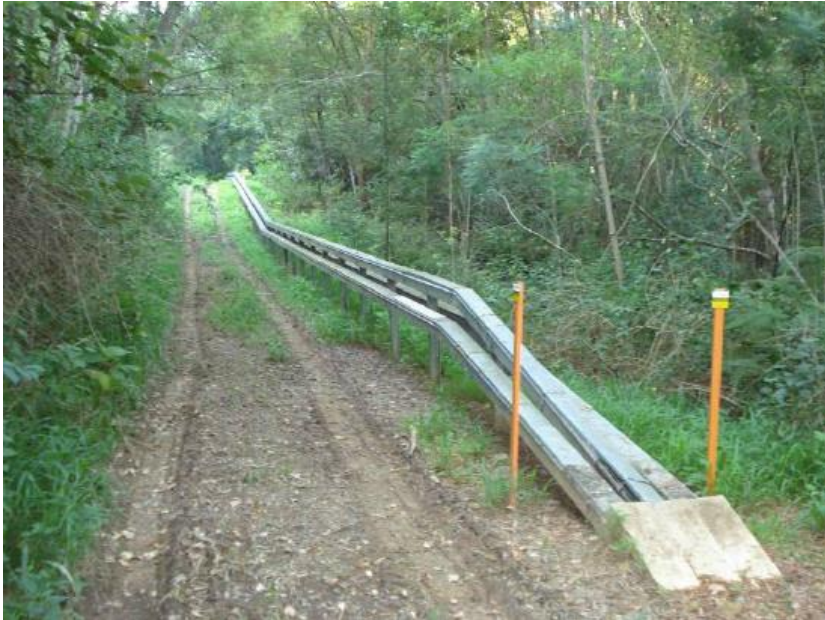
Figure 1 - Typical Directlink GST and Transition

Table 3 summarises the key differences between Directlink and Murraylink in relation to the DC cable installation. The Directlink cables were not installed by the manufacturer (ABB) as it was for Murraylink. Compared to Murraylink, Directlink's terrain is hilly, often wet, has difficult access and includes underground to above ground GST transitions as shown in Figure 1. Finally, Directlink experienced numerous cable joint body failures which exposed the joints and cables to construction activity and water ingress, compared to zero cable joint failures at Murraylink.

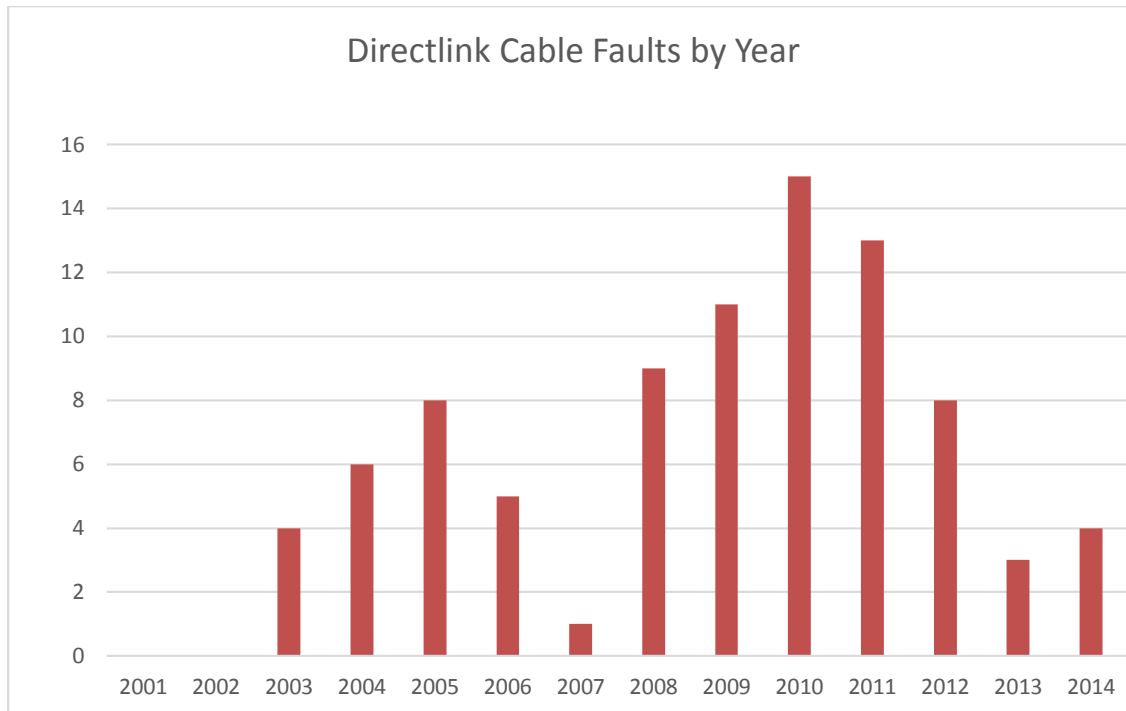
Figure 2 - Directlink Cable Faults - Jan 2001 to Nov 2014 – Excluding Joint Failures

Directlink initially had problems with cable joint faults due to the type SOJ joint bodies mechanically splitting followed by electrical failure. Cable joint failures began to taper off in early 2008. Cable faults (Figure 2) started to show up in 2003 largely near the GST transitions and then showing up in the buried sections in 2008 between the joint bays. Figure 2 excludes faults caused by joint failures.

Figure 2 illustrates that the number of cable faults per year increased significantly between 2007 and 2010. One of the concerns due to the original installation and numerous repairs to the Directlink cables, is the ingress of water. A cable is very dry inside and will absorb water readily when the cable jacket or a joint is punctured. Figure 3 shows the annual rainfall in the Murwillumbah (Tweed River) area. The increase in annual rainfall from 2007 to 2010 correlates well with the dramatic increase in the cable faults between 2007 and 2010.

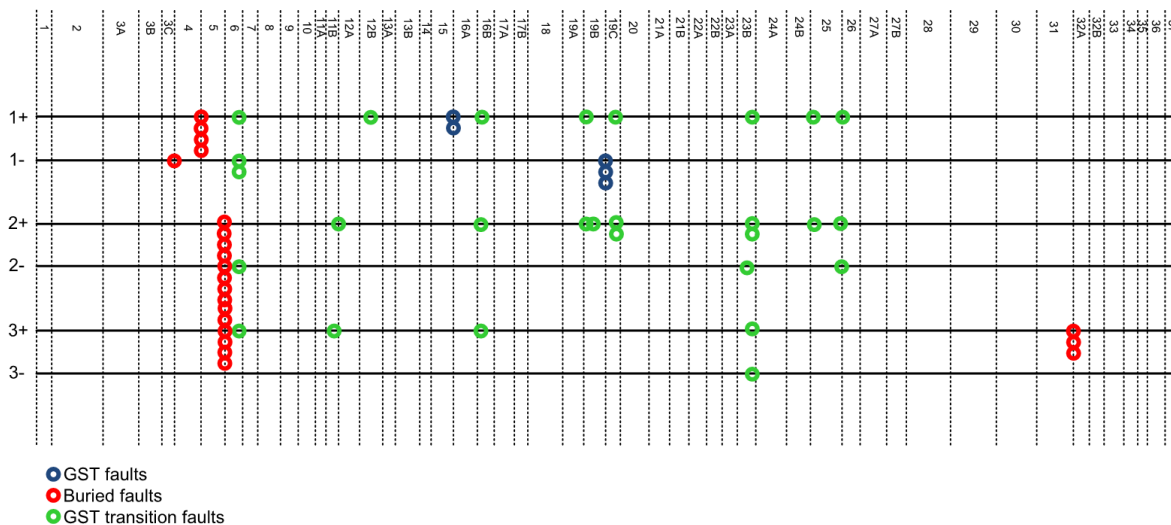
Figure 4 - ABB Mapping of Directlink’s Cable Faults

APA retained ABB High Voltage Cables in November 2010 to perform an investigation to determine the root cause of the cable faults. ABB performed a desktop study of the Directlink cable failure data and a field investigation in January 2011 and provided a report in May 2011. One of the more interesting observations by ABB was a “map” showing the 59 Directlink cable faults that occurred between May 2003 and April 2011, in terms of their location on the cable route as shown in Figure 4.

The numbers at the top of Figure 4 are the joint bay locations with #1 starting at Mullumbimby and #37 ending at Bungalora. The numbers on the left side of the figure identify which cable faulted (i.e. the positive (+) and negative (-) cable of System 1, System 2 or System 3). There were cable fault clusters identified in the cable route sections as listed in Table 4, which also shows the length

of the cable route section. The entire route length is not targeted for replacement, but Figure 4 shows that there are sections of the cable within these route sections that have been exposed to multiple failures on either System 1, System 2 or System 3.

The information presented in Figure 4 and Table 4 indicates that there are certain parts of the cable route more susceptible to cable faults than others, and hints at a failure mechanism related to the cable location rather than the design and construction of the cable itself. In our opinion though, using historical analysis on the basis that the same behaviours will continue into the future is not a reasonable assumption without engineering analysis to support it.

1. The presence of water in the faulty cables as the reason for all cable failures in the buried sections and the GST sections (i.e. red and blue circles in Figure 4).
2. Mechanical exposure of the cables is considered another contributing factor (in addition to the presence of water in many instances) to the cable faults at the GST transitions (i.e. green circles in Figure 4).

The water is suspected of entering the cables either during installation, through the hole created when a cable has faulted or during the repair of cables, including during the repair of those initial cable faults caused by joint failure. The possible effects of cable location on faults caused by the mechanisms concluded by ABB is clear – it could be the case that areas of cable close to where previous repairs had taken place (particularly during wet or rainy periods) and which is more susceptible to water (exposure to heavy rain and/or the pooling or flooding of water) would be more likely to fail. The authors do not have any more detail to conclusively prove why certain clusters fail more than others, but based on the evidence have the opinion that the failures could reasonably be location dependent.

1. Short term repair strategy - Replace approximately $\pm 100\text{m}$ of cable in cable sections where cable faults have occurred within close proximity to each other.
2. Medium term repair strategy – Replace the cables on all sections where faults have occurred. Repair, modify and/or replace the GST transitions where cable failures have occurred.
3. Long term repair strategy – Replace any remaining cable sections where water is suspected to have migrated into the cable.

1. When there is an internal fault (i.e. not an external fault, for example a fault caused by digging or excavation), take the opportunity to replace 125m of the DC cable either side of the fault (a total of 250m per repair).
2. Immediately undertake the necessary analysis and investigation (including and specifically parts of the cable routes that have experienced prior joint failures and/or where water ingress into the cables is likely to have occurred) to identify sections for strategic proactive replacement, replacing a 250m length each time.
3. Target an average replacement of 3km (combination of opportunistic and proactive) per year for 5 years.
