TS617 – Prospect ZS transformer replacement

BUSINESS CASE FOR 2017/18

Prepared by Asset Strategy and Planning

July 2017

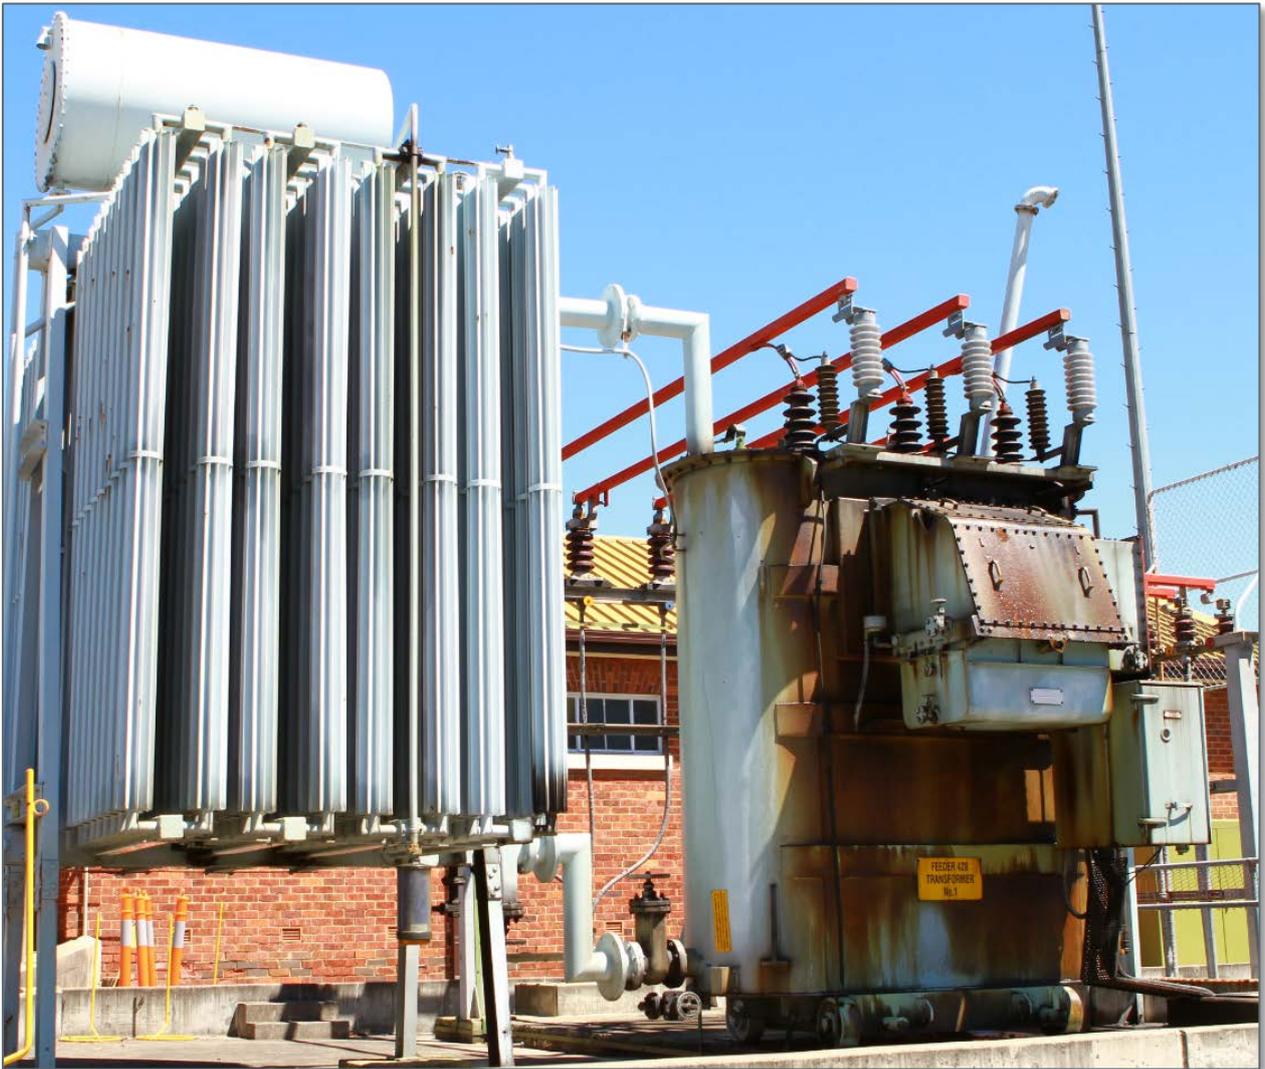
FIGURE 1 : TRANSFORMER NO. 1

Condition Indicator	Units	Limits	Values	Rating	Comments
Age indicators	Furan levels	ppm	<2.5	1.0	Good	Furan values are low due to frequency of oil top ups which dilute the oil indicators, giving a result which appears to be better than it is in reality.
	Paper degree of polymerization (DP)		250	259	Very poor	DP was tested in 2013. It is expected to be much lower at this time
	CO ₂ /CO ratio		>7	13	Reasonable	This ratio appears to be reasonable but is unreliable due to dilution of the oil
Oil condition indicators	Oil colour classification		<5	4	Fair	This suite of indicators appear to be fair but are not reliable due to the frequency of oil top ups which distort the results, giving results which appear to be better than they are in reality.
	Myers Index			160	Very poor	
	Oil breakdown voltage	kV	>40	52	Fair	
	Water content in the oil	ppm	30 @ 40 – 60°C	20	Wet	
	Oil Dielectric dissipation Factor (DDF)	mW/Var	<40 @ 90°C	49	Poor

Condition Indicator	Units	Limits	Values	Rating	Comments
Winding differential resistance	Ω	<0.02	0.004	Fair	
Dissolved gas levels		various		Good	DGA levels appear to be good but are unreliable due to numerous oil top ups which dilute the oil markers

3.1.2.1 TRANSFORMER NO. 1 CONDITION SUMMARY

Although a number of condition indicators appear to be fair to poor, these indicators underestimate the condition due to dilution which is caused by the regular oil top ups that have been carried out.

This transformer is in very poor condition due to the very low DP level, which is exacerbated due to oil leaks and moisture ingress and makes the transformer susceptible to internal failure if subjected to a through fault event.

This business case considers a range of options to address the transformer condition and noise issues and recommends replacing Transformer No. 1 and No. 2 with new low noise 15 MVA transformers and disposing of the old Transformer No. 1 and No. 2.

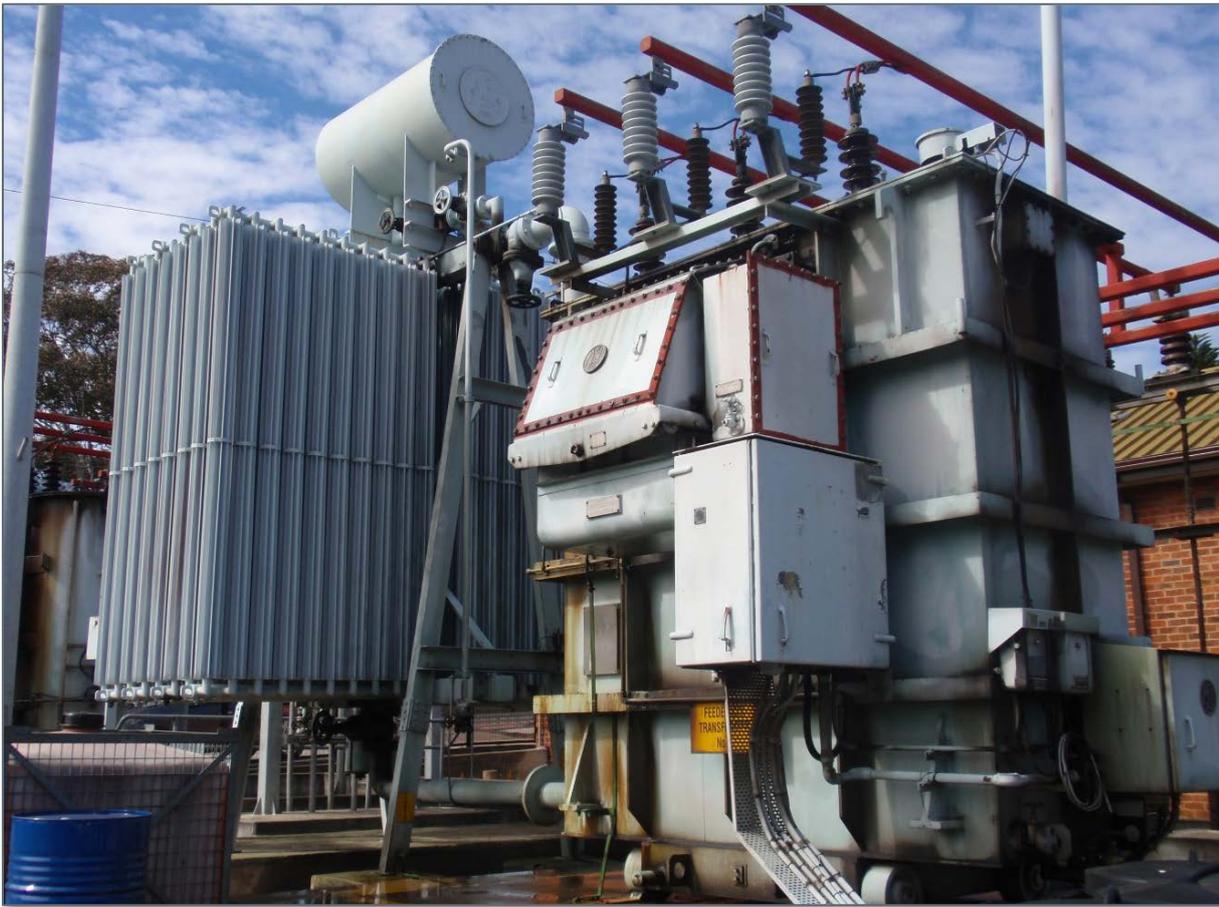
FIGURE 2 : TRANSFORMER NO. 2

Transformer No. 2 is 52 years old and is the same design as Transformer No. 1. Further detail of the condition of Transformer No. 2 is provided in TABLE 3 below.

Condition Indicator	Units	Limits	Values	Rating	Comments
Age indicators	Furan levels	ppm	<2.5	0.5	Fair	Furan values are low due to frequency of oil top ups which dilute the oil indicators, giving a result which appears to be better than it is in reality.
	Paper degree of polymerization (DP)		250	363	Poor	The DP was tested in 2009 when this transformer was 44 years old and in better condition. Since then its condition has deteriorated and the DP levels are expected to be very poor
	CO ₂ /CO ratio		>7	16	Reasonable	This suite of indicators appear to be fair but are not reliable due to the frequency of oil top ups which distort the results, giving results which appear to be better than they are in reality.
Oil condition indicators	Oil colour classification		<5	4	Fair	
	Myers Index			526	Fair	
	Oil breakdown voltage	kV	>40	42	Poor	
	Water content in the oil	ppm	30 @ 40 – 60°C	23	Wet	
	Oil Dielectric dissipation Factor (DDF)	mW/Var	<40 @ 90°C	43	Poor

Although a number of condition indicators appear to be fair to poor, these indicators underestimate the condition due to dilution which is caused by the regular oil top ups that have been carried out.

Transformer No. 2 is in poor condition and its DP level is expected to be below 250 as its condition has deteriorated since 2009 when the DP level of 363 was measured.

This transformer is in very poor condition due to the very low DP level, which is exacerbated due to oil leaks and moisture ingress and makes the transformer susceptible to internal failure if subjected to a through fault event.

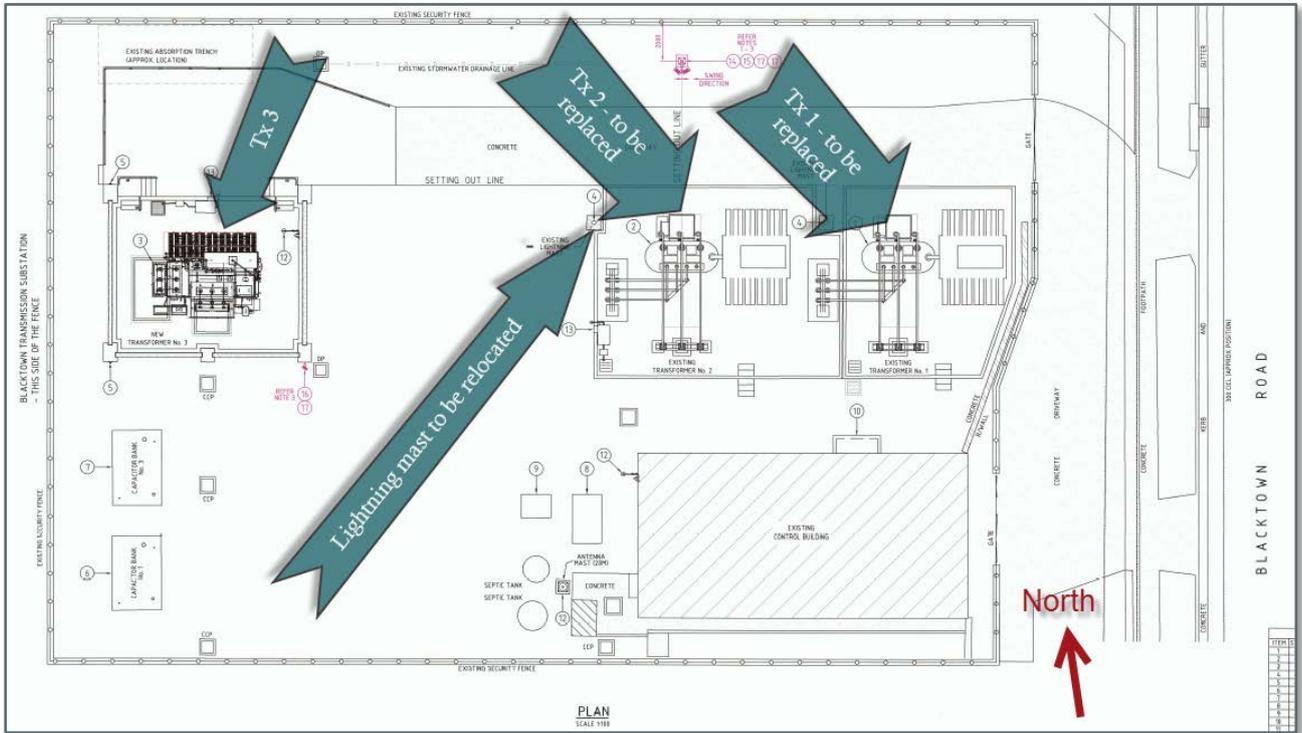
FIGURE 4 : EXISTING TRANSFORMER ARRANGEMENT

Currently there are inadequate fire separation distances or firewalls between Transformers 1 and 2 and between these transformers and the control building, that houses the 11kV switchgear. As both transformers No.1 and No.2 are in poor condition, they are likely to fail when subjected to a through

fault event. If the failure results in a transformer fire, the fire is likely to destroy the adjacent transformer and the control building.

This option is to replace the existing Transformer No. 1 and No. 2 with low noise 15MVA transformers in new bunds that are fitted with firewalls. Also included in this option is the replacement of the 33kV cables from Blacktown TS, replacement of the 11kV cables to the 11kV switch room, the relocation of a lightning mast and disposal of the redundant transformers.
