**Annexure B - Condition assessment and reporting form – (Refer Page 14 and onwards for equipment photos)**

<b>Transmission/zone substation and switching station condition assessment and reporting form</b>		Date of review:	22/02/2017				
		Reviewed by:	Humayoun Khan				
		Date of site visit:	07/12/16 and 15/02/17				
SUBSTATION NAME: MARAYONG ZONE SUBSTATION							
<b>OVERVIEW OF SUBSTATION DETAILS</b>							
Year built or commissioned:	Established 1965						
Location:	Charles Street, Blacktown (Cnr Frederick St)						
<b>POWER TRANSFORMERS</b>							
<b>Power transformer no. 1</b>							
Year of manufacture:	1973	Age:	43	MVA / Vector group:	25/19/15 / Dyn1	Make:	Tyree
Voltage HV/LV/TV:	33kV/11kV		Serial no.:	70686			
Tap changer make:	Reinhausen		Tap changer model:	CIII350D			
<b>Mechanical strength of the paper insulation</b>							
Degree of polymerisation:	360 (DP sample gathered from B phase high voltage bushing lead - DP test date: 20/10/2008) 316 (based on 2FAL – last oil test conducted on 27/06/2016)

MARAYONG ZONE SUBSTATION

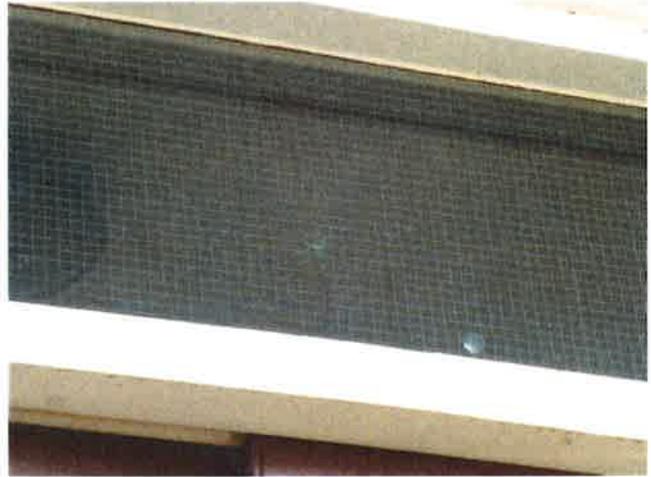
**Substation building door glass panel damaged**

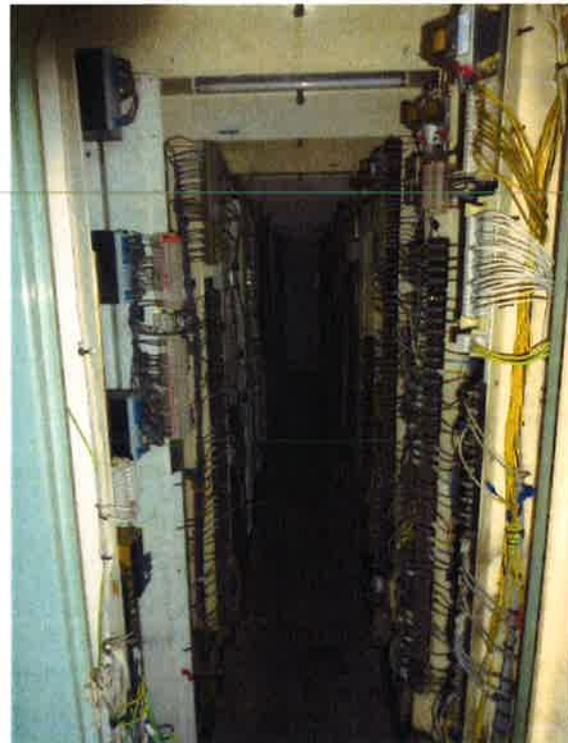
**Tunnel boards (old design - all exposed terminations)**

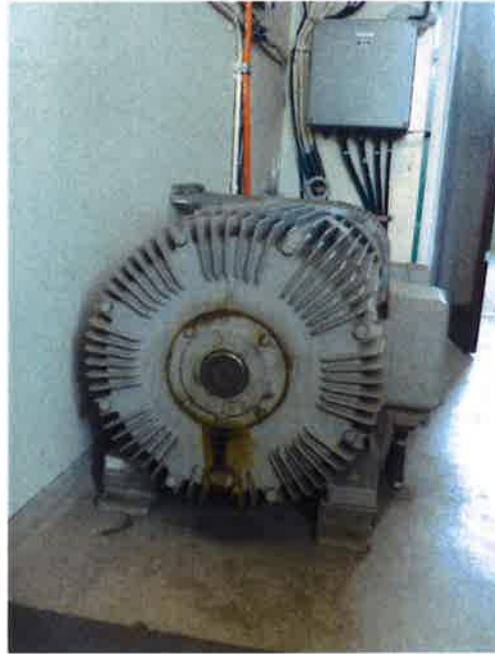
AFIC EQUIPMENT
<i>Assessment of equipment based on test reports current defects and issues</i>
Old motor-generator set - The condition is generally ok however minor lubricant leak was found coming from the motor side during the site visit on 6/12/2016.

Motor generator set oil leak from motor side

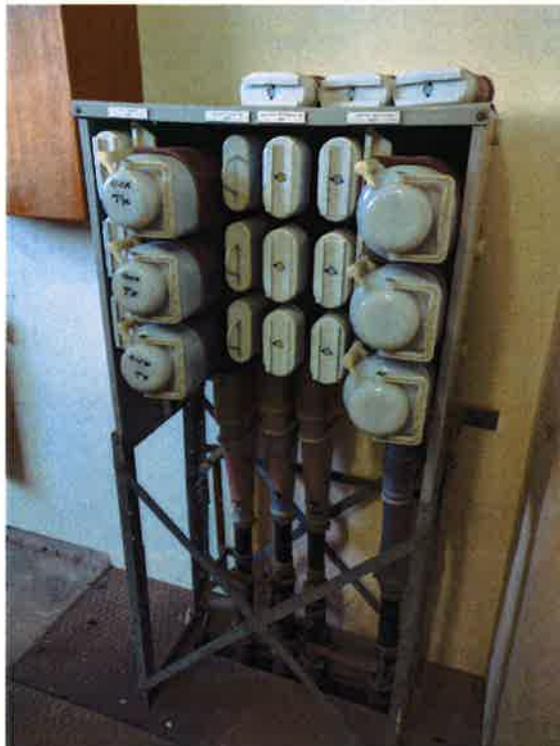
SPN	Feeder No.	Make/ Part No.	Serial no.	Comments based on recent test results and defect history
9504SL01SW006211	MARAYONG ZS, 11kV, Aux Busbar, Magnefix	Holec/MD4	A3830	Serviceable condition. PD and thermovision tests on 10/08/2015. PD activity categorised as category 5 defect requiring a re-test within 12-18 months (Max TEV: 18 dB, Ultrasonic: 0 dB). A follow-up/re-test has not yet occurred.
9504SL01SW006210	MARAYONG ZS, 11kV, Aux Busbar, Magnefix	Holec/MD4	A3830	Serviceable condition. PD and thermovision tests on 10/08/2015. PD activity categorised as category 5 defect requiring a re-test within 12-18 months (Max TEV: 18 dB, Ultrasonic: 0 dB). A follow-up/re-test has not yet occurred.
9504SL01SW000A88	MARAYONG ZS, 11kV, Aux Busbar, Magnefix	Holec/MD4	A3830	Serviceable condition. PD and thermovision tests on 10/08/2015. PD activity categorised as category 5 defect requiring a re-test within 12-18 months (Max TEV: 18 dB, Ultrasonic: 0 dB). A follow-up/re-test has not yet occurred.

9504SL01SW006637	MARAYONG ZS, 11kV, Aux Busbar, Magnefix	Holec/MD4	A3830	Serviceable condition. PD and thermovision tests on 10/08/2015. PD activity categorised as category 5 defect requiring a re-test within 12-18 months (Max TEV: 18 dB, Ultrasonic: 0 dB). A follow-up/re-test has not yet occurred. No overheating of joints or connection defects detected from thermovision.

Holec MD4 auxiliary switchboard

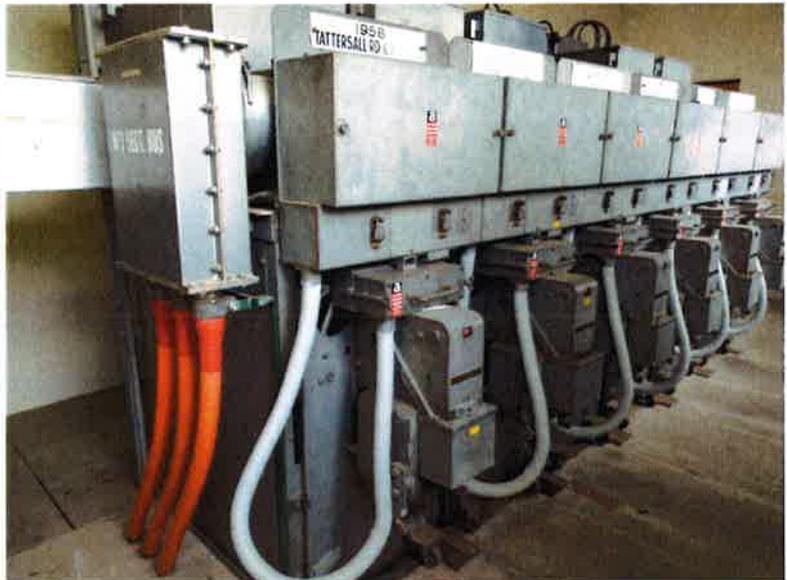
11kV Westinghouse B18 breakers arc chute and closing coil contactor covers contain asbestos

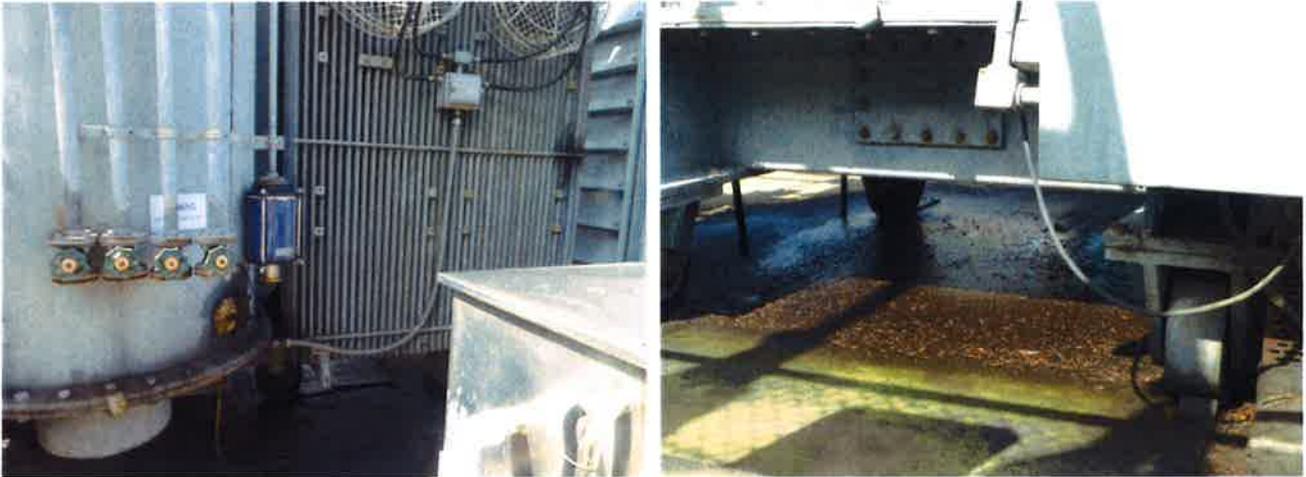
<b>Tap changer</b>							
<b>Comments:</b> The tap changer is a CIII Reinhausen in which the carbonised oil contaminates main tank oil and therefore requires annual inspection and drainage of carbonised oil. The exercise is required once each year with transformers de-energised and complete oil in tap changer is replaced once every three (3) years to address the issue of contamination of TC oil with main tank oil. Tap changer cubicle shows normal signs of wear.							
<b>Overall condition</b>							
<b>Comments:</b> In addition to the above criteria, there is noticeable rust on radiator fins. There are also leaks from the bottom radiator connections with slight bulge in tap changer gasket

Tyree 33kV/11kV 25 MVA TX no. 1 oil leak from radiator and tap changer

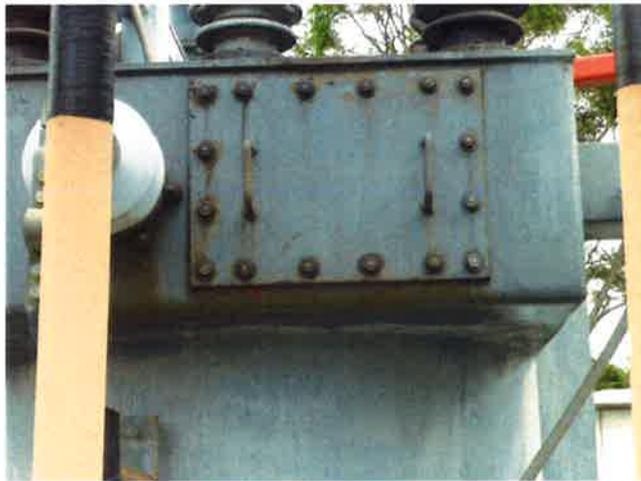
TX no. 1 oil leak from top bushing gaskets

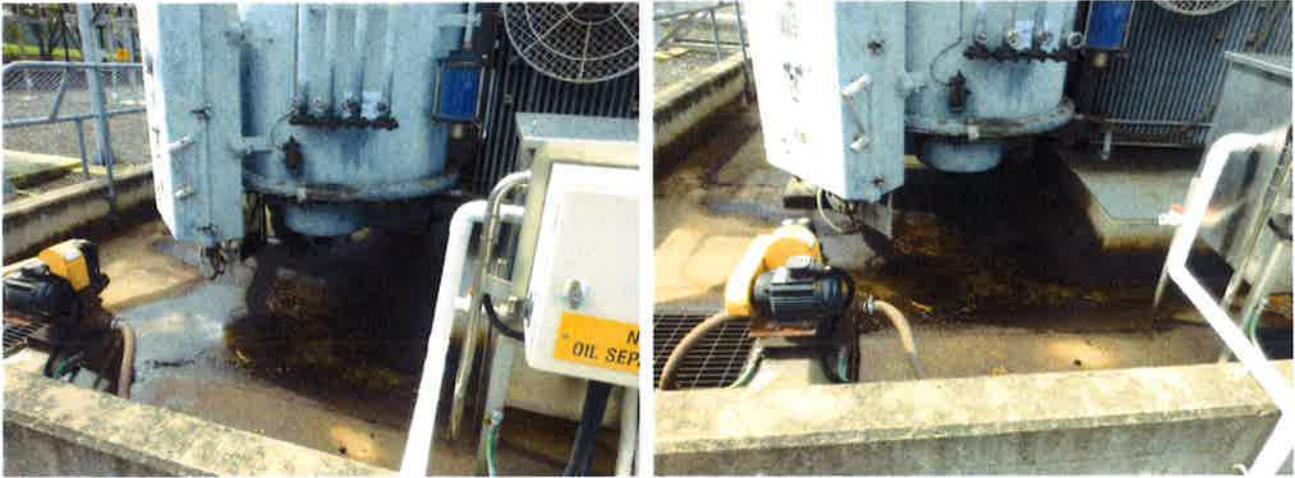
**Tyree 33kV/11kV 25 MVA TX no. 2 – oil leak from gaskets**

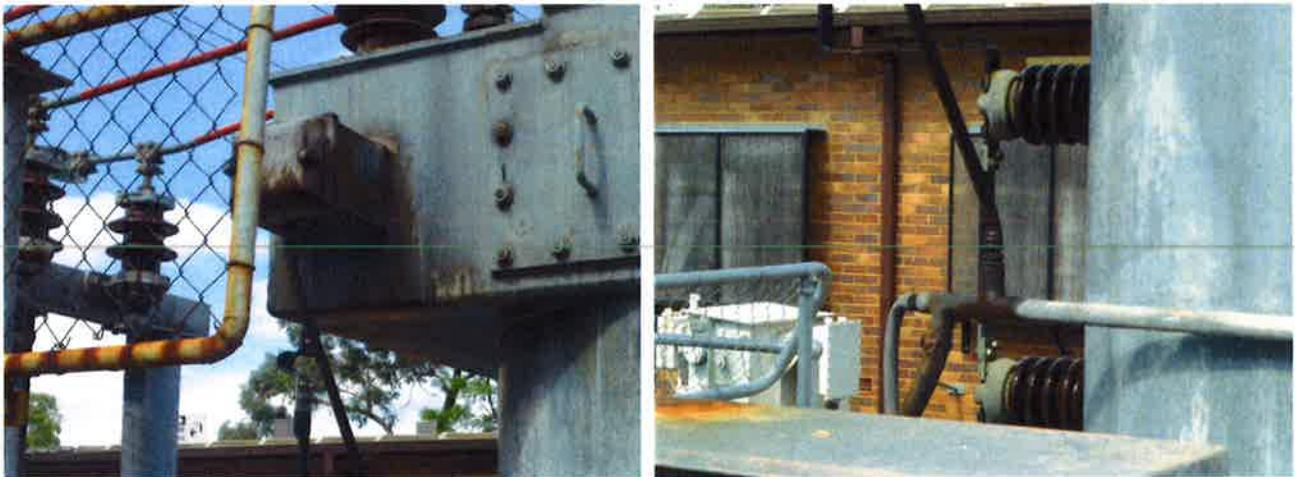
**Tyree 33kV/11kV 25 MVA TX no. 2 – oil leak from RTD box**

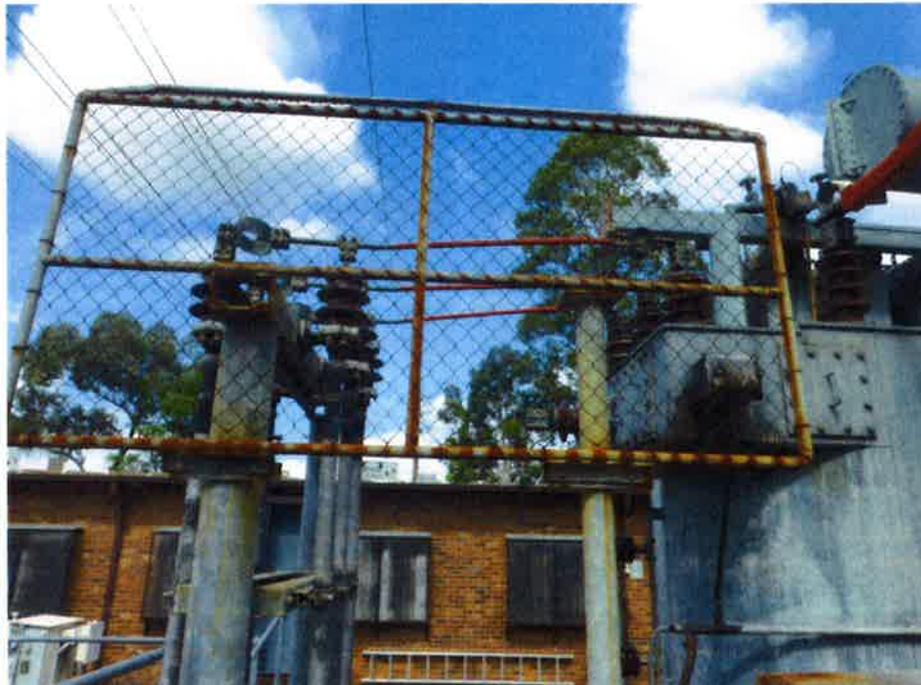
**Tyree 33kV/11kV 25 MVA TX no. 2 – rust and surface corrosion on structures**

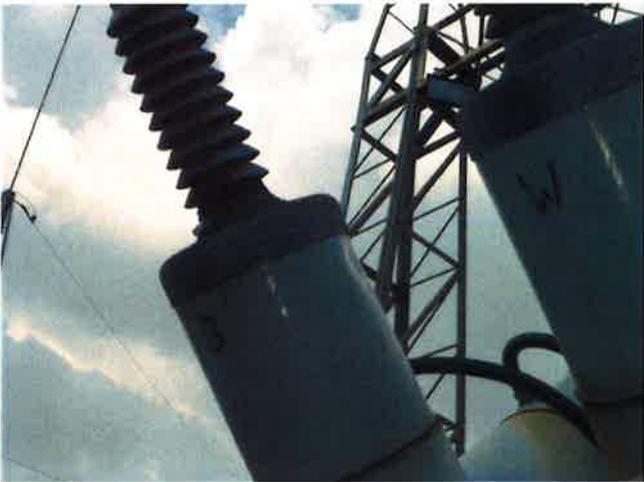
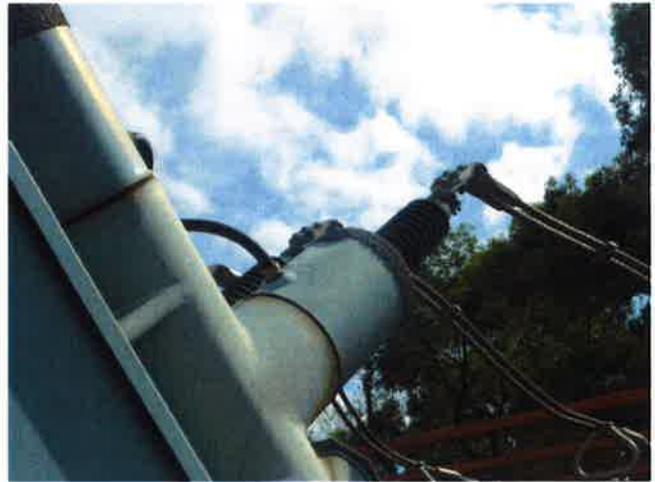
<b>33kV CBs</b>				
<b>Common name/SPN</b>	<b>Make</b>	<b>Year of manufacture</b>	<b>Serial no.</b>	<b>Comments based on recent test results, defect history and availability of spares</b>
9504SA02CB00S041	ALSTOM/OX36	2003	49R3244/1K	IR and contact resistance values are good. Trip and close times results are within acceptable limits. Minor damage on the incoming blue phase bushing weather shroud and dent on bushing turret.
9504SA03CB00S042	ALSTOM/OX36	2003	49R2883/1C	IR and contact resistance values are good. Trip and close times results are within acceptable limits.
9504SA01CB00S040	ALSTOM/OX36	2003	49R3244/1C	IR and contact resistance values are good. Trip and close times results are within acceptable limits. Minor damage on the incoming blue phase bushing weather shroud and dent on bushing turret.
9504SC02CB00S052	ALSTOM/OX36	2003	49R2883/1D	IR and contact resistance values are good. Trip and close times results are within acceptable limits. Dent on one bushing turret. Also, minor damage on the incoming red phase bushing weather shroud.

Bushing weather shield and denting on bushing turrets on Alstom 33kV OX36 CBs

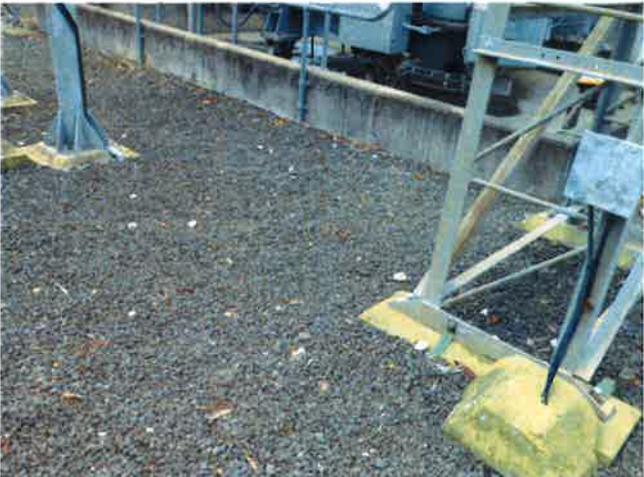
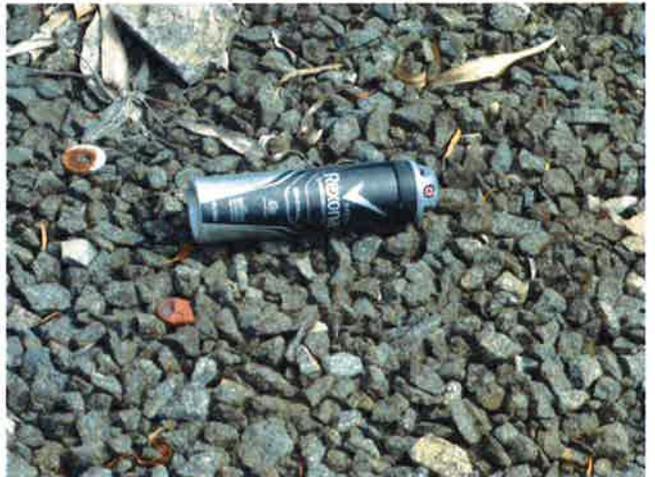
The substation site was found to be vandalised as stones and glass were found in the switchyard. It is suspected that the damage to the 33kV CB's and some insulators was from stones and other projectiles being thrown from the outside.

Stones (white) and other foreign material was found scattered in the switchyard near power transformers and 33kV outdoor circuit breakers

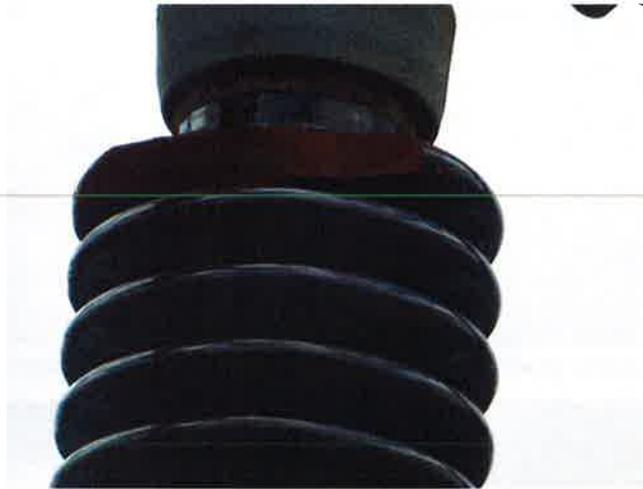
**Feeder 470 Bus Isolator S045 support insulator**

Half of the first skirt of the support insulator on Feeder 470 Bus Isolator S045 was broken, possibly from stones thrown into the substation.

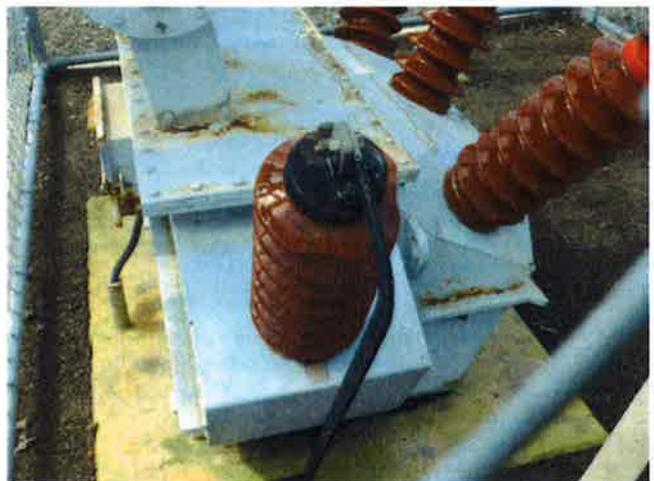
**Neutral bushing found damaged on Feeder 470 Voltage Transformer**

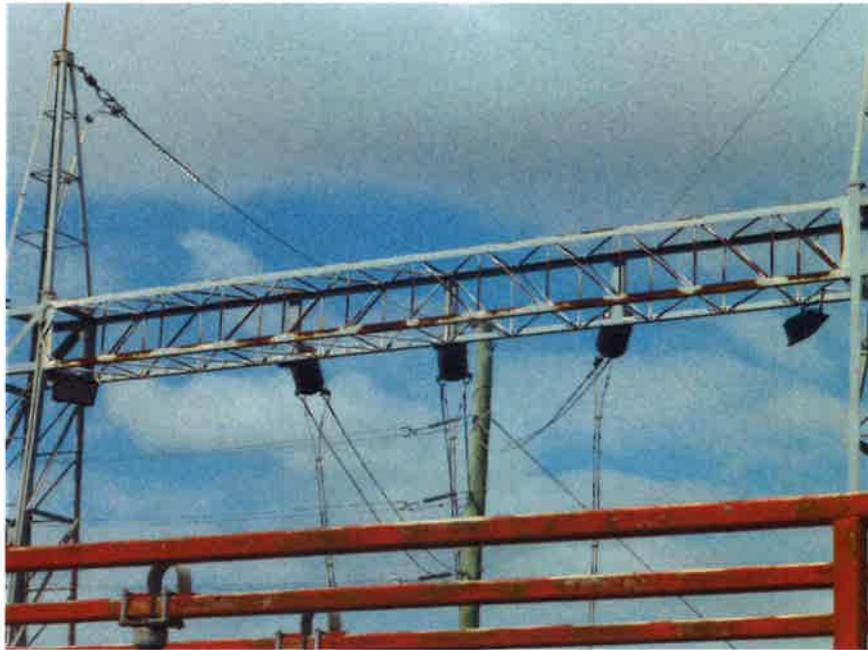
Rust and surface corrosion was evident on the following structures:

- No. 1-2 bus section isolator S046
- feeders 445 and 470 gantries

**Rust and surface corrosion on feeder gantries**

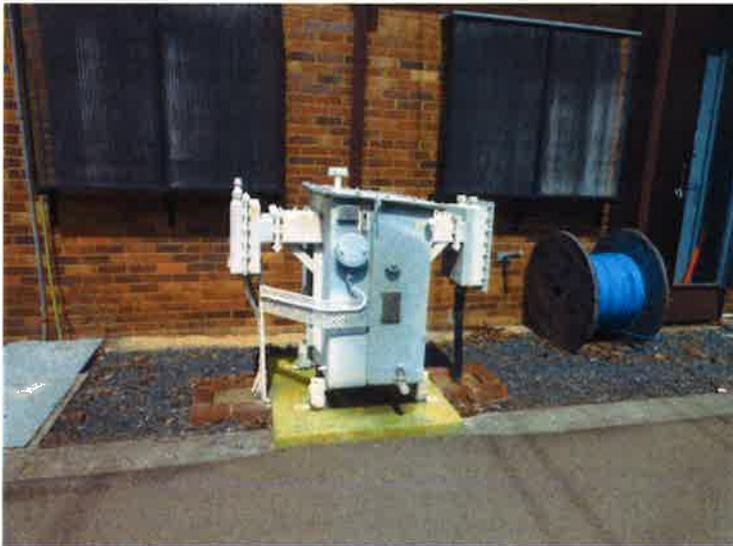
**Auxiliary transformer – slight oil leak from tap changer**

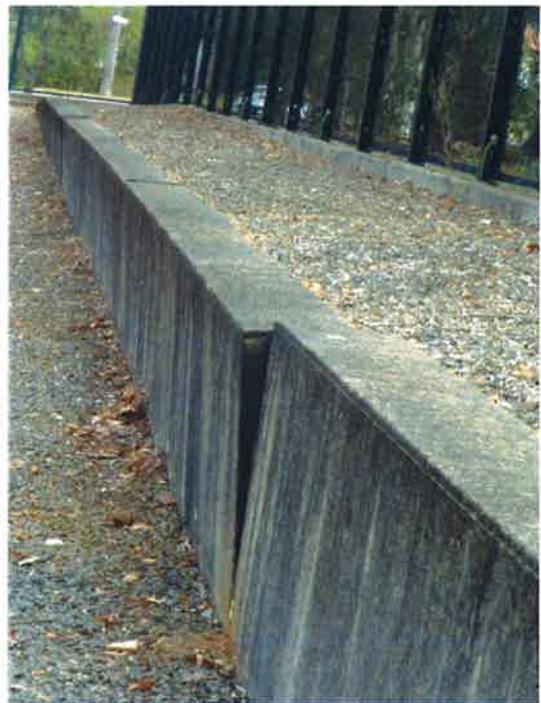
Part of the retaining wall in the switchyard is slanted with respect to adjacent retaining walls.

**Retaining wall is slanted**
