MARAYONG ZONE SUBSTATION STATEMENT OF NETWORK NEED

Project TS146 2017/18

Prepared by Asset and Network Planning

November 2016

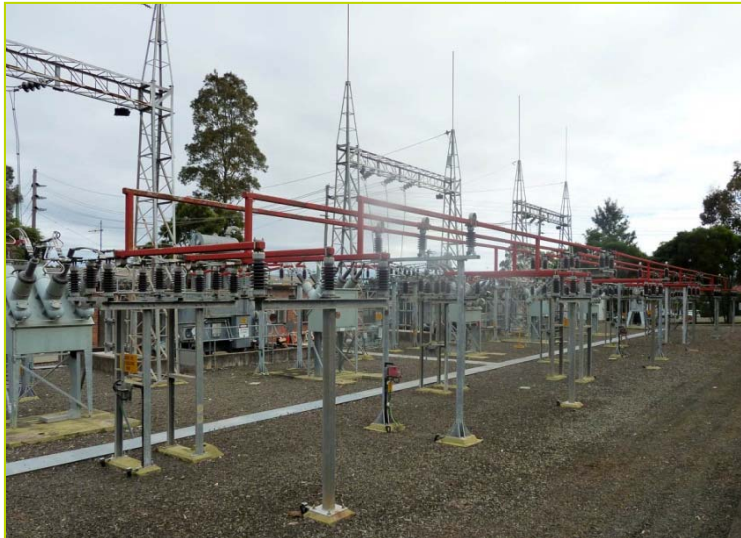
33kV switchyard

Five of the six 33kV circuit breakers were replaced in 2004 and the fifth in 2011. They are in good condition and have no short to medium term renewal needs.

The 33kV isolators are rotary double-break types which are inherently reliable and appear to be in satisfactory condition.

The busbars and supports are aluminium and galvanised steel respectively and appear to be in satisfactory condition.

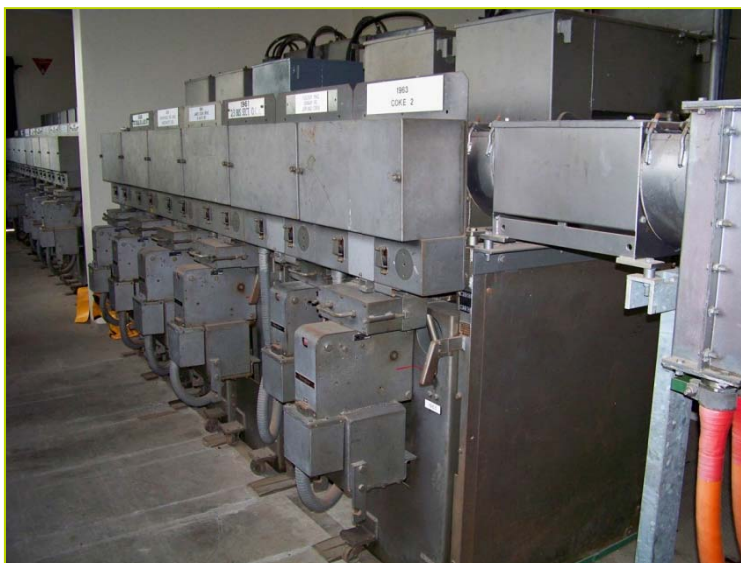
11kV Westinghouse
B18 switchgear

The 11kV switchboard is a Westinghouse type HQ switchboard which features a compound filled busbar and Westinghouse B18 circuit breakers. It is estimated (based on their serial numbers) that 12 of these circuit breakers were manufactured circa 1960 and a further three in 1965. There are also three Reyrolle LMT bulk oil breakers which were installed in 1980 in three separate rooms as transformer circuit breakers. These breakers are connected by cable to the Westinghouse switchboard.

The Westinghouse B18 circuit breakers are in varied condition with a number with consistently high values of contact resistance and or low insulation resistance indicating that they are approaching the end of their effective lives. A number of other breakers however are showing respectable values of insulation resistance and contact resistance suggesting they have considerable life remaining. The three Reyrolle LMT circuit breakers are in good condition.

However, these circuit breakers are oil filled and breakers of this type have resulted in fires which have caused widespread damage to and a prolonged outage of other substations in Endeavour Energy's and Ausgrid's areas. In response Ausgrid are in the process of decommissioning all of their Westinghouse HQ switchboards.

The switchboard could be retrofitted with vacuum trucks under program TS173 as the 11kV busbar is currently in satisfactory condition. However, there is a level of uncertainty of when this compound filled busbar will start to display poor condition indicators, which will require the replacement of the switchboard. Therefore, it was resolved in the business case for program TS173 that the two substations with compound filled switchboards (Marayong and West Wollongong zone substations) would have their switchboards replaced rather than have vacuum trucks installed.

Given the design, safety issues and limitations of the 11kV switchboard and auxiliary switchboard at Marayong Zone Substation and the limitations of the existing control building it is proposed that consideration be given to the redevelopment or partial redevelopment of the substation.
