132kV oil filled cable failure risk mitigation (feeders 228, 22W and 233)

Case for investment FY23
October 2022

Investment Title	132kV oil filled cable failure risk mitigation
<< project # / code >>	NTM-000535
Portfolio	Repex
CFI Date	
Pre RIT-D	<input checked="" type="checkbox"/>
Final CFI	<input type="checkbox"/>
Other	<input type="checkbox"/>

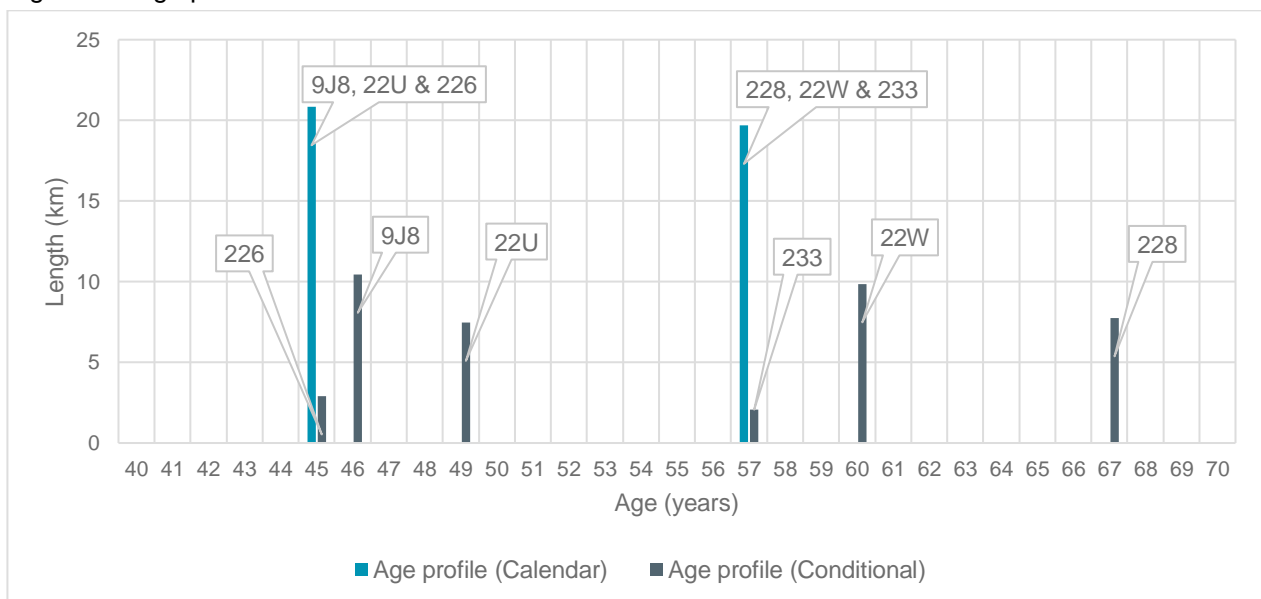
Figure 4 – Age profiles of 132kV oil filled cables

The age profile for the cables is shown in Figure 4. In this profile, the calendar age of each cable has been included as well as an adjusted age to reflect its assessed condition. The adjusted age profile represents the “conditional” age of the cables which better reflects the health of the assets than an age profile based on calendar ages.

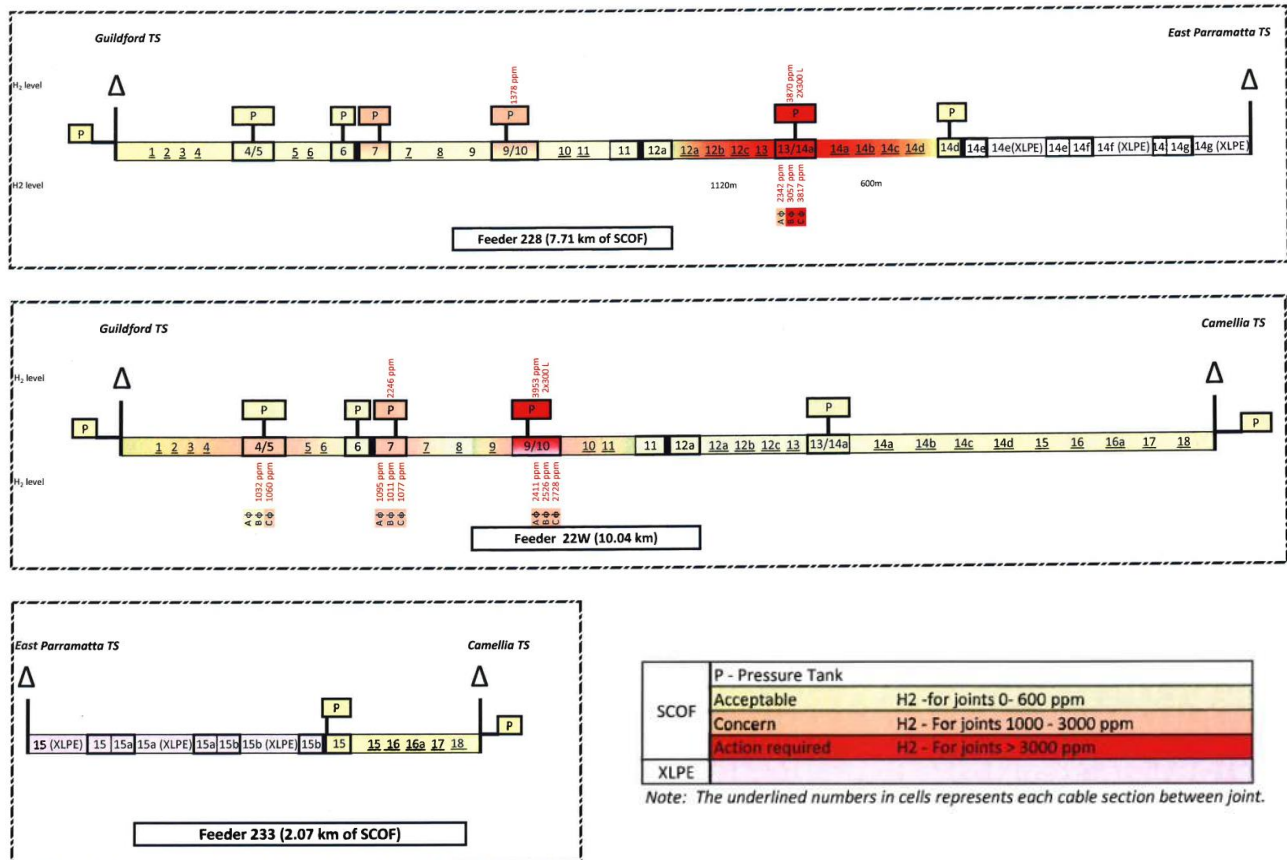
Figure 10 – Health of oil across sections of feeders 228, 22W and 233

The most recent results from the dissolved gas analysis have identified two sections of cable on feeders 228 and 22W with signs of moisture ingress and atmospheric contamination within the oil samples. This is indicative of environmental contaminants passing into the cable system through leaks in the outer cable layers, sheath and/or cable joints.

A further nine oil samples taken from joint locations across feeders 228, 22W, 22U and 9J8 show poor oil health ratings from dissolved gas analysis. The low ratios of carbon dioxide to carbon monoxide in the oil samples on feeders 22U and 9J8 indicate signs of paper degradation while the high hydrogen levels in oil samples on feeders 228 and 22W are indicative of high electrical stresses.

A summary of the health of the oil across each section of the oil filled cables is provided in Figure 10 and Figure 11. The analysis results are based on criteria provided in the Electric Power Research Institute (EPRI) – Canada report No. 1000275 (September 2000).

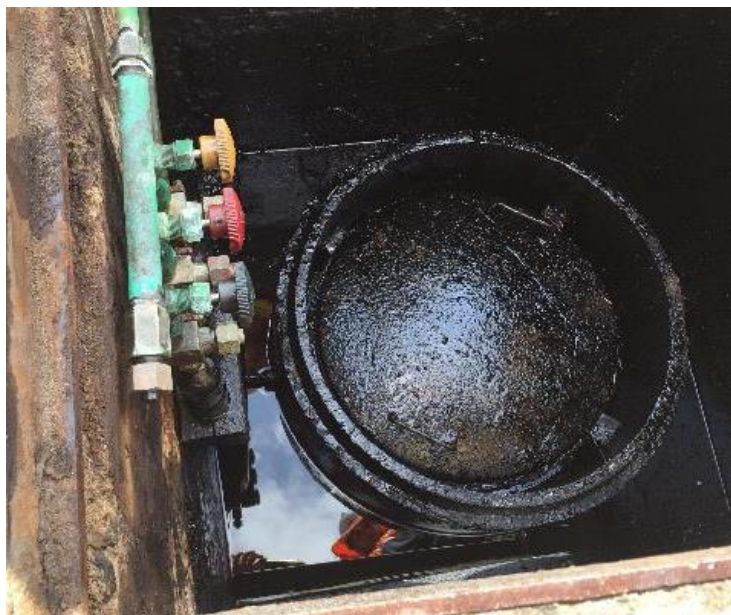
Top Left – Feeder 228 joint bay 4-5 (cable oil in base of joint pit) - 2017

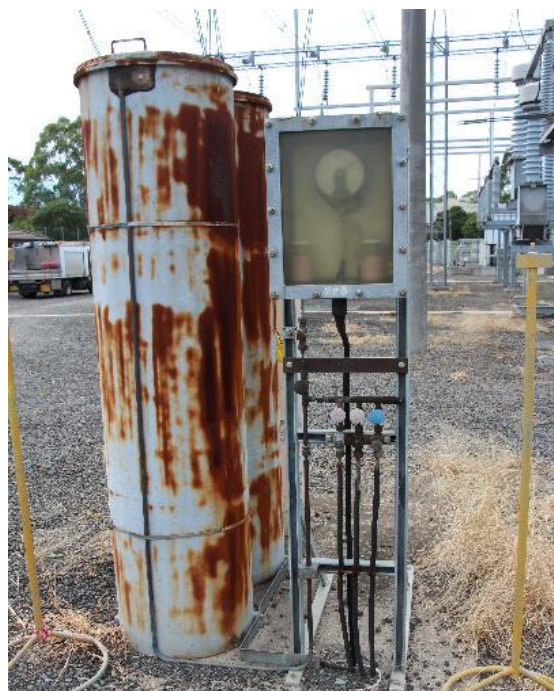
Top Right – Feeder 228 at Guildford TS (severely corroded oil reservoir tanks prior to TM302) - 2017

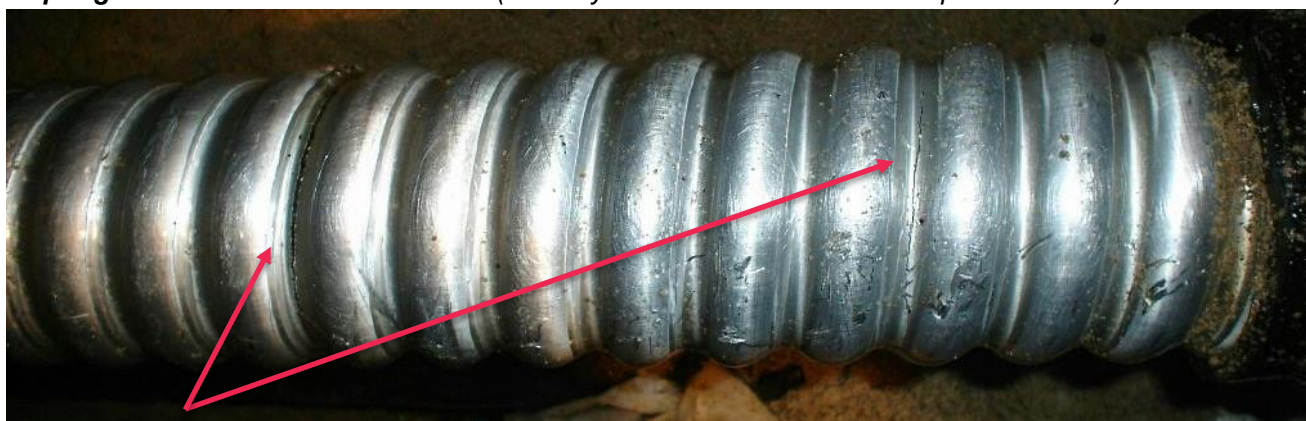
Concerns with the condition of the oil filled cables were initially raised in 2011 after the discovery of a major oil leak on feeder 233. The leak required significant repair works at the time totalling \$650,000. The source of the failure was traced to a damaged section of cable sheath. This initial area of failure was located where feeders 233 and 22W pass under both the M4 motorway ramps and James Ruse Drive in Rosehill. At the time of the failure, it was suspected the cause of this damage was due to earth subsidence from a burst water main which occurred four years prior in 2007. During the subsequent investigations, numerous cracks unrelated to the area of the burst water main were visually identified in the sheaths raising concern for the overall condition across other sections of oil filled cables, with the same type of lead sheaths, installed in the network.

Middle – Feeder 233 sheath (existing cracks around sheath and additional cracks forming) - 2011

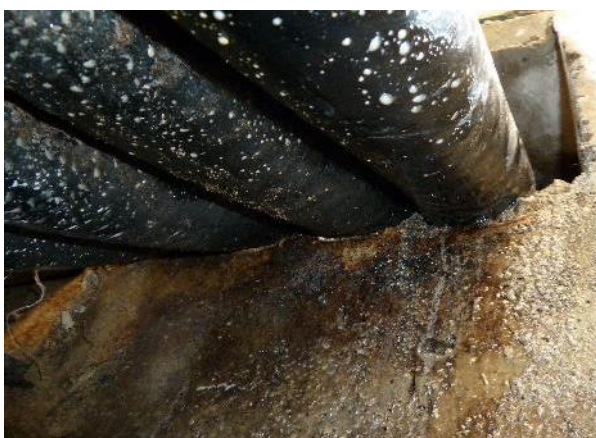
Bottom left – Feeder 9J8 (leaking oil at bridge crossing in Rosehill) - 2013

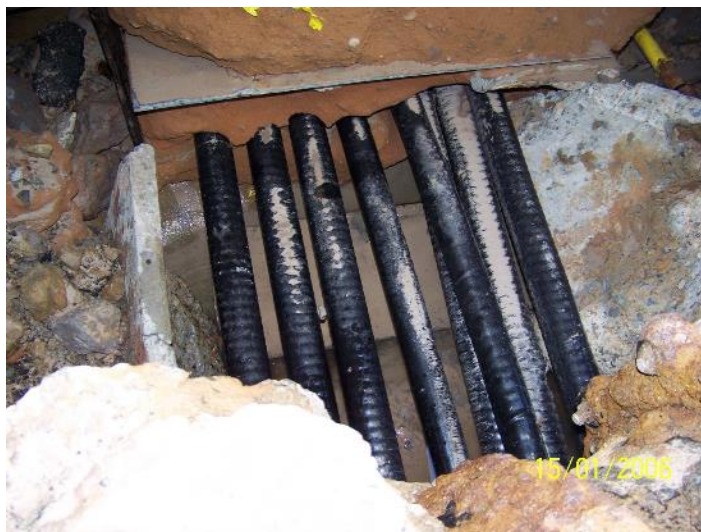
Bottom Right – Feeder 22W & 233 (ground subsidence and debris impacting cables after water mains failure in 2007) - 2007
