Timber Poles Overview and Opportunities

Network Failure Investigation

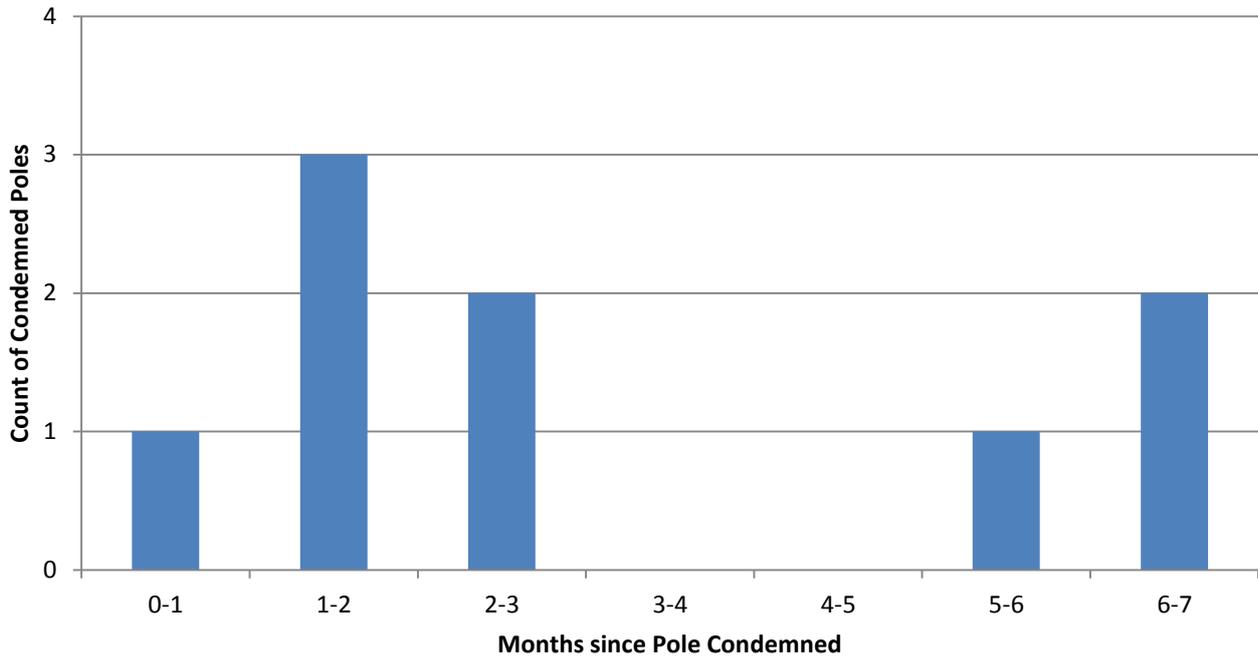
Figure 5: Functional Failures - Months since Condemned (condemned only)

- 9 of the poles that failed (13%) were condemned at the time of failure (see Table 13 and Figure 5). These failures could have possibly been prevented, either by improved prioritisation or by strutting when they were condemned. An additional pole (pole CE171623) had a previous replace work task that had been closed in WASP in recent years, but appears not to have actually been replaced. The 9 condemned failures are explained below;

The count of poles vs the number of months since the pole was condemned is shown in Figure 5.

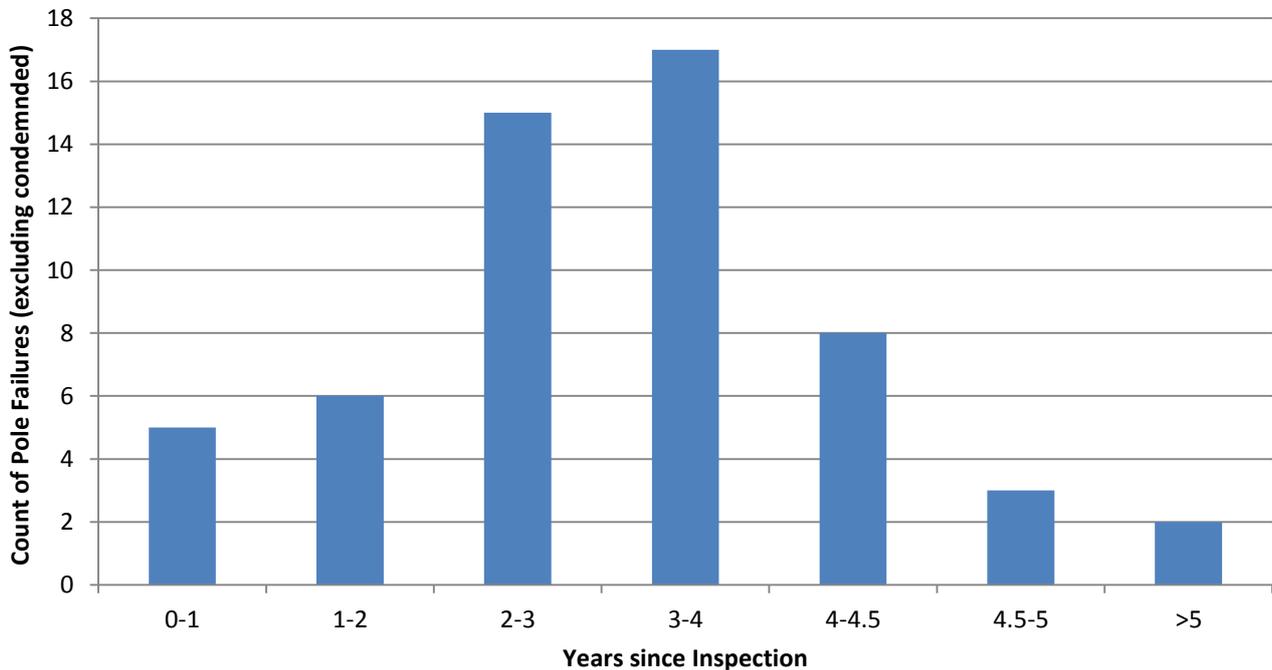
Figure 6: Functional Failures - Years since Inspection (excluding condemned)

NOTE: Figure 6 shows the number of failures vs the time since inspection. The failures that occurred greater than 4 years from inspection are from a smaller population (as the inspection frequency is 4 years with 6 months latitude), hence the significance of these failures is greater due to the smaller population.
