2017 Major Electricity Company BFM and ELC Audit

Audit Report

Jemena

September - October 2017

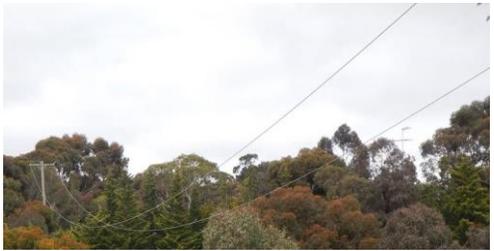
During the course of the Electric Line Clearance field assessment the auditor recorded one item which has been referred to Jemena for follow-up. The items related to an open wire LV POEL which didn’t have a spreader fitted. Refer photo’s below:

<p>Feeder: COO-011 LIS: A038861 Issue: Service runs from A038861 – query if spreader required.</p> <p>Referred to Jemena 6th October 2017.</p>

The item has been referred to Jemena to follow-up as per it’s POEL management procedures.

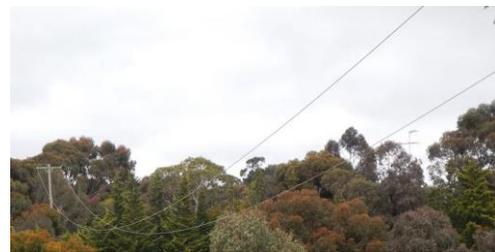
During the course of the field assessment the auditor identified 1 line item for follow-up by Jemena to determine if further action was required. The items has been discussed further in Section 2 of the report.

<p>Feeder: COO-011 LIS: A038861 Issue: Service runs from A038861 – query if spreader required.</p> <p>Referred to Jemena 6th October 2017.</p>
