Jemena Electricity Networks (Vic) Ltd

Replace Broadmeadows (BD) Zone Substation Transformer

2021 and 2022 Business Case

31 January 2020

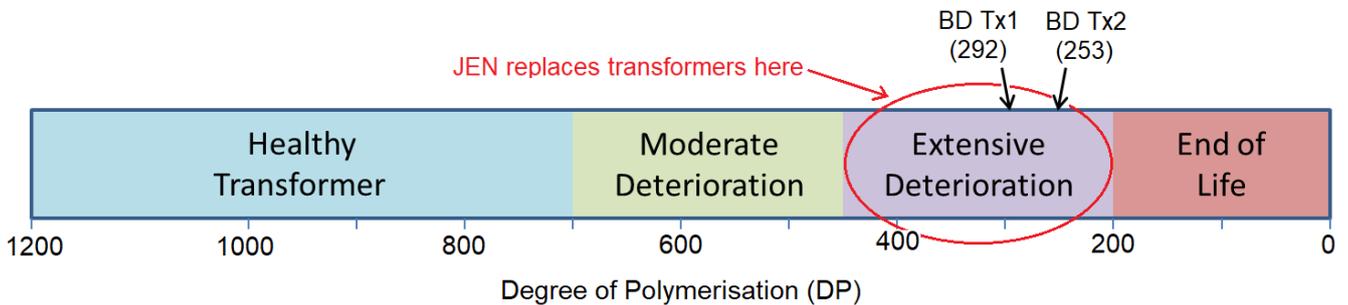
Figure 1–1: Degree of Polymerisation Index

The paper samples from the No.1 and No.2 transformers’ confirm that the mechanical strength of the cellulose is extensively deteriorated as shown below.

The paper samples at BD were taken from leads located within the top of the main tank, but DP values will be significantly lower within the transformer windings. The degradation of paper of a small localised area of insulation in the vicinity of the hottest spot within the transformer winding can be just as terminal as the degradation of the entire winding insulation. The DP of the No.1 and No.2 transformers at BD can be as low as 150 within the hottest spot of the winding which is well below industry standard. Refer to Section 2.2.1 for more information on the DP variance along a transformer winding.

The paper samples from the two transformers confirm the mechanical strength of the cellulose has deteriorated and is placing the transformers at risk of failure. A close in feeder fault will impose mechanical stress on the winding and may tear the paper and reduce the electrical insulation, resulting in a catastrophic transformer failure. This is the critical issue.

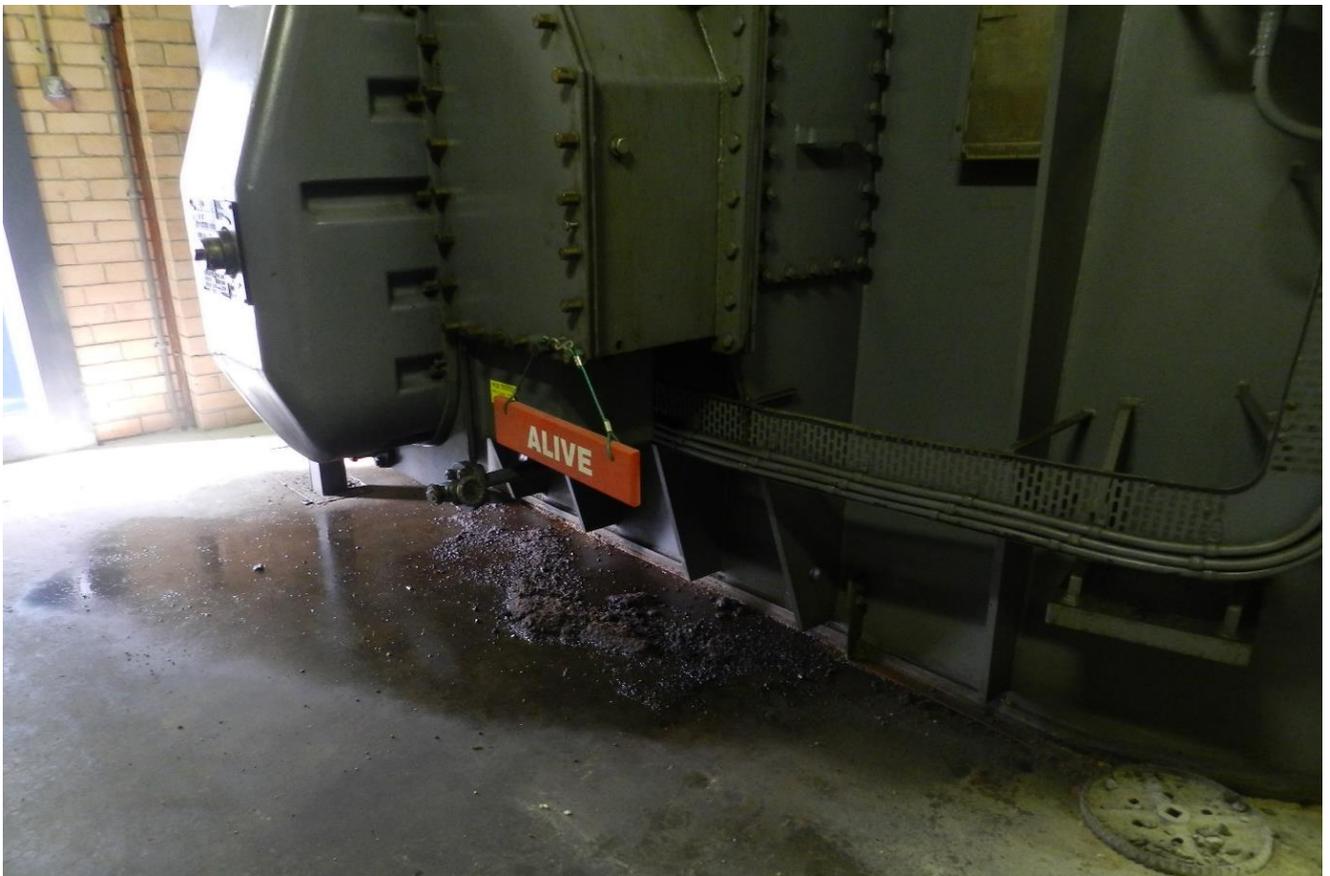
Figure 2–4: No.2 Power Transformer Oil Leaks

3. The transformers have a history of oil leaks on the main tank and radiators.

This is not an issue that is driving the replacement of the transformers however it does require elevated levels of operating expenditure to manage. The oil leaks make the transformers maintenance intensive.

There have been thirty two recorded defects on the transformers at BD since 2009. A capex life extension project was initiated in 2013 and the lid gaskets of the No.1, No.2 and No.3 transformers were replaced, the 66kV bushings were also replaced during the lid gasket project. The defects are shown in Table 2-3.

By replacing the transformers the maintenance costs could be minimized and used to offset the cost to replace the transformer/s.

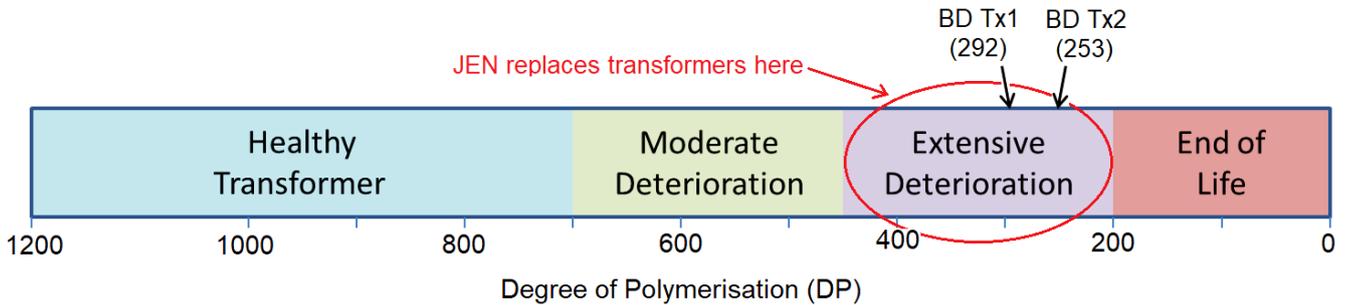
Figure 2-5: Degree of Polymerisation Index

Currently the accepted method of life assessment for transformers is Degree of Polymerisation (**DP**) which quantifies transformer paper condition. While the determination of “end of life” is not absolute, a DP value of between 200 and 450 signifies that a transformer’s insulation has experienced extensive deterioration and should be scheduled for replacement before failure occurs. A DP value less than 200 signifies a transformer has reached end of life and is unreliable. The No.1 and No.2 transformers’ paper is extensively deteriorated as shown below.

The paper samples at zone sub BD were taken from leads located within the top of the main tank, but DP values will be significantly lower within the transformer windings. Statistically it can be expected that failure rates will increase quite rapidly as a result of the transformers present condition.

In addition the degradation of paper of a small localised area of insulation in the vicinity of the hottest spot within the transformer winding can be just as terminal as the degradation of the entire winding insulation. The DP of the No.1 and No.2 transformers at BD can be as low as 150 within the hottest spot of the winding which is well below industry standard.

The paper samples from the two transformers confirm the mechanical strength of the cellulose has deteriorated and is placing the transformers at risk of failure. A close in feeder fault will impose mechanical stress on the winding and may tear the paper and reduce the electrical insulation, resulting in a catastrophic transformer failure. This is the critical issue.
