# Jemena Electricity Networks (Vic) Ltd

## Replace Coburg South (CS) Zone Substation Switchgear

2024 and 2025 Business Case

31 January 2020

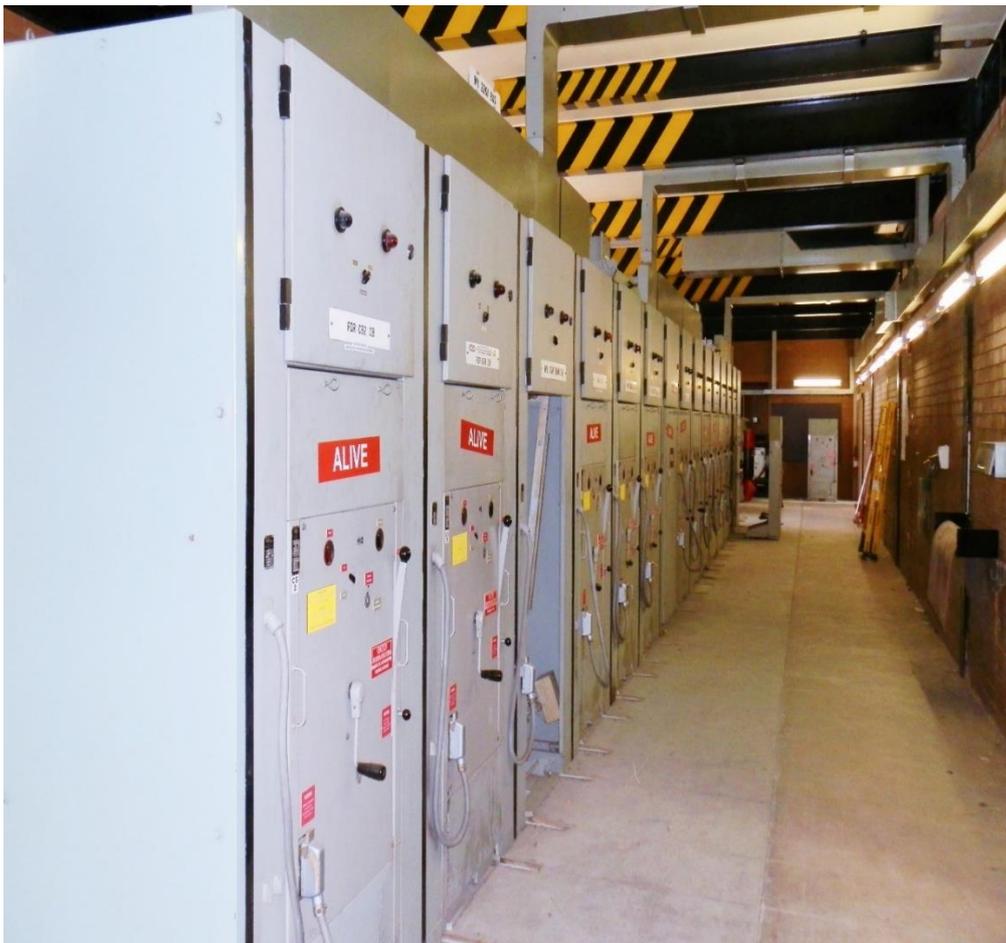
**Figure 2–2: CS 22kV Switchgear**

The two indoor 22kV metalclad buses and associated CBs at Zone Substation CS are estimated to be 51 years old. The circuit breakers are minimum oil circuit breakers and were manufactured by Sprecher & Schuh type HPTW306-FS in 1967.

It has been found that the Sprecher & Schuh HptW306 22kV CBs are leaking oil as a family from "O" ring seals on the drive shafts. This defect was identified during a routine annual audit of the switchgear at ZSS CS in 2013. A program was initiated for the urgent monitoring of oil levels and the replacement of all "O" ring seals in all of these CBs across JEN. As of 2014 all of the CBs on JEN have had their seals replaced.

In 2016 partial discharge (PD) was detected on switchboards at CS and NH during routine PD testing. An intrusive inspection was carried out subsequently and it was identified that there was visible PD damage on 22kV busbars and standoff insulators. The switchboards had non-OEM modifications made to them at the time of installation. These modifications included PVC conduit covers over bus bars to increase BIL and the addition of plastic barrier boards to shield LV CT from the HV busbar connections. In the absence of design documentation, detailing the extent of non-OEM medications of the switchboards, the options to rectify the defects are limited.

The presence of PD and the oil leaks are the most serious defects identified on the Sprecher & Schuh HptW306 switchgear as they have the potential for catastrophic failure.

It is recommended that Option 5 be adopted and the two 22kV metalclad buses and the 66kV bus tie CB be replaced with new modern equivalents and installing them to current standards. The replacement of the switchgear is recommended and consistent with regulatory requirements in section 6.5.7 of the National Electricity Rules, and section 3.1 of the Electricity Distribution Code.

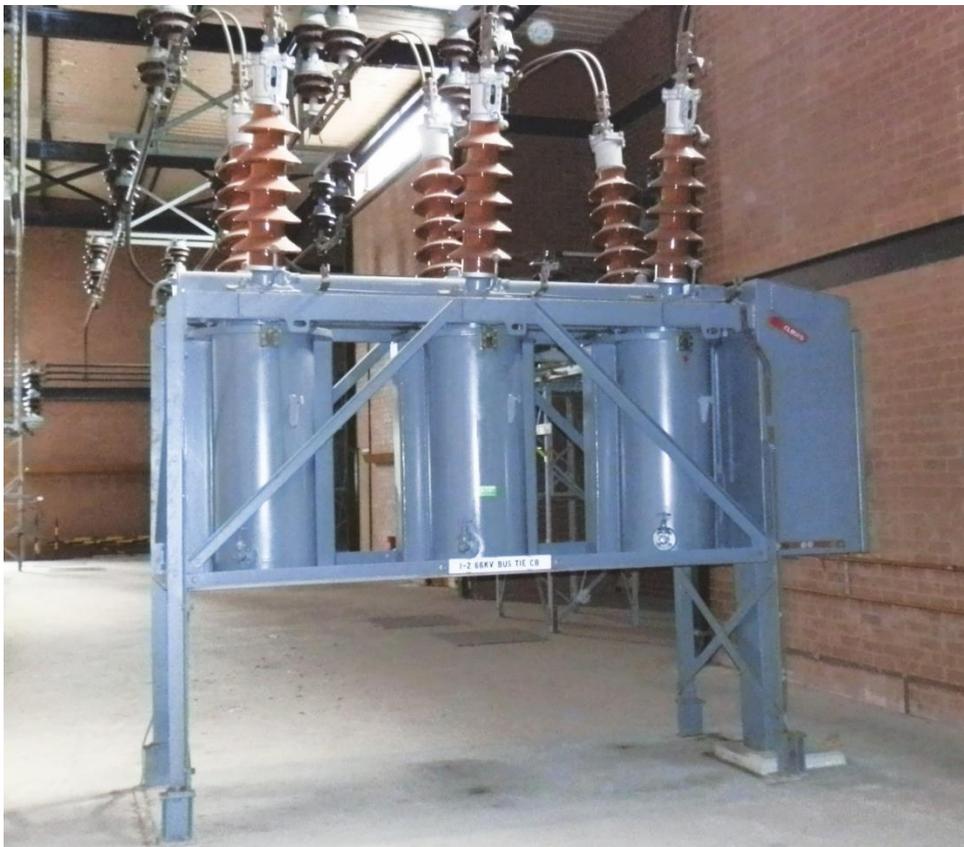
**Figure 2-3: CS 66kV Bus Tie CBs**

There have been no recorded defects on the 1-2 66 kV Bus Tie CB on JEN; however there are records of this type of CB, in the Victorian Electricity Industry, with a history of defects and catastrophic failures. Please refer to Section 2.2.1, dot point 5 for further details.

There were two catastrophic failures of this type of CB at Brooklyn and one at West Melbourne Terminal Stations in the late 1990's and early 2000's and these failures related to the 66kV bushings as the bushing DLA (Dielectric Loss Angle) had deteriorated to point causing failure.

These CBs are no longer supported by the manufacturer and consequently spare components such as 66kV bushings, turbulators, solenoids and mechanism components are no longer available. The failures of the 66kV bushings is a risk to the safety of field crews. Continued maintenance and testing will not prevent the failure of a bushing as the DLA and PD continues to deteriorate. The cost of engineering new replacement bushings, procurement and installation would be comparable to a new CB installed. Replacement of the bushings alone does not address the mechanical wear and lack of spare parts

There has been a defect identified in the mechanism of these CBs involving the retaining of a shaft by a washer that is peened on the end of the shaft. This indicates component failure due to mechanical wear and has resulted in damage to the mechanism. A new component was designed and manufactured as original spare parts are not available. An inspection of all of these breakers has been undertaken and a plant defect notice issued. This shows that the CBs are entering a wear out phase and due to a lack of spare parts, components are being reengineered independently outside of the original equipment manufacturer specification which takes time, and is costly. This development of a single pin cost in excess of \$5,000 to develop.

For the 66kV CB, the CBRM modelling indicates that the CS 1-2 66kV bus tie CB has a current health index (Y0) result of 5.45. This indicates that the CB is in a poor condition. In Year 6 (2025, Y6), the CB result becomes 6.81. This modelling result is consistent with the issues identified.

The 1-2 66kV bus tie CB will also be replaced with a new SF6 dead tank circuit breaker as per current Jemena standard.

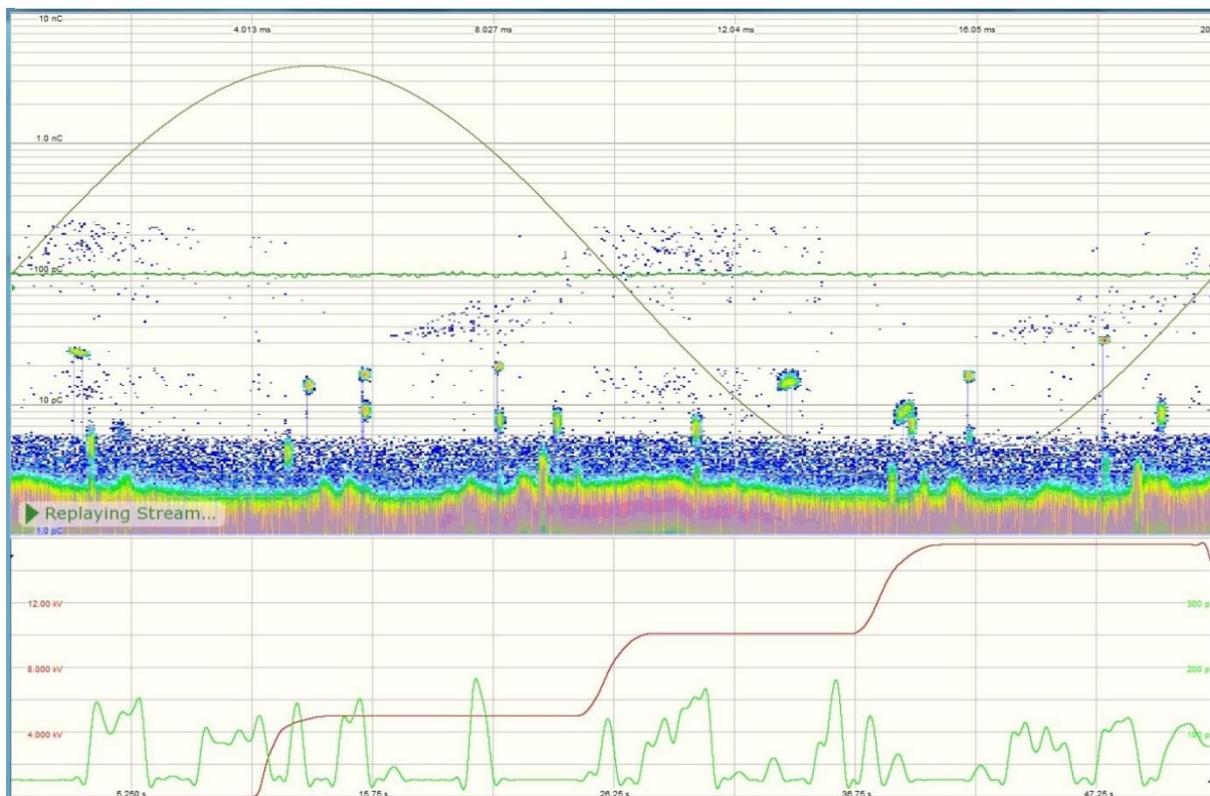
No.1 22kV Bus Red Phase Partial Discharge measurements

Sprecher and Schuh HPtW306-FS circuit breakers installed at zone substation CS are showing signs of age related deterioration. During recent condition monitoring tests they exhibited PD activity which is a sign of degraded insulation. PD is an electrical discharge which occurs in the voids within the insulation and results in irreversible damage due to carbon build up in the voids.

The presence of PD on the switchgear could be attributed to the lack of air gaps between the PVC conduit covers and the solid insulation, especially around exposed copper busbar conductors. However, because of the absence of design documentation detailing the extent of the non-OEM modifications, and a conclusive cause for the elevated PD, it is not feasible to introduce remedial changes as this could exacerbate the issue further.

Partial Discharge levels for new HV plant are typically less than 50pC and consistent with good industry practice. Partial discharge measurements are used in industry to detect defects in HV insulation in either new or aged HV plant. Experience shows that partial discharges have led to a progressive degradation in the dielectric strength of the insulation. For solid insulation, acceptable limits of 10 pC are stated in AS 62271.200-2005 HV Switchgear and Control Gear.
